Coastal Management for Traditional Villages

June
2011

COASTAL MANAGEMENT FOR TRADITIONAL VILLAGES: ROYAL OAK ASSESSMENT

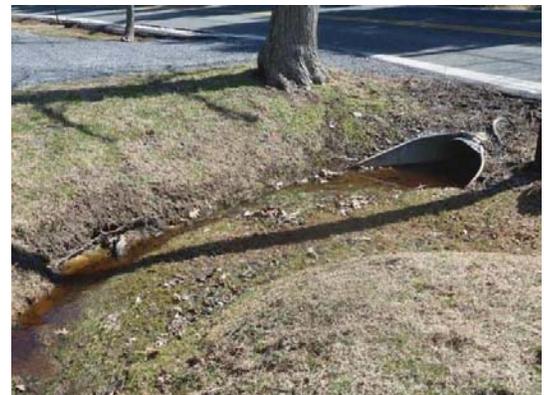
Figure 1. The culvert at Royal Oak Site 3 has been directly connected to another culvert without using a junction box, which impacts the drainage system by reducing flow capacity.

Drainage system upgrades are recommended at Sites 1, 2, 3 and 5. Upgrades include adding manhole structures or junction boxes at pipe connections as needed to increase flow capacity (Figure 1); installing headwall or end wall sections as needed to improve culvert hydraulics and capacity; and replacing old and broken sections of pipe. Because part of the system is underground, identifying and prioritizing the upgrades would include using video inspection equipment or other means of investigating the actual alignment and pipe system condition.

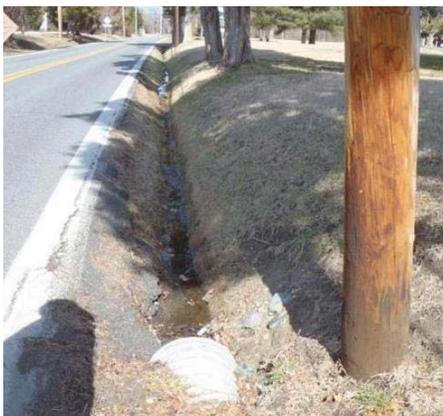
Figure 2. The flat bottom and vertical side slopes of this ditch at Royal Oak Site 2 can contribute to flooding and reduced flow capacity but can be improved with changes to ditch maintenance.

Periodic maintenance of the system over the years to remove sediment has resulted in very rectangular ditch cross sections (Figure 2). This is generally considered unsafe when positioned within the roadway clear zone and, over time, will reduce flow capacity in the ditches and adjacent culverts, increasing the frequency of minor flooding over the roadway.

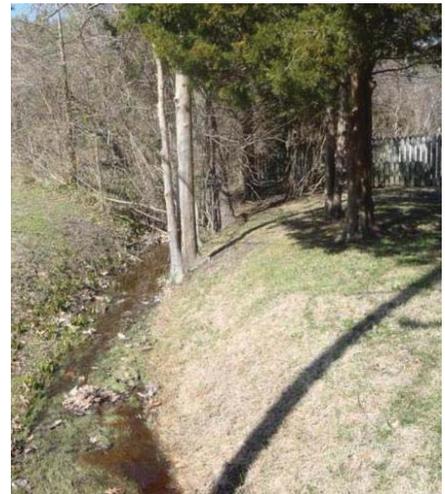
Figure 3. Minor channel erosion at Royal Oak Site 3.

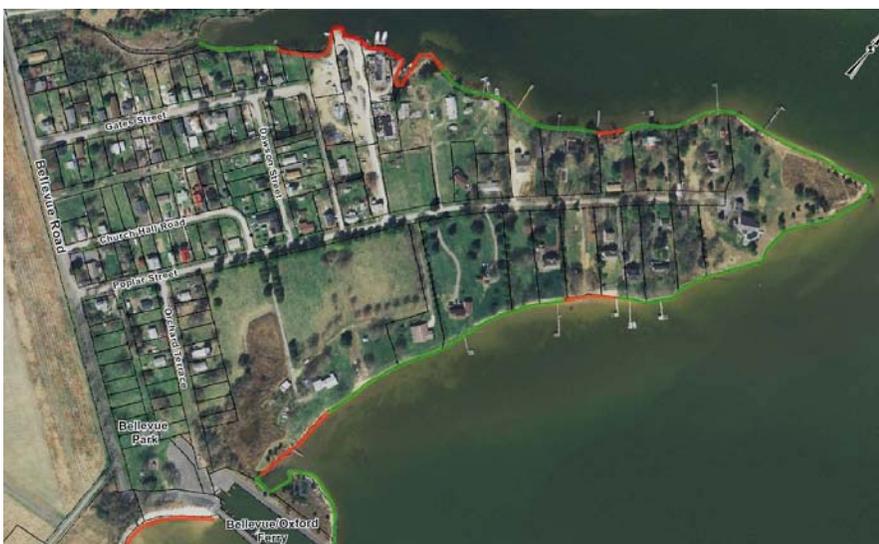
Map 2. Village of Bellevue. Bay Land Consultants & Designs, Inc. determined that there were 4,285 linear feet stable shoreline (shown in green) and 1,875 linear feet unstable shoreline (shown in red).

Shoreline erosion: The shoreline is mostly protected with bulkhead or revetment armoring. Around 30% of the shoreline is considered unstable (shown in red in Map 2), with the most significant erosion in the northwest of the peninsula where Tar Creek empties into the Tred Avon River. Several landowners here have experienced failure of the stabilization system.

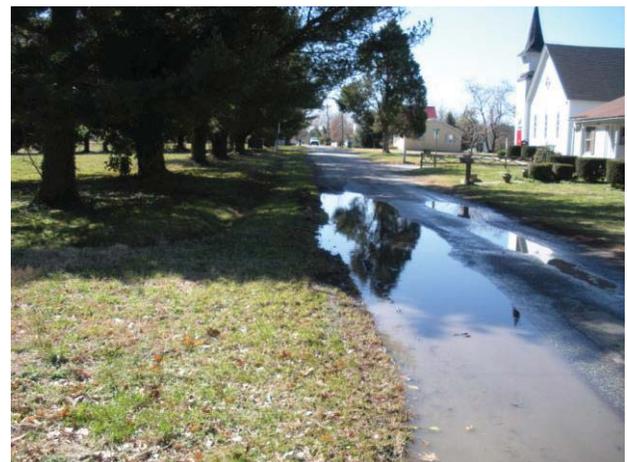
The interior roads of the Bellevue Village are either deteriorated asphalt or gravel surfaces. The road edge often becomes the collection point for concentrated stormwater flows (see Figure 6), resulting in gully erosion and high sediment loads. The recommendation is to resurface the roads so that water drains properly and prevents accelerated deterioration and erosion of the driving surface. Additionally, it would be beneficial for individual property owners to maintain their driveways in a manner that reduces the amount of water ponding at the edge of the driveway and road surface.

Figure 6. Interior Bellevue Village road.

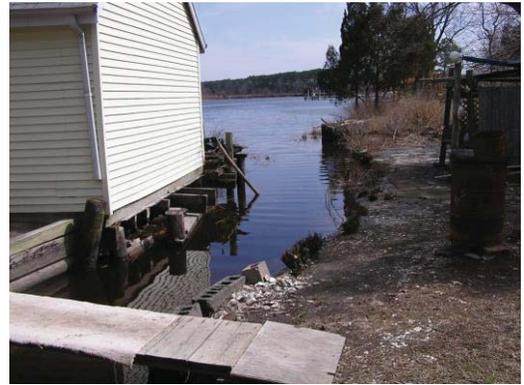
Figure 10. Shoreline erosion can be alleviated by living shorelines. Oak 4 and Section 9 site where a stormwater gravel wetland and living shoreline was recommended.

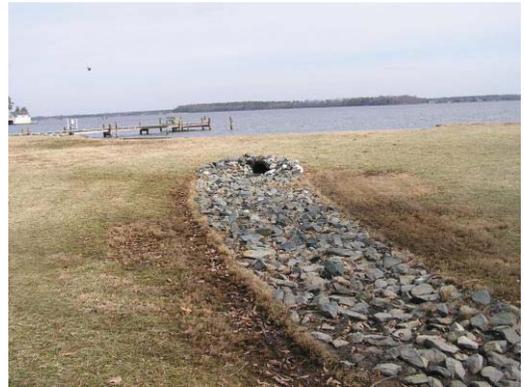
Figure 11. Miles 2 where a proposed swale and native plants could be placed.

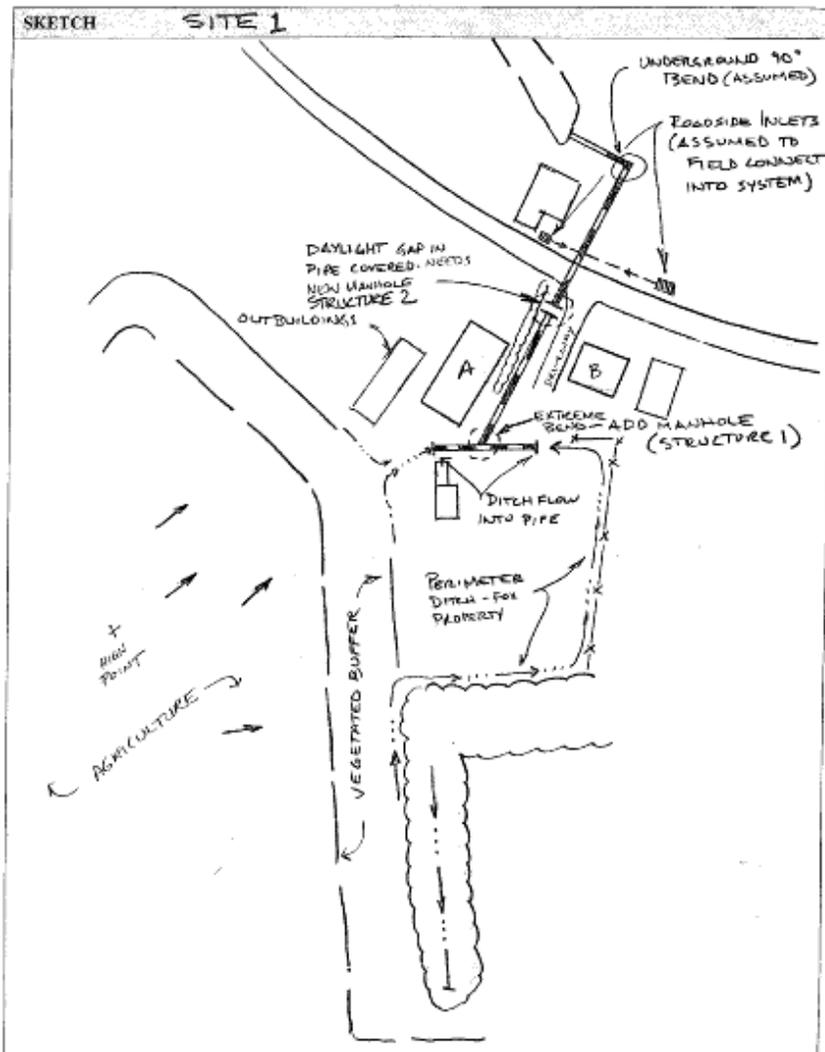
Drainage System Upgrades: The drainage system described in Site 1 represents the most extensive system observed: multiple inlets and underground pipe alignments connecting private and public (County and State road) drainage systems, including possible field connections. Similarly, the system described in Site 2, while much simpler, was also difficult to accurately assess. The observed alignment of what appeared to be single run pipes or culverts did not continue to the expected terminus inlet (no pipe outlet or connection located in the field), indicating a possible underground horizontal bend or field connection.

Figure 5. Site 1 system was sketched from field work and includes drainage inlets serving Royal Oak Road.

Drainage system upgrades would include a prioritized list of system components identified at Sites 1, 2, 3 and 5. Upgrades include eliminating field connections and horizontal bends by adding manhole structures or junction boxes, the installation of headwall or end wall sections as needed to improve culvert entrance hydraulics and capacity, and the replacement of old and broken pipe (or sections of pipe). Identifying and prioritizing the upgrades would include using video inspection equipment or other means of investigating the actual alignment and pipe system condition.

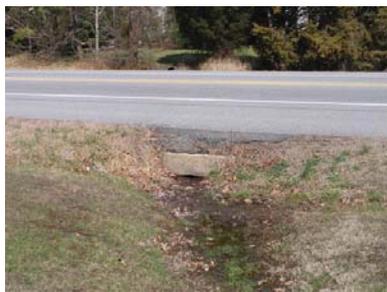
Photo 63

The most noteworthy item discovered from the field investigation was that a majority of the driveway and cross culverts were clogged between 50-75% with sediment. This factor of clogged culverts and minimum slopes in ditches results in extended ponding or flooding in the low lying areas.

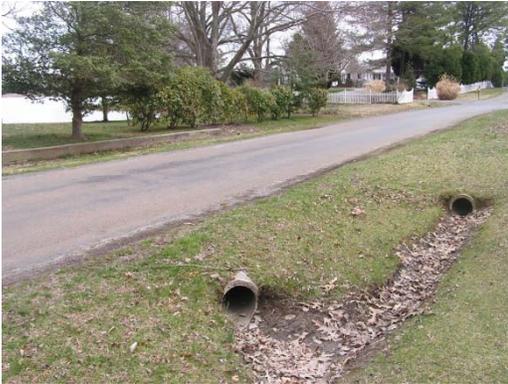
Photo 103

OAK 5 is an outfall culvert that receives runoff from River Road. Two culvert pipes and a roadside swale drain towards the outfall culvert. Although the downstream of the pipe was identified, the upstream side was not visible (P103 - P104). The outfall pipe discharges through a deteriorated timber bulkhead (P105) where significant washout is evident (Photo 105A). In observing the elevations of the pipe's downstream invert compared to the estimated upstream invert, it appears the pipe has a negative slope. Outfall pipe and bulkhead are in disrepair.

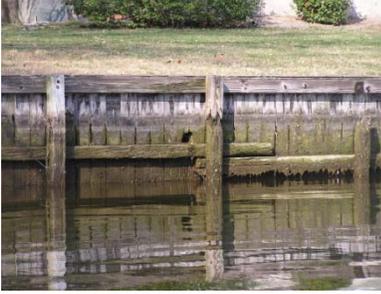
<p>Photos: W63 – W67</p> <p>Remarks: Aged bulkhead in need of replacement. Openings between timber sheeting boards evident. At time of investigation, water was draining from hole in bulkhead (shown in picture). Pipe visible in hole (Photo 67). OAK 5 daylight through bulkhead. Area behind OAK 5 is washed out (Photo 103 & 105A).</p>					
9	265'	Natural - Vegetation	Moderately Unstable

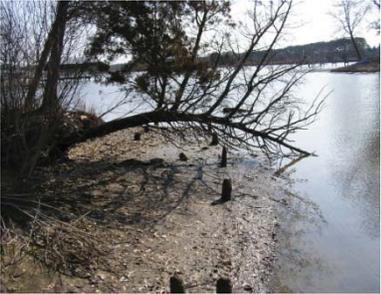
<p>Photos: W68 – W73</p> <p>Remarks: Small peninsula and mud flat area with a natural shoreline. Broken piles are evident around perimeter of peninsula, indicating possible bulkhead existed here at one time. Elevations on peninsula are high enough to support upland evergreen trees. Peninsula transforms into a mud flat area which is the outfall of OAK 4 (Photo 73).</p>					
10	75'	Make Shift Bulkhead	Moderately Unstable

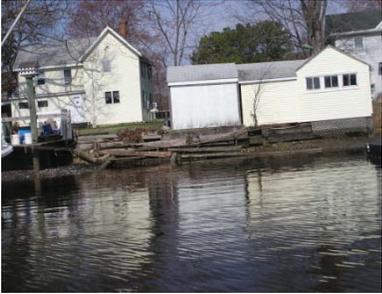
<p>Photos: W74 – W75</p> <p>Remarks: Make shift bulkhead made from various sized and located boards. Sheds/buildings located directly behind bulkhead.</p>

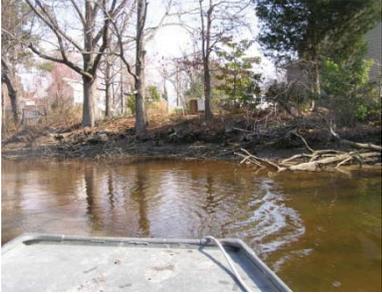
<p>Photos: W76 – W77</p> <p>Remarks: Natural shoreline covered with sparse vegetation and trees. Limbs and minor scouring are evident on northwest side of cove. Mud flat outfall of OAK 3 is located before scoured shoreline. Area is secluded thus it is anticipated that erosion is caused by either rainfall or refracted waves from nearby bulkhead.</p>

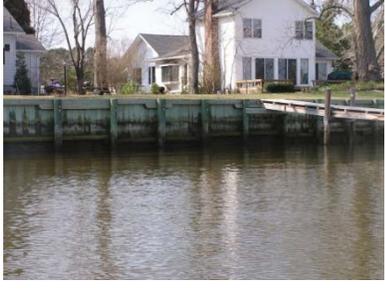
<p>Photos: W96 – W109</p> <p>Remarks: Timber bulkhead of various ages. Appears bulkheads have been sporadically replaced over the years. Some sections are recent construction. 165' of bulkhead fronting new construction at end of Beach Av. is in state of disrepair (Photos W106). This is the outfall location of MILES 3 (Photo 105). Sand accretion is apparent in front of some bulkhead sections.</p>
