# BRETON BAY STREAM CORRIDOR ASSESSMENT SURVEY

Robin Pellicano and  
Kenneth T. Yetman

WATERSHED RESTORATION DIVISION  
CHESAPEAKE AND COASTAL WATERSHED SERVICES  
MARYLAND DEPARTMENT OF NATURAL RESOURCES  
ANNAPOLIS, MARYLAND

January 2003

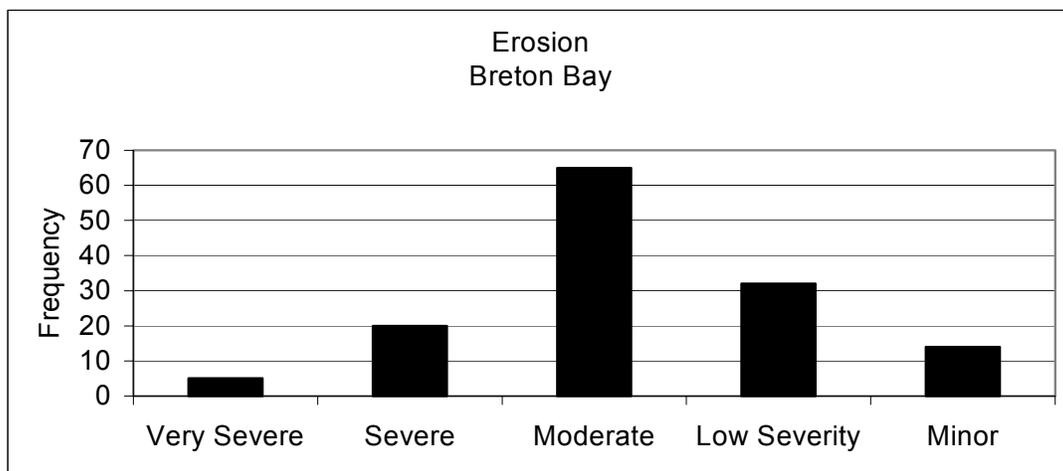
**Figure 5b Histogram showing the frequency of severity ratings given to erosion sites during Breton Bay SCA survey.**

Erosion is a natural process and necessary to maintain good aquatic habitat in a stream. Too much erosion, however, can have the opposite effect, destabilizing stream banks, destroying in-stream habitat and causing significant sediment pollution problems downstream. Severe erosion problems occur when a stream's hydrology and/or sediment supply have been significantly altered. This often occurs when land use in a watershed changes. As a watershed becomes more urbanized, forest and agricultural fields are developed into residential housing complexes and commercial properties. As a result, the amount of impervious surface in a drainage basin increases, which then causes the amount of runoff entering a stream to also increase. In the Breton Bay watershed, 4.3% of the landscape surface is impervious (Watershed Profiles-Breton Bay, 2002). The stream channel will, over time, adjust to the new flows by eroding the streambed and banks to increase its size. This channel readjustment can extend over decades, during which time excessive amounts of sediment from unstable eroding stream banks can have very detrimental impacts on the stream's aquatic resources.

Unstable eroding streams are areas where the stream banks are almost vertical and the roots from the vegetation along the stream's banks are unable to hold the soil on the banks. Unstable eroding stream banks were reported at 136 sites during the survey (Figure 5a). The majority of the erosion sites showed moderate to minor erosion that extended over long distances. The lengths of stream segments that were recorded as having unstable banks varied from 20 feet in some areas, to other areas where up to 6,200 feet of stream were found to have an erosion problem (Appendix B). Overall, results indicate approximately 21.8 miles of unstable eroding banks in the Breton Bay watershed. Figure 5b shows the frequency of the severity rating given to erosion sites. Five sites received a very severe rating. One area of special note is an unnamed tributary to McIntosh Run. The unnamed tributary flows east to west and enters the lower portion of the stream near Route 5. Survey crews found a number of significant erosion problems along this unnamed tributary.

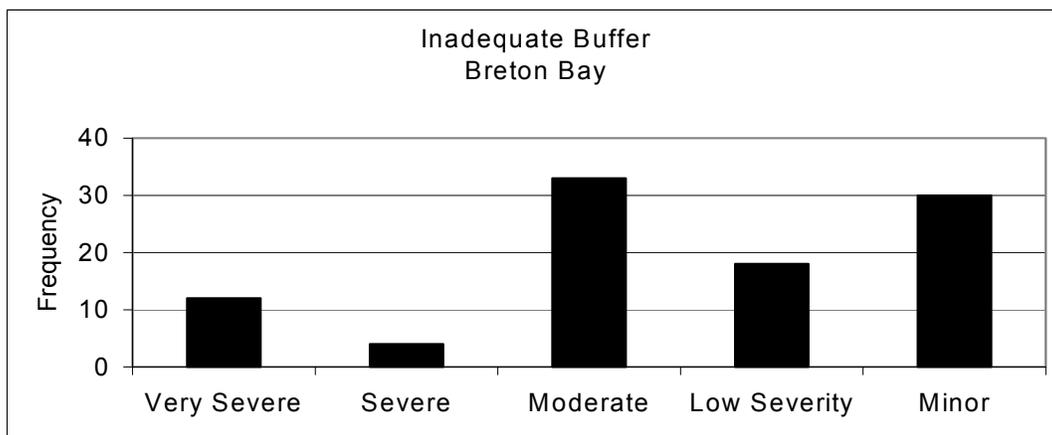
**Figure 6b Histogram showing the frequency of severity ratings given to inadequate buffer sites during Breton Bay SCA survey.**

While there is no single minimum standard for how wide a stream buffer should be in Maryland, for the purposes of this study a buffer is generally considered inadequate if it is less than 50 feet wide, measured from the edge of the stream. Inadequate buffers were reported at 97 sites during the survey and their locations are shown in Figure 6a. The field crew provided a rough estimate of the length of the inadequate stream buffer at all sites (Appendix B). Based on the data that was collected, there are approximately 59,635 feet (11.3 miles) of inadequate buffer in the Breton Bay watershed. Field teams found inadequate buffers ranging in distance from 30 feet to 2,600 feet. This survey was done in a mostly rural area, with crop fields and pasture reported as the dominant adjacent land use at inadequate buffer sites, accompanied by a moderate amount of lawn. Most sites received a moderate to minor severity rating (Figure 6b). This would indicate that most of the stream reaches with inadequate buffers were not very long or some trees were already present at many of the sites.

Survey results indicate that there are several possible locations where forested buffers could be reestablished. Almost half of the most severe sites were where agriculture was the dominant land use. These areas may qualify for inclusion into the Maryland Conservation Reserve Program, which provides farmers with financial assistance to establish forested buffers along stream on their property.

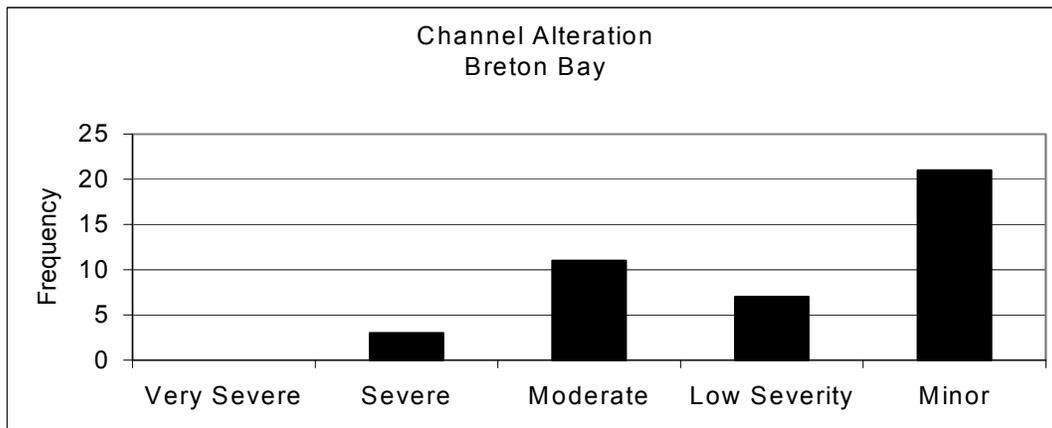
**Figure 7b Histogram showing the frequency of severity ratings given to channel alteration sites during Breton Bay SCA survey.**

Results of this survey indicate that the stream has been recognizably altered in 42 areas and their locations are shown in Figure 7a. The total length of stream affected by channelization was estimated to be 14,366 feet or about 2.7 miles. Sixteen sites were channelized with concrete, nine were earthen channels that had been straightened, and nine were reported to be armored with rip-rap. Only three sites received a severe rating. These sites were lined with rip-rap. Most of the sites were given a moderate to minor severity rating (Figure 7b).

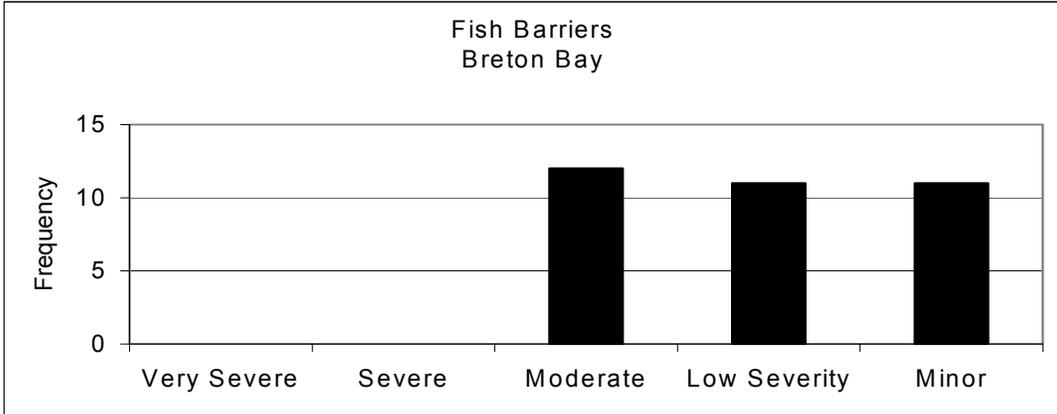
**Figure 8b** Histogram showing the frequency of severity ratings given to fish blockage sites during Breton Bay SCA survey.

Thirty-four fish migration barriers were reported during the survey. The locations of fish migration blockages are shown in Figure 8a. The blockages were due to a number of reasons including road crossings (18), in-stream ponds (5), and natural falls (4). All of the sites were given moderate to minor severity ratings (Figure 8b).

One fish barrier, Site BBH12202, which isolates Town Run from Breton Bay, should be evaluated for a fish passage project. It is at the road crossing for Fenwick Street. The water level is too shallow for the fish to pass through. Barriers that isolate significant portions of the upper portion of a tributary, such as Site BBE28401, BBJ12202, BBL19301, which are also road crossings, should also be evaluated.

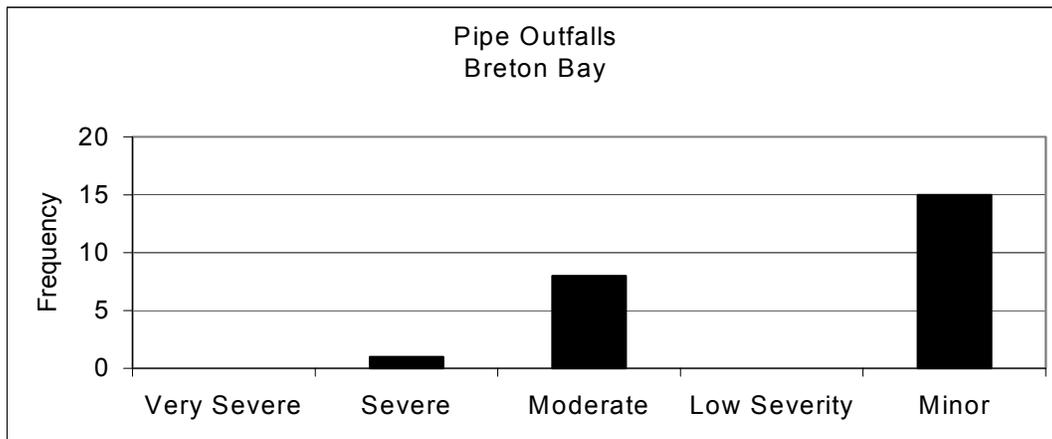
**Figure 9b** Histogram showing the frequency of severity ratings given to pipe outfall sites during Breton Bay SCA survey.

Figure 9b shows the frequency of the severity rating given to pipe outfalls during the survey. Most of the pipe outfalls were given either a moderate to minor severity rating.

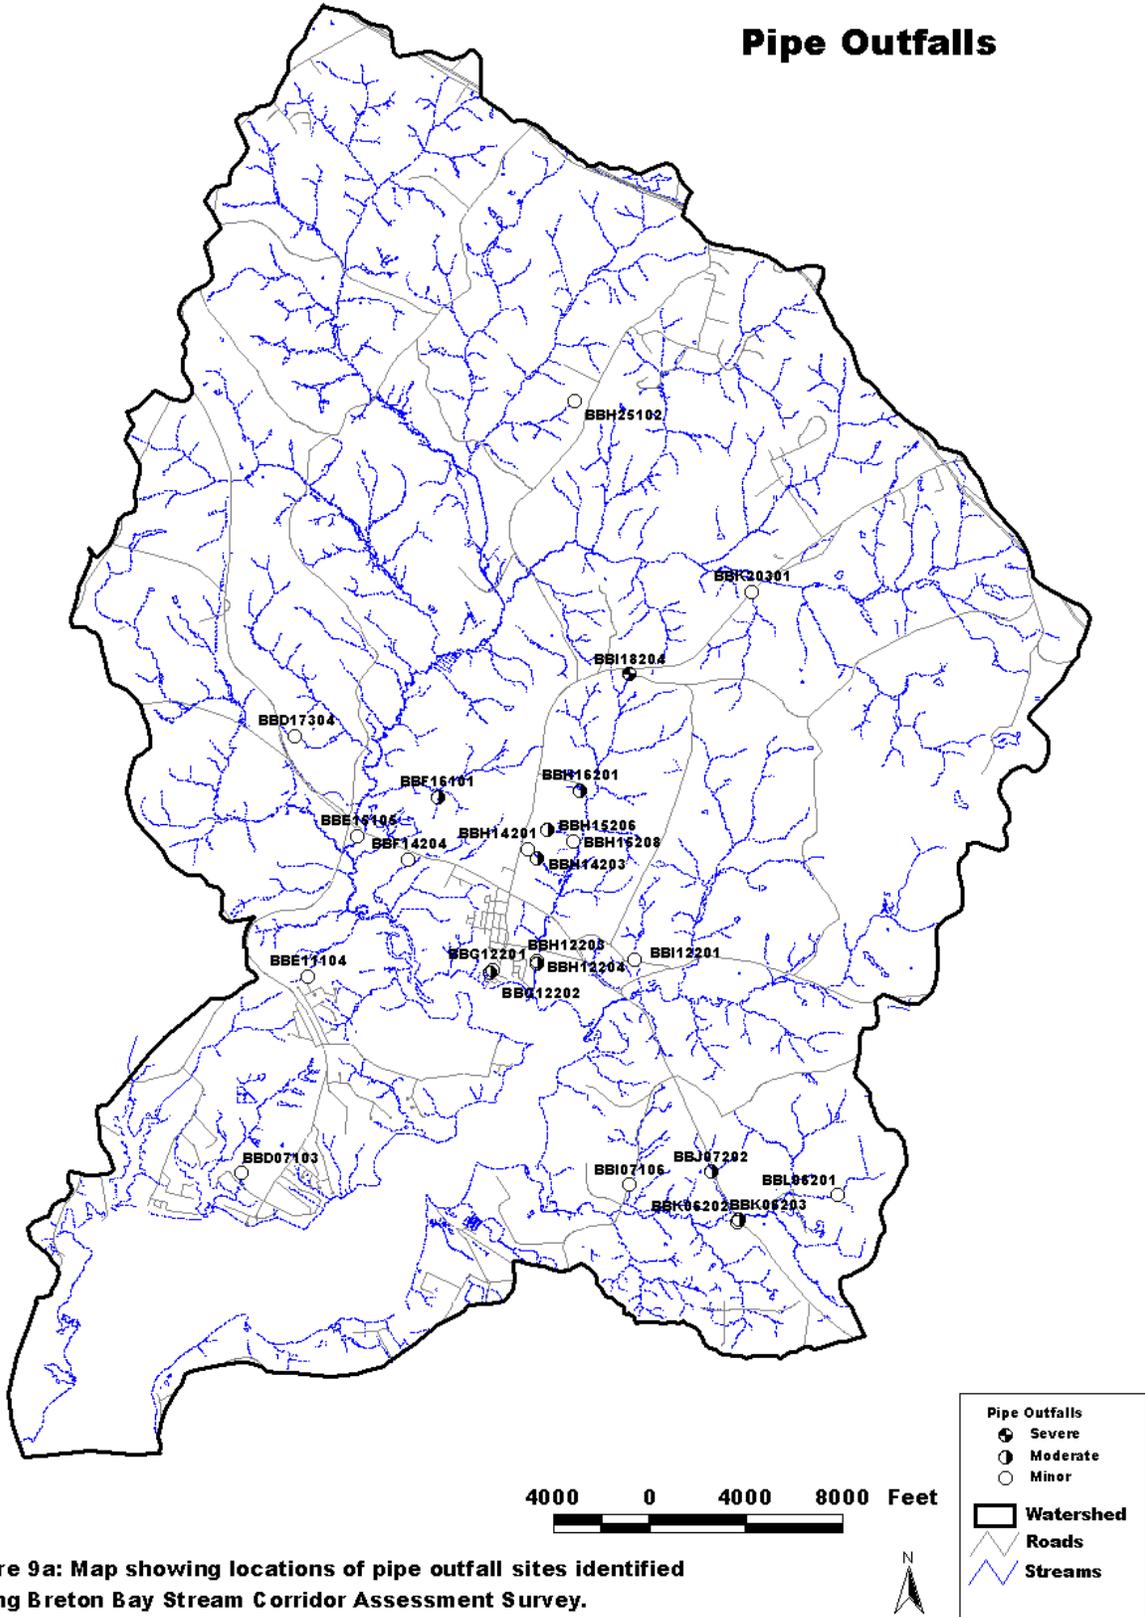
Figure 9a: Map showing locations of pipe outfall sites identified during Breton Bay Stream Corridor Assessment Survey.

Thirty-three percent or 8 of the 24 outfall pipes observed during the survey were found to have some type of discharge coming out of them. Of these, only one was reported to have a discharge that had some coloration or smell associated with it (Appendix B). At Site BBI18204 the pipe discharge was reported to be brown with a sewage odor. No immediate follow up actions were taken as part of this study to determine the source of the color or smell coming from the pipe. The remaining discharges were recorded as clear with no odor. There weren't any estimates of the amount of fluid coming from the pipes.

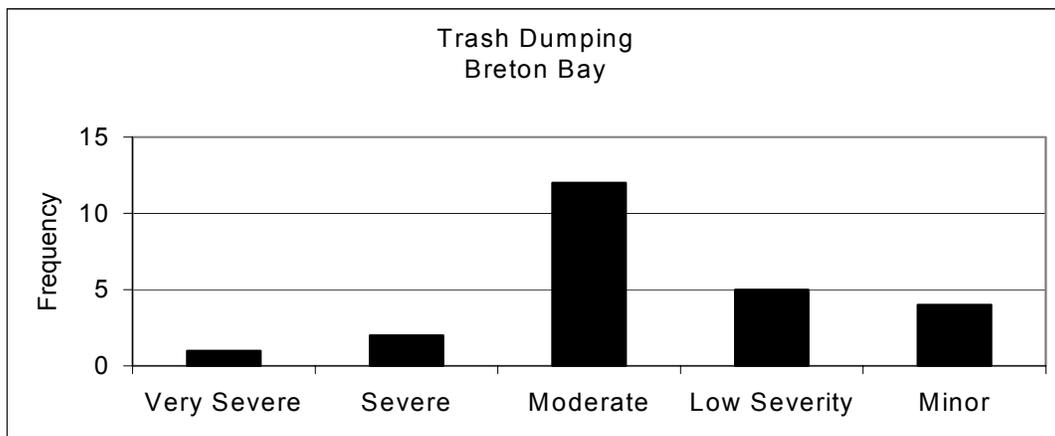
**Figure 10b Histogram showing the frequency of severity ratings given to trash dumping sites during Breton Bay SCA survey.**

The trash dumping data sheets are used to record the location of places where large amounts of trash has been dumped inside the stream corridor or to note places where trash tends to accumulate. The field survey crew found twenty-four sites where there was excessive trash and their locations are shown in Figure 10a. One site was very severe. At site BBL08102 old cars were dumped near the stream. Two sites were reported as severe. The sites had mixed types of trash. The trash ranged from recyclables to appliances and engines. Two sites were recorded as having yard waste, eleven had residential waste, two were construction, two were industrial, and four were recorded as tires. These sites were given severity ratings ranging from moderate to minor (Figure 10b).

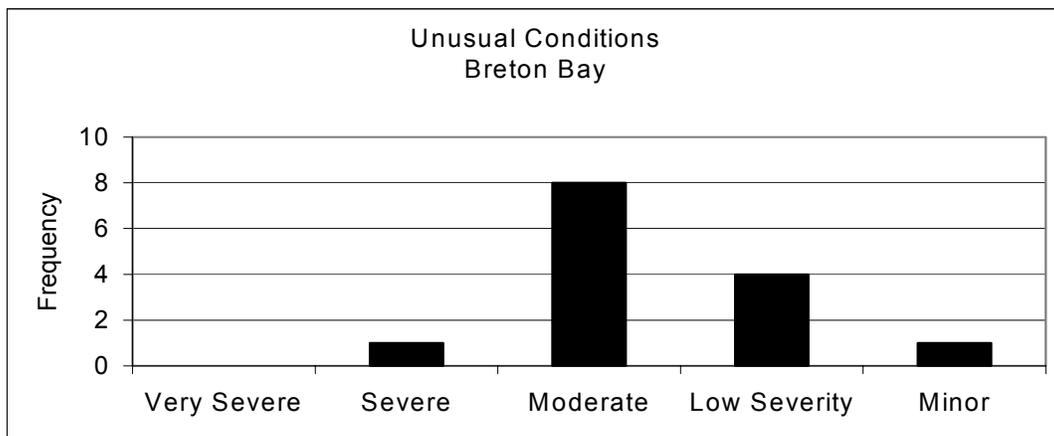
**Figure 11b Histogram showing the frequency of severity ratings given to unusual condition sites during Breton Bay SCA survey.**

The unusual condition/comment data sheets are used by survey teams to record the location of anything out of the ordinary seen during the survey or to provide some additional written comments on a specific problem. Fourteen unusual condition sites were found during the Breton Bay survey (Figure 11a). Only one site received a severe rating. At site BBI07103 a bridge is caving in across the stream at a driveway. Other unusual condition sites include BBC23401 where the concrete channel is falling apart and at site BBD17301 there is a major debris problem blocking the road crossing at Budds Creek Road. The majority of the unusual condition sites were where a red precipitate or “red flock” was observed in the water. Red flock can occur naturally and is an indication of elevated iron levels in the water. This is not unusual in Maryland coastal plain streams.

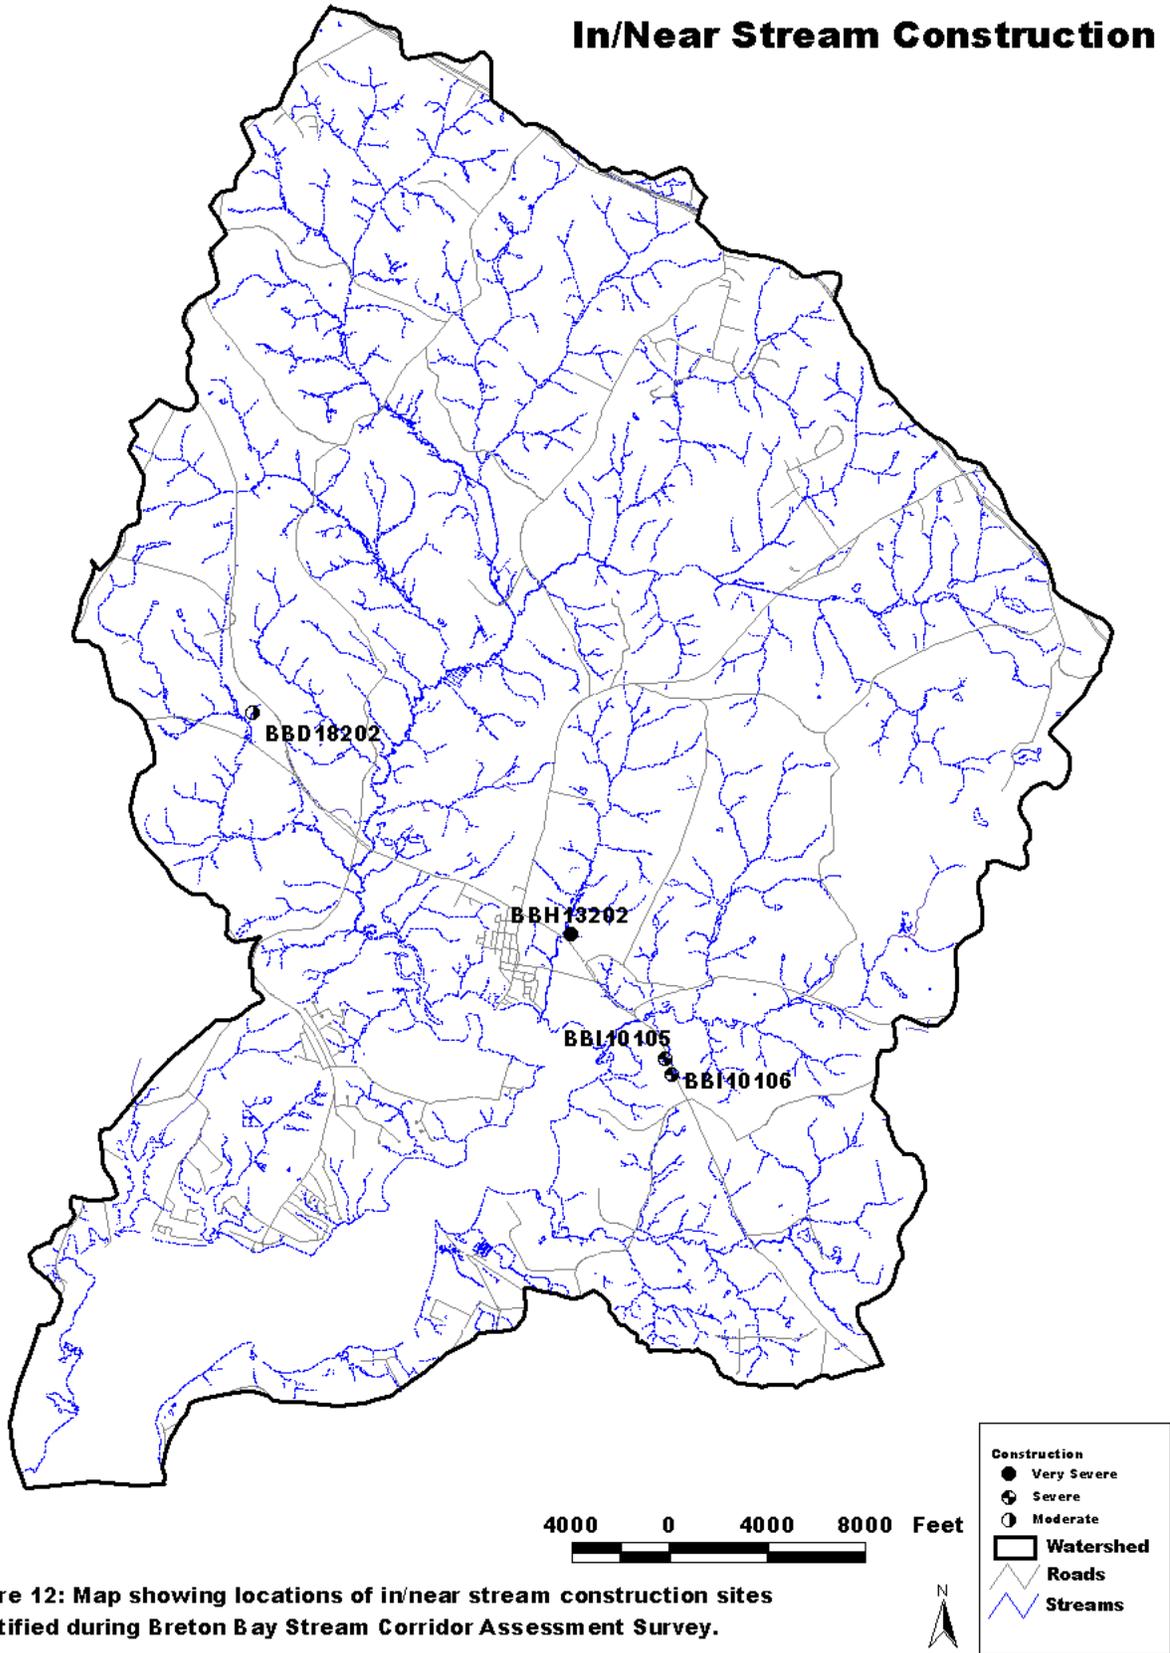
Figure 12: Map showing locations of in/near stream construction sites identified during Breton Bay Stream Corridor Assessment Survey.

In/near stream construction data sheets are used to document the locations where major disturbances are occurring inside or near the stream corridor at the time of the survey. Survey teams report evidence of inadequate sediment control measures or if sediment pollution from the site has affected the stream. In/near stream construction was reported at four sites during the survey (Figure 12). Site BBH13202 received a very severe rating. The tributary to Town Run was turned brown with sediment and created a small plume into Town Run. On a tributary to Glebe Run two sites, BBI10105 and BBI10106, received severe ratings. At these sites field crews did not see any sediment controls present. Field crews reported the apparent lack of proper sediment control to local officials. The crew was informed that follow up inspections were done and that the problems had been corrected.

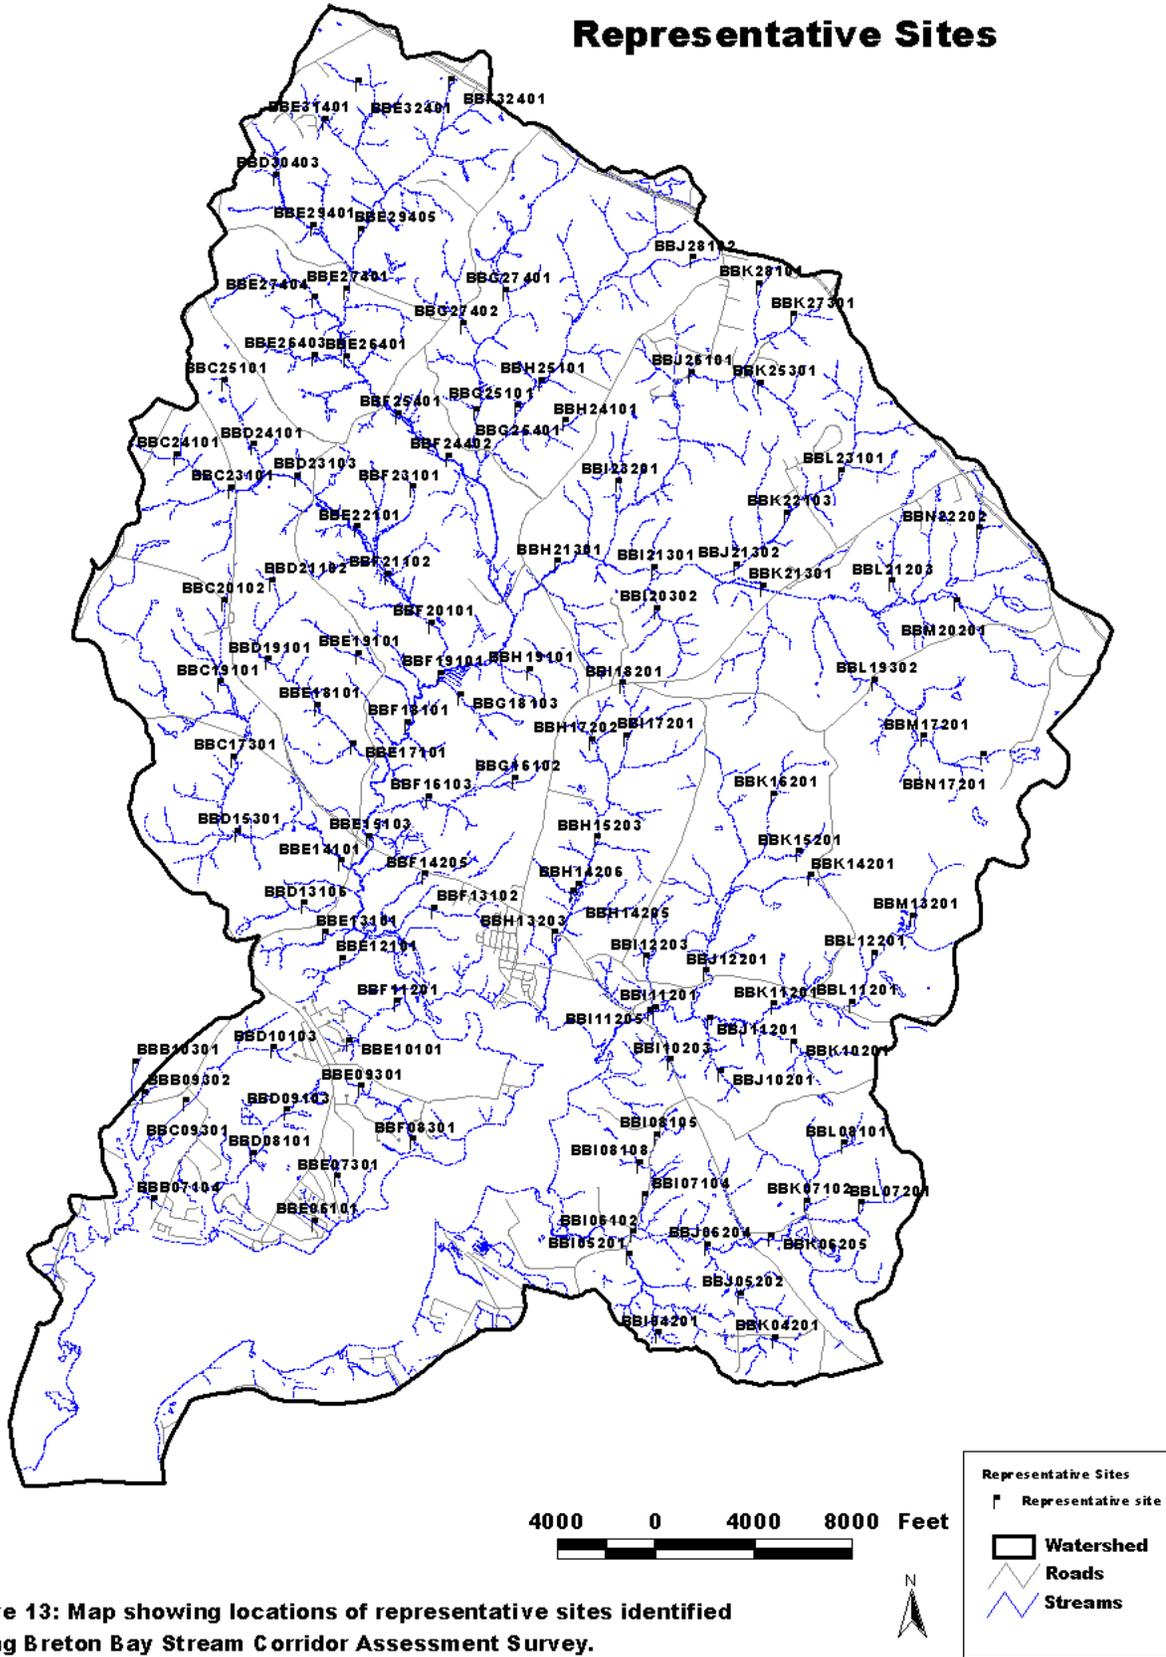
Figure 13: Map showing locations of representative sites identified during Breton Bay Stream Corridor Assessment Survey.

The Breton Bay Watershed lies in Maryland's coastal plain so it is not surprising that macroinvertebrate substrate was suboptimal or marginal in most cases. The bottom type is mostly gravel and sand. The embeddedness of the stream bottom is suboptimal to marginal. Erosion upstream of the areas can be the cause of the siltation. Channel alteration was optimal on nearly all the tributaries. This watershed is mainly in a rural area so there are few disturbances to the natural meandering stream. The bank condition was suboptimal. Erosion is prevalent throughout the watershed. Lastly, the riparian vegetation was mainly optimal to suboptimal. Most of the watershed is covered in mature forests.
