Chincoteague Bay Stream Corridor Assessment Survey

Maryland Department of Natural Resources
Watershed Services
May 2005

CHINCOTEAGUE BAY STREAM CORRIDOR ASSESSMENT

Robin Pellicano & Ken Yetman
Watershed Services Unit
Maryland Department of Natural Resources

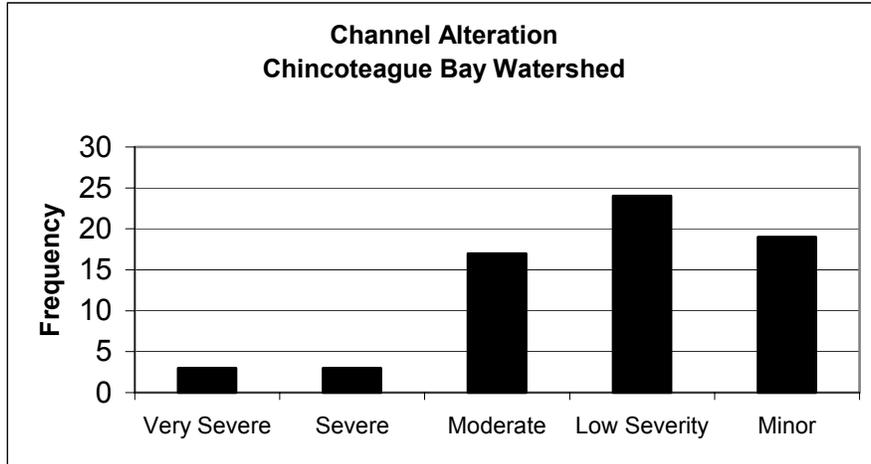
Severity rankings for the sites range from minor to very severe with most of the sites ranked moderate to minor in severity (Figure 5a). The severity of channel alterations is based on both the channel type and the length of the site. Earth channels are regularly rated as moderate but due the extreme length of some of the channels, those over 5,000 feet that did not have an adequate forest buffer were given a very severe rating. Three sites within this watershed are ranked as very severe due to a length of over 5,000 feet.

Figure 5a. Histogram showing the frequency of severity ratings given to channel alteration sites during the Chincoteague Bay SCA survey.

Restoring channel alteration sites can increase fish and wildlife habitat and may allow for more time for nutrient uptake in the waterway. In its simplest form, restoration for earth channels would include allowing vegetation and/or tree roots to stabilize the sediment along the channel, causing sinuosity to re-form naturally. This sinuosity may reform within the bed of the channelization or along its banks, depending on the site and the depth of the channel alteration.

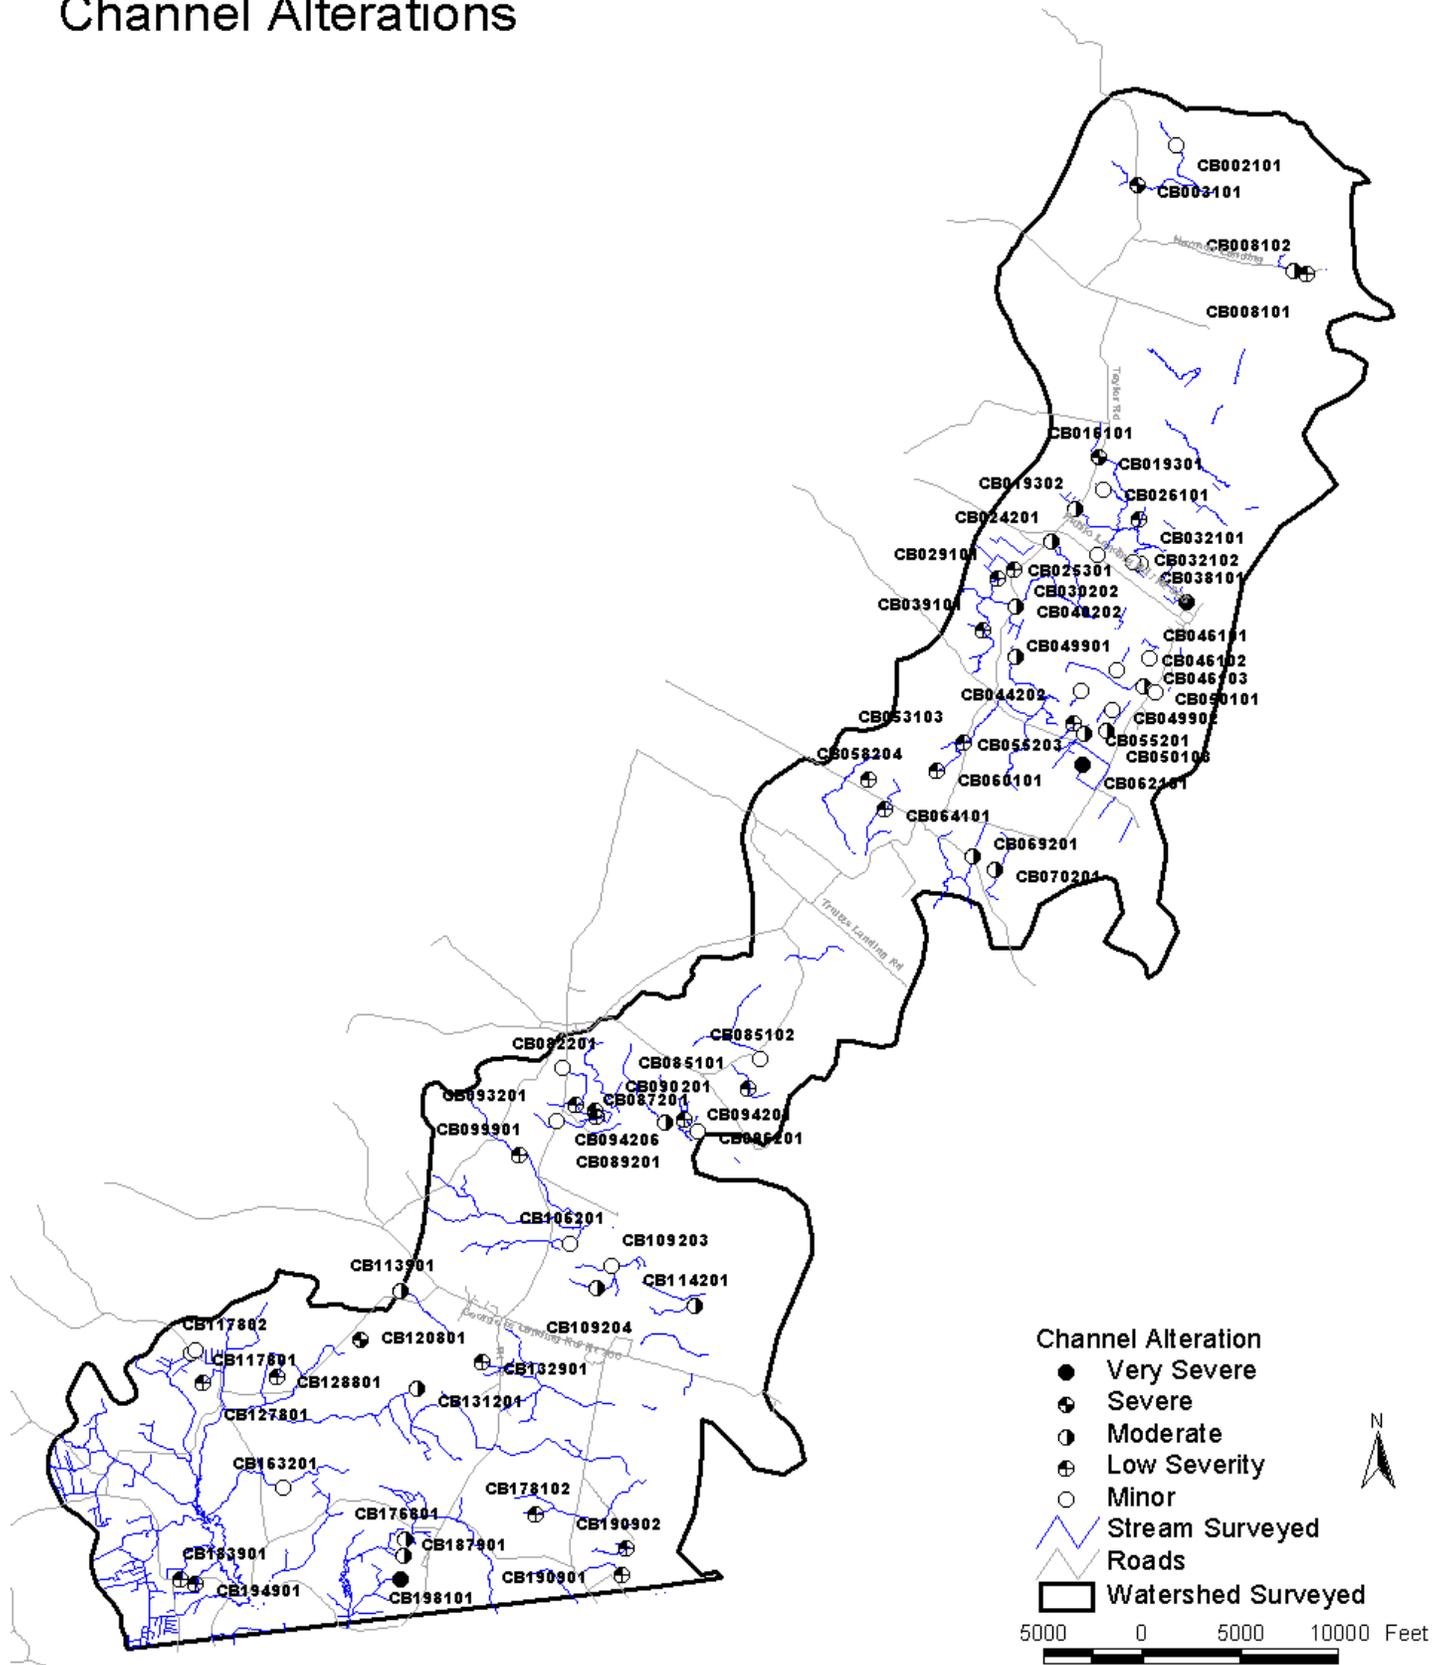
Figure 5b: Map showing the locations of the Channel Alterations in the Chincoteague Bay Watershed

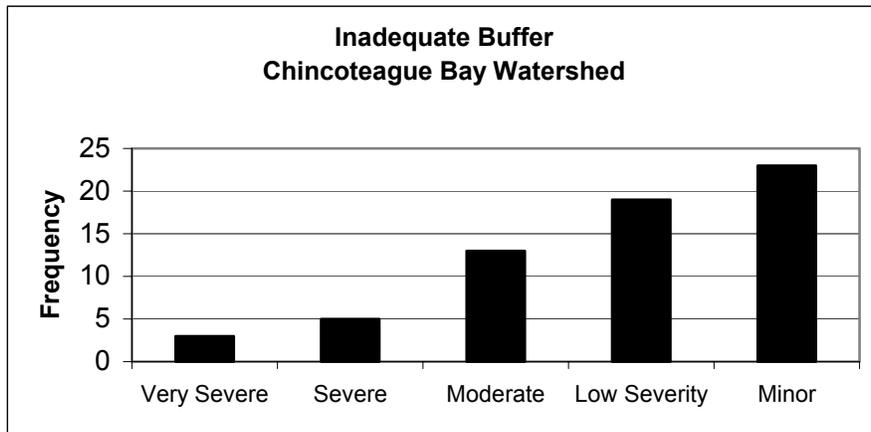
Figure 6a. Histogram showing the frequency of severity ratings given to inadequate buffer sites during the Chincoteague Bay SCA survey.

Any inadequate buffer site would benefit from the restoration of trees and shrubs along both stream banks. For sites on agricultural land, farmers also may qualify for federal and state government financial incentives for allowing 50-foot forest buffers to grow on their farmland. Those sites that may have particular natural resource value are headwater streams, streams running directly into either bay, or those that form gaps in existing forested buffer areas.

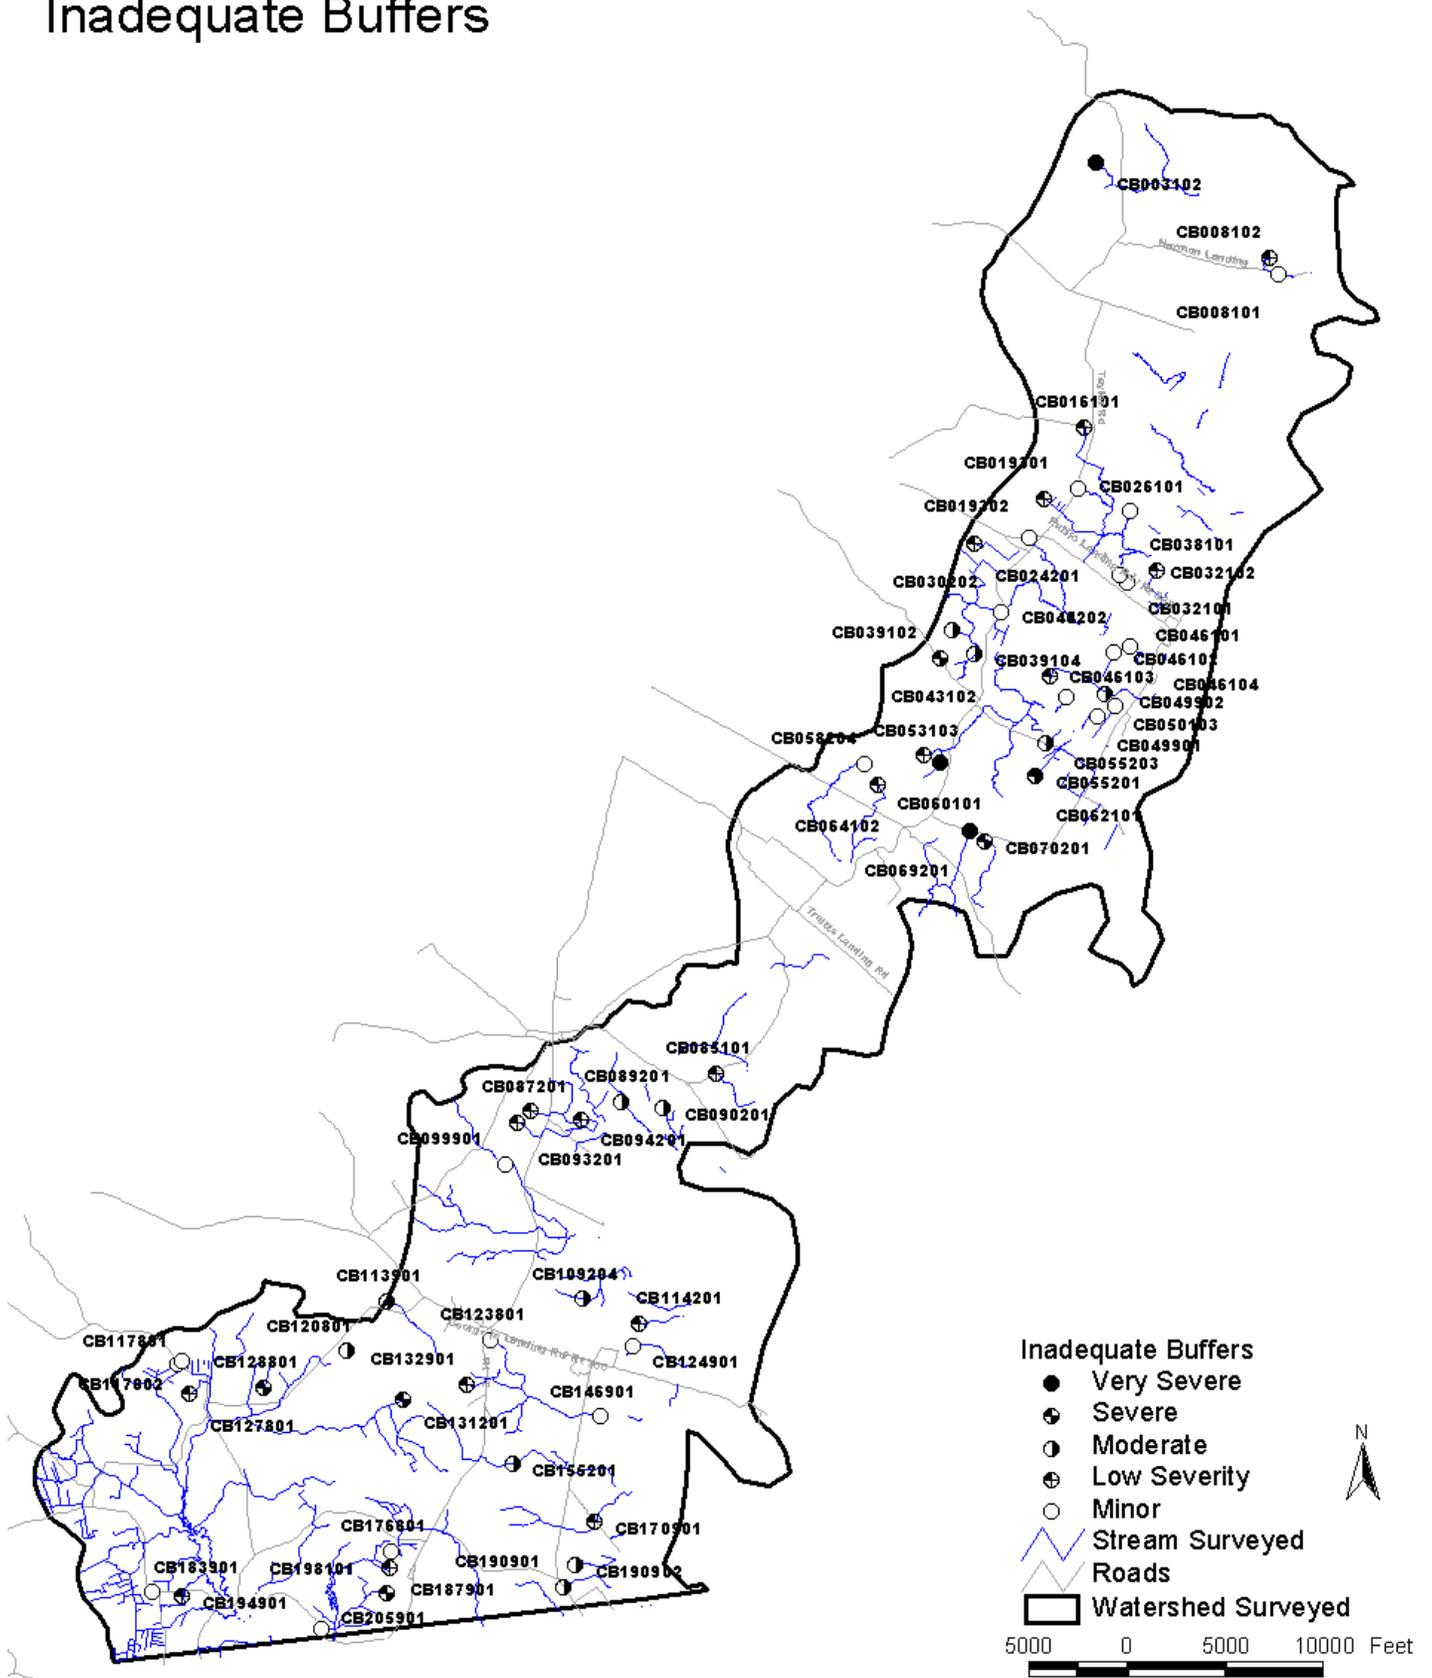
Survey crews identified 63 inadequate buffer sites with a total length of 117,605 feet (22.3 miles), or approximately 28 percent of the 79 miles streams surveyed. The severity and location of inadequate buffer sites is shown in Figure 6b. Eight of these sites are ranked as very severe or severe, while the other fifty-five sites are moderate, of low severity, or minor (Figure 6a). Land use along the stream at inadequate buffer sites, were reported as mostly cropland.

Figure 6b: Map showing the locations of the Inadequate Buffers in the Chincoteague Bay Watershed

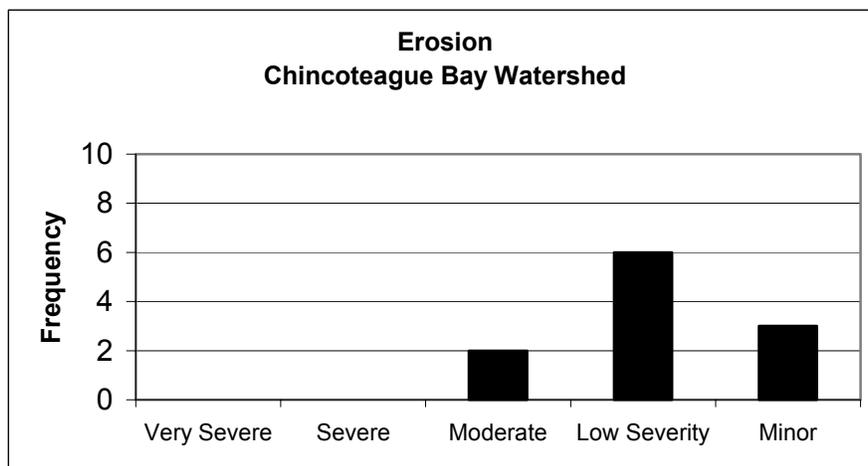
Figure 7a. Histogram showing the frequency of severity ratings given to erosion sites during the Chincoteague Bay SCA survey.

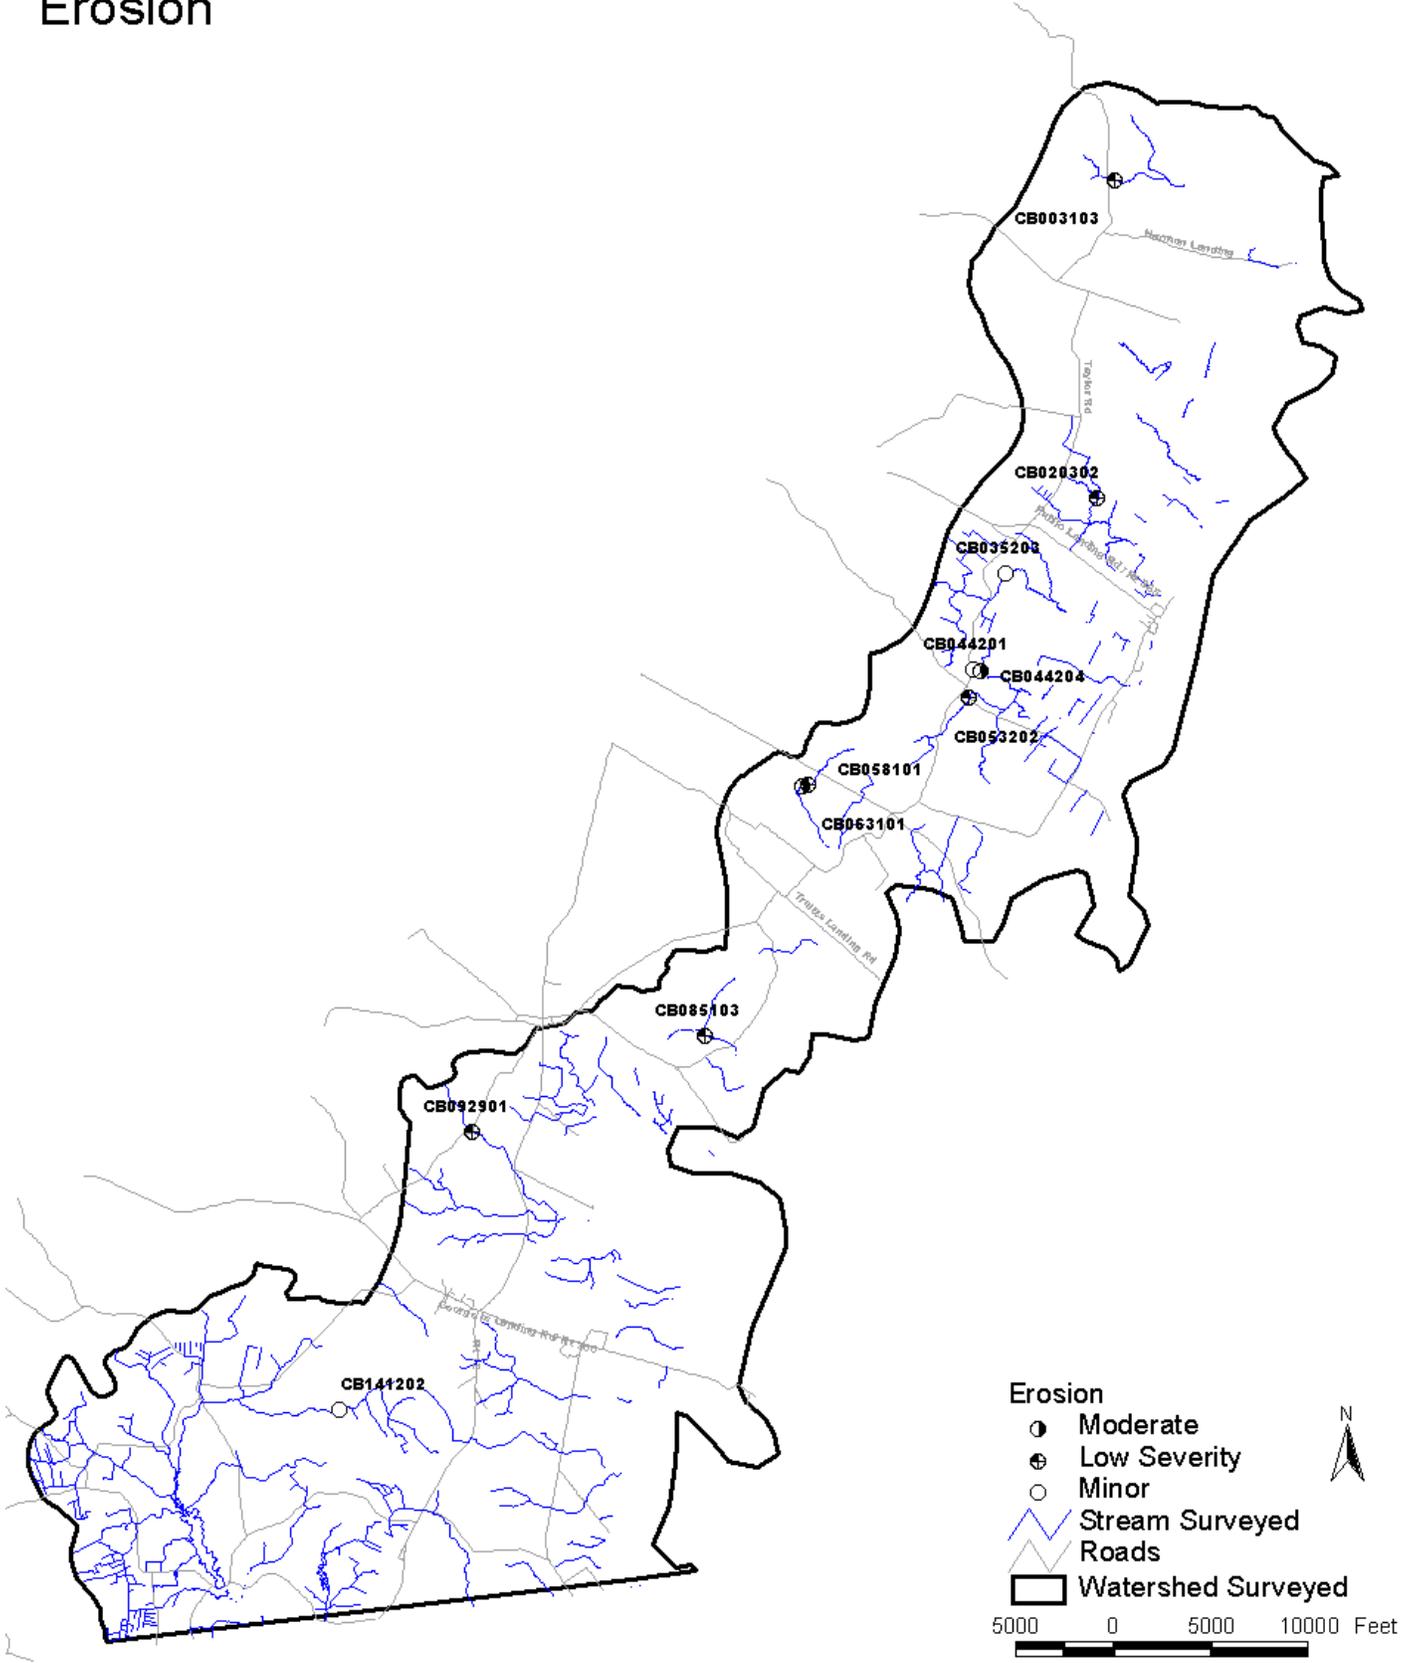
The SCA survey found 11 eroding stream banks over the length of 8,420 feet (1.6 miles) of stream, or about 2 percent of streams surveyed. The severity and location of erosion sites is shown in Figure 7b. Two sites are ranked as moderate, six as of low severity, and three as minor (Figure 7a). Nearly all erosion sites are three feet in height or less, only one site has a height greater than 3 feet (Appendix B).

Figure 7b: Map showing the locations of the Erosion Sites in the Chincoteague Bay Watershed

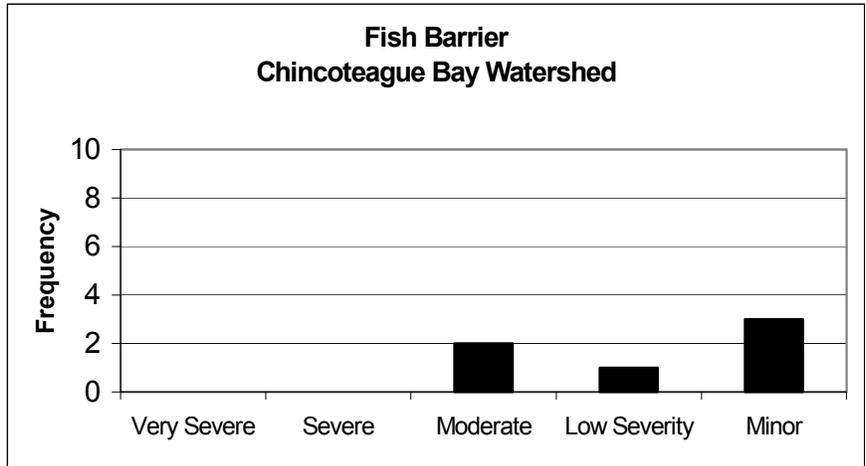
Figure 8a. Histogram showing the frequency of severity ratings given to fish barrier sites during the Chincoteague Bay SCA survey.

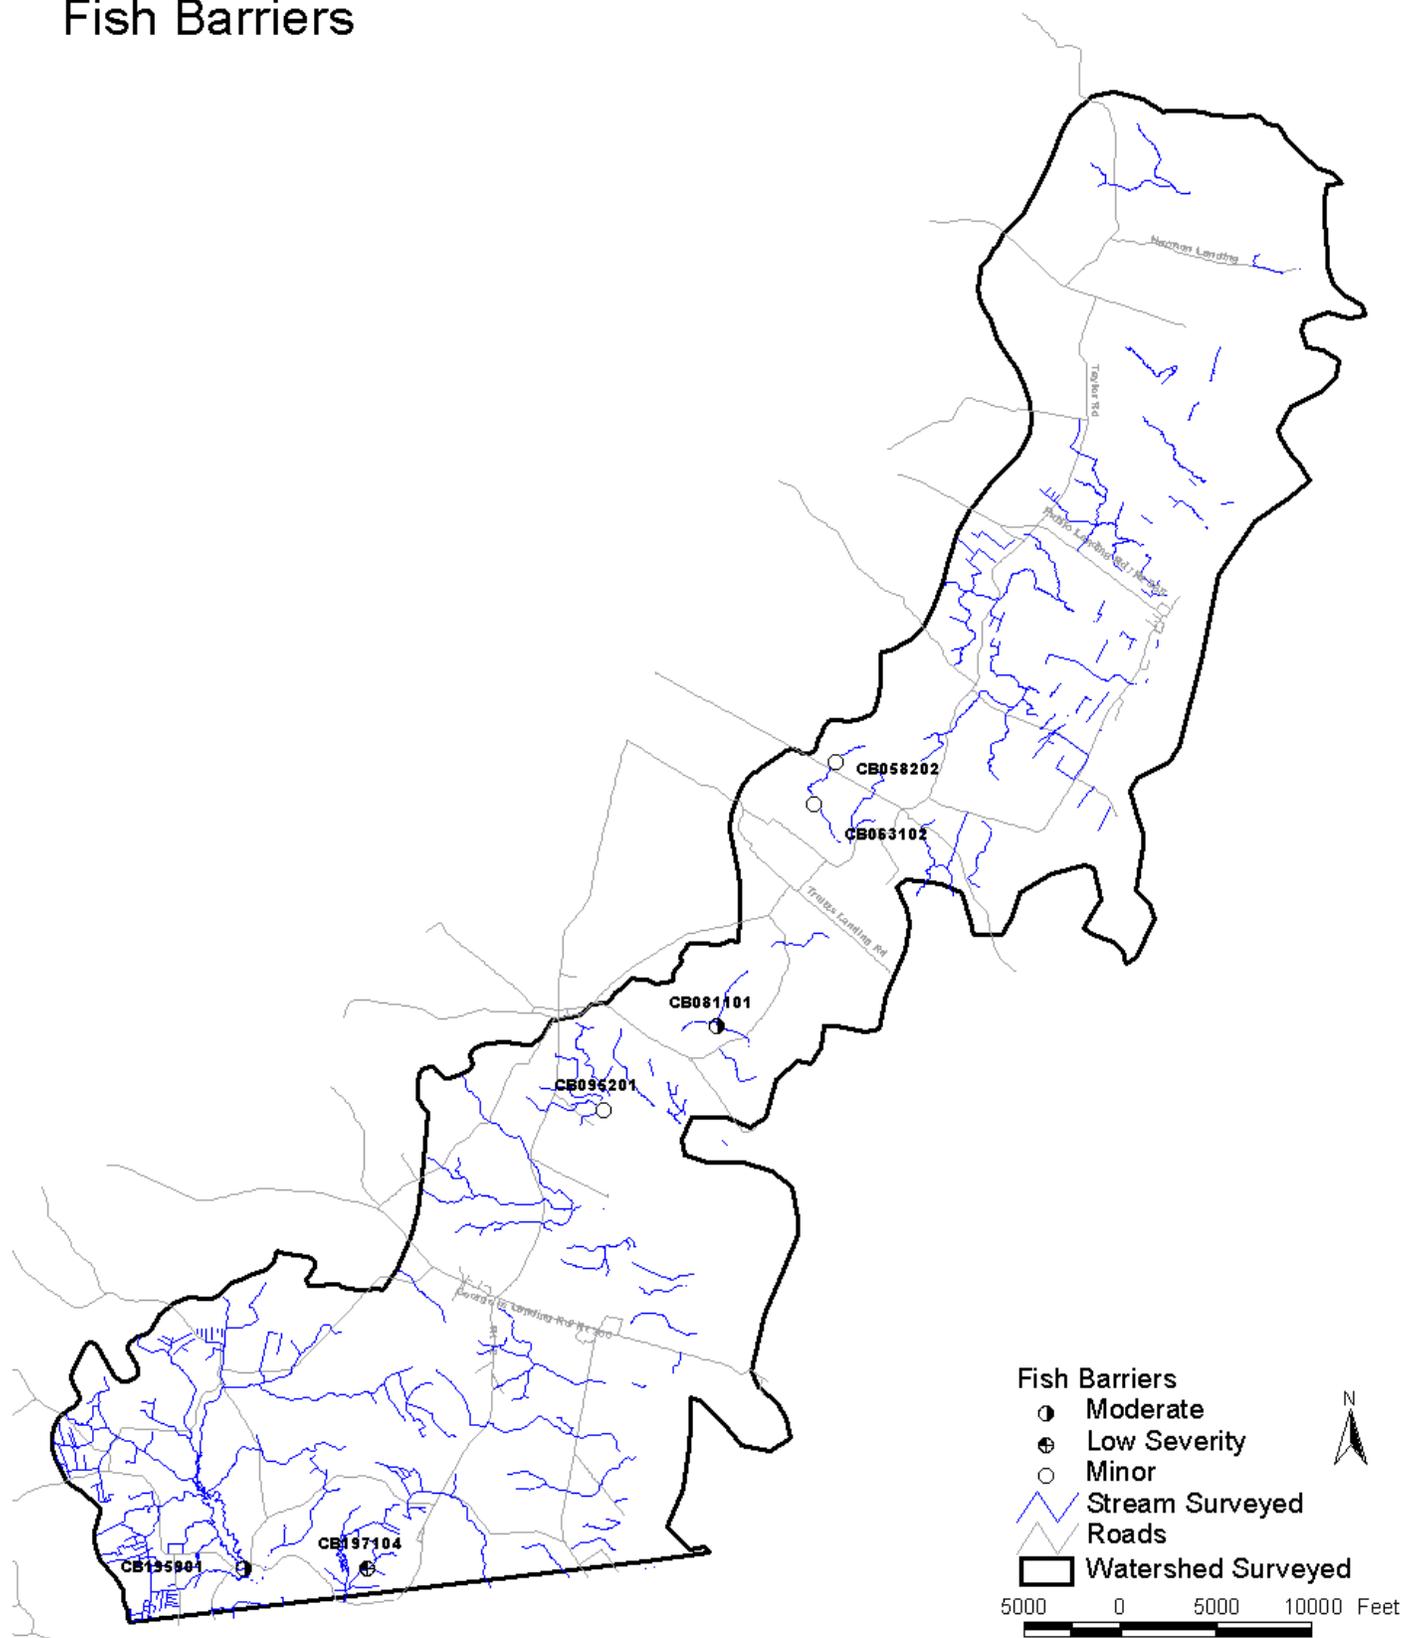
The Chincoteague Bay SCA survey found 6 fish migration barriers. The locations of fish blockages are shown in Figure 8b. Fish barriers in these watersheds are due instream ponds (3) and debris dams (3). Two sites CB081101 and CB195901 received moderate ratings. They were instream ponds.

Figure 8b: Map showing the locations of the Fish Barriers in the Chincoteague Bay Watershed

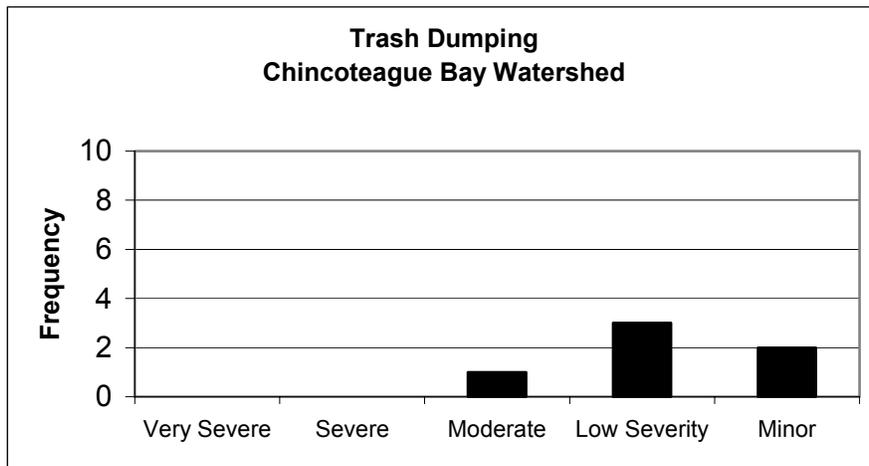
Figure 9a. Histogram showing the frequency of severity ratings given to trash dumping sites during the Chincoteague Bay SCA survey.

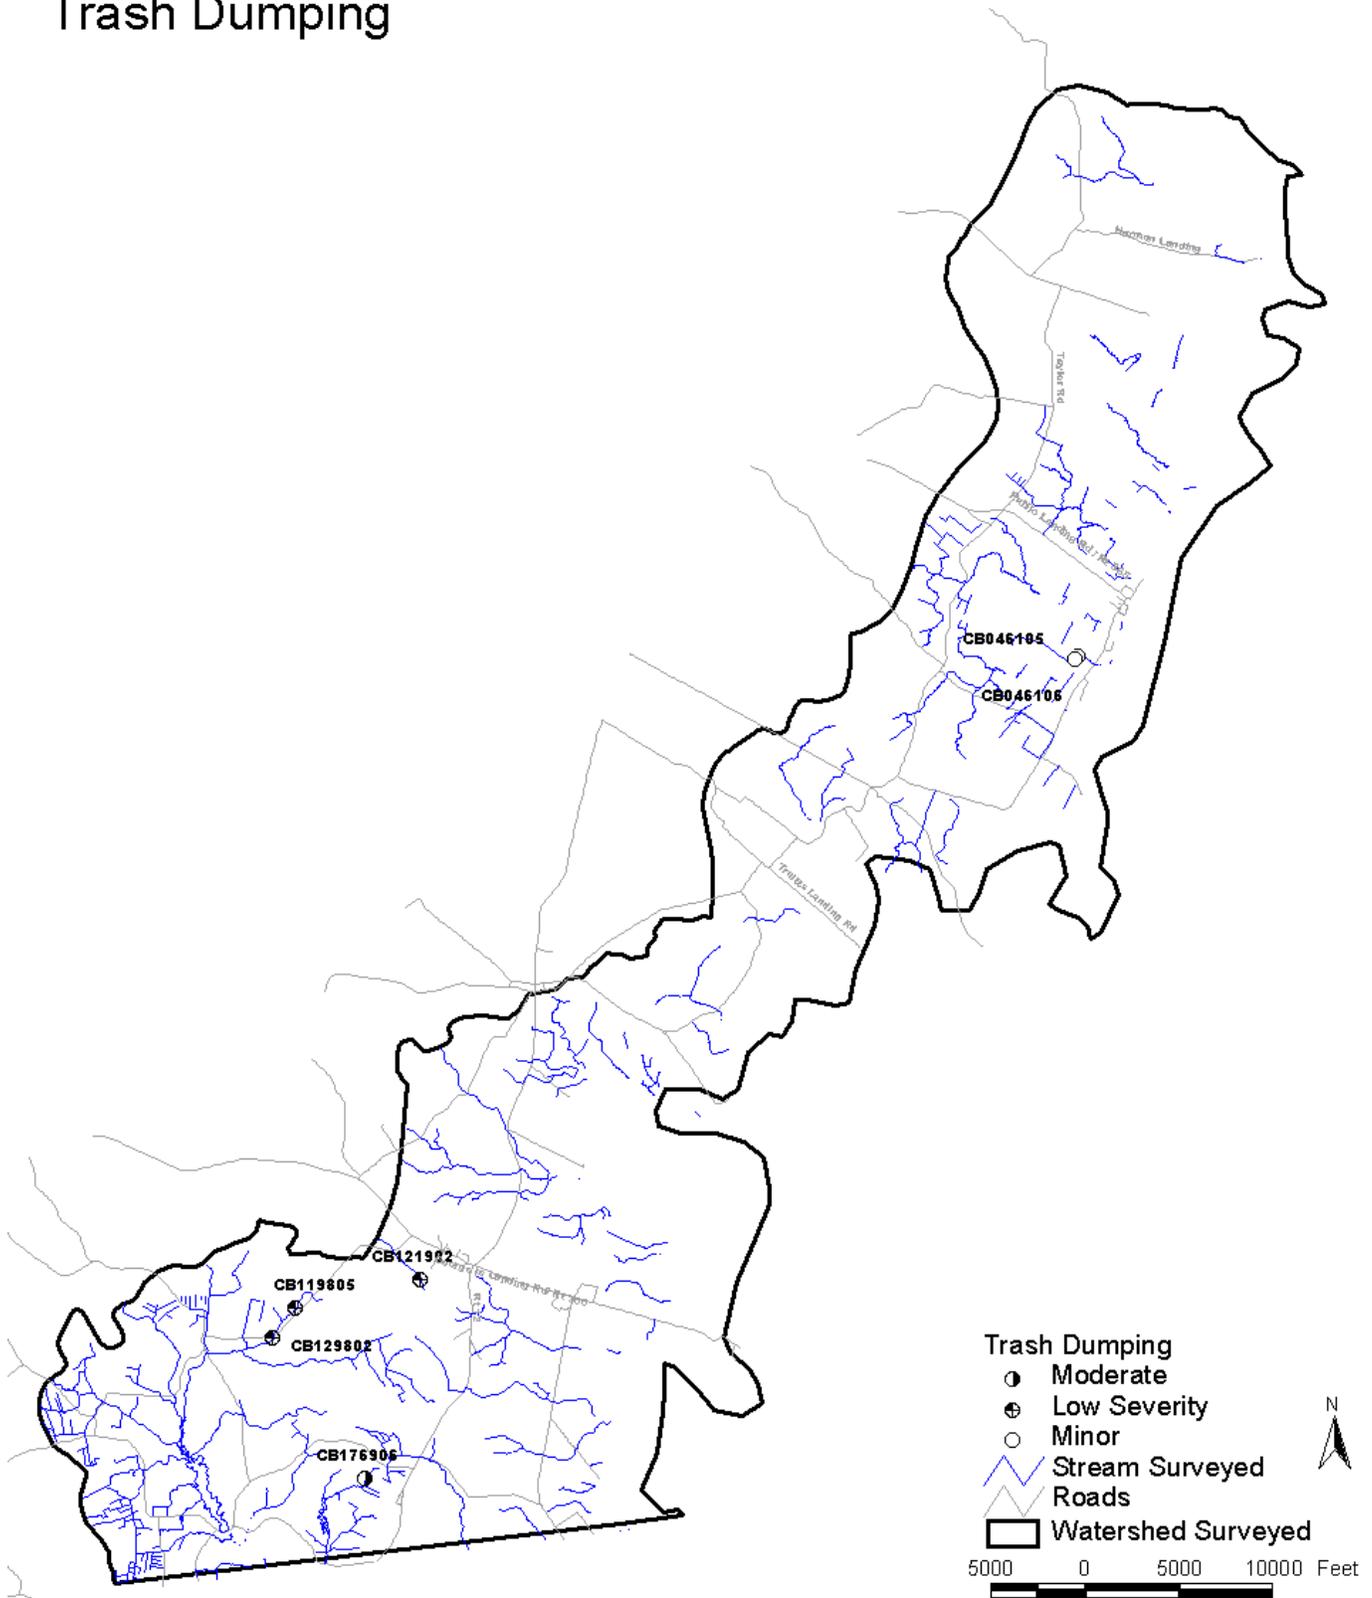
Survey crews found six trash dumping sites (Figure 9b). The sites contained residential waste (4), tires (1), and metal roofing, siding (1). The one moderate site consisted of residential waste over a larger area within the stream corridor.

Figure 9b: Map showing the locations of the Trash Dumping in the Chincoteague Bay Watershed

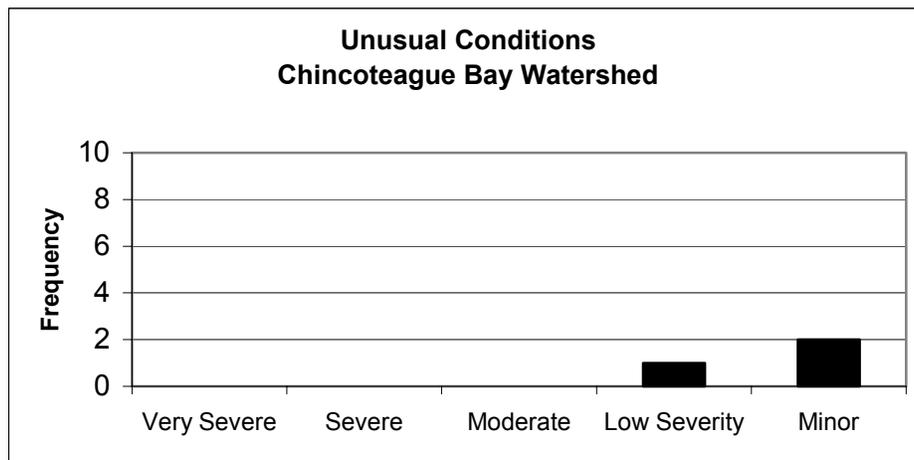
The three unusual conditions were sites with red flock (1), scum (1), and cement blocks used as erosion control (1). The sites ranked as low (1), and minor (2) in severity (Figure 10a).

Figure 10a. Histogram showing the frequency of severity ratings given to unusual condition sites during the Chincoteague Bay SCA survey.

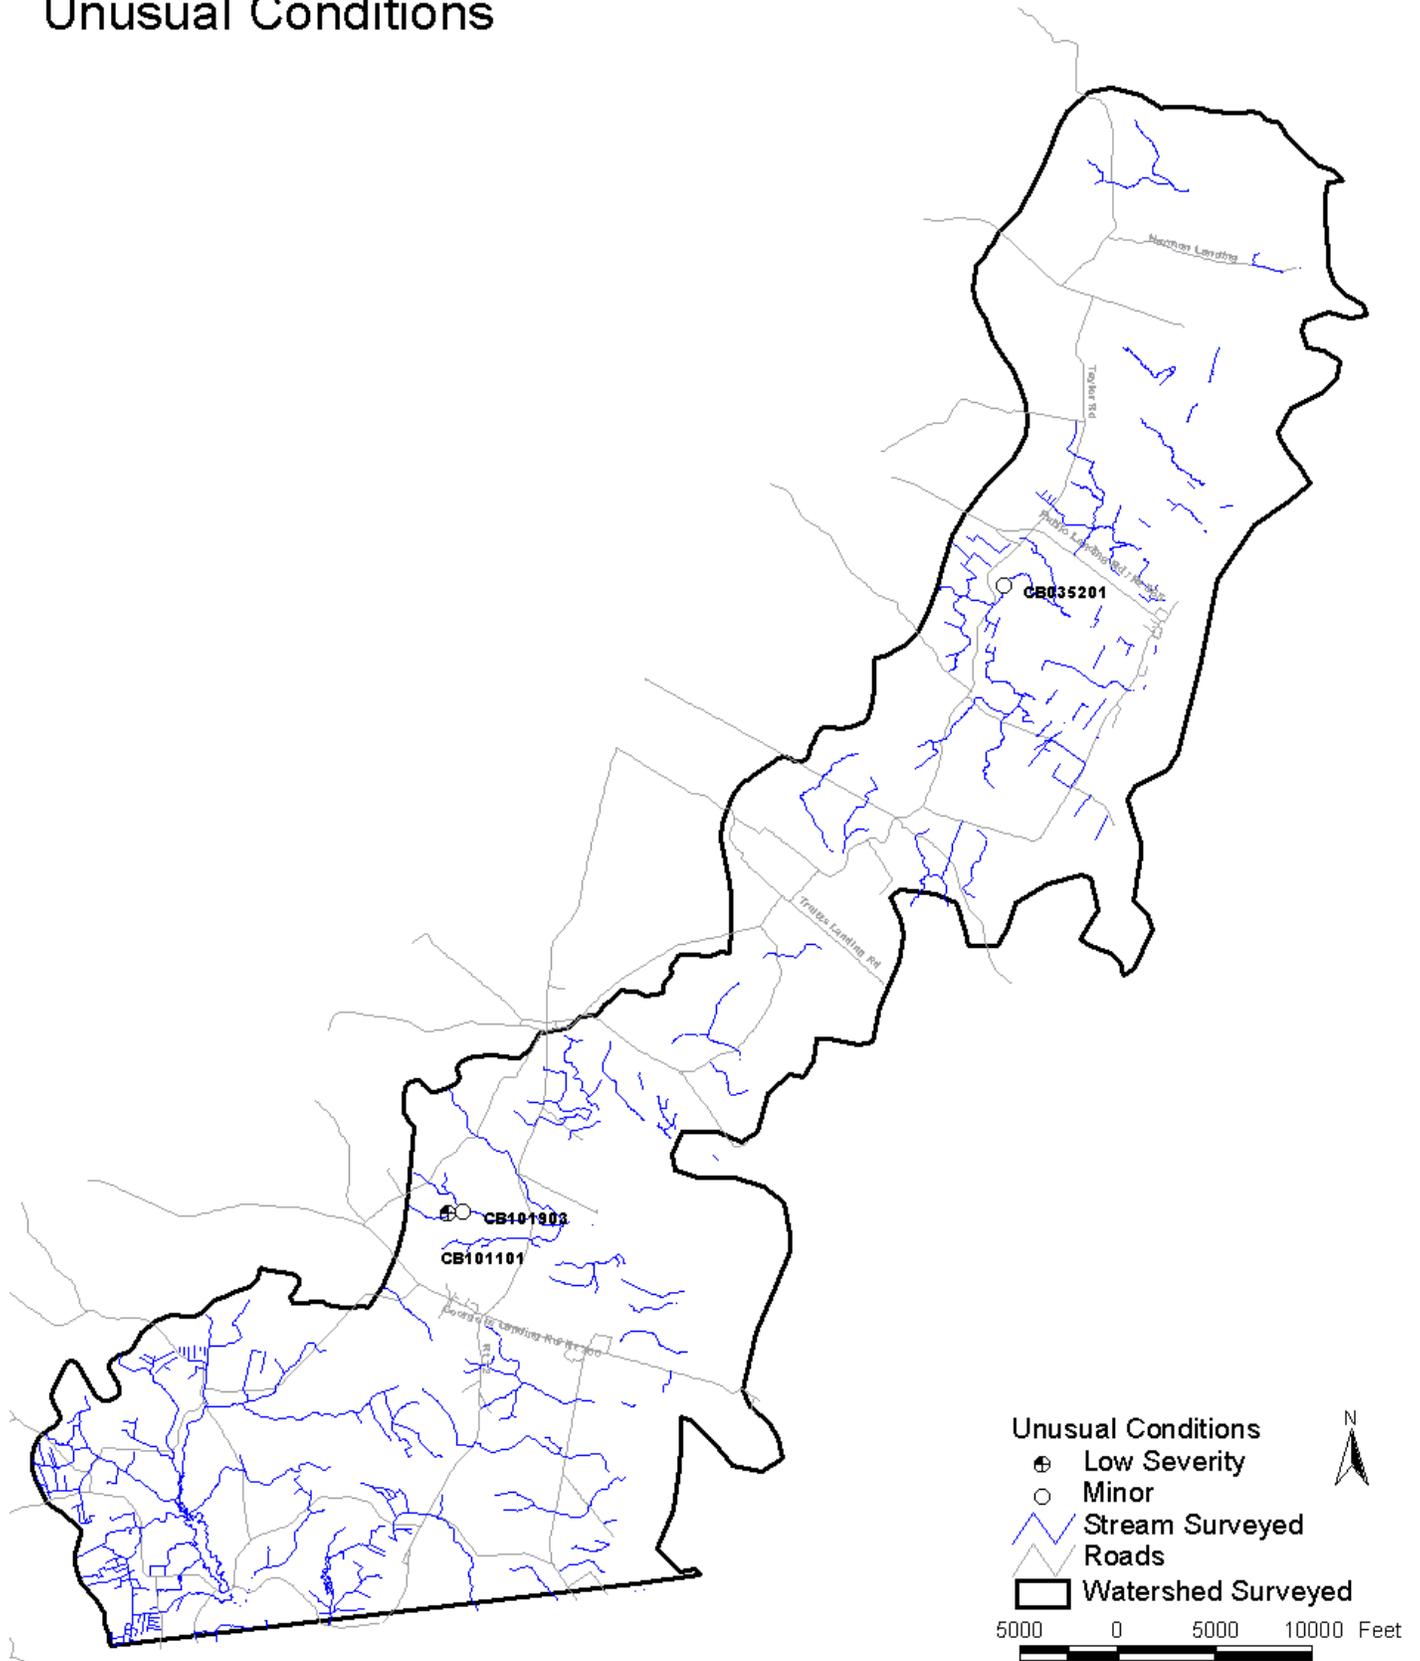
Survey teams record unusual conditions or comments to note the location of anything out of the ordinary observed during the survey or to provide additional written comments on a specific problem site. The survey crew identified 3 unusual conditions and 21 comments throughout the Chincoteague Bay watershed. The severity and location of unusual condition sites is shown in Figure 10b.

Figure 10b: Map showing the locations of the Unusual Conditions in the Chincoteague Bay Watershed

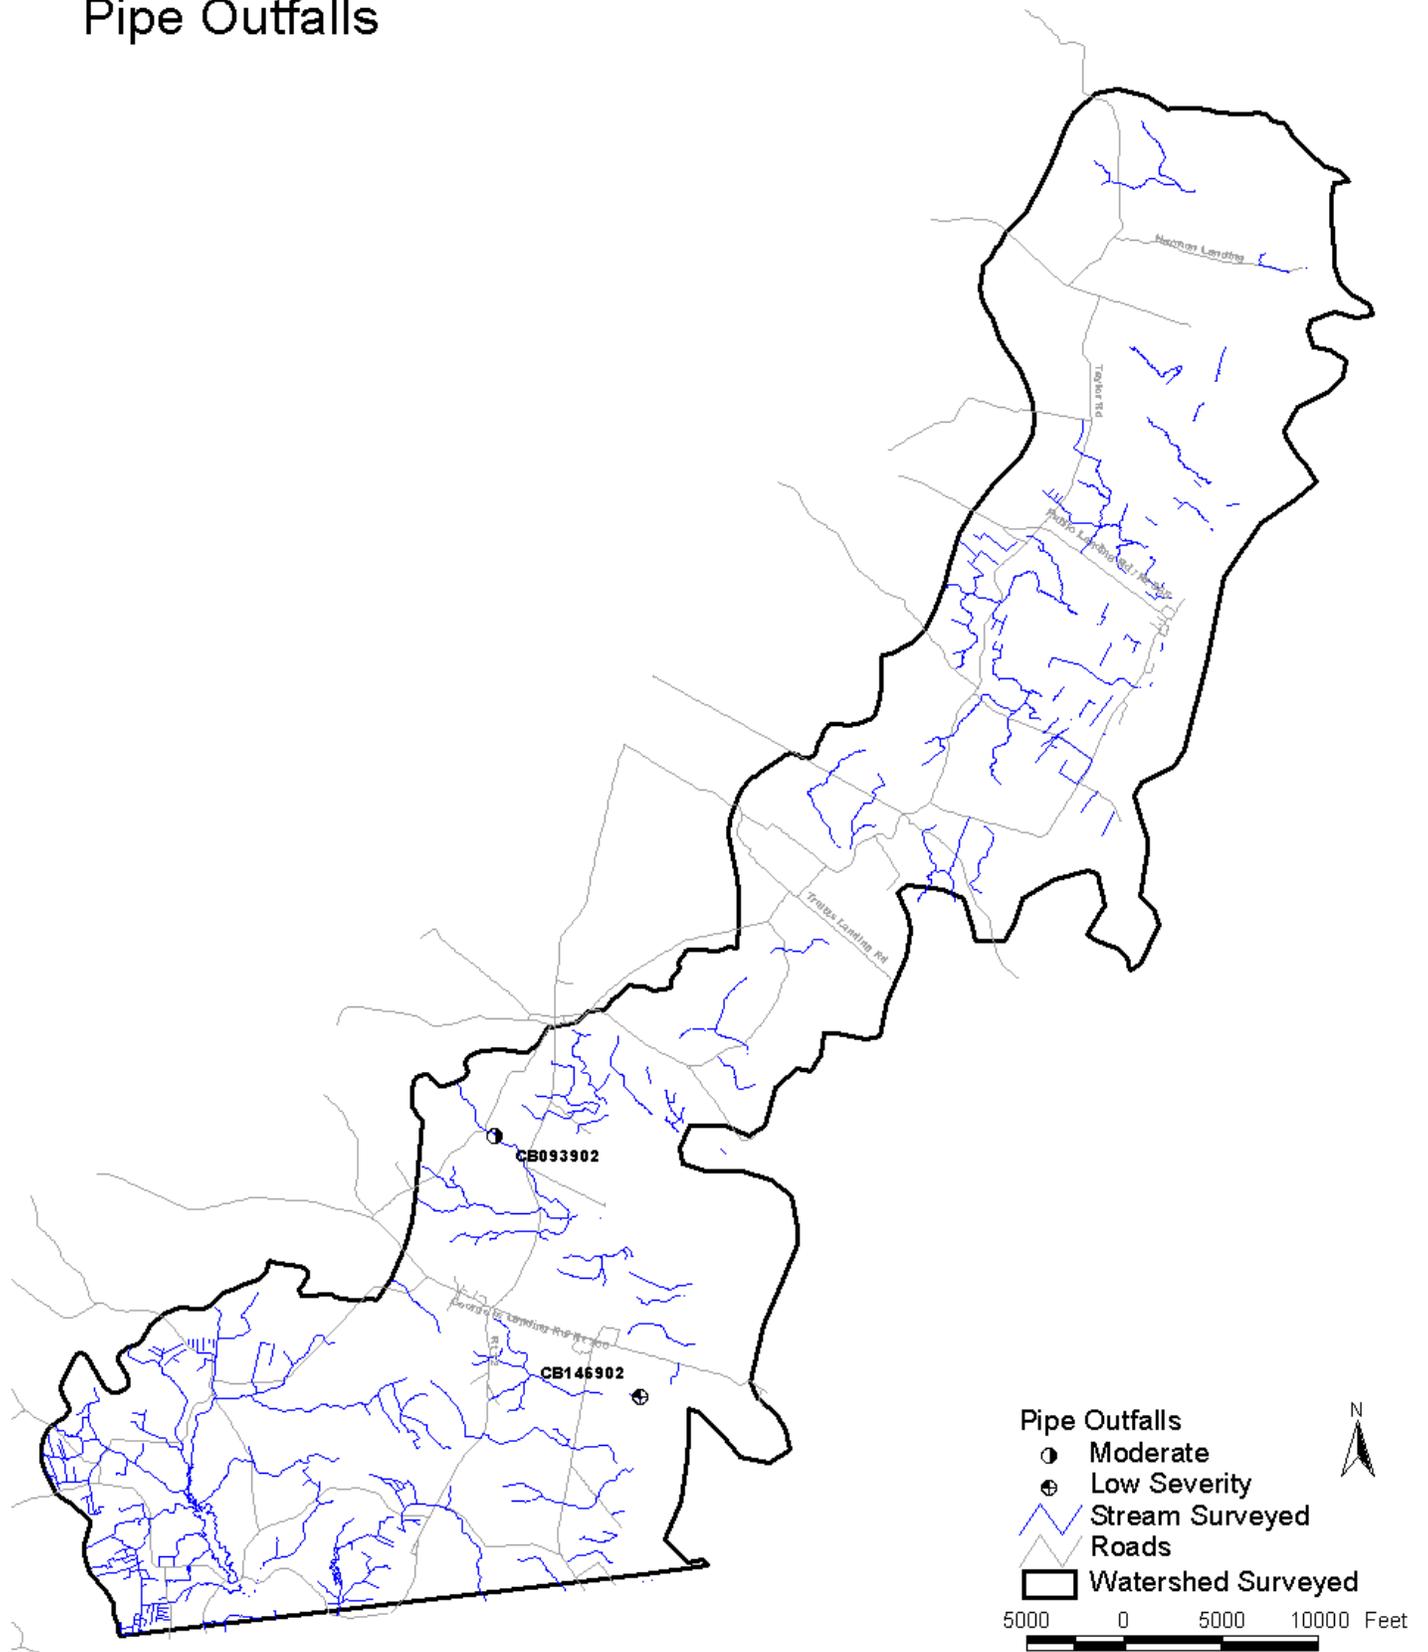
Figure 11a: Map showing the locations of the Pipe Outfalls in the Chincoteague Bay Watershed

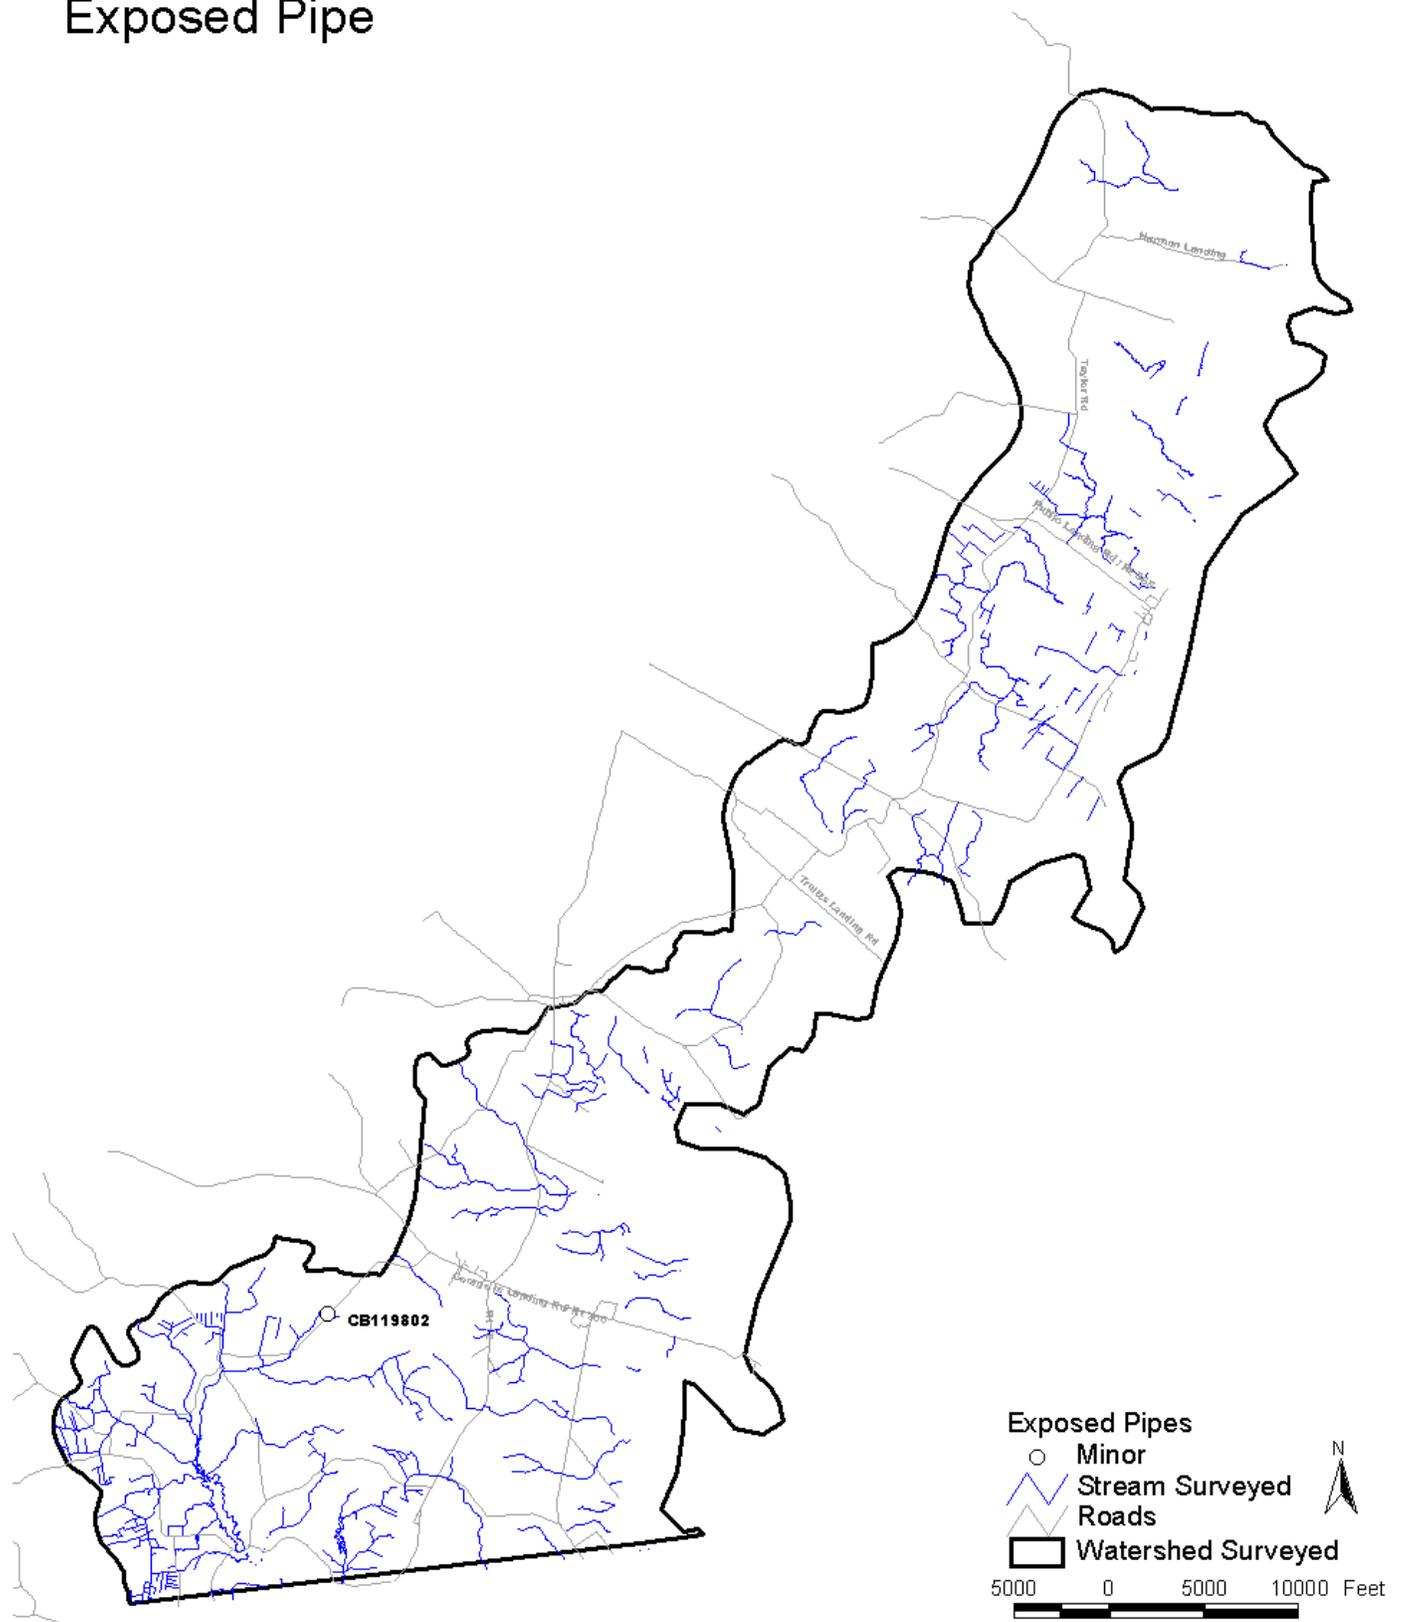
Field crews observed one exposed pipe during the survey, rated as minor in severity. Figure 12a shows the location of this site.

Figure 12a: Map showing the location of the Exposed Pipe in the Chincoteague Bay Watershed
