Georges Creek Stream Corridor Assessment Survey

Watershed Restoration Division
Chesapeake & Coastal Watershed Services
Maryland Department of Natural Resources
December, 2002

GEORGES CREEK

STREAM CORRIDOR ASSESSMENT SURVEY

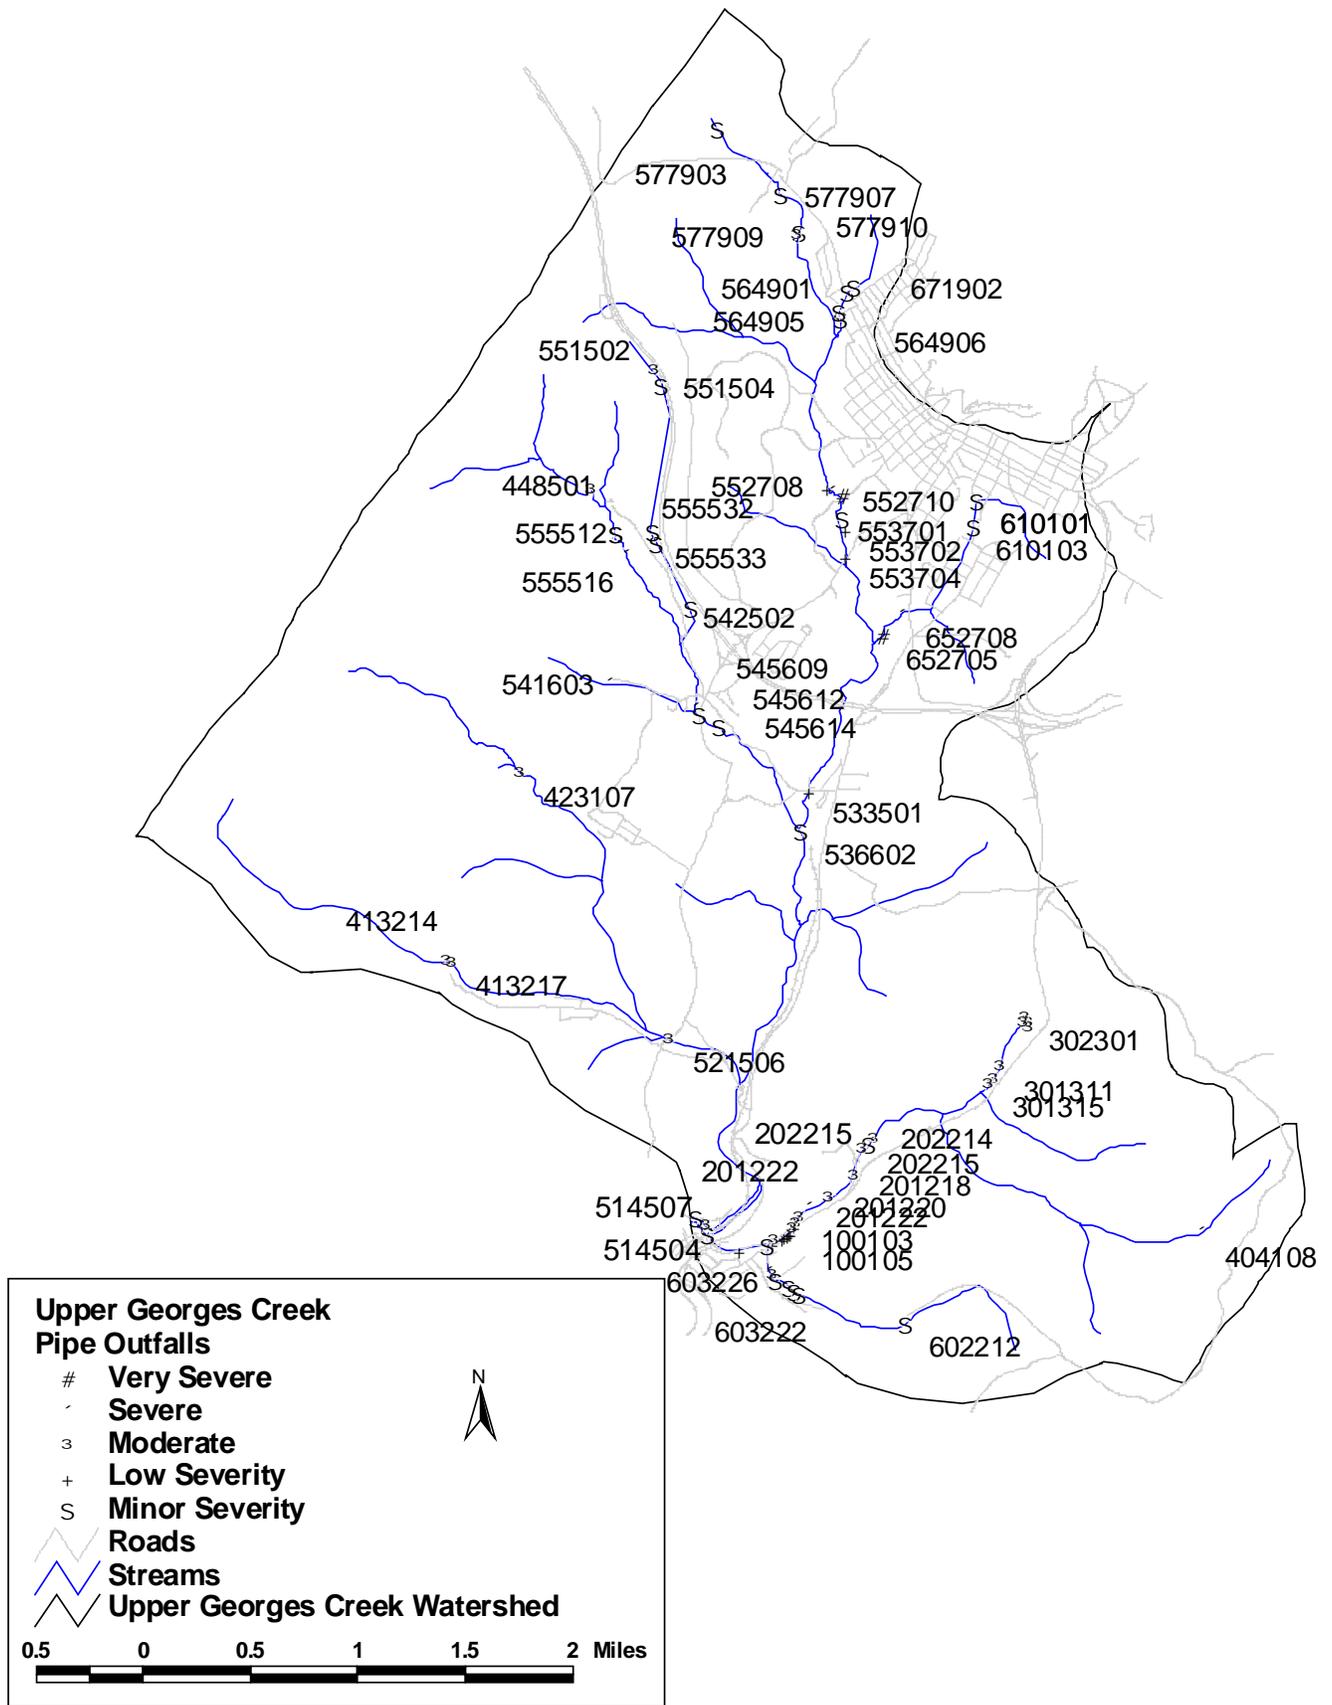
Figure 4b: Upper Georges Creek Pipe Outfall Locations.

This survey identified 75 pipe outfalls in the upper portion of the Georges Creek watershed (Figure 4b). Two of these outfalls (552710, 652705) were given very severe ratings. 552710 is a 6 in. diameter pipe on the left bank of Sand Spring Run with an odor of sewage. 652705 is a 48 in. diameter concrete pipe on the left bank of the mainstem with a dark brown discharge that was reported as having a sewage odor. In addition to the very severe sights, 8 sites were found to be severe.

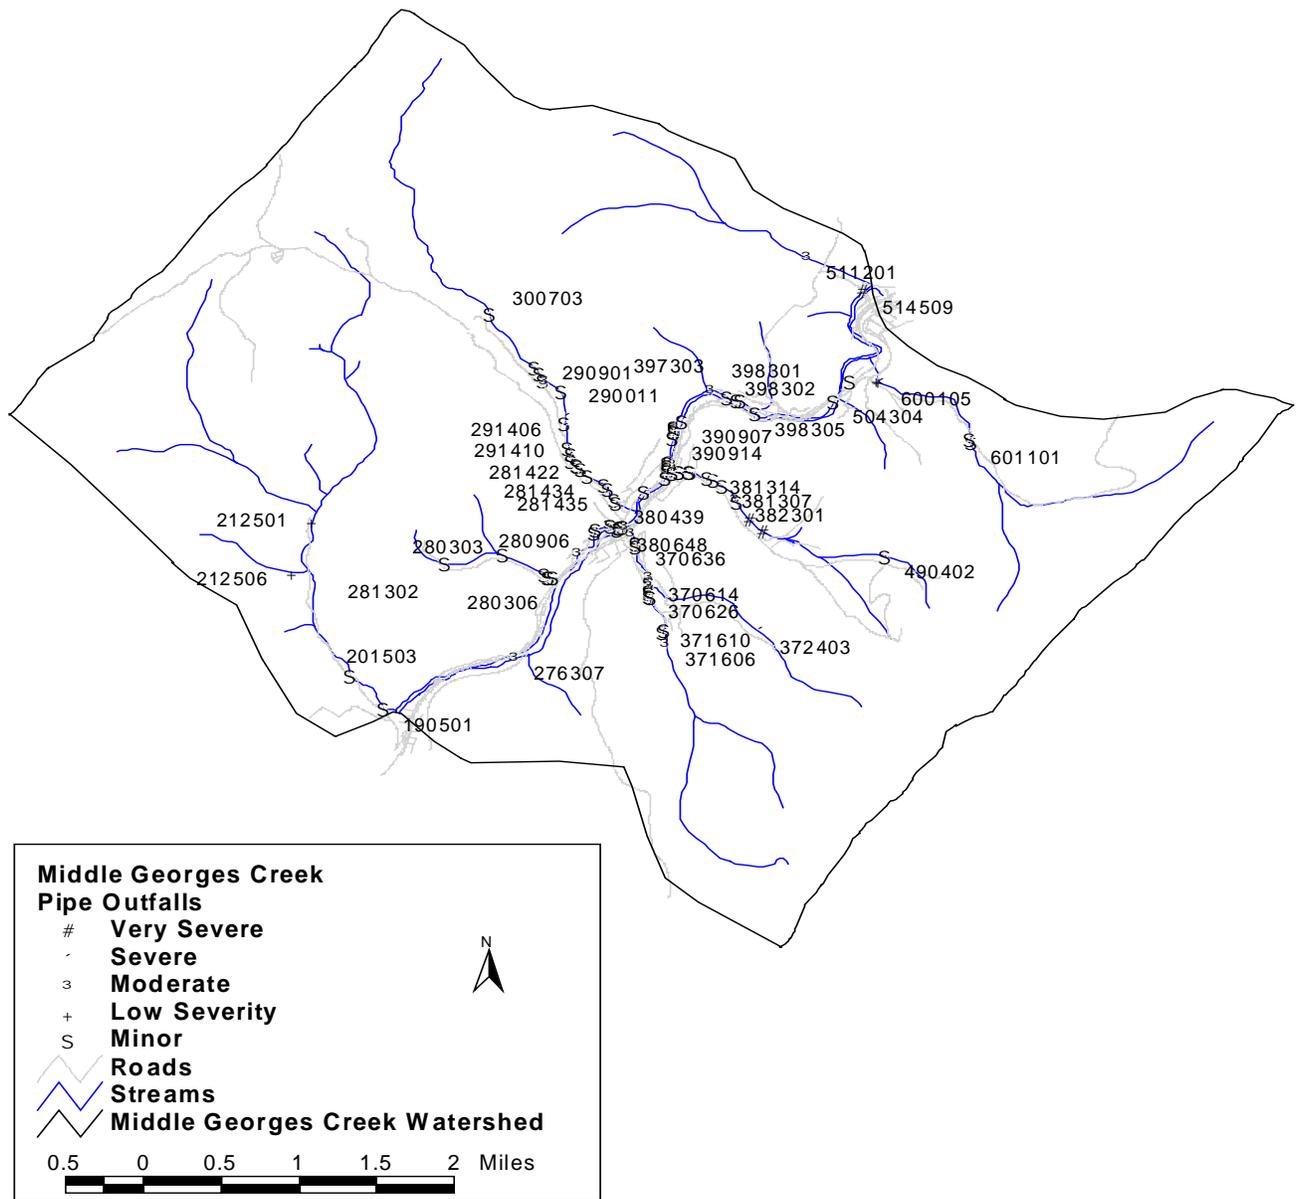
Figure 4c: Middle Georges Creek Pipe Outfall Locations.

One hundred one pipe outfalls were found in the middle portion of the watershed (Figure 4c). Three of these (382411, 382415, 514509) were given very severe ratings. 382411 is a 4 in. diameter plastic pipe on the left bank of Hill Run with an odor of sewage. 382415 is a 3 in. diameter plastic pipe on the left bank of Hill Run with an odor of sewage. 514509 is a 36 in. diameter concrete on the left bank of the mainstem with a dark brown discharge having a sewage odor. Five severe sights also were documented for the middle portion of the watershed.

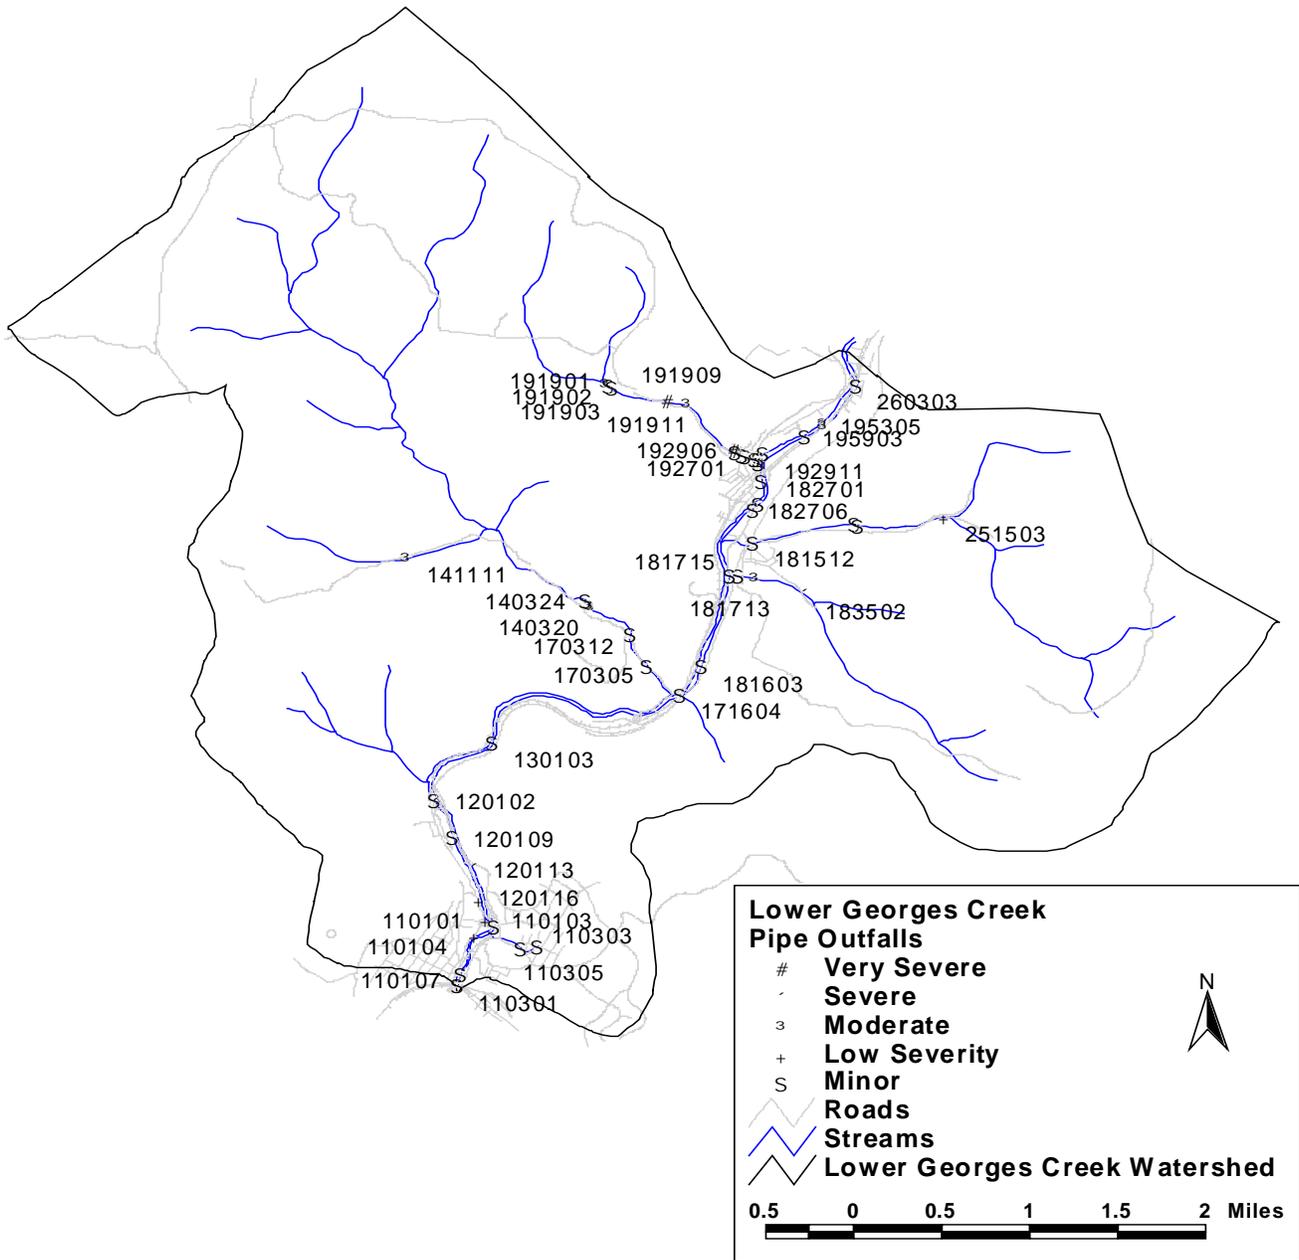
Figure 4d: Lower Georges Creek Pipe Outfall Locations.

The lower portion of the watershed contains 49 reported pipe outfalls (Figure 4d). Two of these (191909, 192904) were given very severe ratings. Both of these pipes were found on Butcher Run. 191909 is a plastic pipe on the left bank with a 4 in. diameter. This pipe was found to have dark brown discharge with a sewage odor. 192904 is a plastic pipe on the right bank with 36 in. diameter and a sewage odor. Three severe sights were recorded in addition to the very severe sights. Three severe sights were recorded in addition to the very severe sights.

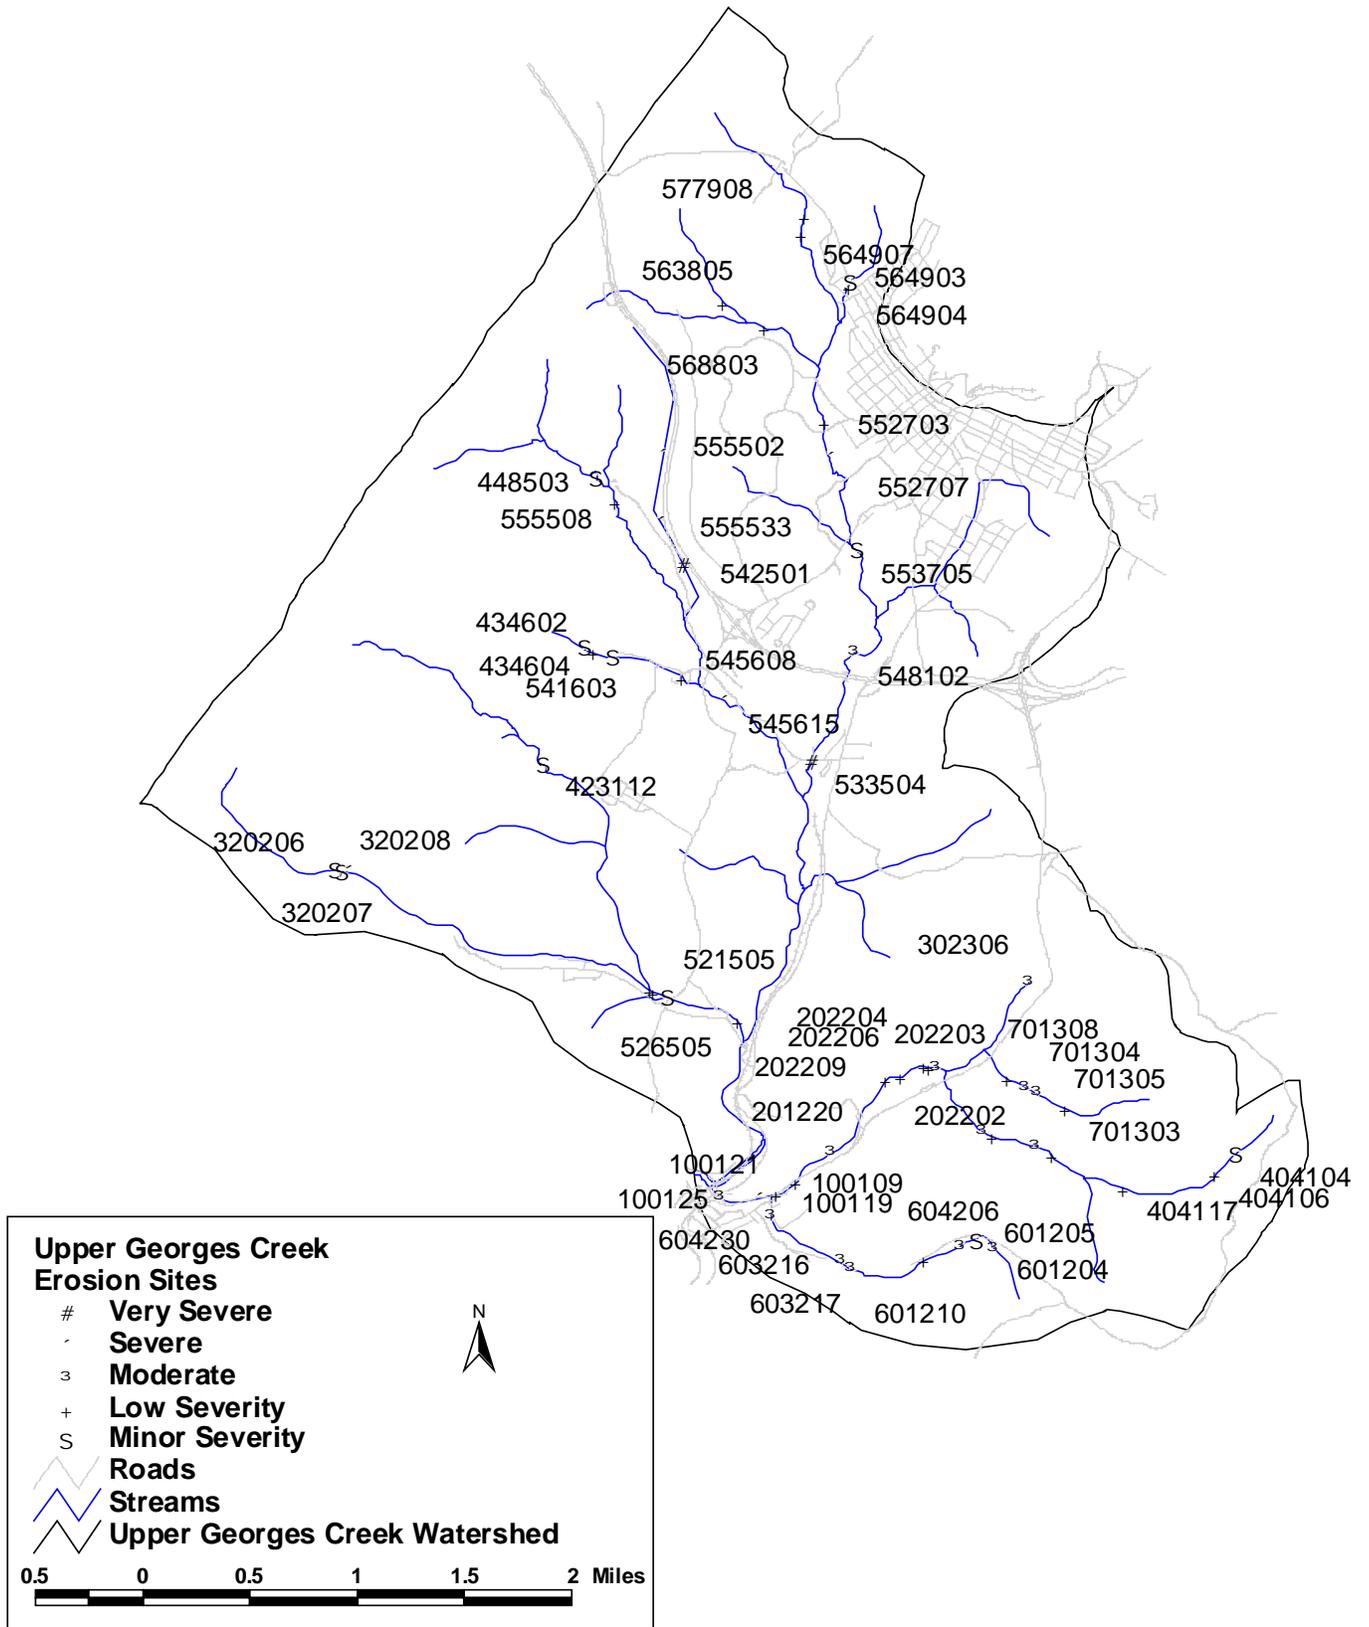
Figure 5b: Upper Georges Creek Erosion Site Locations.

The upper portion of Georges Creek contains 58 erosion sites as identified by this survey. Two of these erosion sites were given very severe ratings. Site 533504 is widening below a channelization for 1,000ft., and is 5ft. high on the mainstem of Georges Creek. Land use is reported as multiflora rose on the right bank and lawn on the left. It is also threatening a house. Site 542501 is a widening channel undercutting its own trapezoidal concrete channel on Winebrenner Run. It is threatening to undercut I-68 as well, and is stated as being caused by channelization. It is marked as 1,000ft. long and 5ft. high.

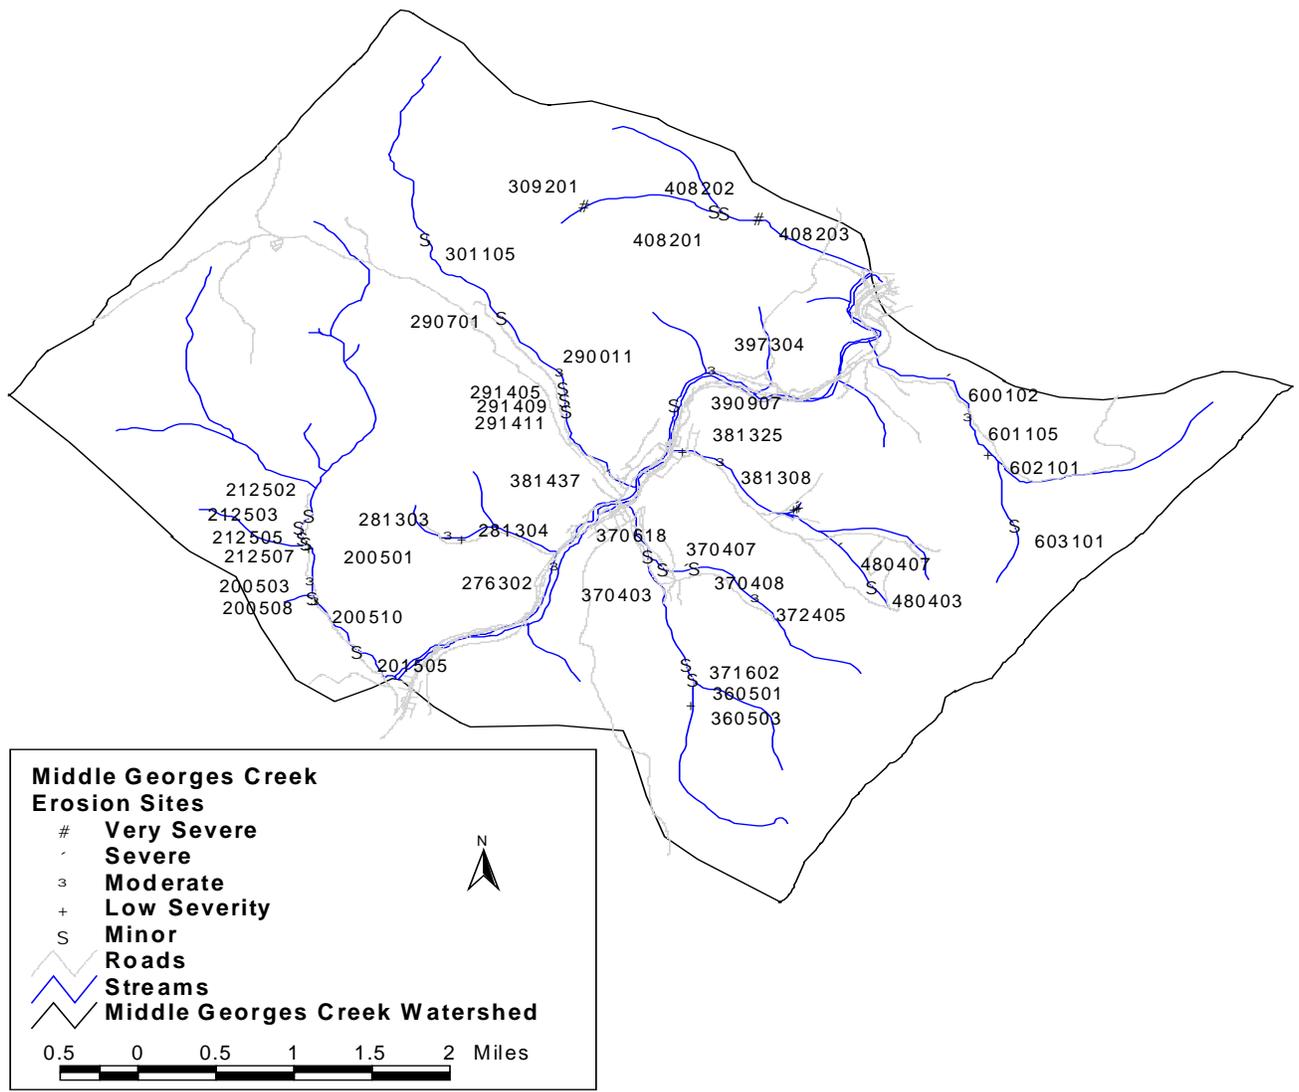
Figure 5c: Middle Georges Creek Erosion Site Locations.

Middle Georges Creek has 45 erosion sites found in this survey. Of these, 2 were very severe, both found on Seldom Seen Run. Site 309201 is a stream that has headcut its way upstream for 1,500ft. It is 6ft. high and forested on both banks. This erosion site was most probably the work of natural stream processes. Site 408203 is a 5ft. tall widening erosion site caused by bends at steep slopes for 1,400ft. Both bank are surrounded by forest.

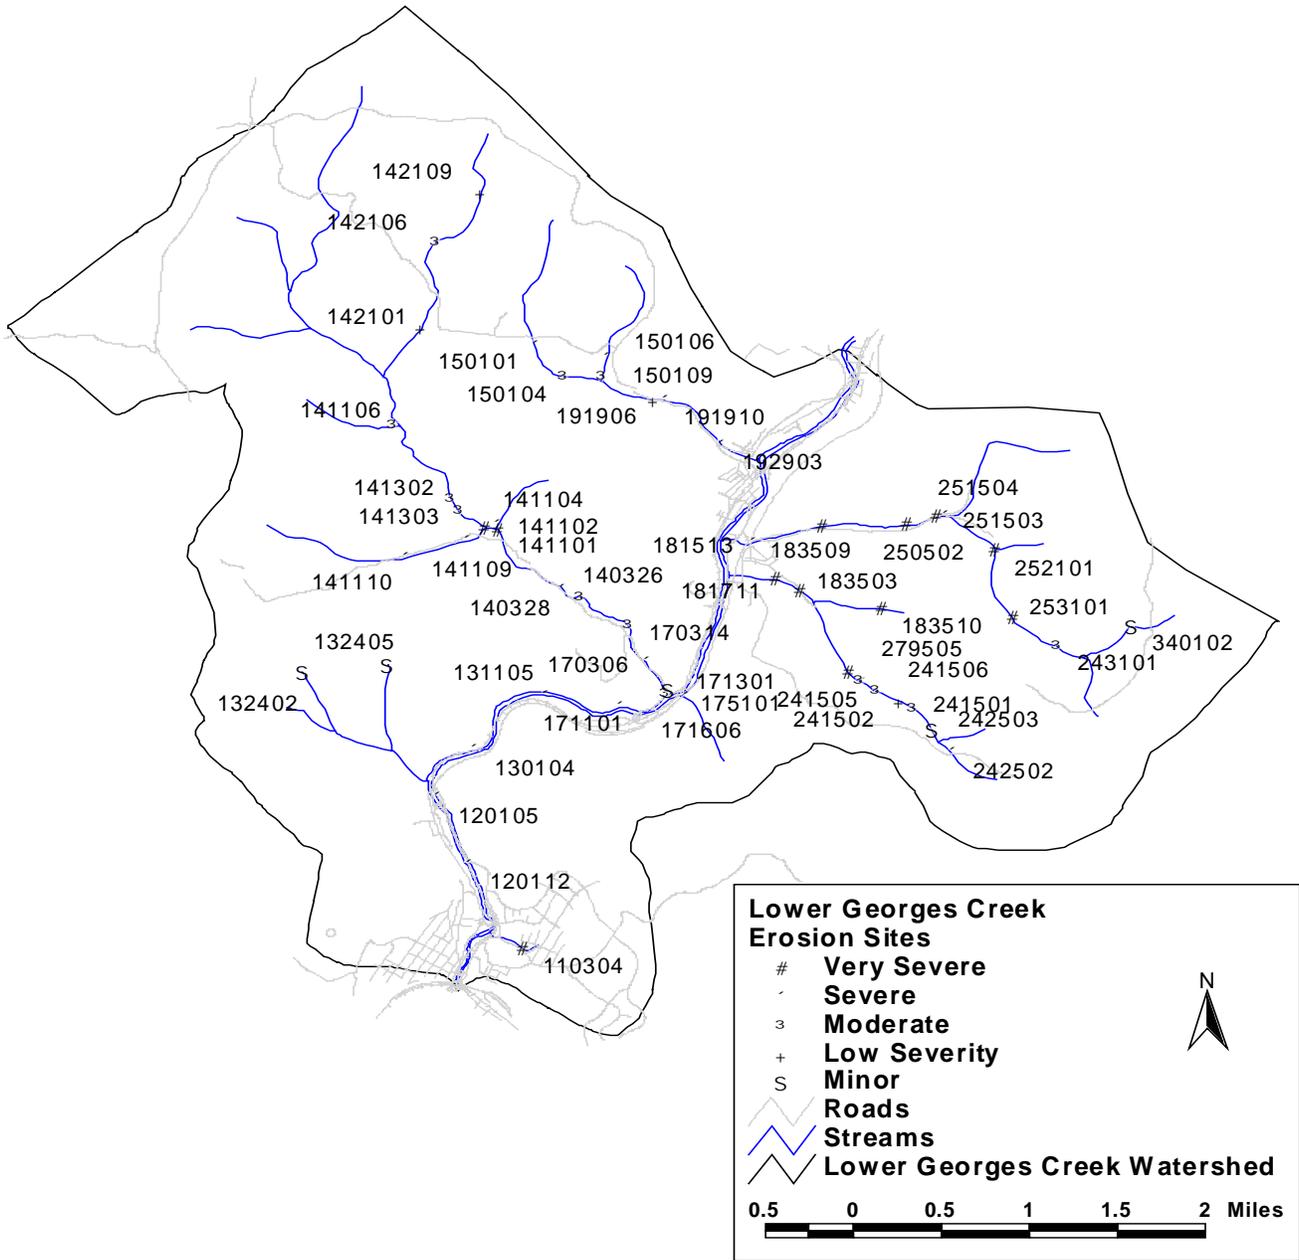
Figure 5d: Lower Georges Creek Erosion Site Locations.

Lower Georges Creek contains 53 erosion sites as identified by this survey. Of these, 9 sites were rated as being very severe. Site 181711 is 7 ft. in height, and is downcutting for 1,600 ft on Potomac Hill Run due to a land use change upstream. This site is surrounded by forest on both banks with the exception of one small segment of erosion threatening a house on the right bank. Site 183503 is a 5ft. high, 1,500ft. long widening erosion site with forest on both banks. Site 183509 is a 6ft. high, 1,500ft. long, widening erosion site that is caused by unknown circumstances on Moore Run. The left bank is forested, while the right bank has a road threatened by the erosion. Site 183510 is a 10ft. high downcut of unknown causes stretching for 1,600ft on Potomac Hill Run. This site was forested on both banks and was not a threat to infrastructure. Site 250502 is a 5ft. tall widening erosion site with unknown causes stretching for 5,000ft on Moore Run. A lawn on the right bank and a threatened road on the left surround the site. Site 251504 is a 10ft. tall widening erosion site with unknown causes stretching for 1,000ft. on Moore Run. The right bank is forested and the left bank has a road that is being threatened by the erosion. Site 252101 is a 10ft. tall, 1,100ft long downcut passing through forest on both sides with a mine road being threatened on Moore Run. Site 253101 is a 12ft. tall, 2,000ft long downcut with forest on each bank. Site 279502 is a 6ft. tall widening erosion site. This site is 2,300ft. long, has forest along both banks, and can be found on Moore Run.

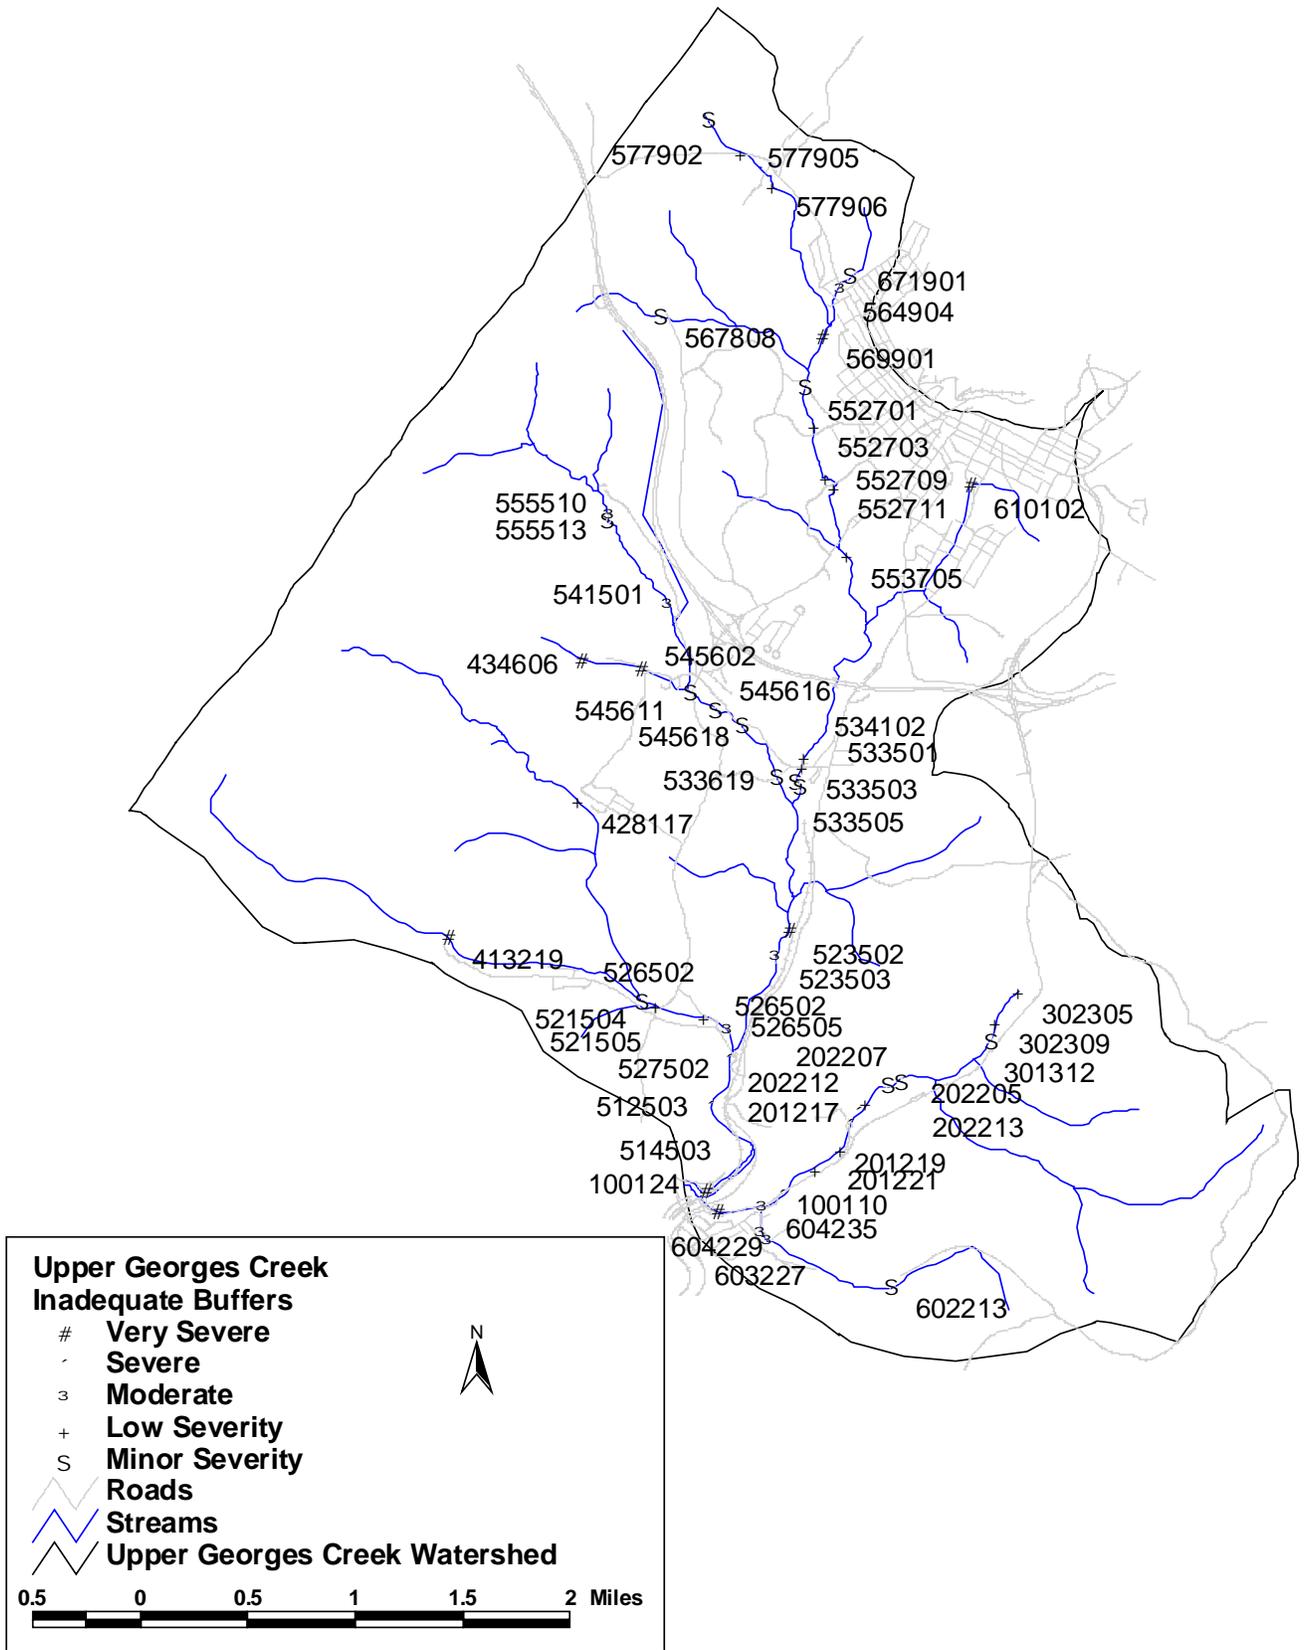
Figure 6b: Upper Georges Creek Inadequate Buffers Locations.

The upper portion of the Georges Creek watershed has the most reported inadequate buffers, 53. Of these 53, 8 were rated as very severe -- the highest amount in the watershed. Site 413219 has 0ft. of buffer on both banks for 6,000ft. Shrubs and small trees were reported as the most common land use on either side of this unshaded inadequate buffer on Woodland Creek. Site 434606 on Winebrenner Run is unshaded and inadequate on both banks for 1,500ft. Lawn is the most prevalent land use surrounding the stream at this inadequate buffer. Site 514503 is unshaded and inadequately buffered on both sides. The land use is cited as being lawn on both sides. The right bank has an inadequate buffer for 250ft., while the left has one for 1,400ft. This site is located on the mainstem. Site 523502 is unshaded on both sides for 2,000ft. and is a pasture on the mainstem with cows present. Site 545602 is 1,500ft. of unshaded inadequately buffered stream on Winebrenner Run, with lawn as its primary land use. Site 569901 is located on Sand Spring Run and is unshaded for 1,000ft. This area has been identified as pasture with horses present. Site 610102 unshaded for 2,400ft. along the mainstem of Georges Creek. The site is reported as being lawn. Site NR100124 is on Neff Run, and is 1,100ft. long. The right side has a buffer averaging 2ft. wide. Land use is lawn on the right and paved on the left.

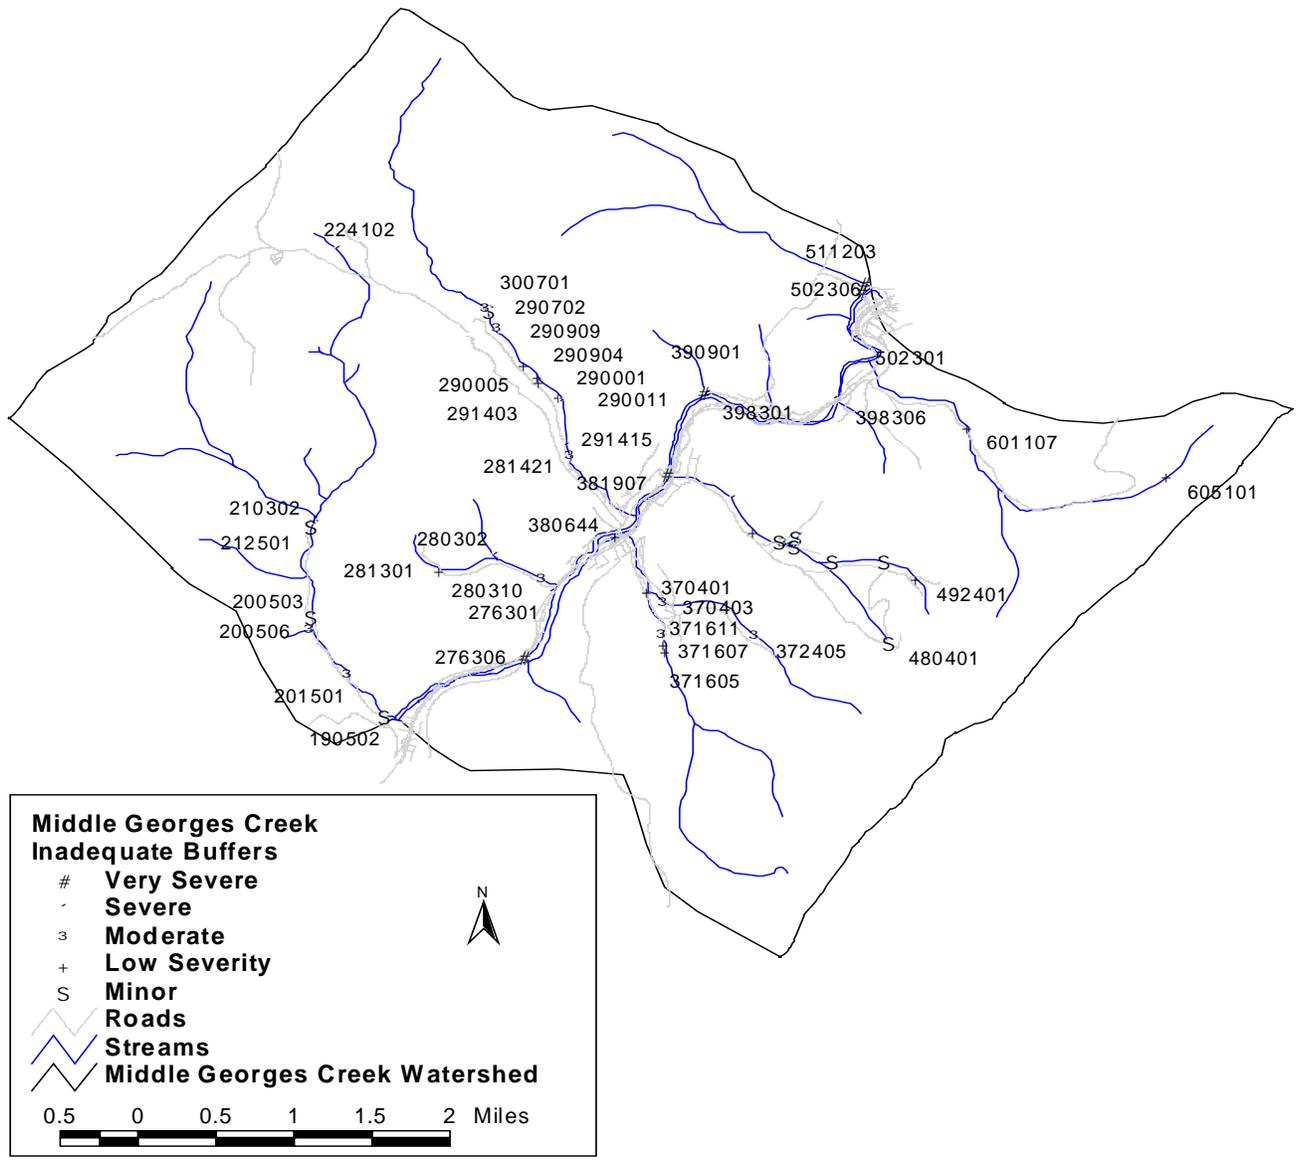
Figure 6c: Middle Georges Creek Inadequate Buffers Locations.

The middle watershed of Georges Creek has 48 reported inadequate buffers. Of these, survey crews rated 5 sites very severe. Site 276306 is 1,500ft. long along the left bank, and 3,000ft. long along the right bank of the mainstem. Land use on the right is paved, and land use on the left is designated as shrubs and small trees. The right buffer has a width of 2ft. Site 381907 is 6,000ft. long on both sides, and 5ft. wide on the left. The land use is lawn on the right and shrubs and small trees on the left. This site is

along the mainstem. Site 390901 is 2,400ft. on the left, and 400ft. on the right. This inadequate buffer is on Unnamed Tributary #4 and is lawn on the left and shrubs and small trees on the right. Site 502306 stretches for 2,800ft. on both sides of the mainstem. Shrubs and small trees are the land use on the right, and lawn is the land use on the left. Site 511203 is 1,000ft. long on both sides of Squirrel Neck Run. The stream is unshaded on the left and has a 20ft. wide recently established buffer on the right. Land is paved on the right and lawn on the left.

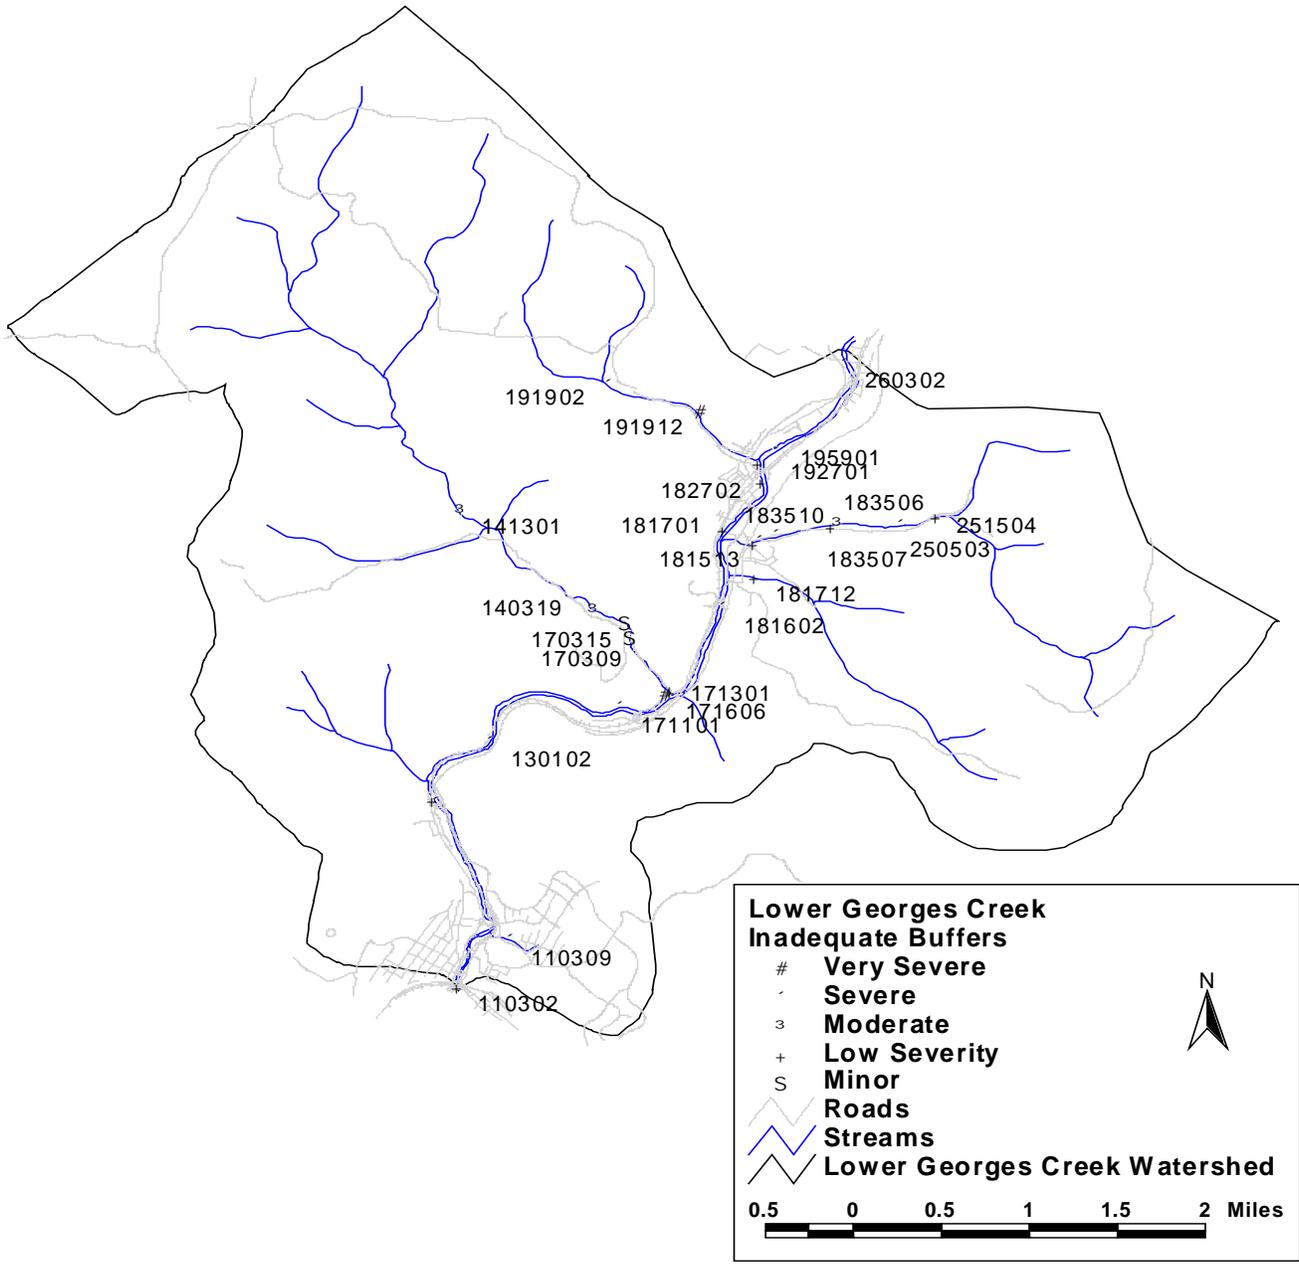
Figure 6d: Lower Georges Creek Inadequate Buffers Locations.

The lower portion of the Georges Creek watershed contains 28 inadequate buffers. Of these, 2 were given very severe rankings. Site 171606 is unshaded and 1,500ft. long on both sides of the mainstem. The right side has a 30ft. wide buffer. Land use on the right is railroad, while land use on the left is paved. Site 191912 is unshaded on both sides. The inadequate buffer is 3,300ft. long on the left, and 1,000ft. long on the right. Land use is paved on the left and lawn on the right.

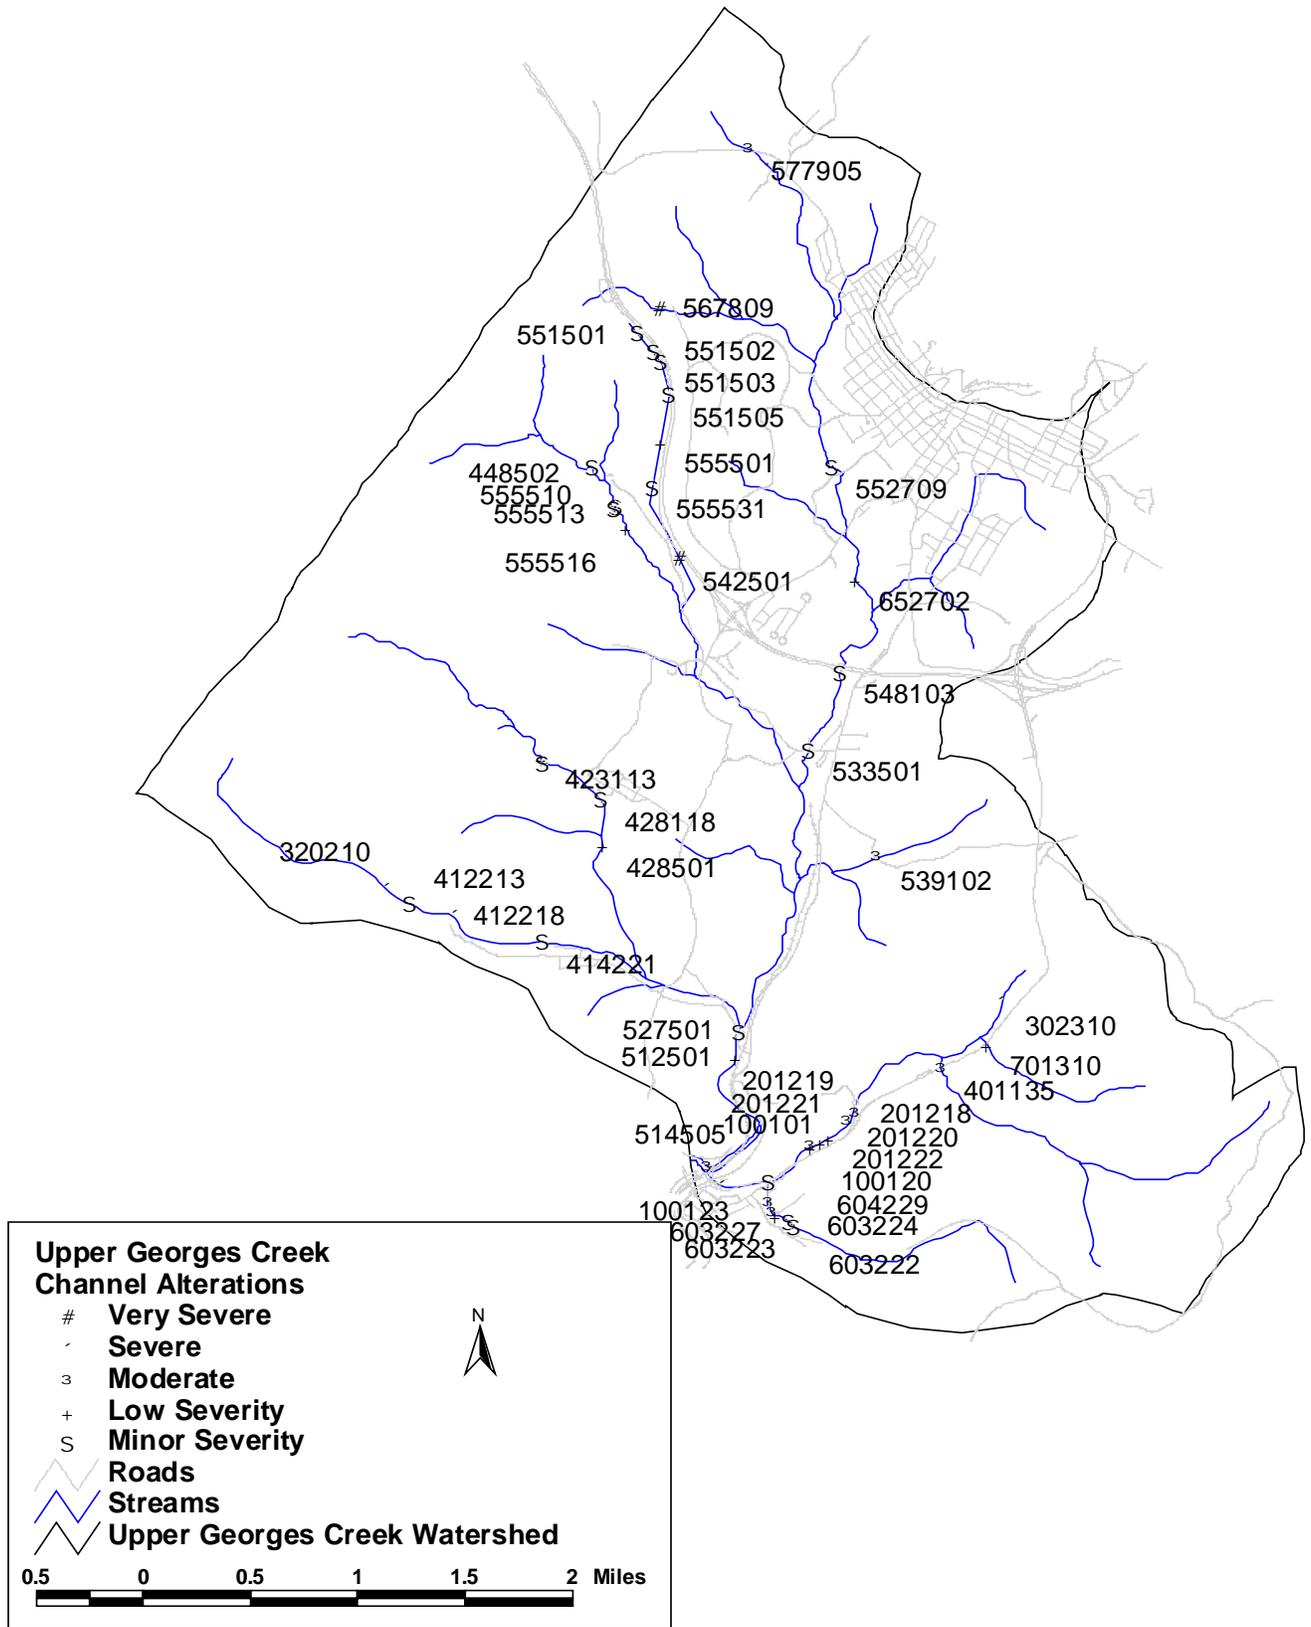
Figure 7b: Upper Georges Creek Channel Alteration Locations.

The upper watershed of Georges Creek has 53 channel alteration sites as reported by this survey. Of these, 2 were designated as very severe. Site 542501 is a severely damaged concrete channel along I-68 on Winebrenner Run. The channel has been blown out by high flow and the stream is now undercutting the concrete channel as well as the highway. The width of the bottom of the channel is 120in., and the length of the channelized section of stream stretches 1,500ft. The channel has no perennial flow or vegetation, but sedimentation is occurring in the channel. Site 567809 is a part of Sand Spring Run in the town of Frostburg. The stream appears to have been piped under town for about 21,000ft. (4 miles). The channel has perennial flow and sedimentation in the channel.

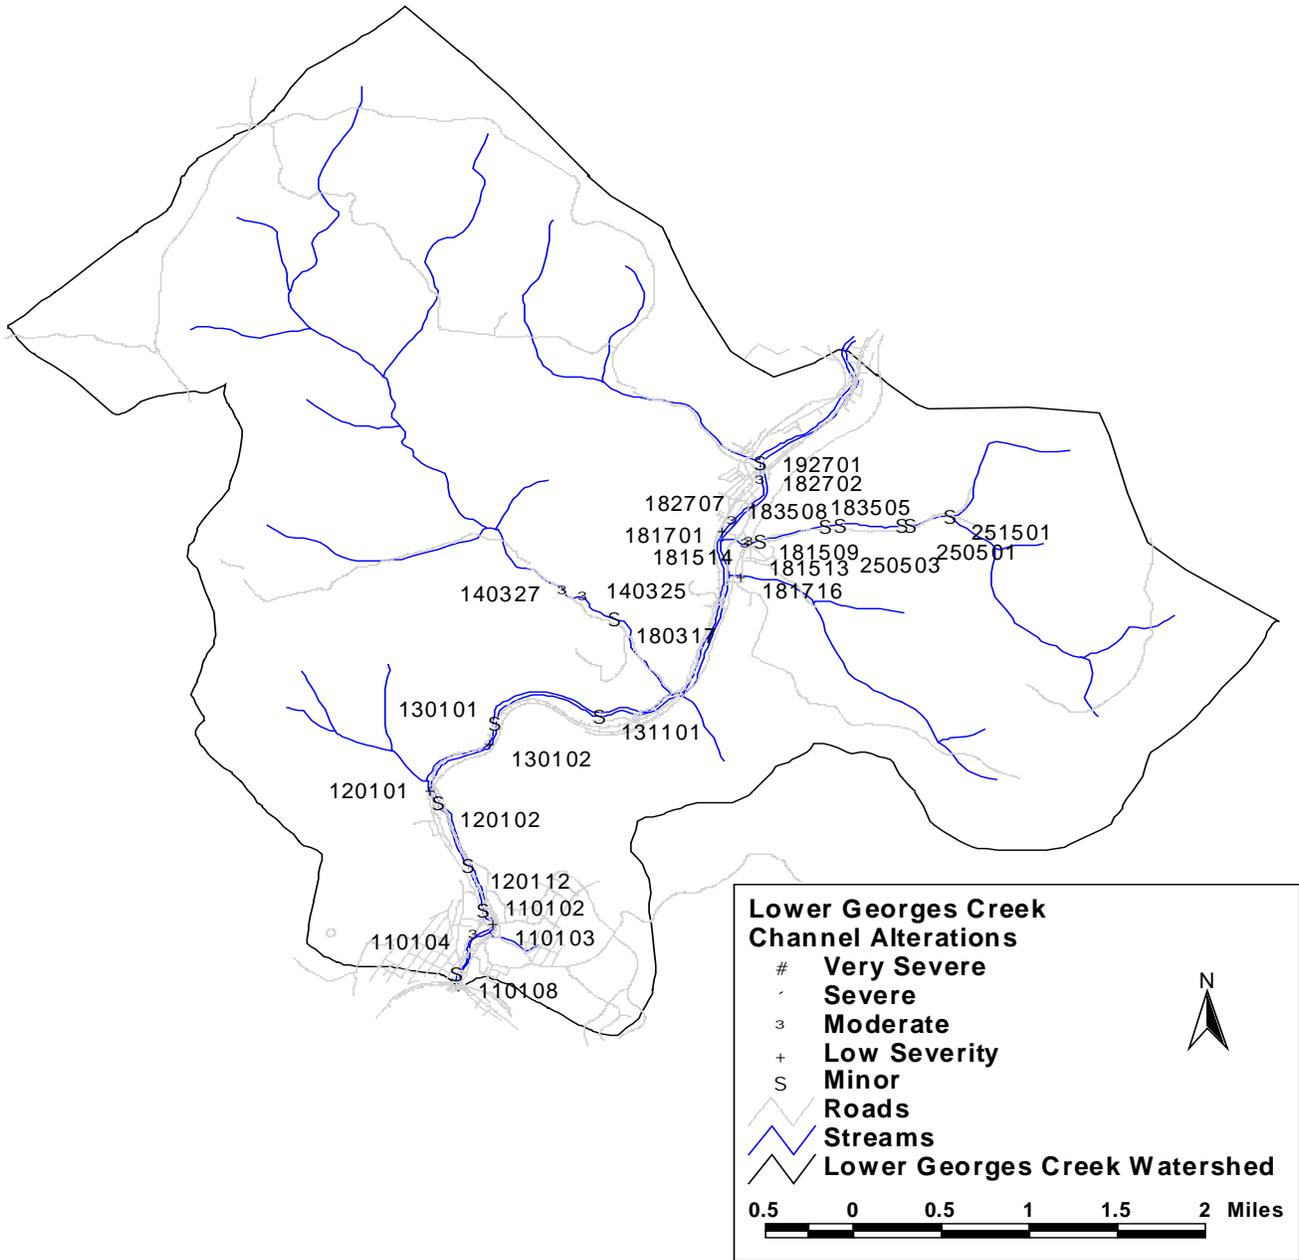
Figure 7d: Lower Georges Creek Channel Alteration Locations.

The lower portion of Georges Creek contains 26 channel alteration sites. None of these sites were given very severe or severe ratings. Seven sites were given moderate ratings, 5 were given low severity ratings, and 14 were given minor ratings. The streams with the most channel alterations in the lower portion of the watershed are the mainstem and Moore Run.
