Georges Creek Stream Corridor Assessment Survey

Watershed Restoration Division
Chesapeake & Coastal Watershed Services
Maryland Department of Natural Resources
December, 2002

GEORGES CREEK

STREAM CORRIDOR ASSESSMENT SURVEY

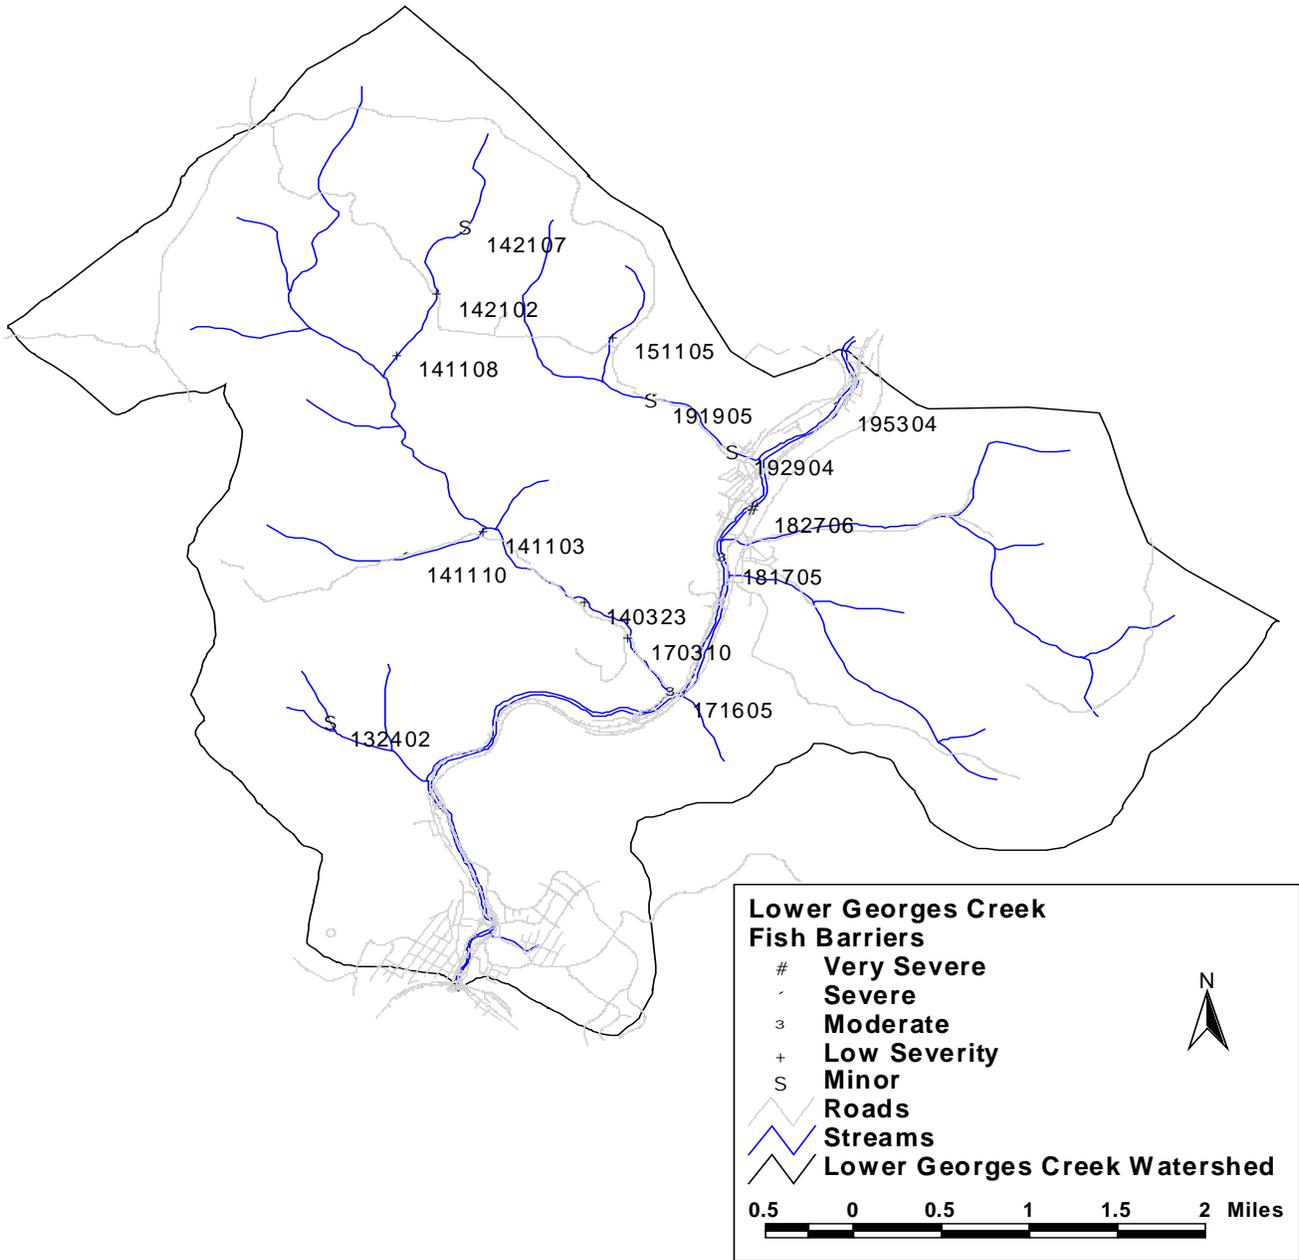
Figure 8d: Lower Georges Creek Fish Barrier Locations.

Sixteen fish migration barriers were reported in the lower portion of the Georges Creek watershed. One was given a very severe rating and three were given severe ratings. Site 182706 is a total blockage dam on the mainstem with a water drop of 48in. It was given a very severe rating due to its position in the watershed in the mainstem. Site 141110 is a natural falls with a water drop of 360in that was given a severe rating. This site is on Michaels Run and is associated with a very severe erosion site. Site 191907 is a severe total blockage dam on Butcher Run with a water drop of 18in. Site 195304 is a severe total blockage due to a pipe crossing with a water drop of 12in. on the mainstem. This site received a severe rating due to its position in the watershed.

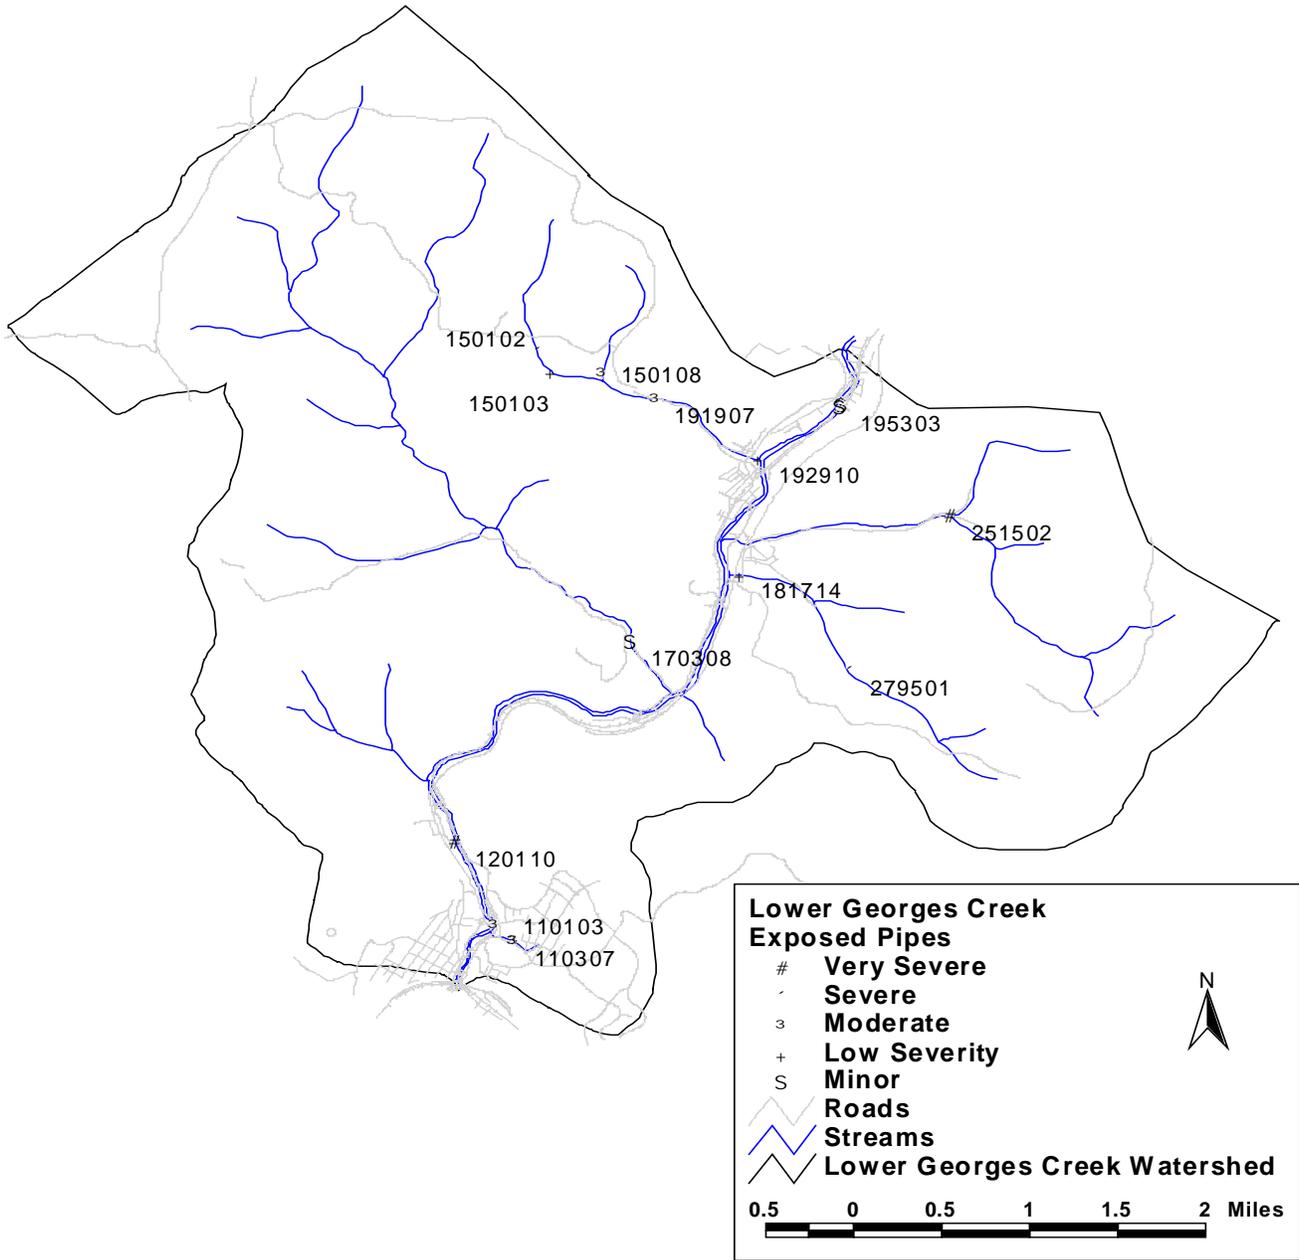
Figure 10d: Lower Georges Creek Exposed Pipes.

Fifteen exposed pipes were found on the lower portion of the watershed. Two were found to be very severe, and 2 were found to be severe. Site 120110 is an 8in. diameter sewage pipe exposed for 5ft. along the stream bank of the mainstem. It was found to have a discharge with no color and a sewage odor, and was given a very severe rating. Site 251502 is a 10in. diameter smooth metal pipe with a white discharge exposed for 12ft. across the bottom of Moore Run. The purpose of the pipe is unknown, and it was given a very severe rating due to its impact on the stream. Site 150102 is a 6in. diameter smooth metal pipe with unknown purpose exposed for 15ft. above Butcher Run. 150102 was given a severe rating. Site 279501 6in. diameter smooth metal pipe exposed for 25ft. across the bottom Potomac Hill Run. This site was given a severe rating.

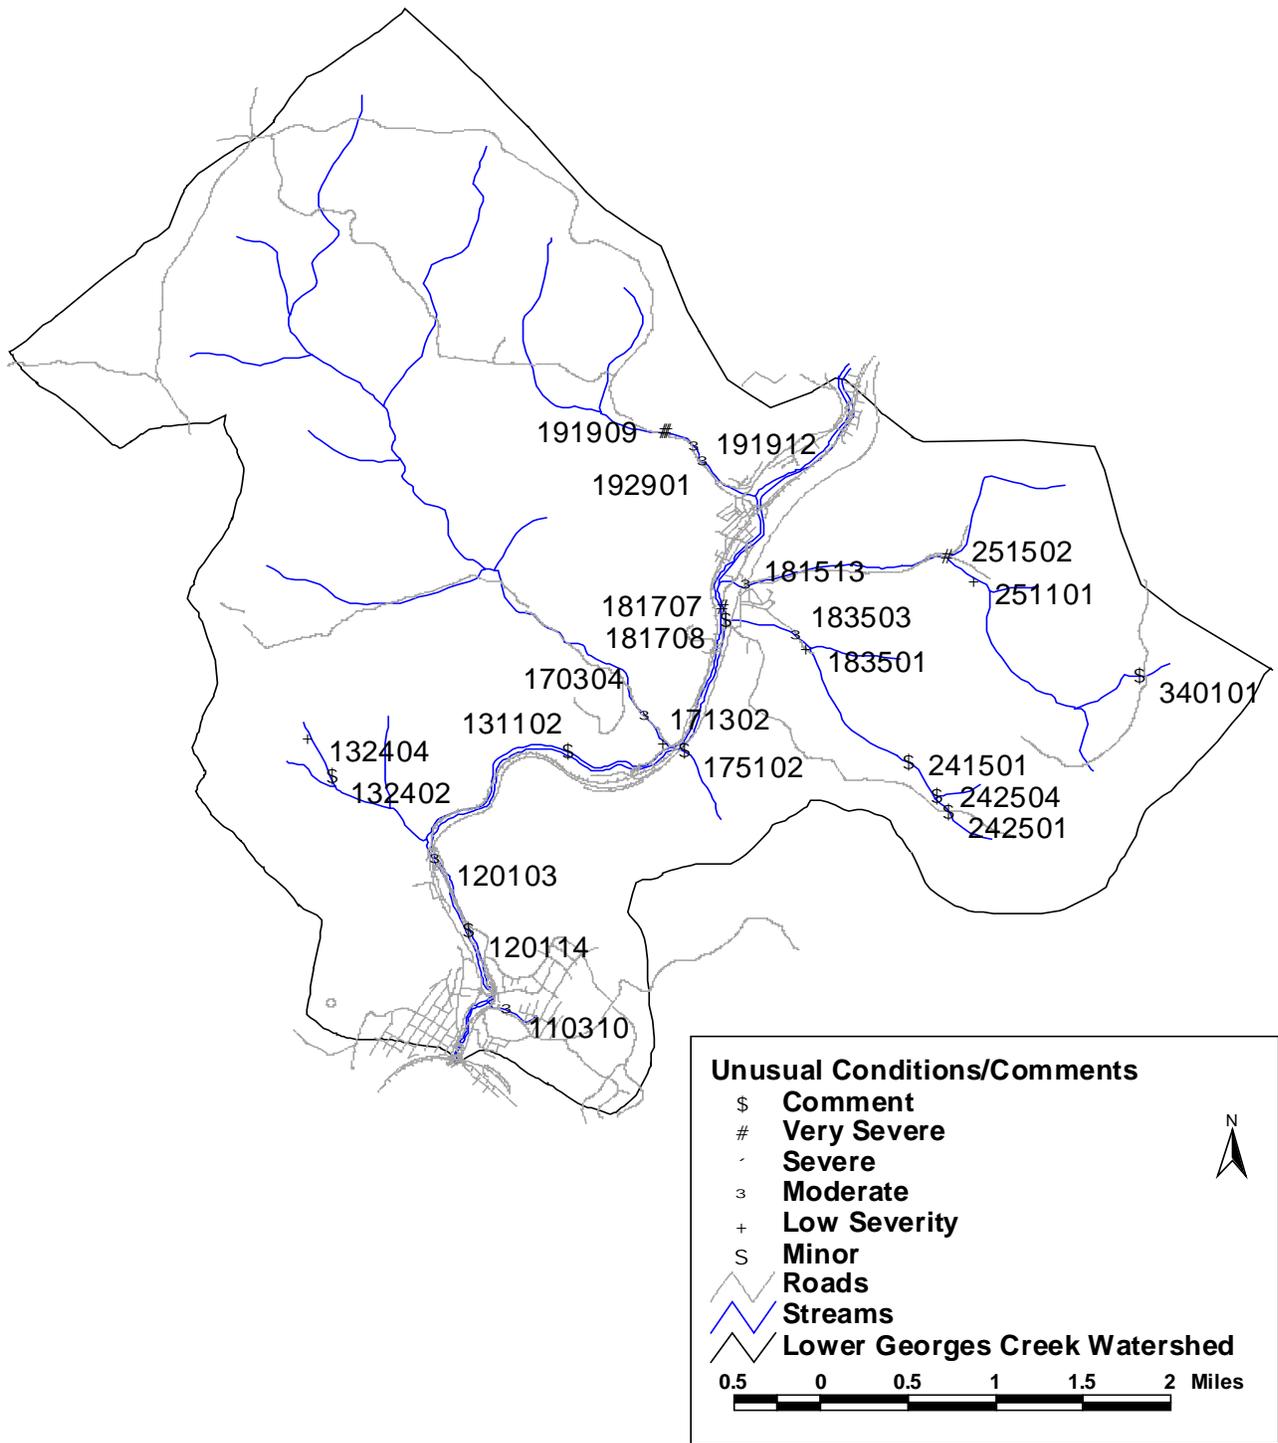
Figure 11d: Lower Georges Creek Unusual Conditions/Comments.

Fifteen unusual conditions and 9 comments were recorded in the Lower watershed. Out of these fifteen, 4 were given very severe ratings, and none were given severe ratings. Site 181707 is major acid mine drainage in the mainstem. Site 191908 is a sewage leak out of a pipe on the left bank of Butcher Run. Site 191909 is a sewage leak from a blue house on the left bank of Butcher Run. Site 251502 is a leak from a pipe on the bottom of Moore Run. Moore Run is white from this pipe downstream. The pipe is on the border of county property and a mine.

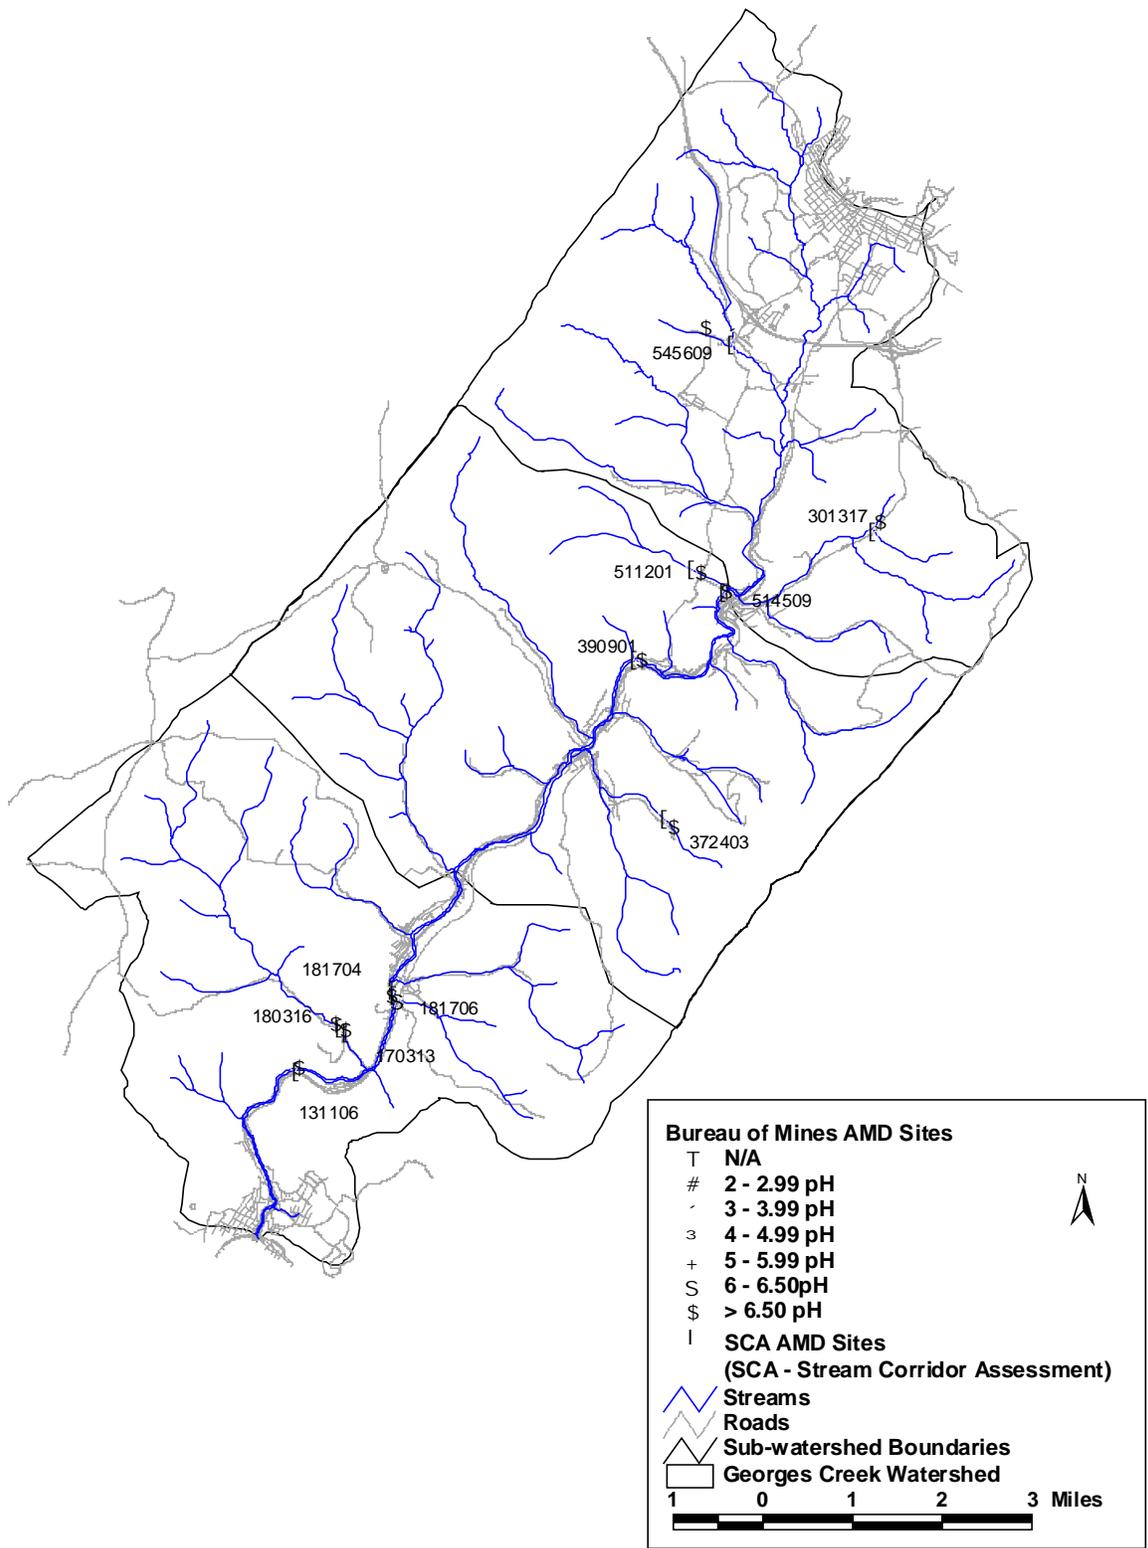
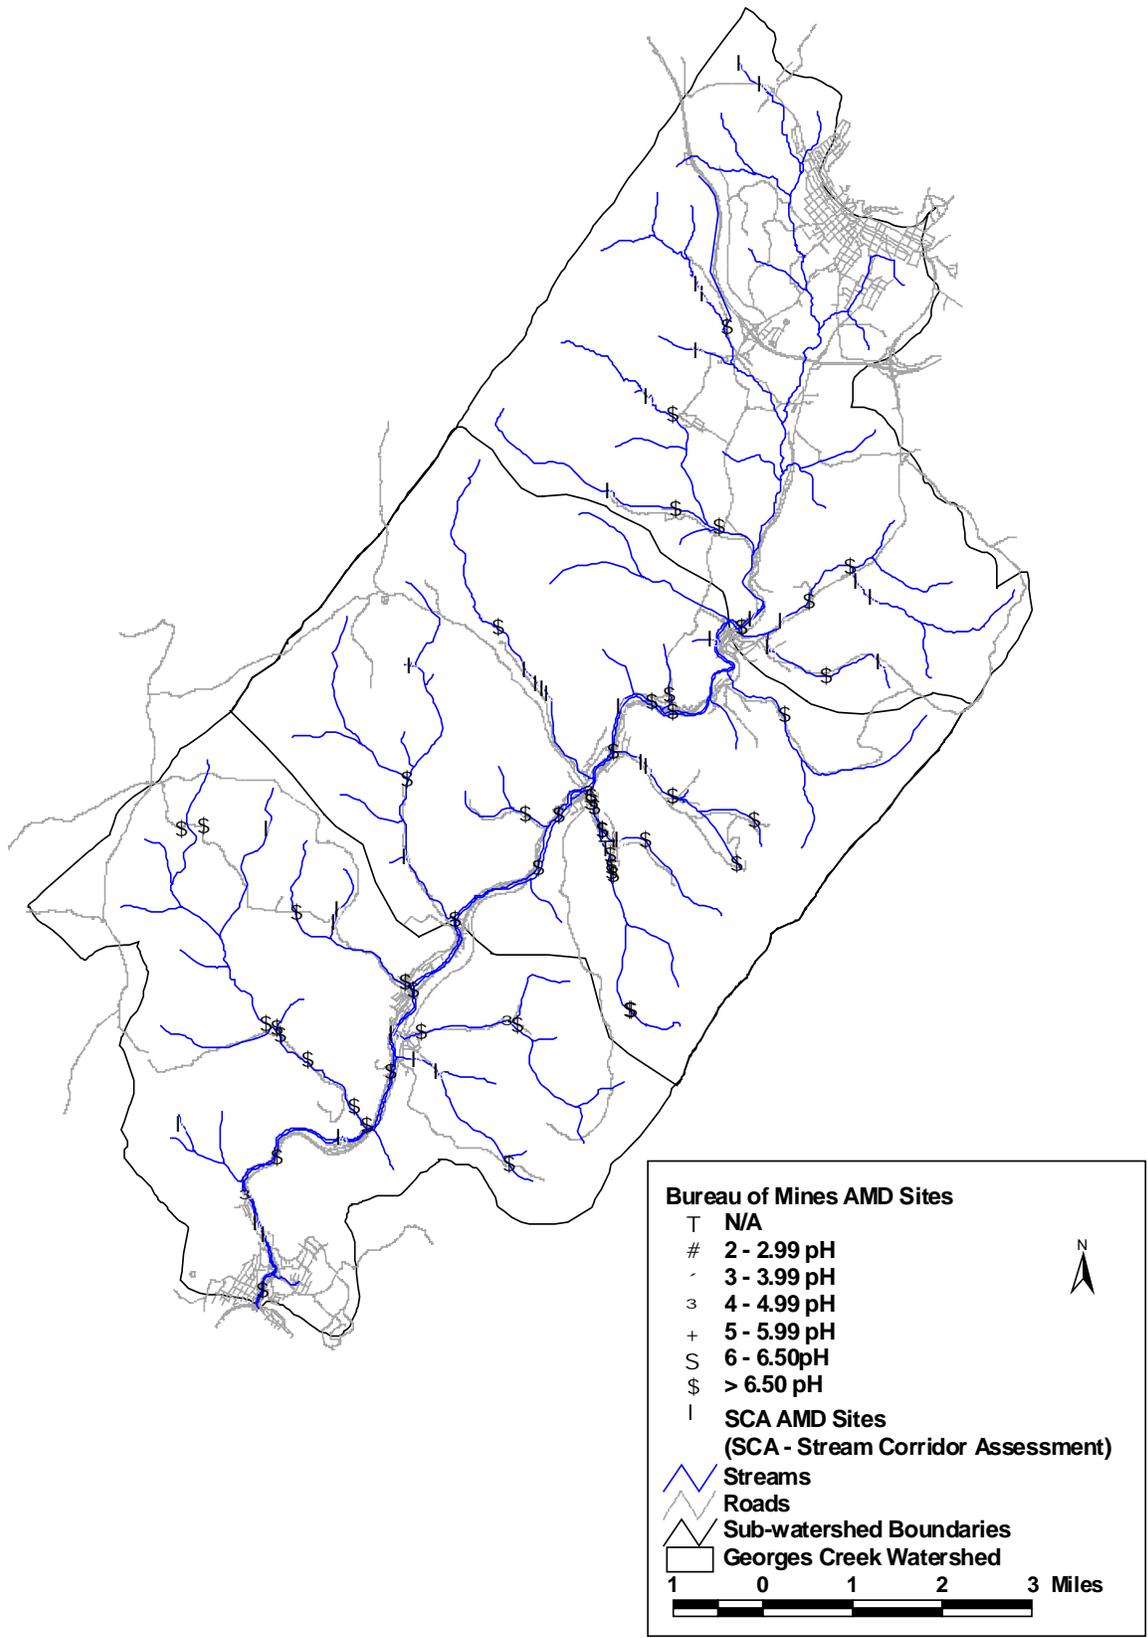
The occurrences of AMD have been mapped in both surveys, and can be found together in Figures 13a and 13b. Figure 13a shows areas in which sample sites from both surveys were found to correspond, and figure 13b shows areas in which they do not overlap. Bureau of Mines data for each site can be found in Appendix B. It is the intent of this document to show the extent of all areas identified in Georges Creek as having Acid Mine Drainage, in order to have a better understanding of AMD properties and occurrences at these sites. MDE's Bureau of Mines expects to publish their report in the near future.

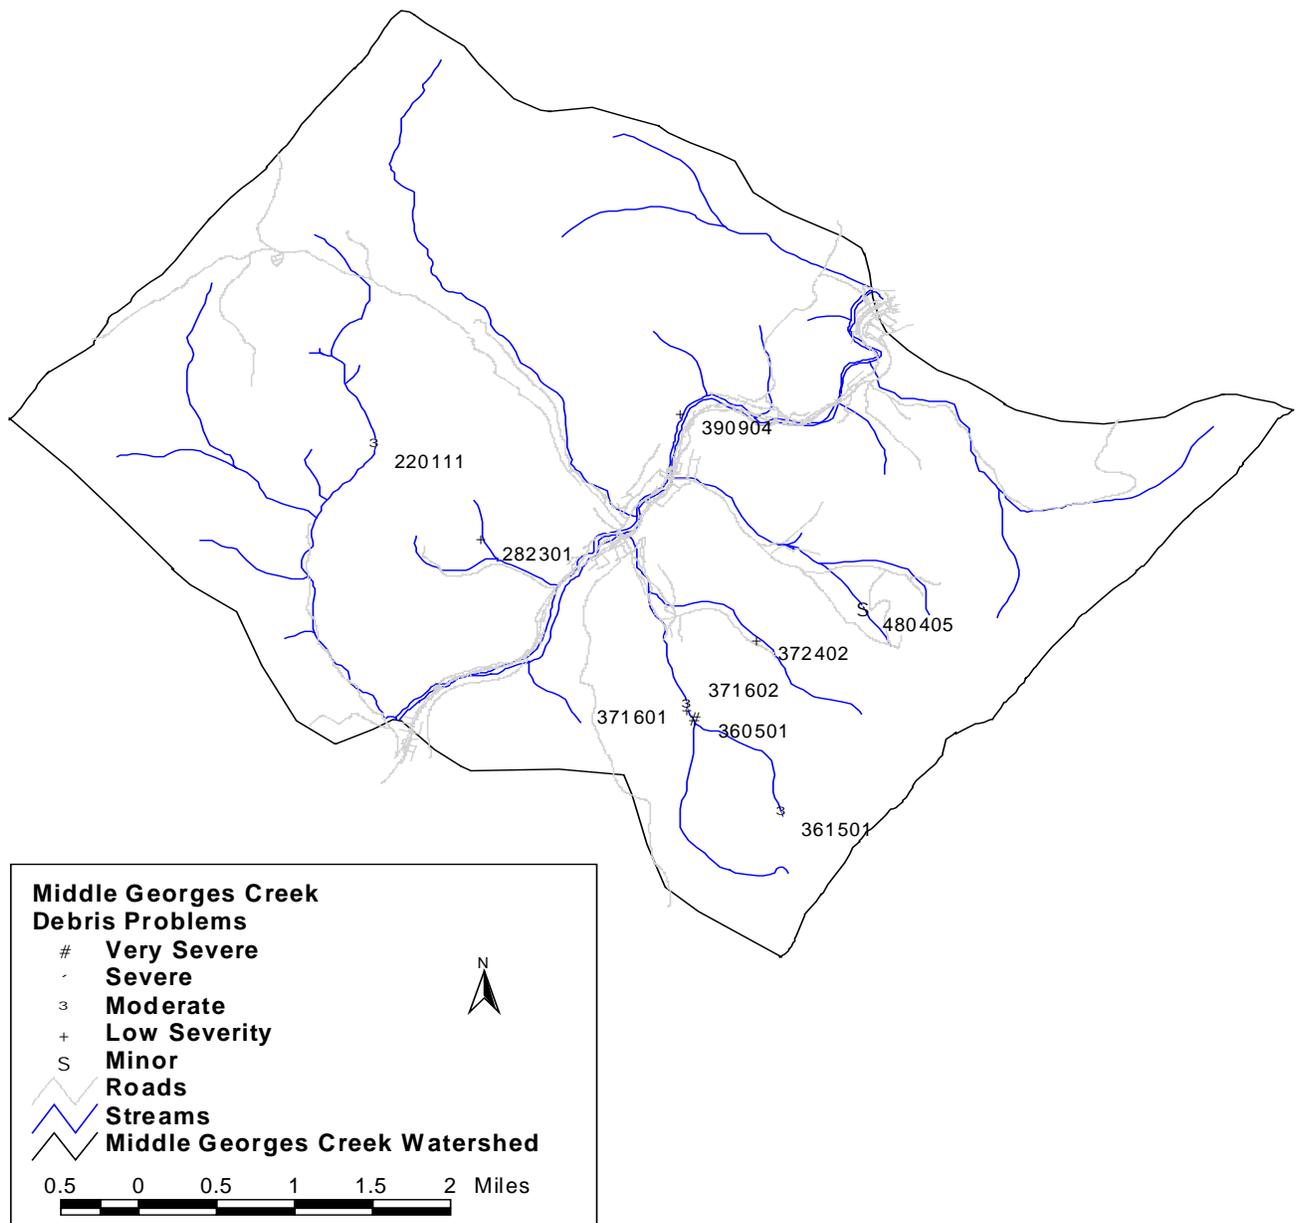
Figure 15c: Middle Georges Creek Debris Problems.

Nine debris problem sites were found in the middle portion of the watershed. One problem in the middle watershed was given a very severe rating, and none were given severe ratings. Site 360501 is a 20 ft. long woody debris jam that is ponding and eroding on Jackson Run. The pond is 50ft. long by 50ft. wide by 1ft. deep.
