# Lower Linganore Creek Stream Corridor Assessment Survey

Watershed Assessment and Targeting Division  
Watershed Services  
Maryland Department of Natural Resources  
June 2005

# LOWER LINGANORE CREEK STREAM CORRIDOR ASSESMENT SURVEY

Frederick County, Maryland

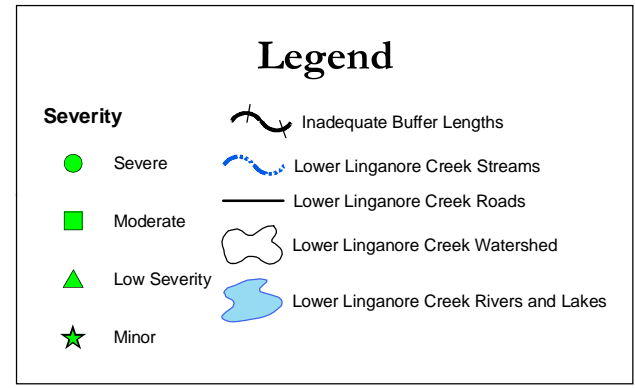
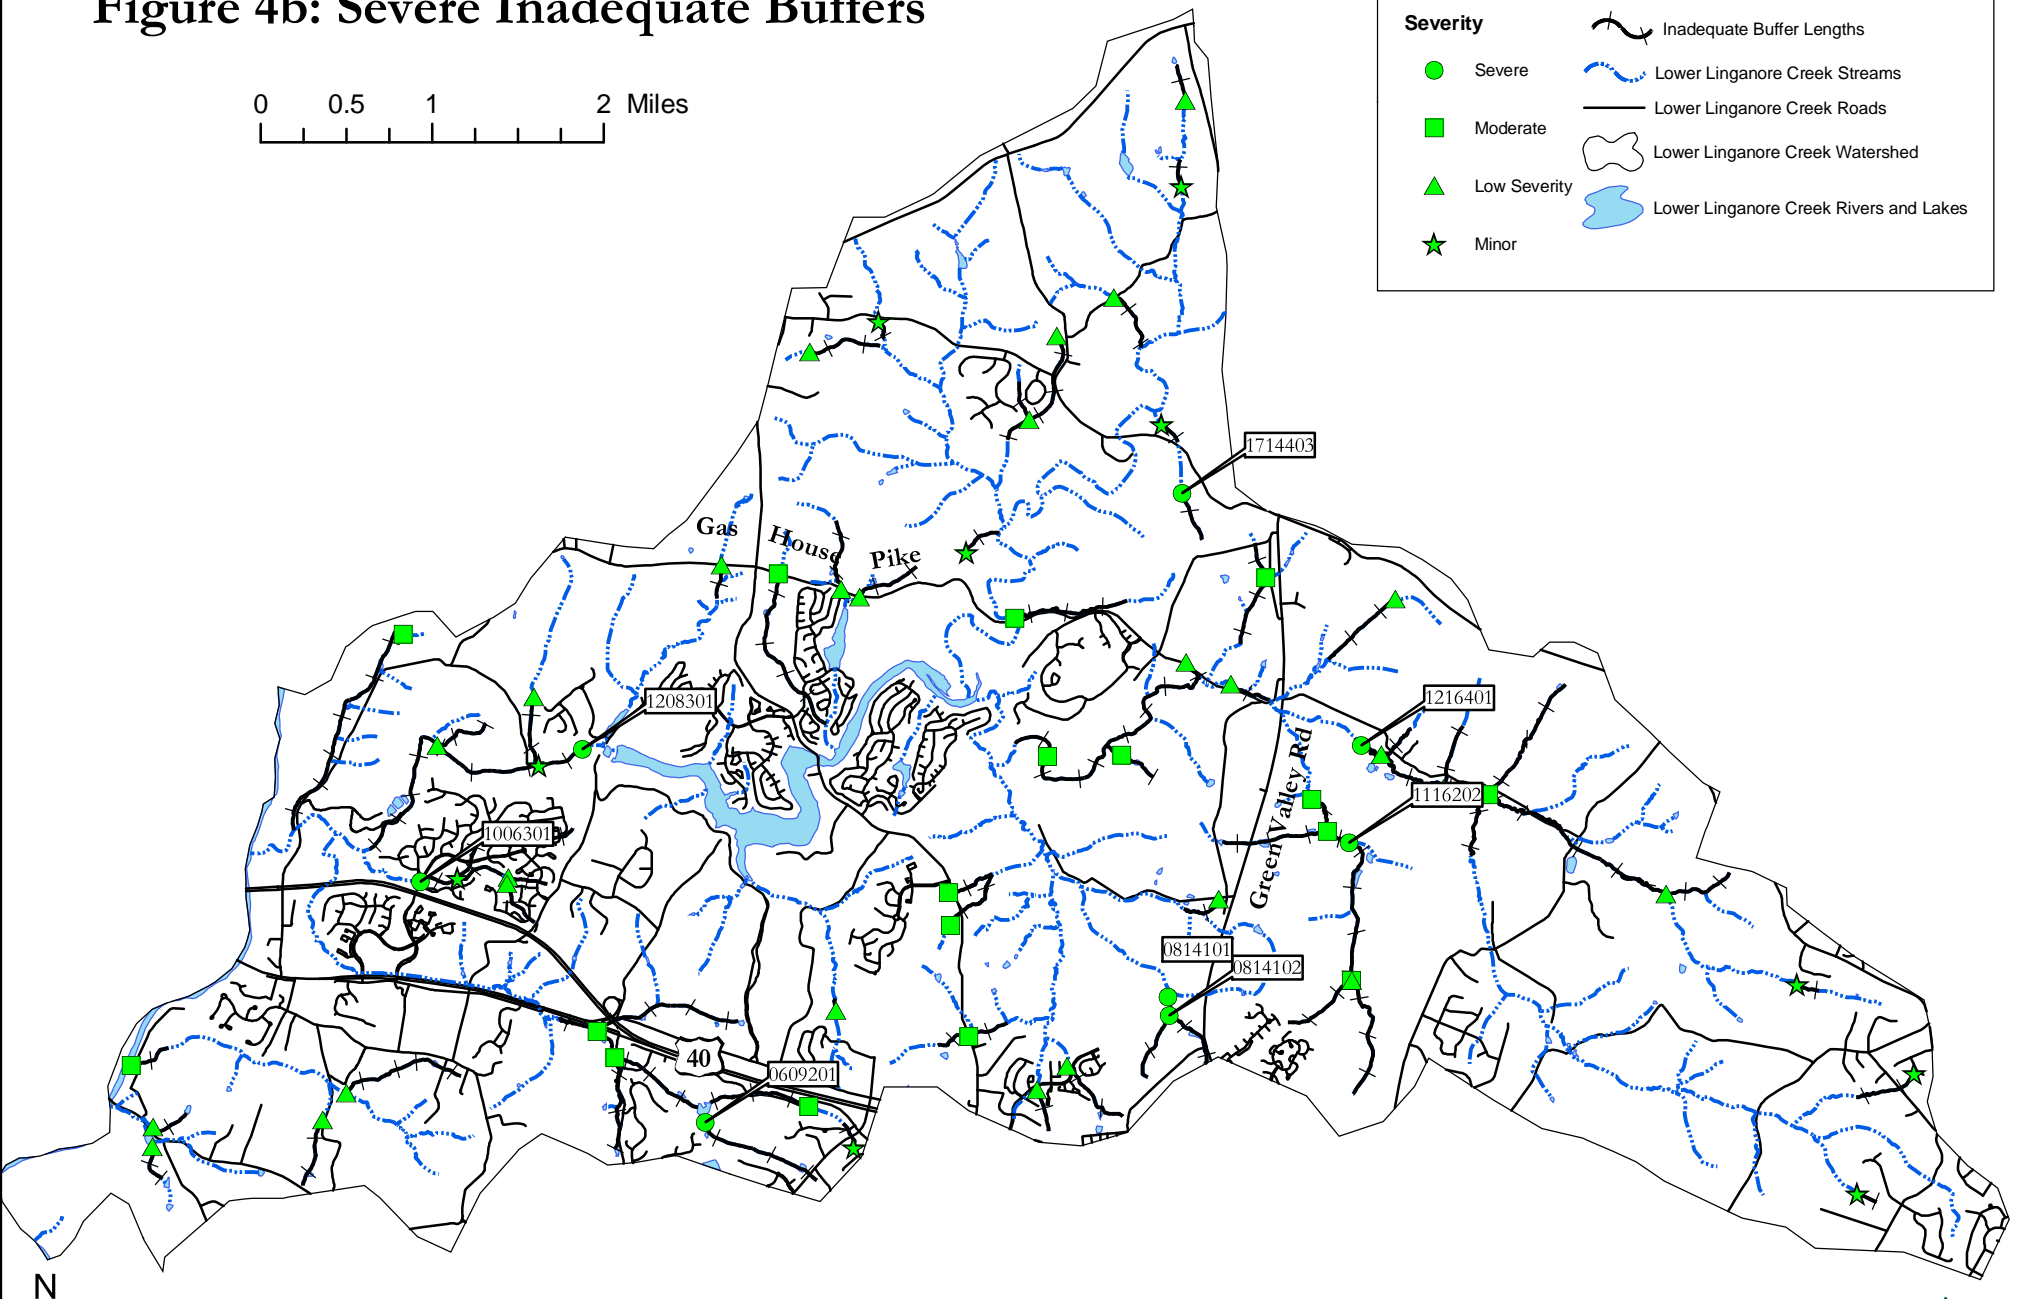
# Figure 4b: Severe Inadequate Buffers

The survey crew identified 63 inadequate buffers sites (Figures 4b-4e) and provided an estimate of the length of the inadequate stream buffer at all sites (Appendix B). Based on the collected data, there are approximately 161,635 feet (30.61 miles) of inadequate buffers on the left bank and 170,258 feet (32.25 miles) on the right bank of the streams (Table 2). Field teams found inadequate buffers ranging in length from 383 feet to 14,415 feet (2.73 miles). Severity ratings varied from severe to minor with the greatest number of sites given a low severity rating (Figure 4a). Inadequate buffer sites are distributed throughout the watershed, with approximately 32.35 percent of the left bank and 34.09 percent of the right bank inadequately buffered.

Of those sites ranked as severe, five of the nine sites have zero feet of buffer on both the left and right stream banks. The land uses noted for the severe sites on the left bank are: 4 pasture, 2 lawn, 1 forest, and 1 golf course. On the right bank, the land uses are as follows: 5 pasture, 2 lawn, and 1 golf course. None of the severe sites were noted as having a recently established buffer. However, three other sites were noted as having recently established buffers: 0916202, 0916203, and 1512402.

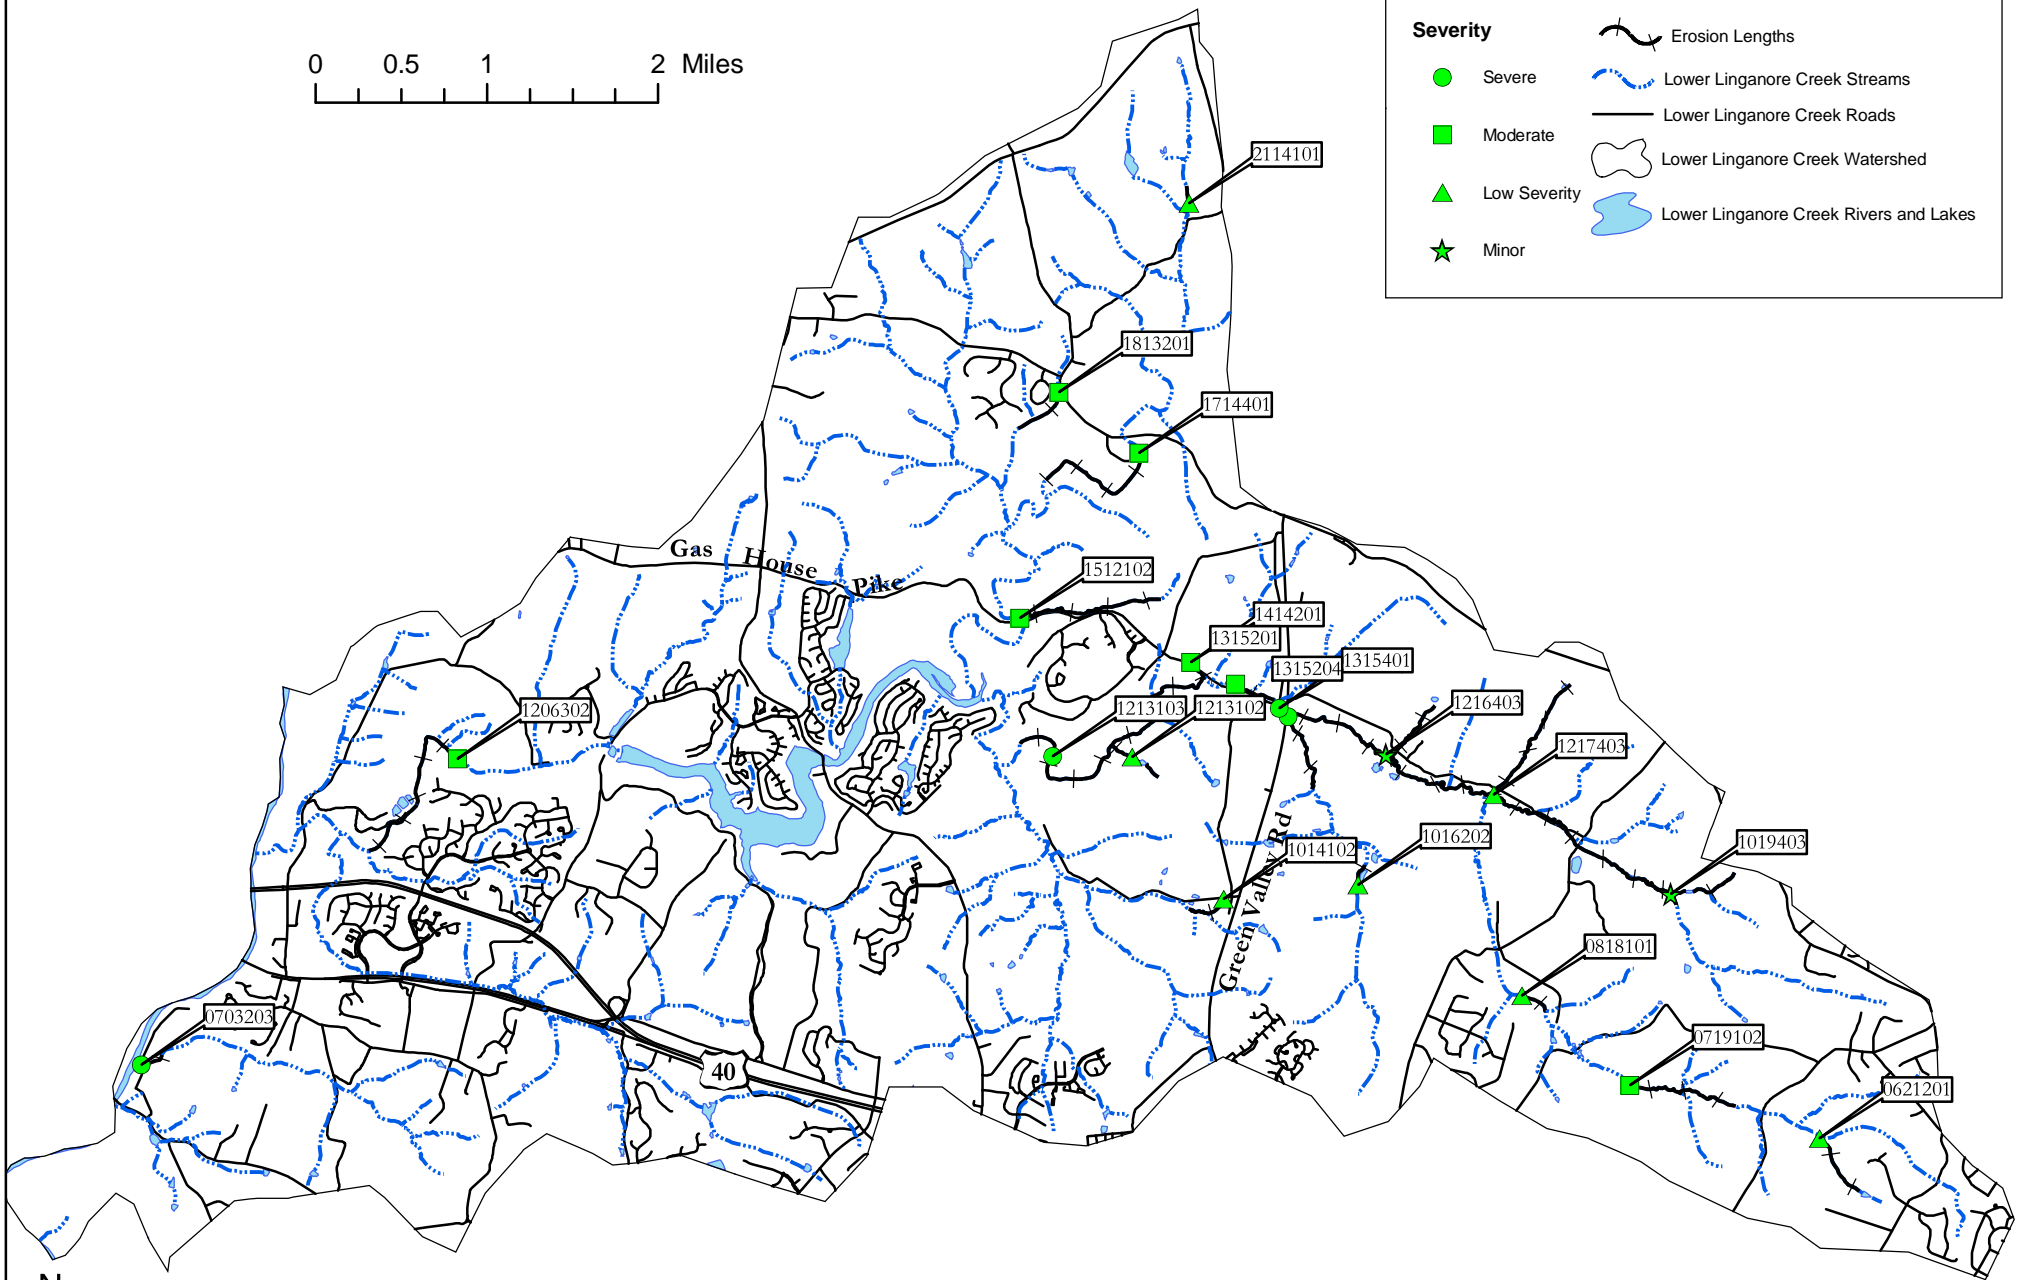
# Figure 5b: Erosion Sites

The SCA survey found 20 eroding stream banks with a total length of 67,316 feet (12.75 miles). Erosion sites noted by the survey crews are congregated primarily in the eastern part of the Lower Linganore Creek watershed. Based on the land use, soil type and gradient within the watershed, levels of erosion vary. According to the Frederick County Annual Report, the Lower Linganore Creek watershed has a total urban impervious area equaling 1,174 acres (7.2% of the watershed). Though it is likely that these impervious surfaces are contributing to erosion levels, the contribution is probably small. Figure 3 shows that the much of the watershed is agricultural in land use. These areas tend to have minimal forest buffering; an increase in forest buffers could help reduce the rate at which water runoff enters the stream channel.

The severity and location of erosion sites in the Lower Linganore Creek watershed are shown in Figure 5b. Severity ratings ranged from minor to severe. The frequency of the severity ratings is shown in Figure 5a.

In addition, survey crews are asked to evaluate whether there is a threat to infrastructure due to the erosion. Crews cited only one instance where this was the case, and the threatened infrastructure is listed as a baseball diamond.

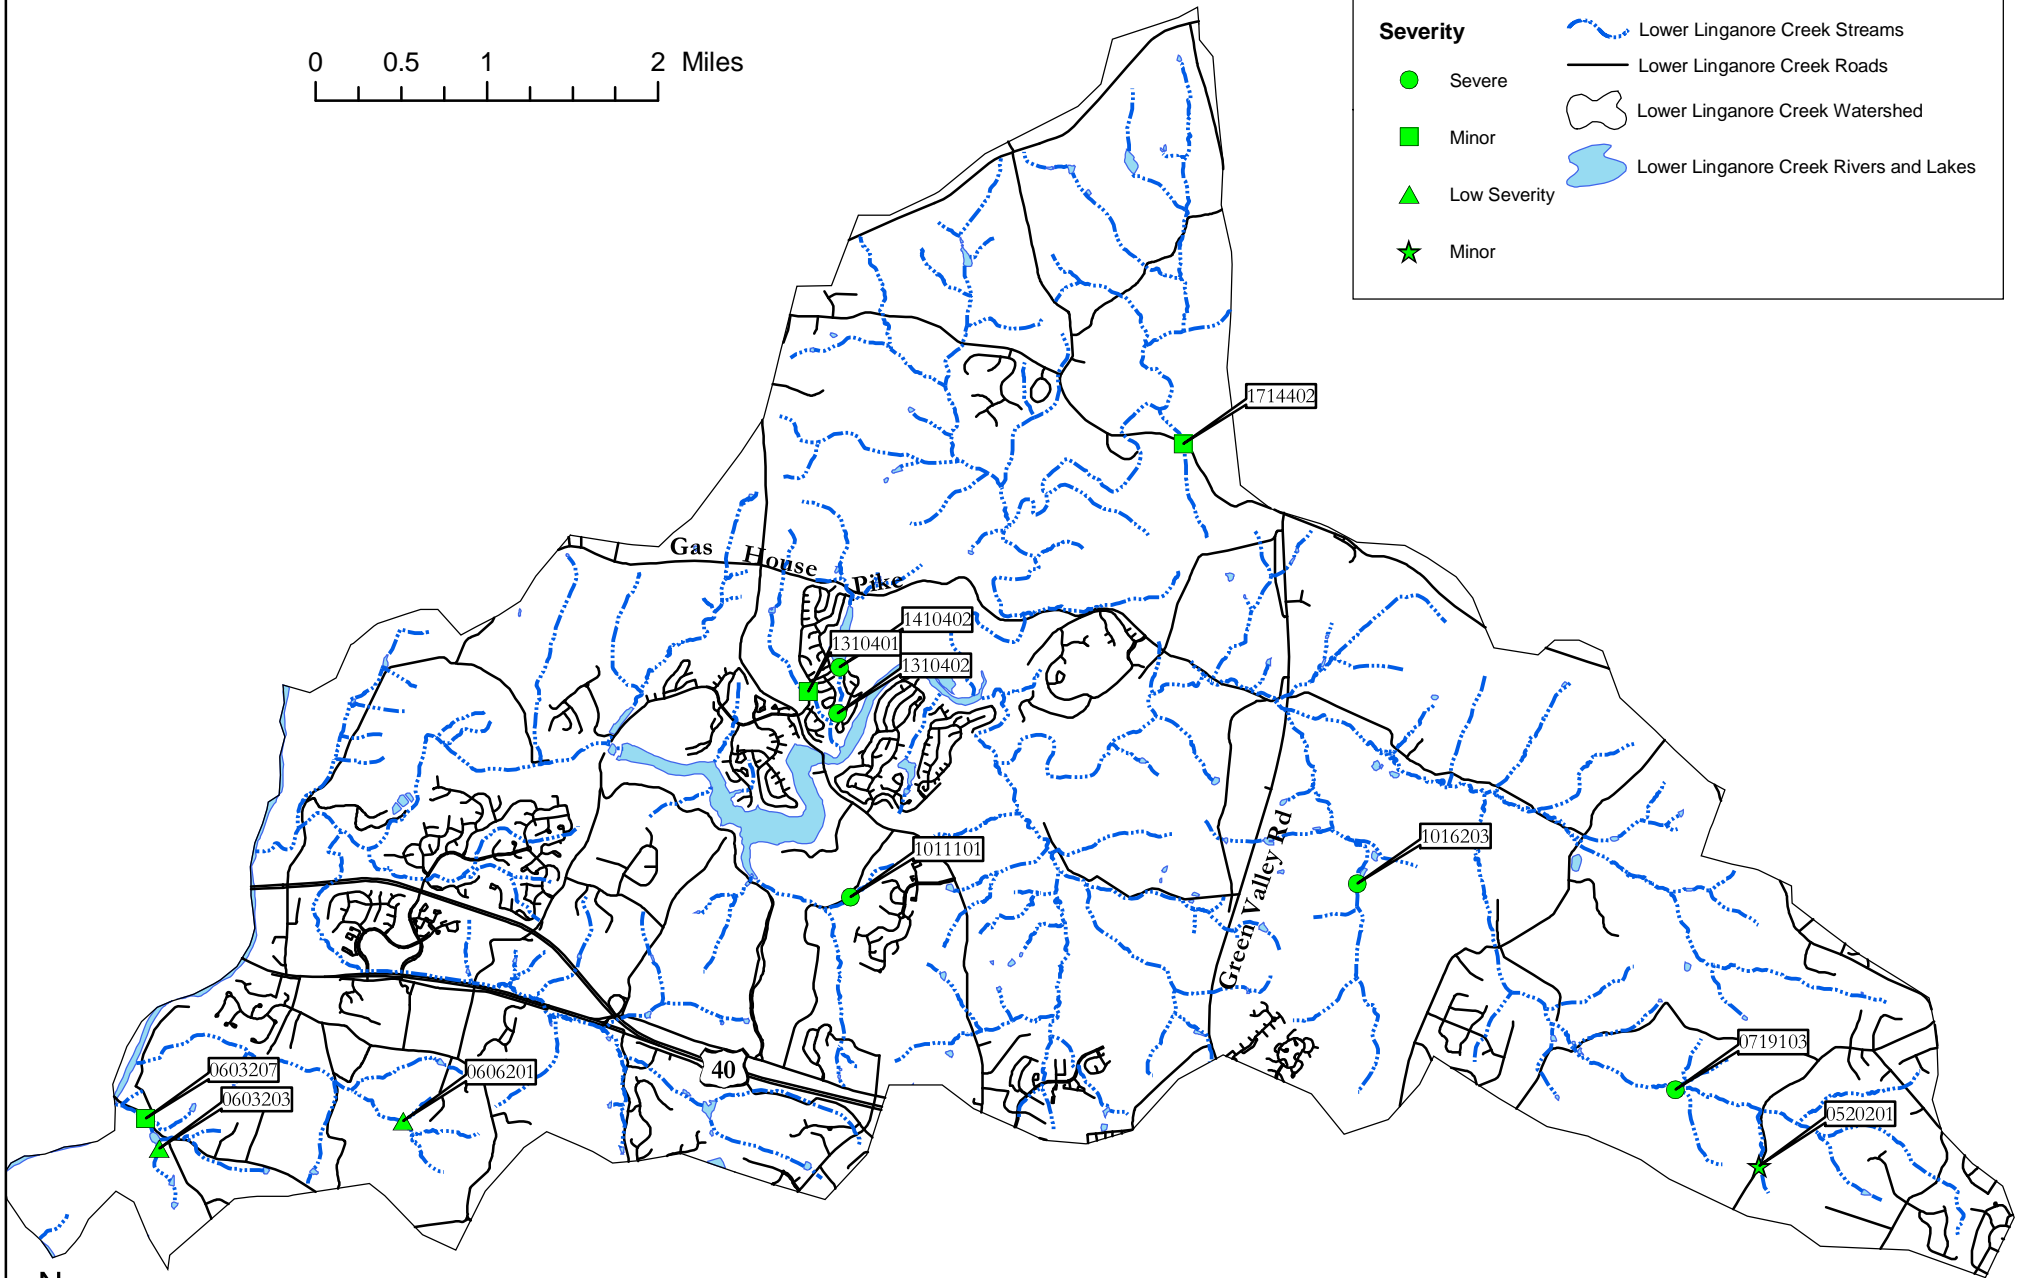
# Figure 6b: Fish Passage Barriers

The Lower Linganore Creek SCA survey found 11 fish passage barriers. The locations of fish blockages are shown in Figure 6b. The fish barriers found in the Lower Linganore Creek watershed are due to road crossings (5), channelized stream beds (2), a debris dam (1), a dam (1), an exposed pipe (1), and a dam/channelized stream bed (1). Figure 6a shows that severity ratings varied from severe to minor with 5 sites listed as severe. These sites were 0719103, 1011101, 1016203, 1310403, and 1410402. Four of the eleven sites were observed to be too shallow with the remainder of the sites marked as too high. Total structures blocking full movement of fish were observed at seven sites while partial barriers allowing some flow were found in three cases. One site was noted as being a temporary barrier.

In all cases, areas should be assessed for viable fish habitat before restoration work begins, giving preference to sites with the most potential habitat area created.

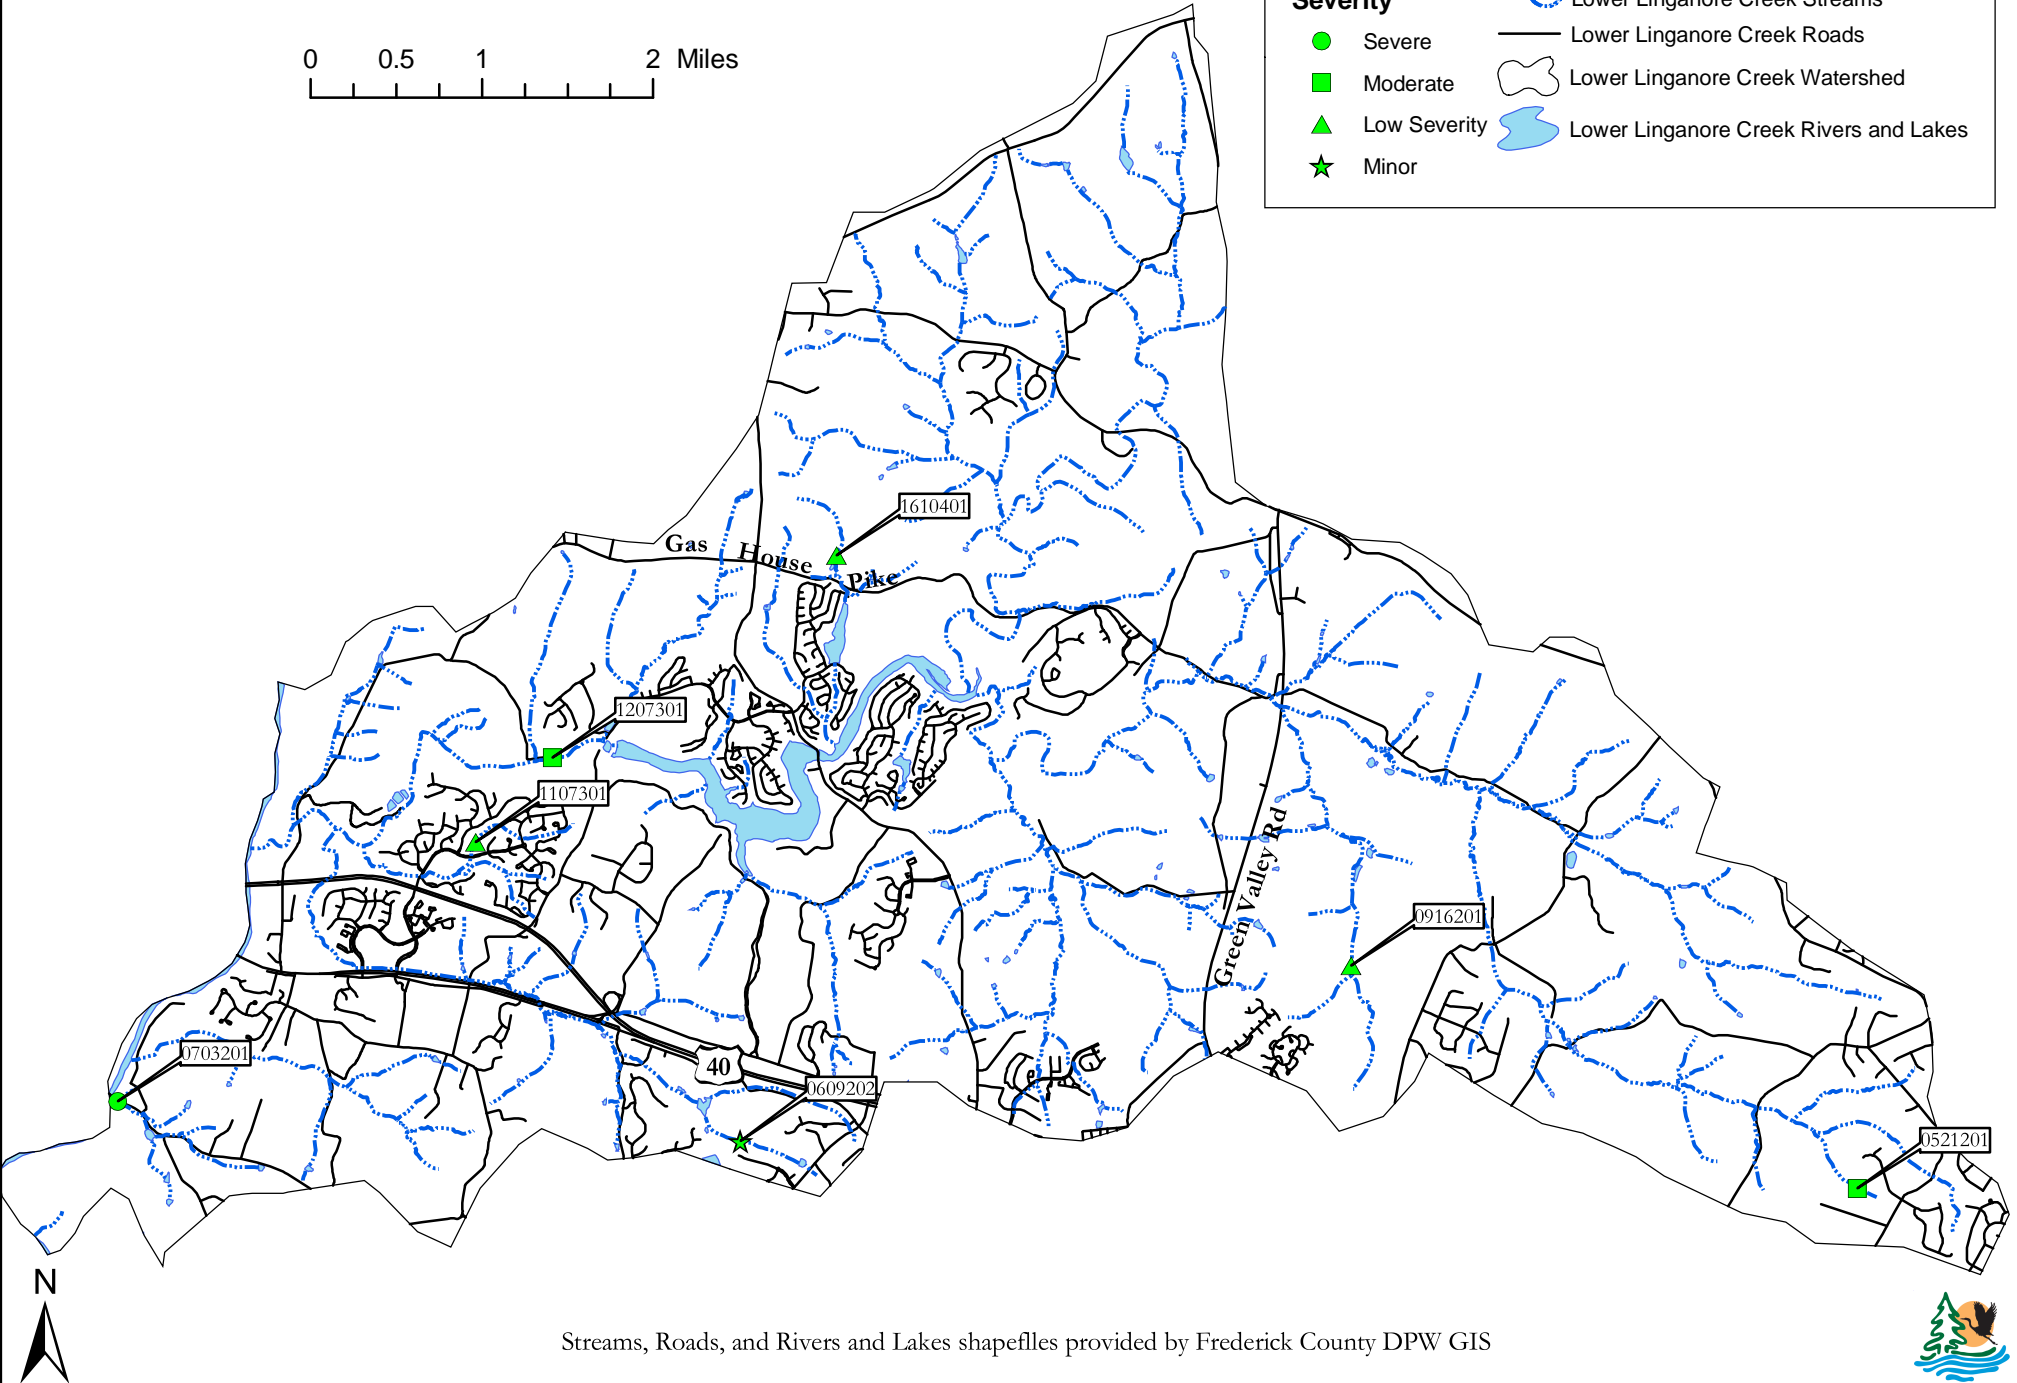
# Figure 7b: Pipe Outfalls

Five of the seven pipe outfalls observed during the survey were recorded as having a discharge. Of these, three had a clear discharge and no odor associated with it at the time of the survey (Appendix B). Site 0521201 was recorded as having a green discharge and no odor, and site 0703201 was recorded as having an oily medium brown discharge. Five of the pipe outfalls were recorded as being stormwater pipes. Those that were not marked as stormwater were either for an unknown use (1107301) or agricultural use (0521201). In these cases, it is recommended that further investigation be performed to determine the type of outfall. It is also recommended that the pipes with a colored discharge be reported to the Environmental Compliance Section for further investigation of the source of discharge.

No immediate follow up actions were taken by the survey crew as part of this study to determine the source of the color or smell coming from the pipe. In some cases, coloration or smell from a storm drainpipe may be a sporadic occurrence. No estimates of the amount of fluid released from the pipes were made.

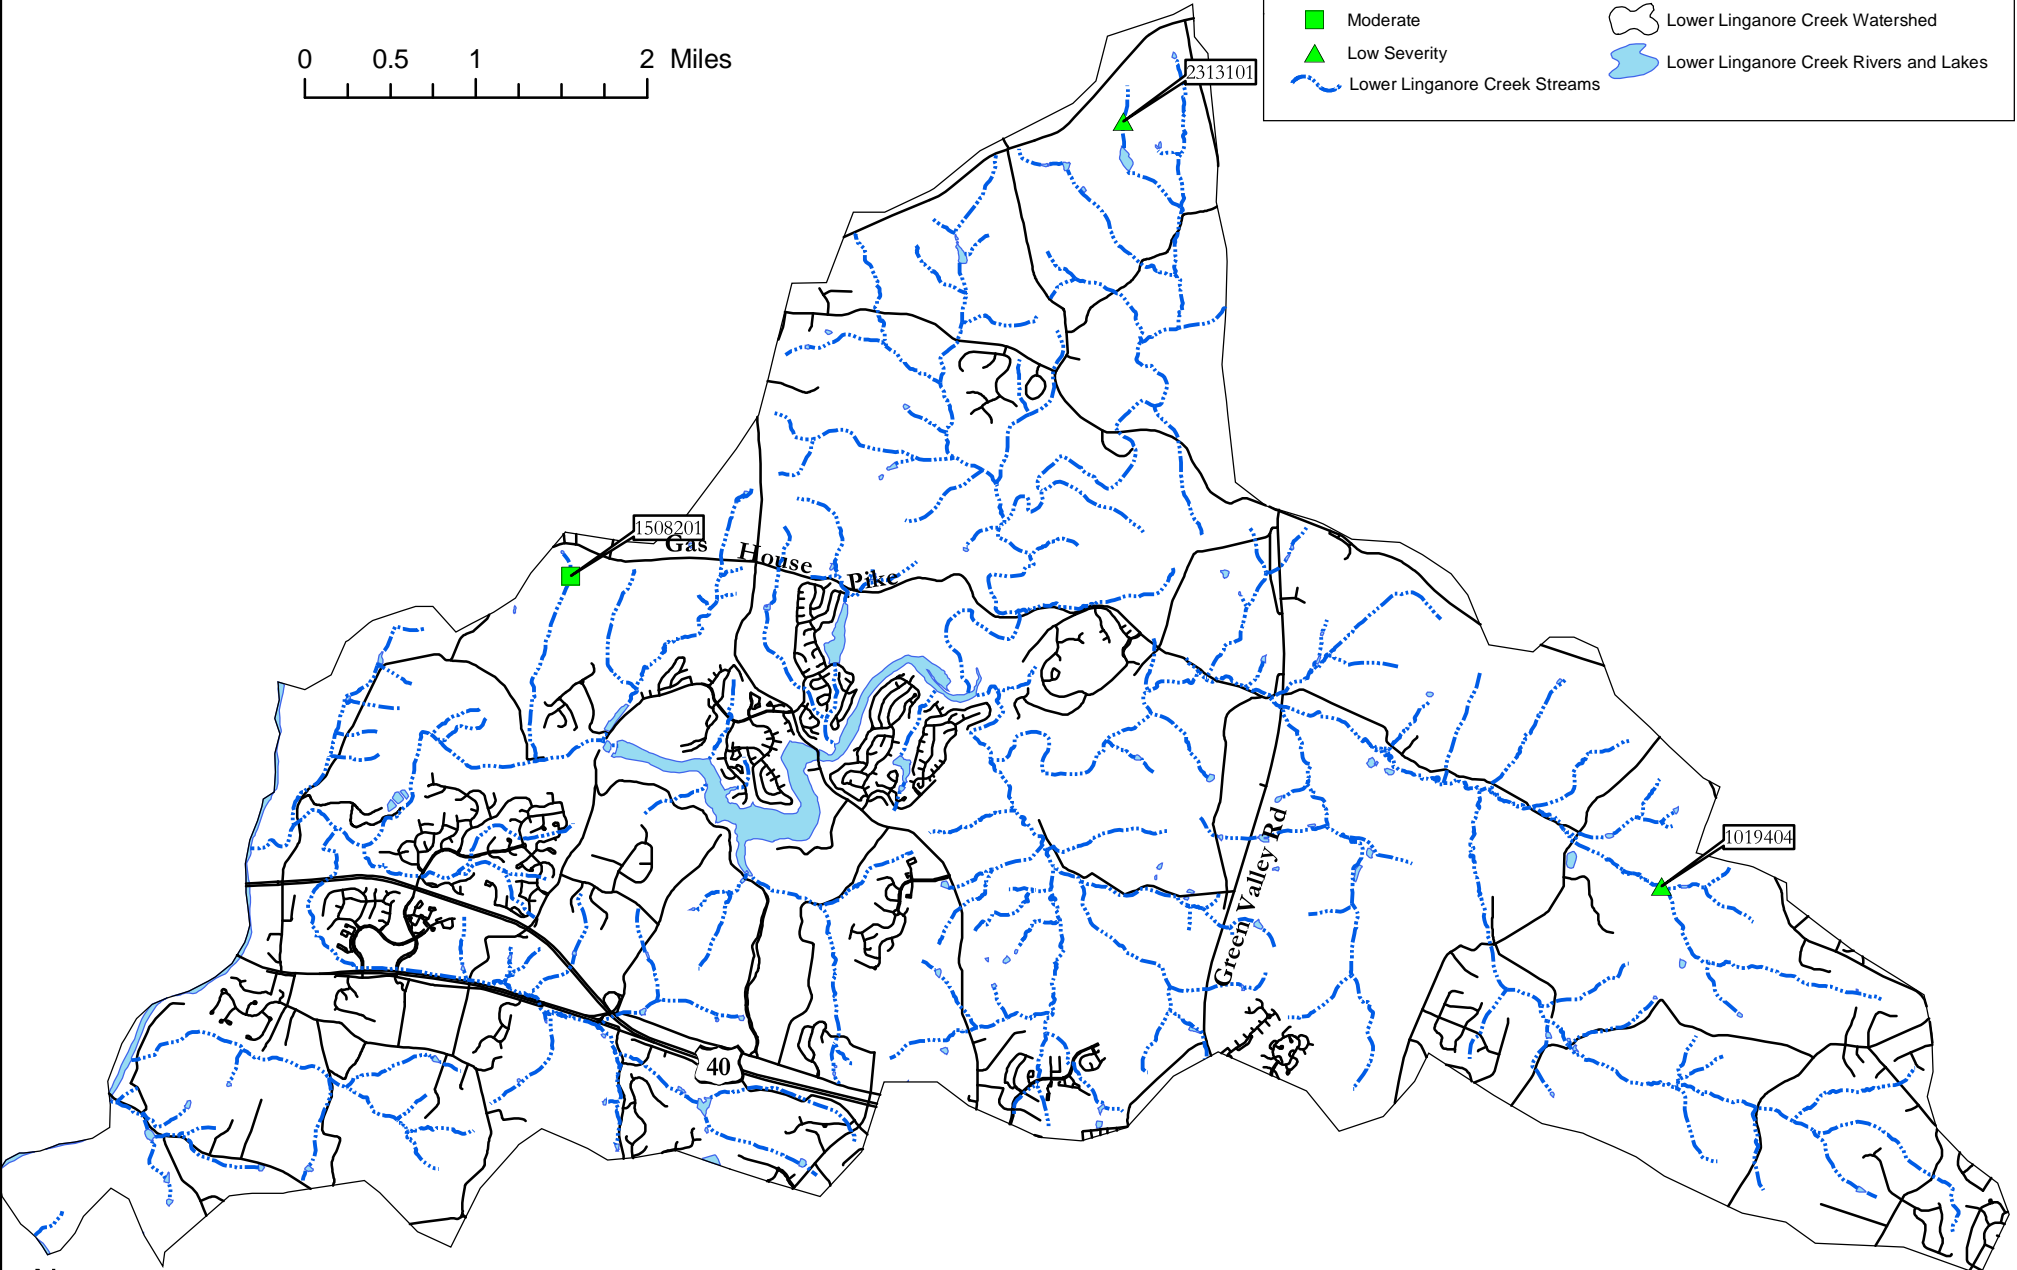
# Figure 9b: Trash Dumping Sites

Survey crews found a total of 3 trash dumping sites dispersed throughout the Lower Linganore Creek watershed (Figure 9b). This is a low number of sites compared to other watersheds previously surveyed throughout Maryland. In terms of severity, the six sites are ranked as moderate (1) and low severity (2), as shown in Figure 9a. The sites contained residential waste (1), agricultural (1), and industrial waste (1). All sites were found on private land and only one was considered suitable for a volunteer clean up project.

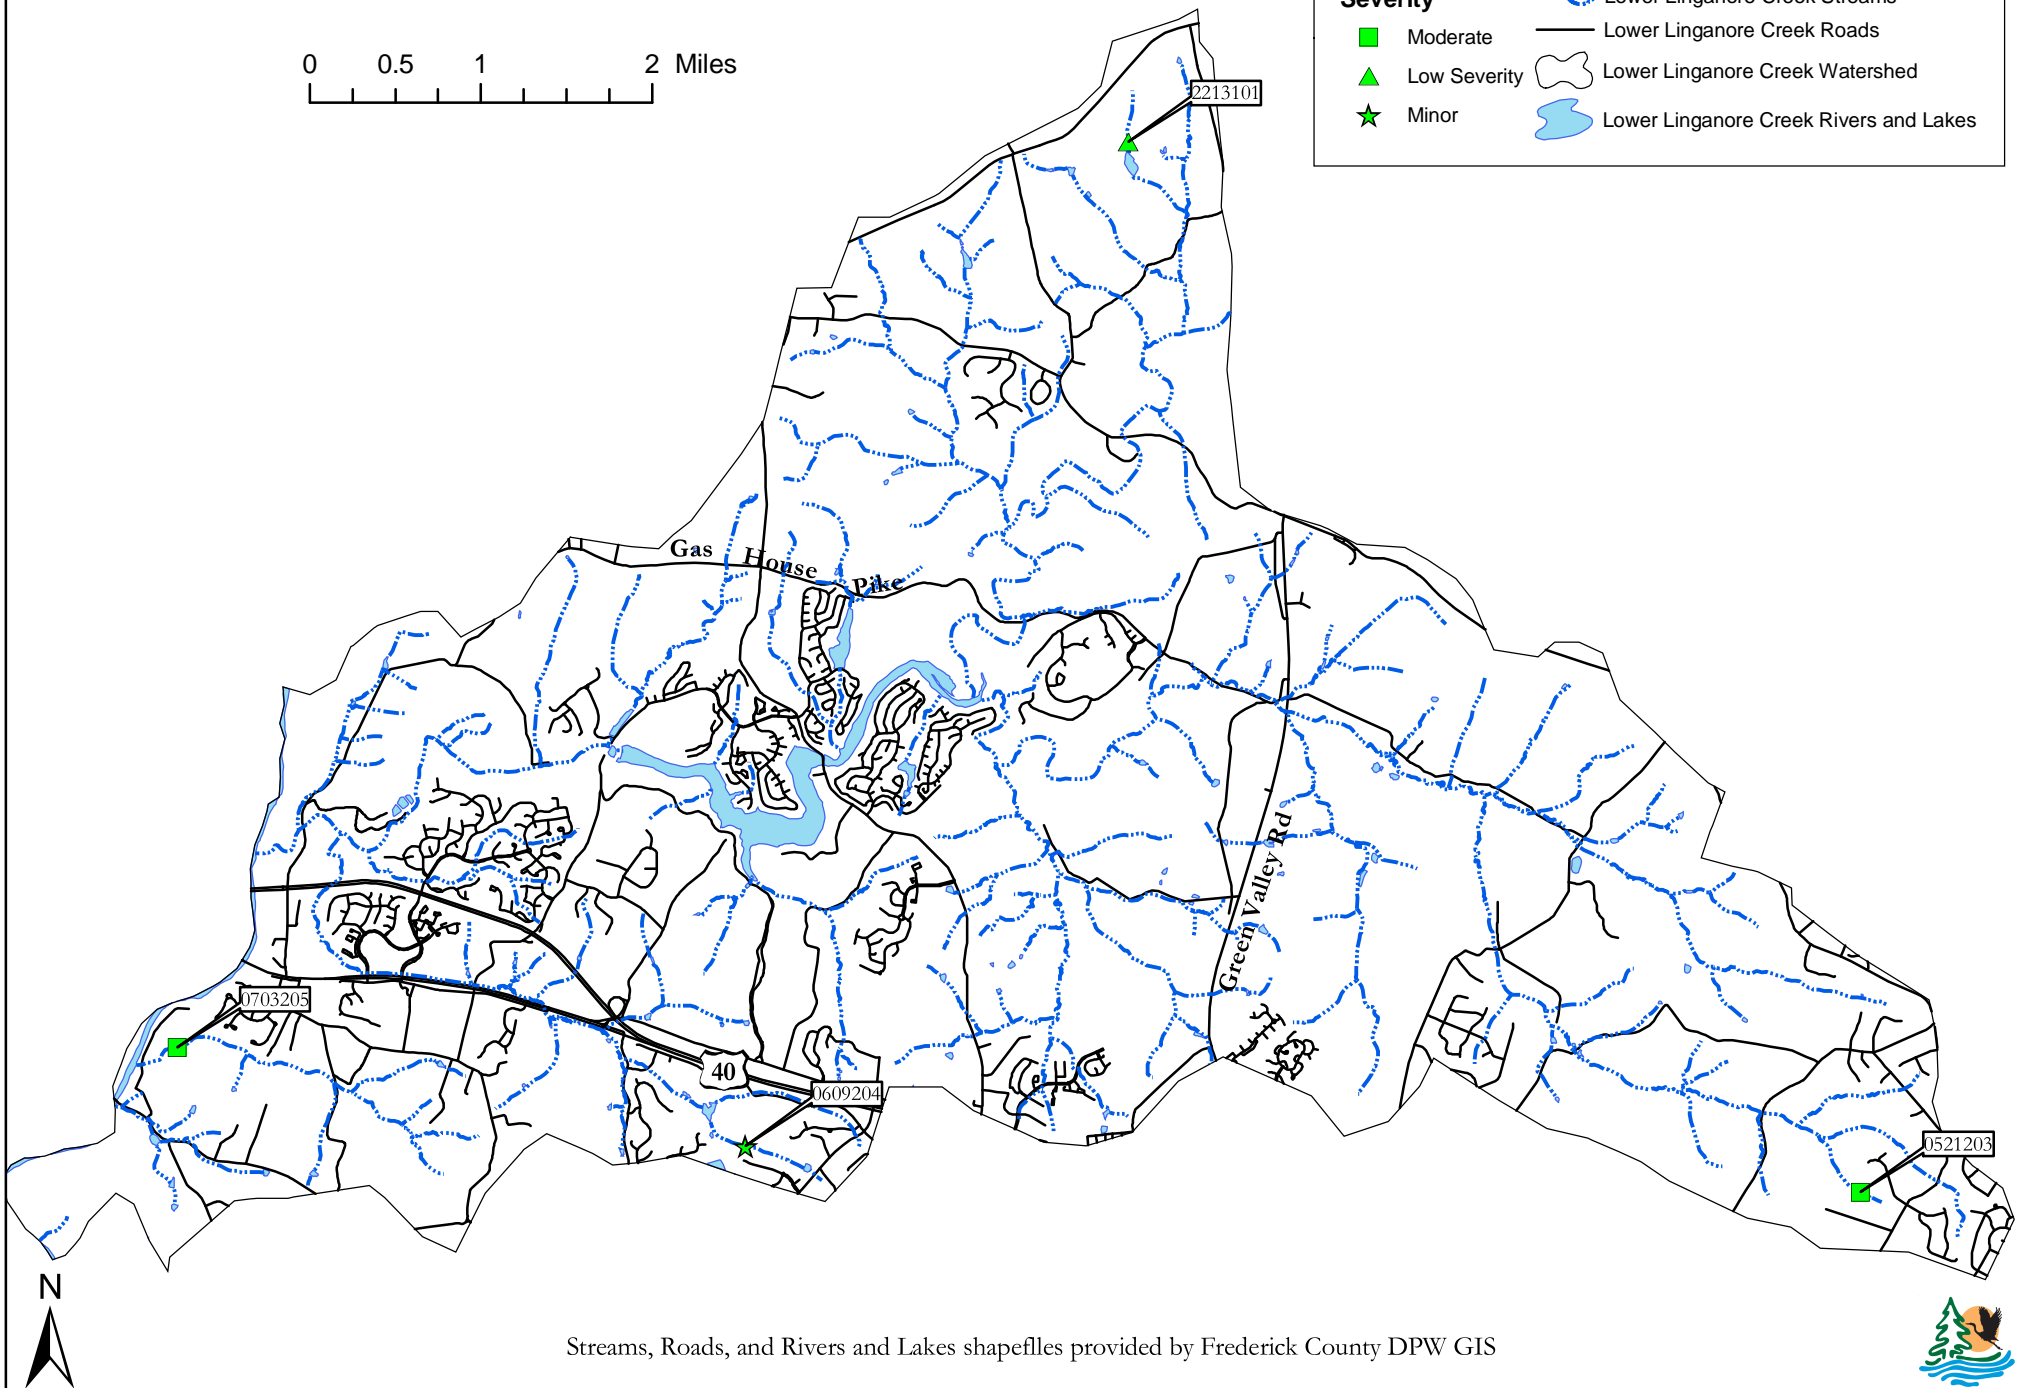
# Figure 10b: Unusual Conditions/Comments

Survey teams record unusual conditions or comments to note the location of anything out of the ordinary observed during the survey or to provide additional written comments on a specific problem site. The survey crews identified 3 unusual conditions and 1 comment site throughout the Lower Linganore Creek watershed. The conditions and comments noted vary from red flock to excessive algae to pipe outfalls along a golf course. It is recommended that unusual conditions be further investigated to determine cause and potential correctability (Figure 10b).

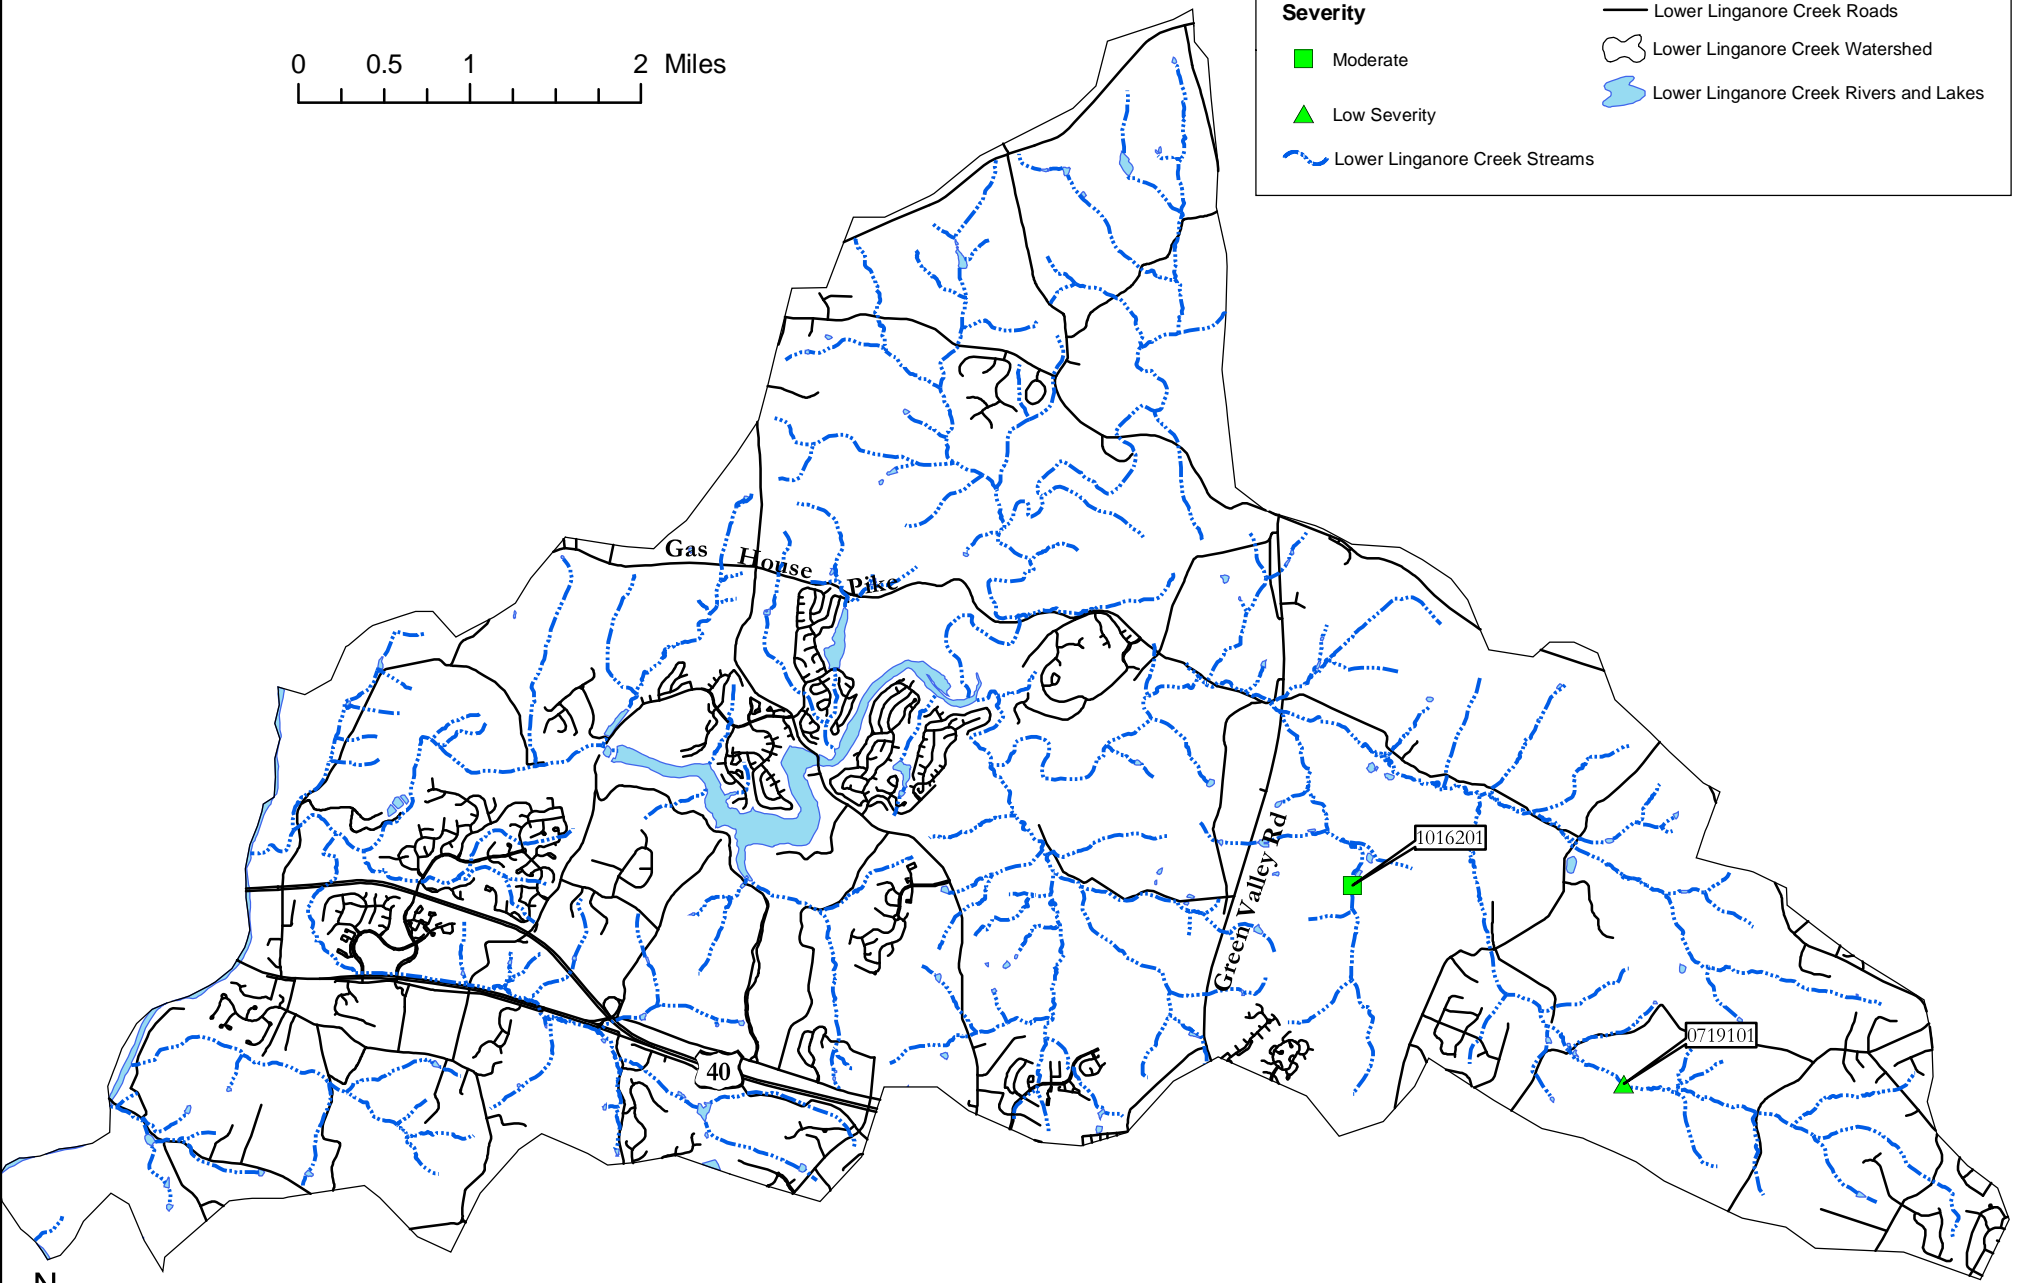
# Figure 11b: Exposed Pipes

Field crews observed two exposed pipes during the survey with a moderate or low severity rating (Figure 11a). Figure 11b shows the locations of the exposed pipes cited within the Lower Linganore Creek watershed. One of the pipes was exposed above the stream and the second pipe was exposed within the stream. Site 0719101 was recorded as having a clear odorless discharge at the time of the survey. Its diameter was estimated to be four inches, while the other pipe had a diameter of 14 inches. One of the pipes was made of corrugated metal and the other pipe was made of plastic. In one case, survey crews were unable to determine the purpose of the pipe (Appendix B).
