Anacostia River Stream Corridor Survey

Maryland Department of Natural Resources
Watershed Services
June 2005

ANACOSTIA RIVER STREAM CORRIDOR ASSESSMENT

Robin Pellicano & Ken Yetman
Watershed Assessment and Targeting Division
Watershed Services Unit
Maryland Department of Natural Resources

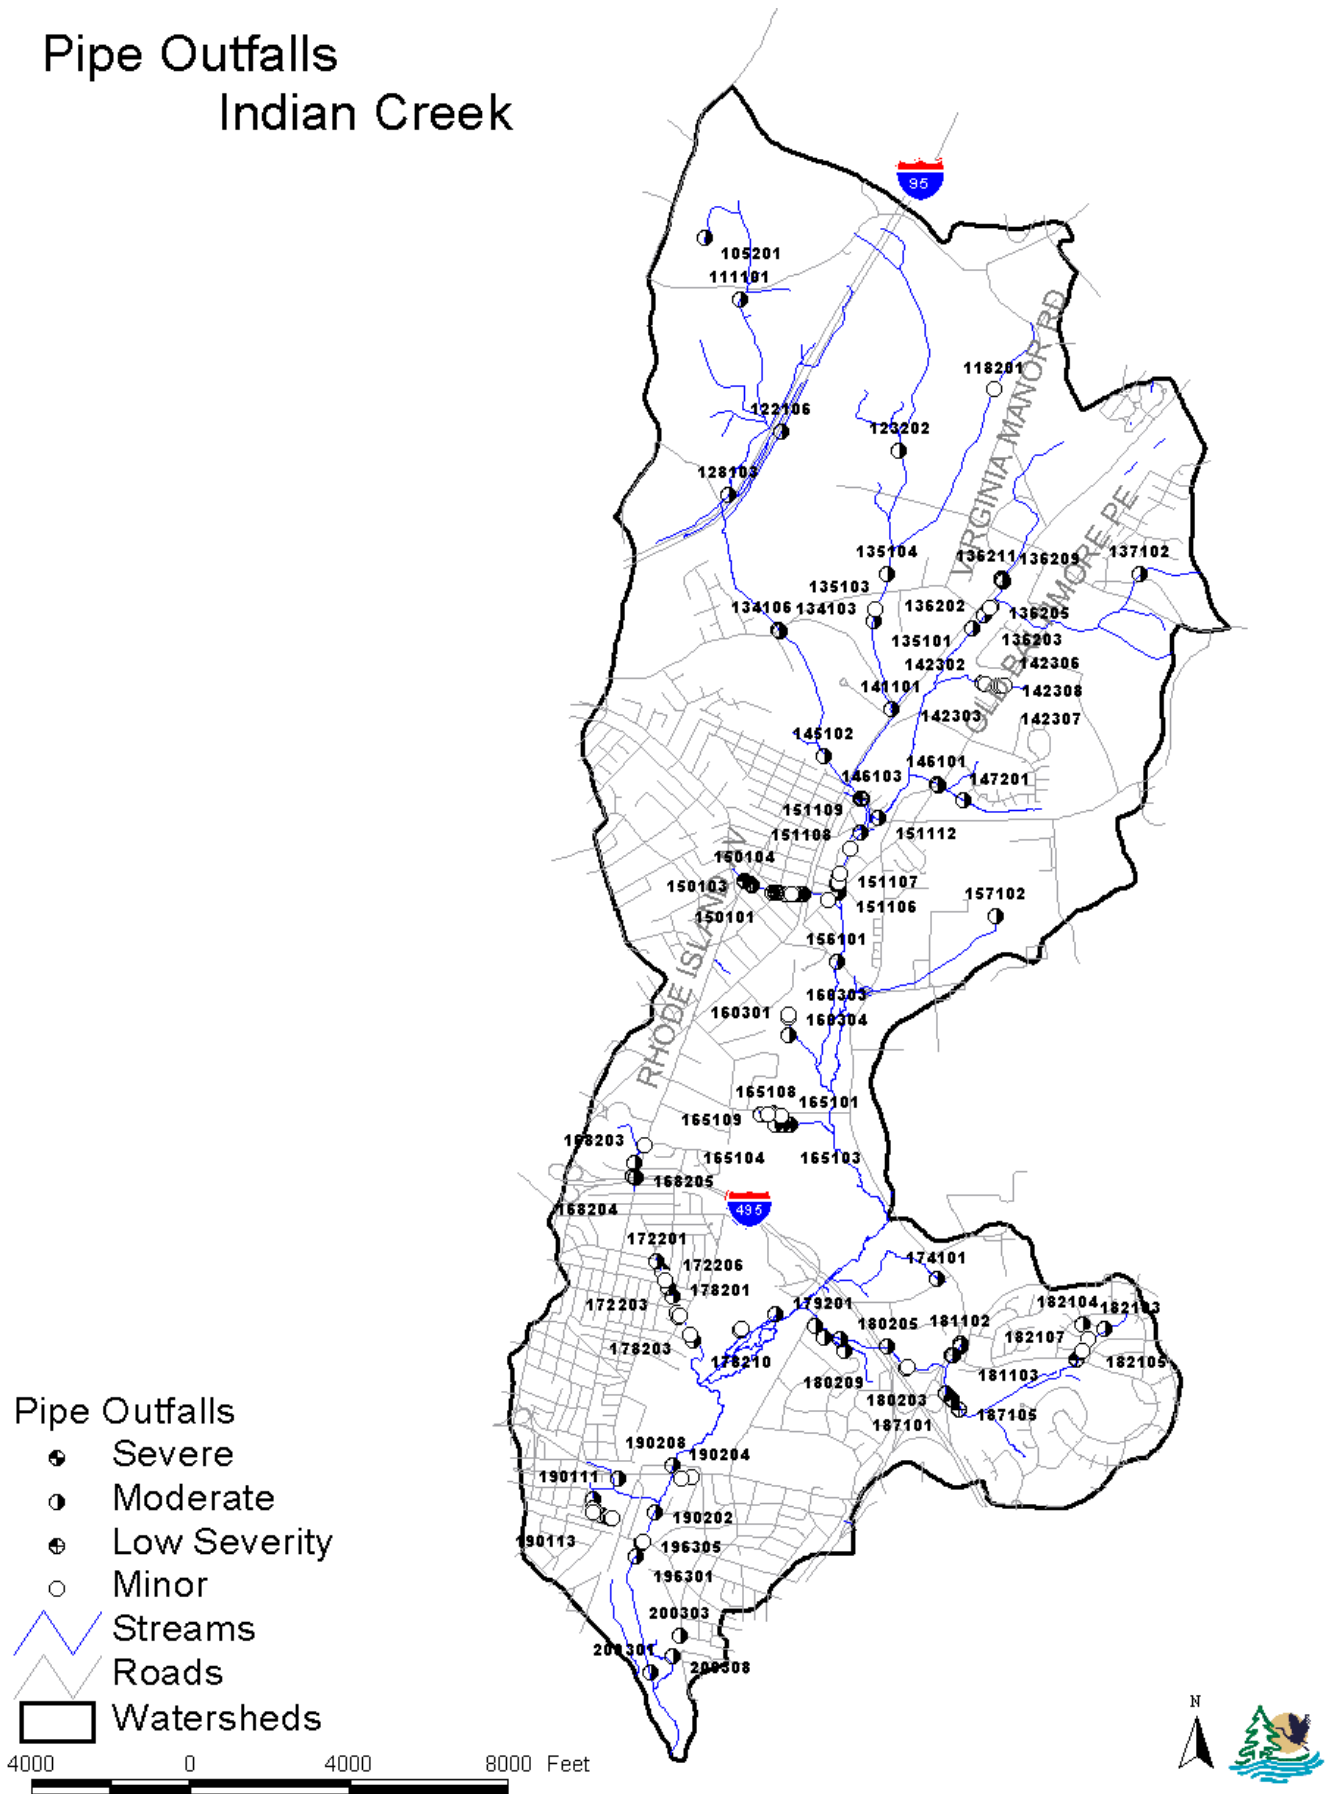
Figure 5b: Map showing the pipe outfalls in Indian Creek sub-watershed of the Anacostia River

Only one pipe outfall was rated as severe. At site 345402, the pipe was discharging a clear fluid that smelled of sewage. Most of the outfalls carried stormwater, or discharged from a small pond or reservoir. Of the outfalls observed, 98 were dry when surveyed and 293 had a clear discharge with no associated odor

No immediate follow up actions were taken as part of this study to determine the source of the color coming from the pipe. In some cases, coloration from a storm drainpipe may be a sporadic occurrence. In addition, we made no estimate of the amount of fluid released from the pipes.

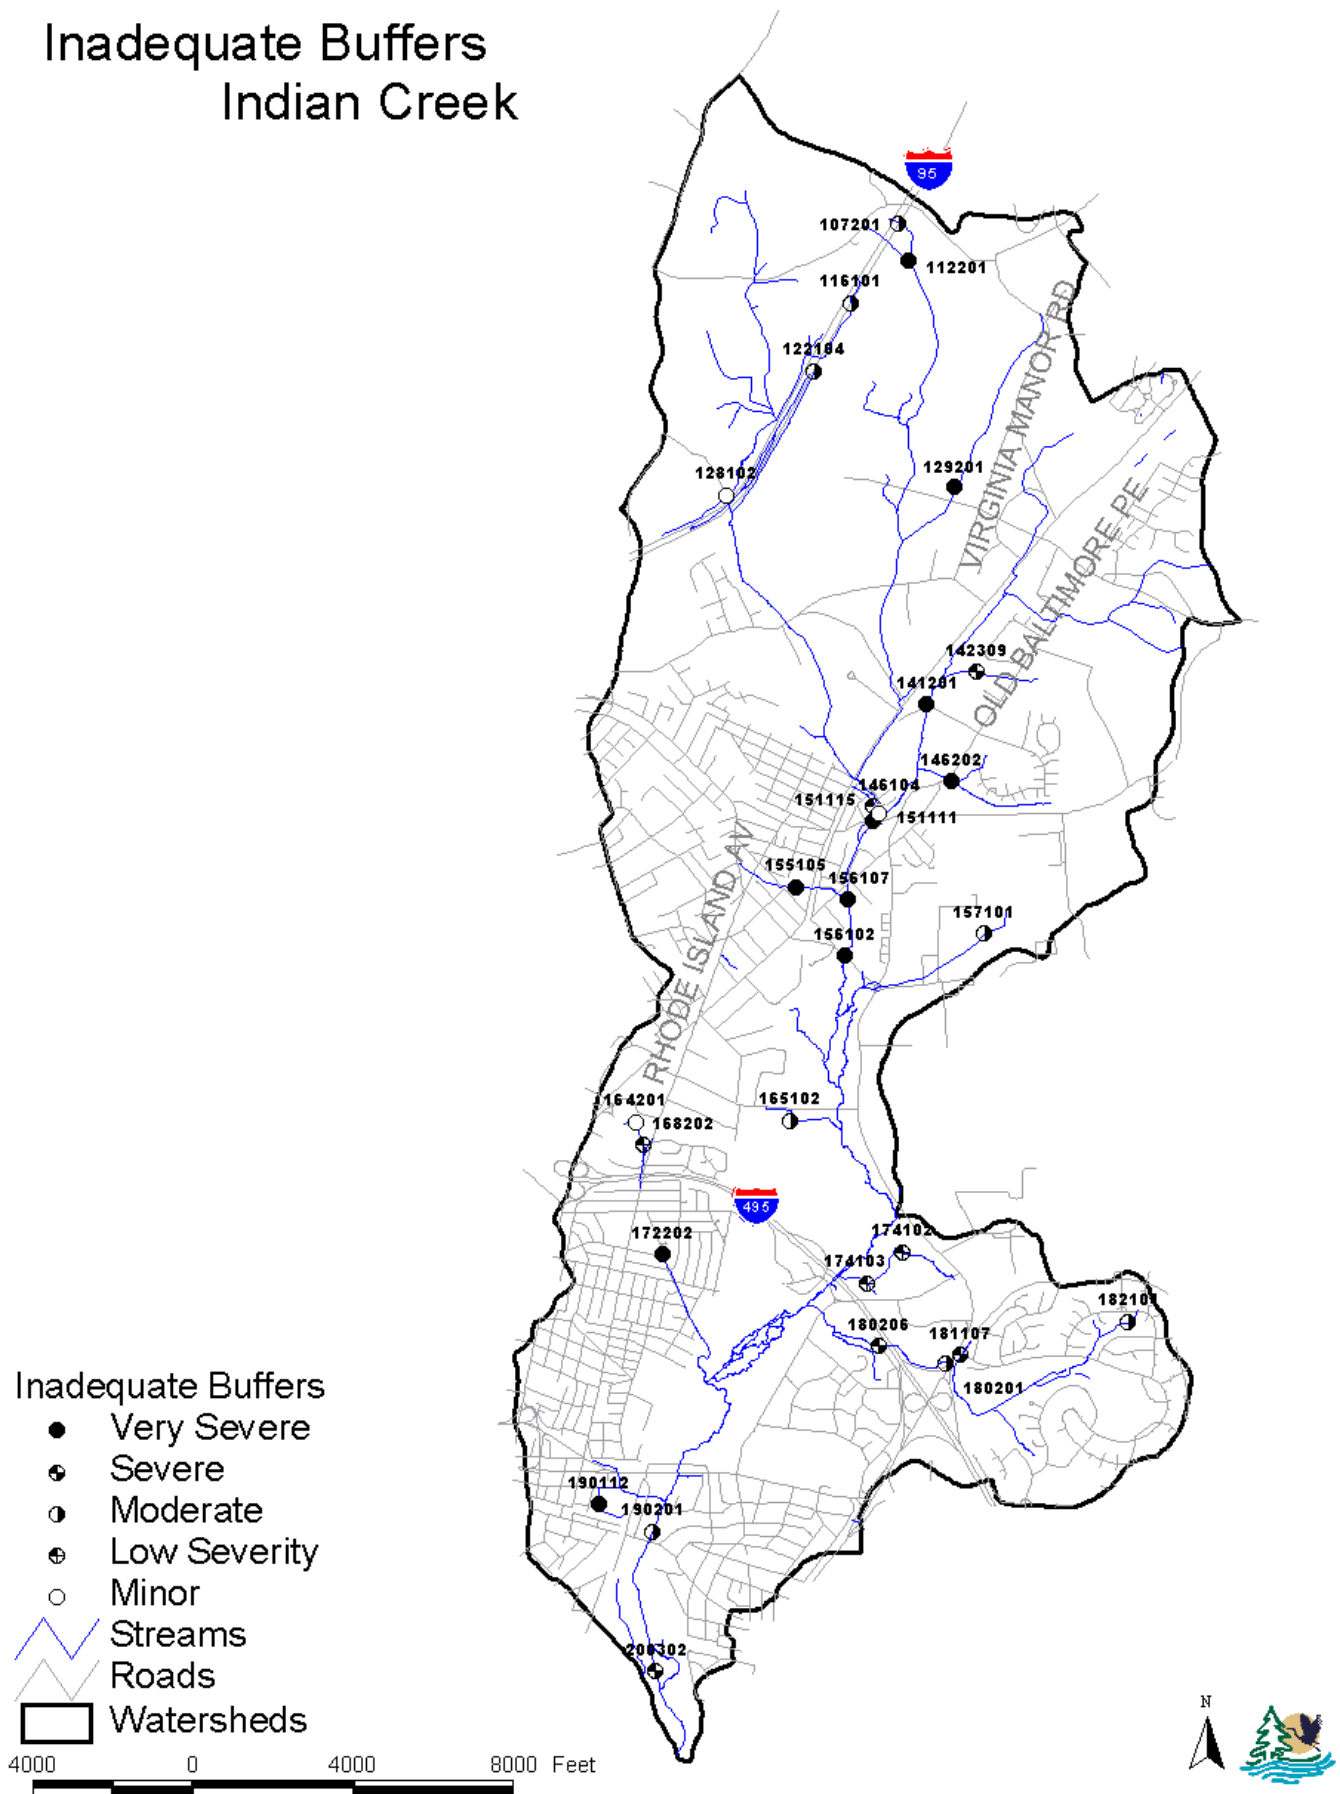
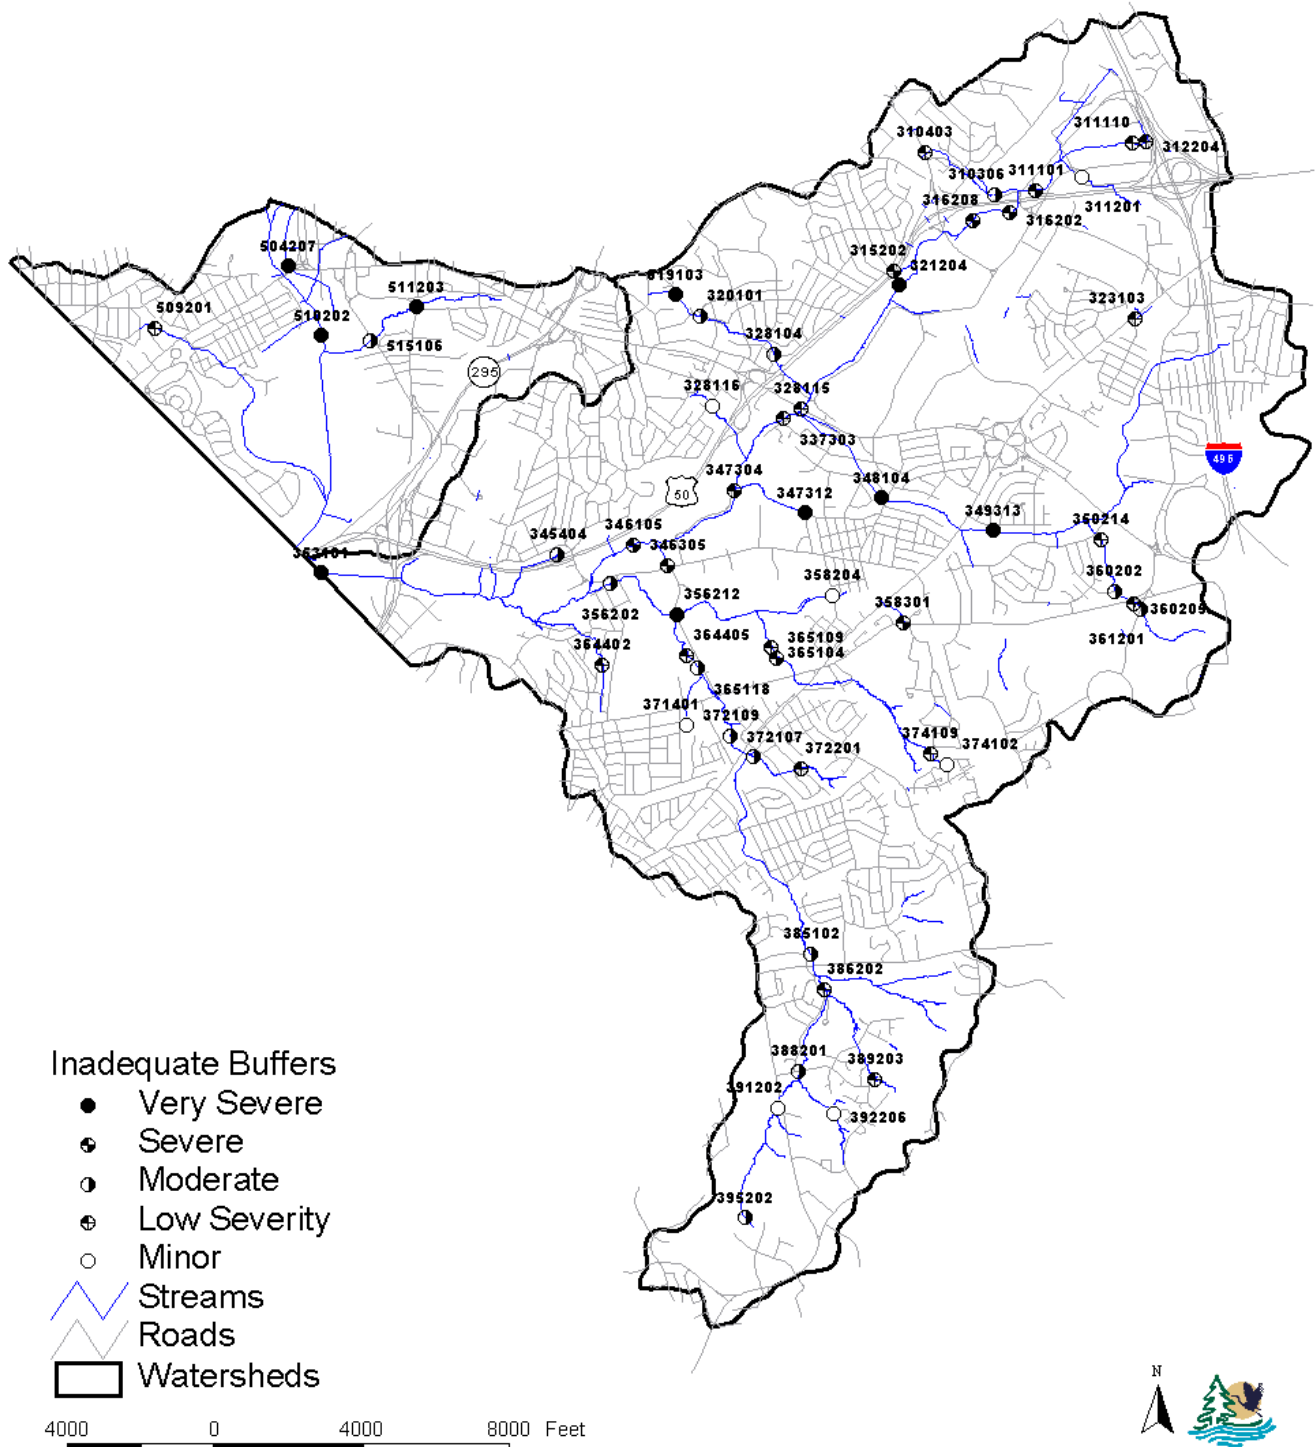
Figure 6b: Map showing the inadequate buffers in Indian Creek sub-watershed of the Anacostia River

While there is no single minimum standard for how wide a stream buffer should be in Maryland, for the purposes of this study a forest buffer is considered inadequate if it is less than 50 feet wide, measured from the edge of the stream. The severity of inadequate forest buffers is based on both the length and width of the site. Those sites over 1,000 feet long with no forest on either side of the stream rank as the most severe.

Survey crews identified 85 inadequate buffer sites with a total length of 112,100 feet (21.2 miles), or approximately 28 percent of streams surveyed. The severity and location of inadequate buffer sites is shown in Figure 6b, and 6c. Thirty-four of these sites are ranked as very severe or severe, while the other sites are moderate, of low severity, or minor (Figure 6a). Crews reported that livestock were present at one site, 157101.

Almost any inadequate buffer site would benefit from the restoration of trees and shrubs along both stream banks. Unfortunately many of the sites in the Anacostia River are along paved areas, sometimes on both sides. This would prevent any tree planting. Some sites are located in the gaps of green infrastructure. Green infrastructure are areas where there are natural lands. There are hubs, which is an area of unfragmented natural landscape. Corridors are areas that allow movement from one hub to another. Sites 129201, 174102, 174103, 190201, 510202 are located in those gaps. Planting these areas could help provide better movement between hub areas.

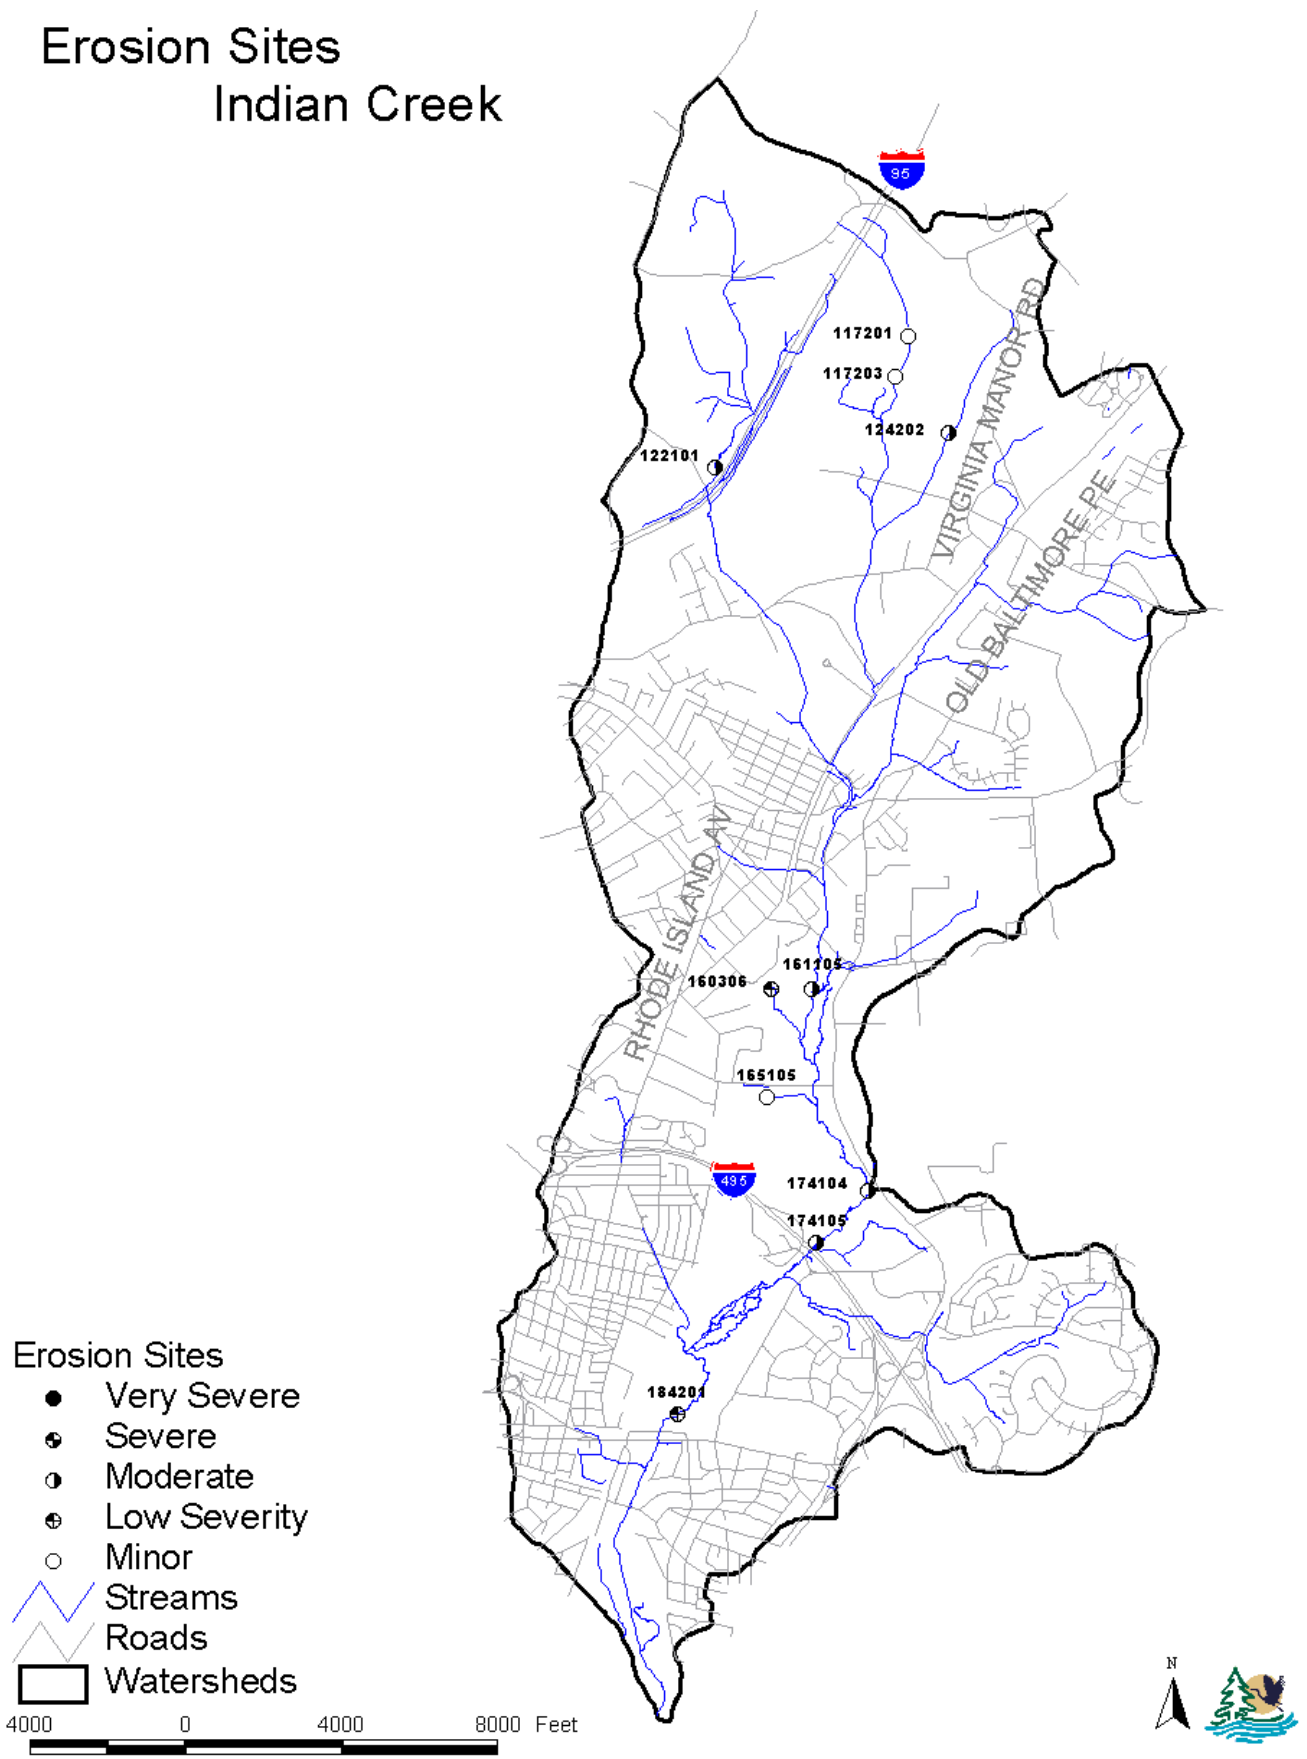
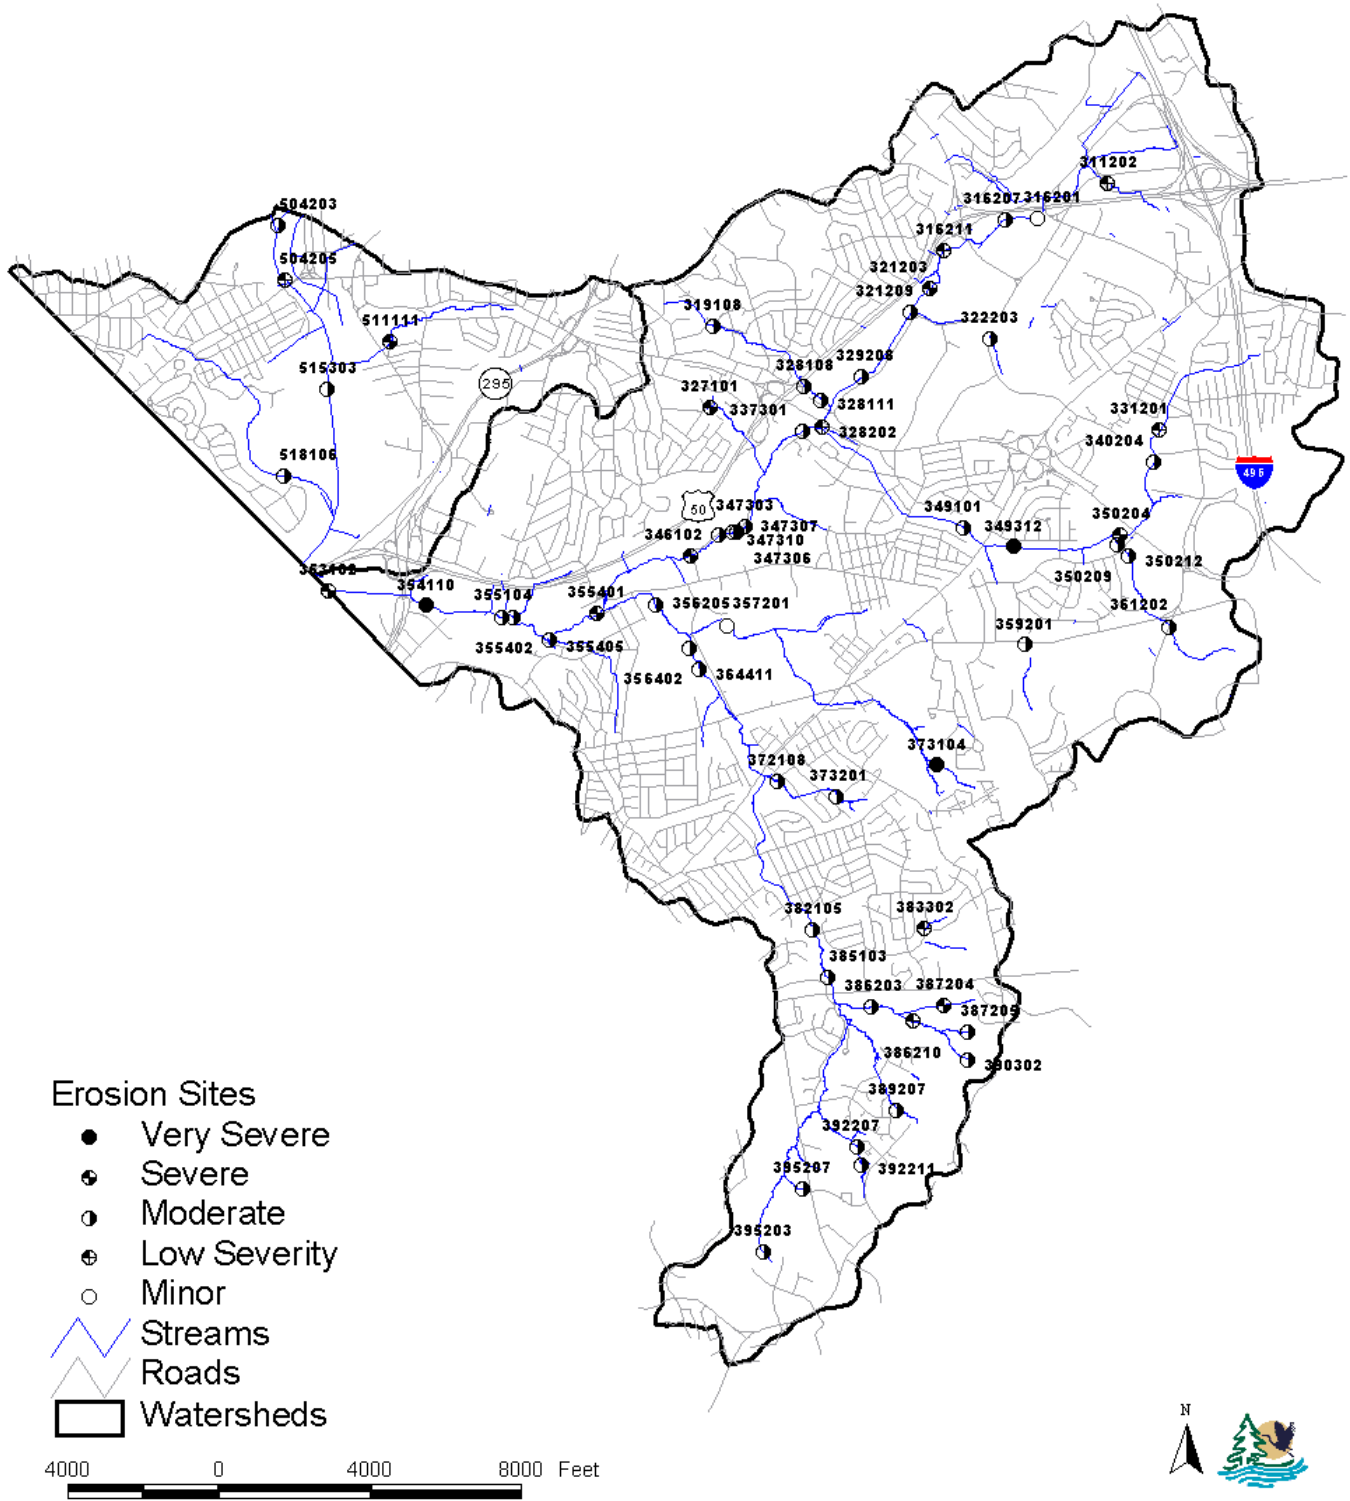
Figure 7b: Map showing the erosion sites in Indian Creek sub-watershed of the Anacostia River

The SCA survey found 69 eroding stream banks over the length of 61,525 feet (11.65 miles) of stream, or about 15 percent of streams surveyed. The severity and location of erosion sites is shown in Figure 7b, and 7c. Three sites are ranked as very severe, 349312, 354110, and 373104.

Eight erosion sites are threats to infrastructure. The first, 160306 is right near a parking lot, and sites 316201.321203 are also near a parking lot. Sites 347310 and 364411 are near roads.

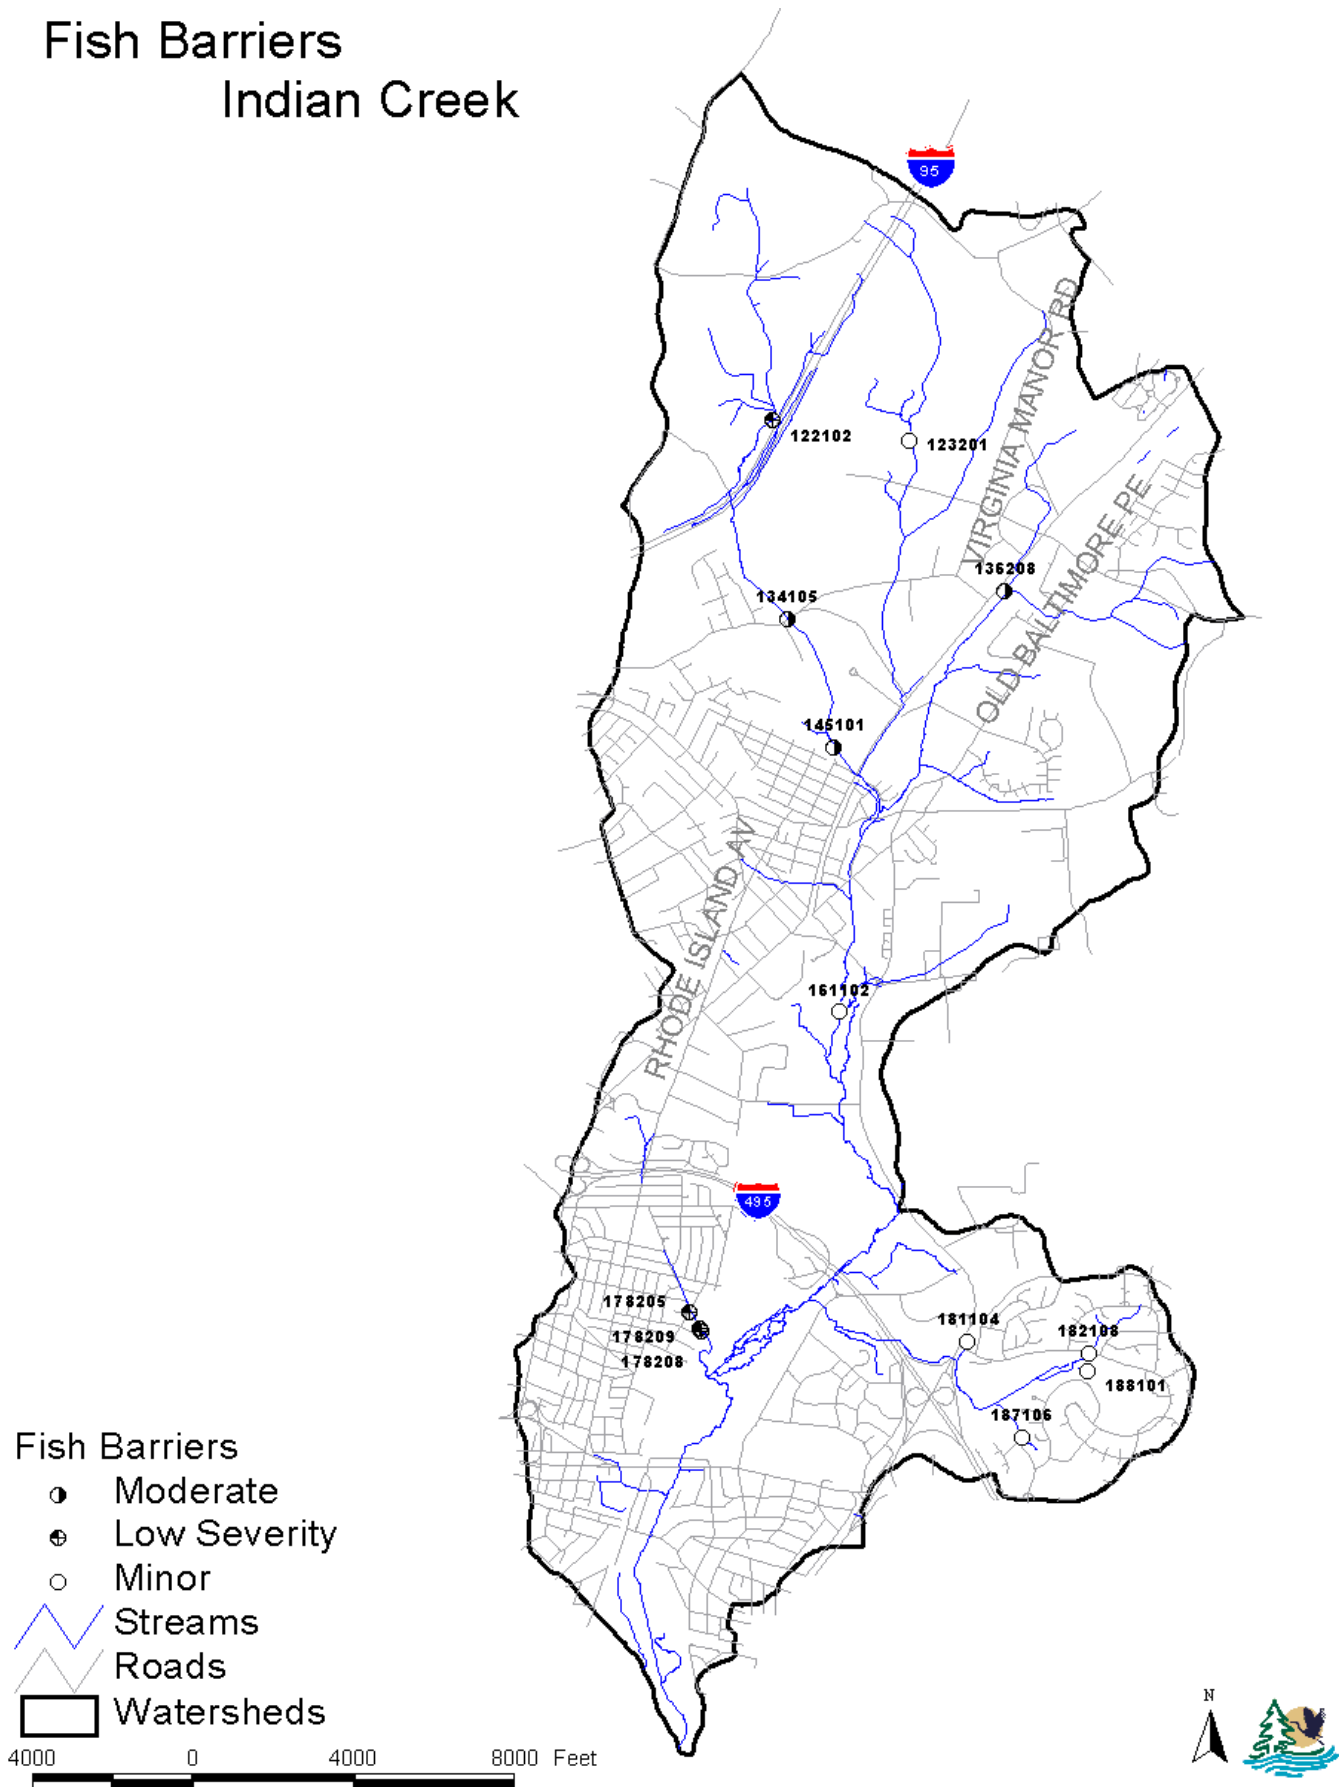
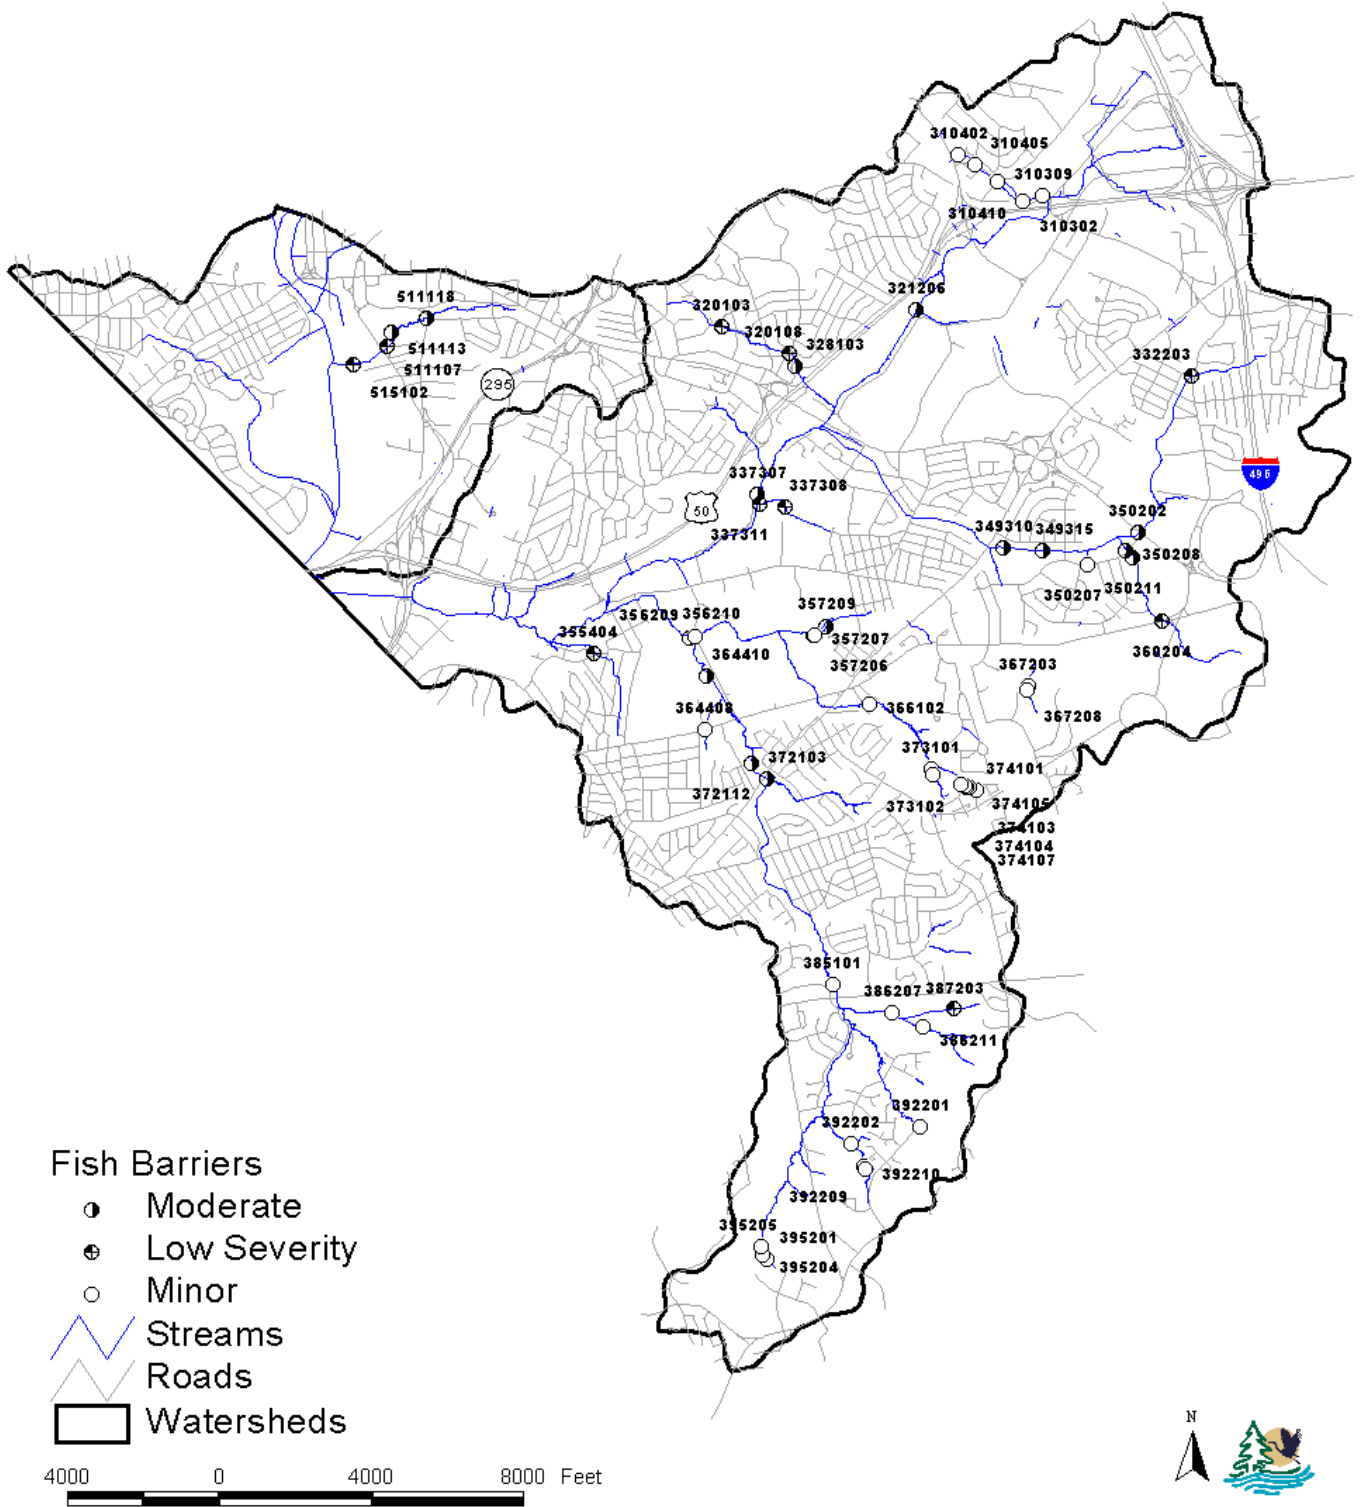
Figure 8b: Map showing the fish barriers in Indian Creek sub-watershed of the Anacostia River

The Anacostia River SCA survey found 68 fish migration barriers. The locations of fish blockages are shown in Figure 8b and 8c. Fish barriers in these watershed are due to road crossings (18), natural falls (14), debris (9), a pipe crossing (7), beaver dam (3), railroad crossing (2), instream pond (1) and where the stream goes underground (1). The majority of fish migration barriers (50 out of 68) are low to minor in severity (Figure 8a). Eighteen barriers received moderate severity rankings because they isolate a significant length of the tributary upstream from the barrier. Five fish barrier sites in the watershed, which have a moderate rating, are in channelized areas.

In all cases, areas should be assessed for viable fish habitat before restoration work begins, giving preference to sites with the most potential habitat area created.

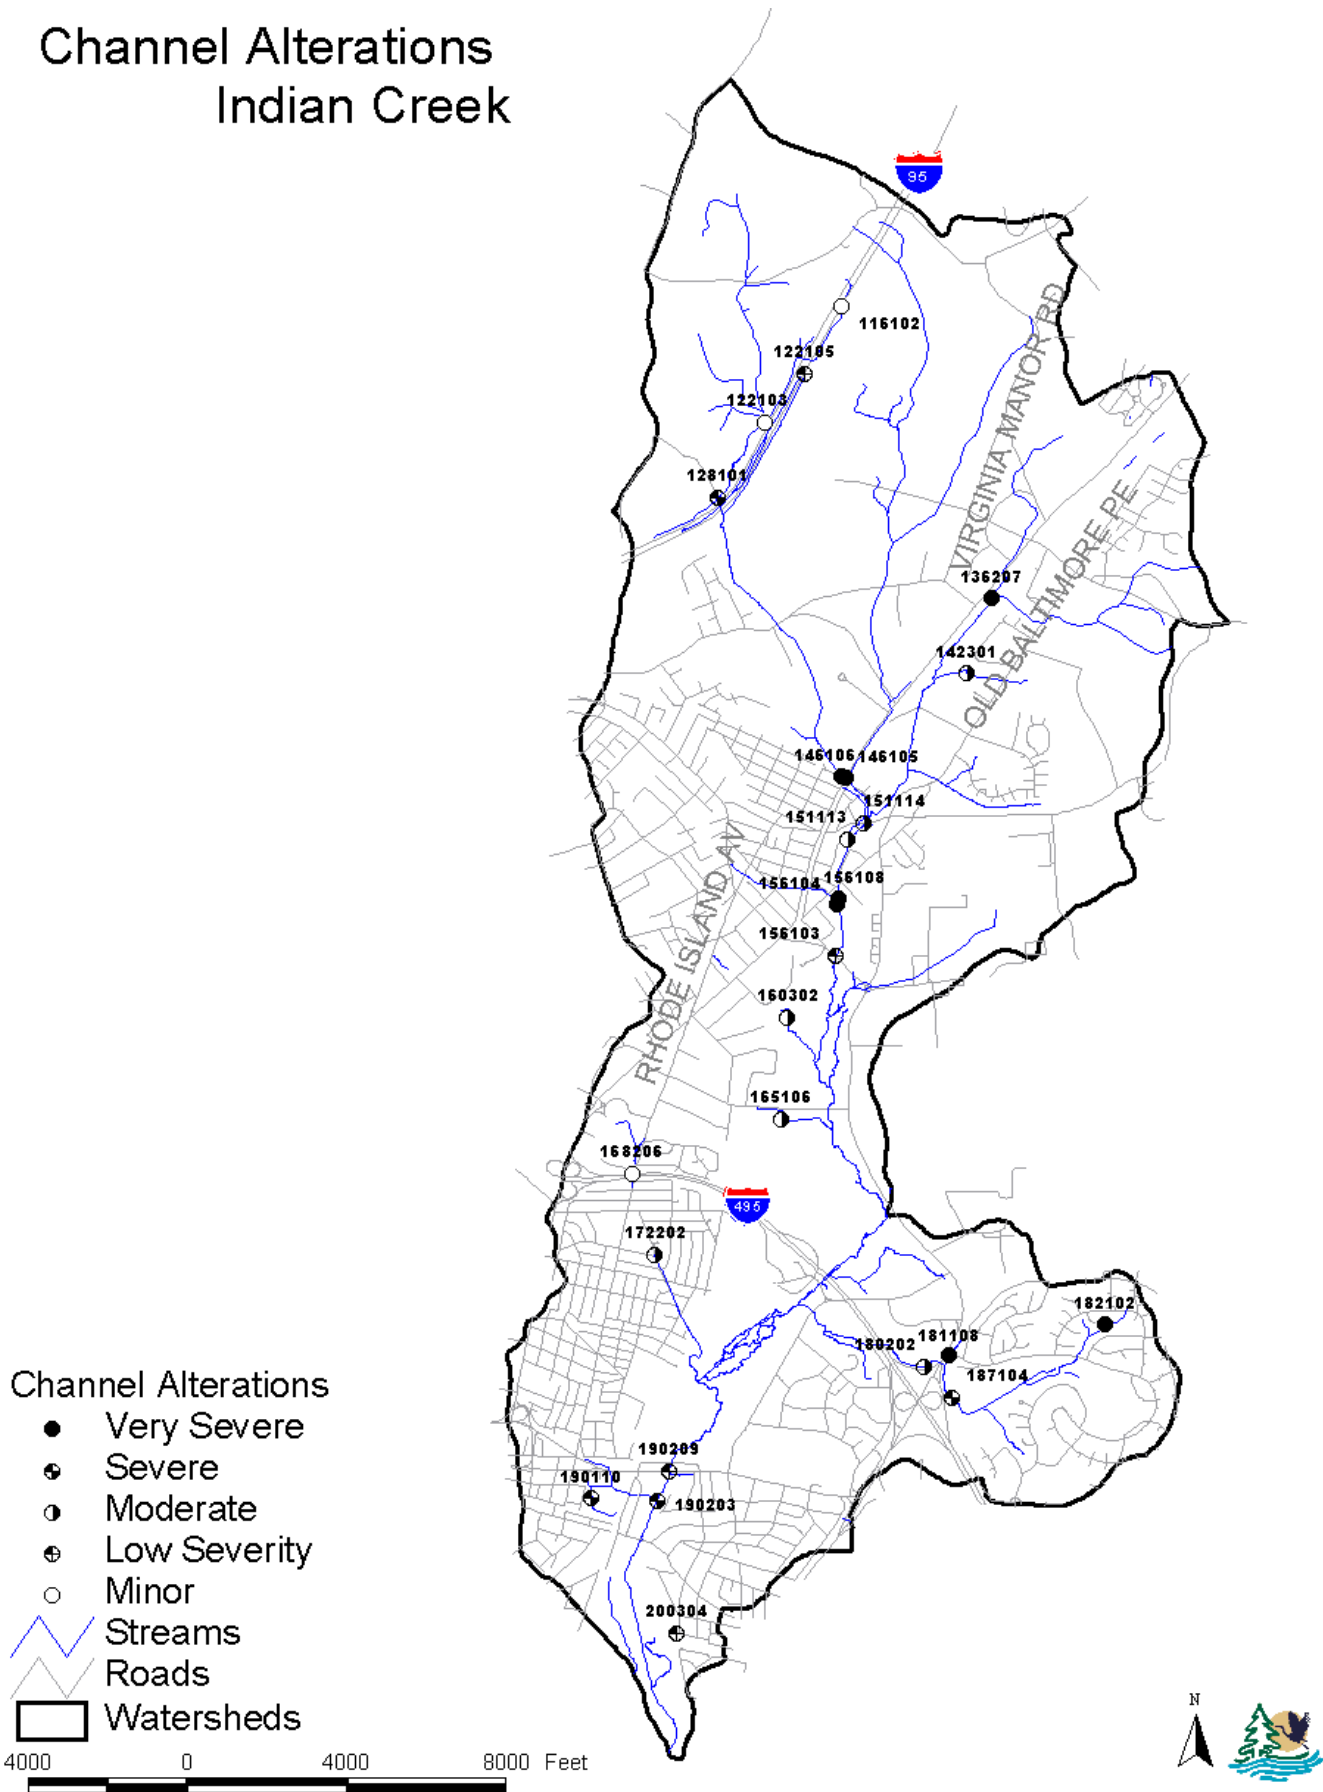
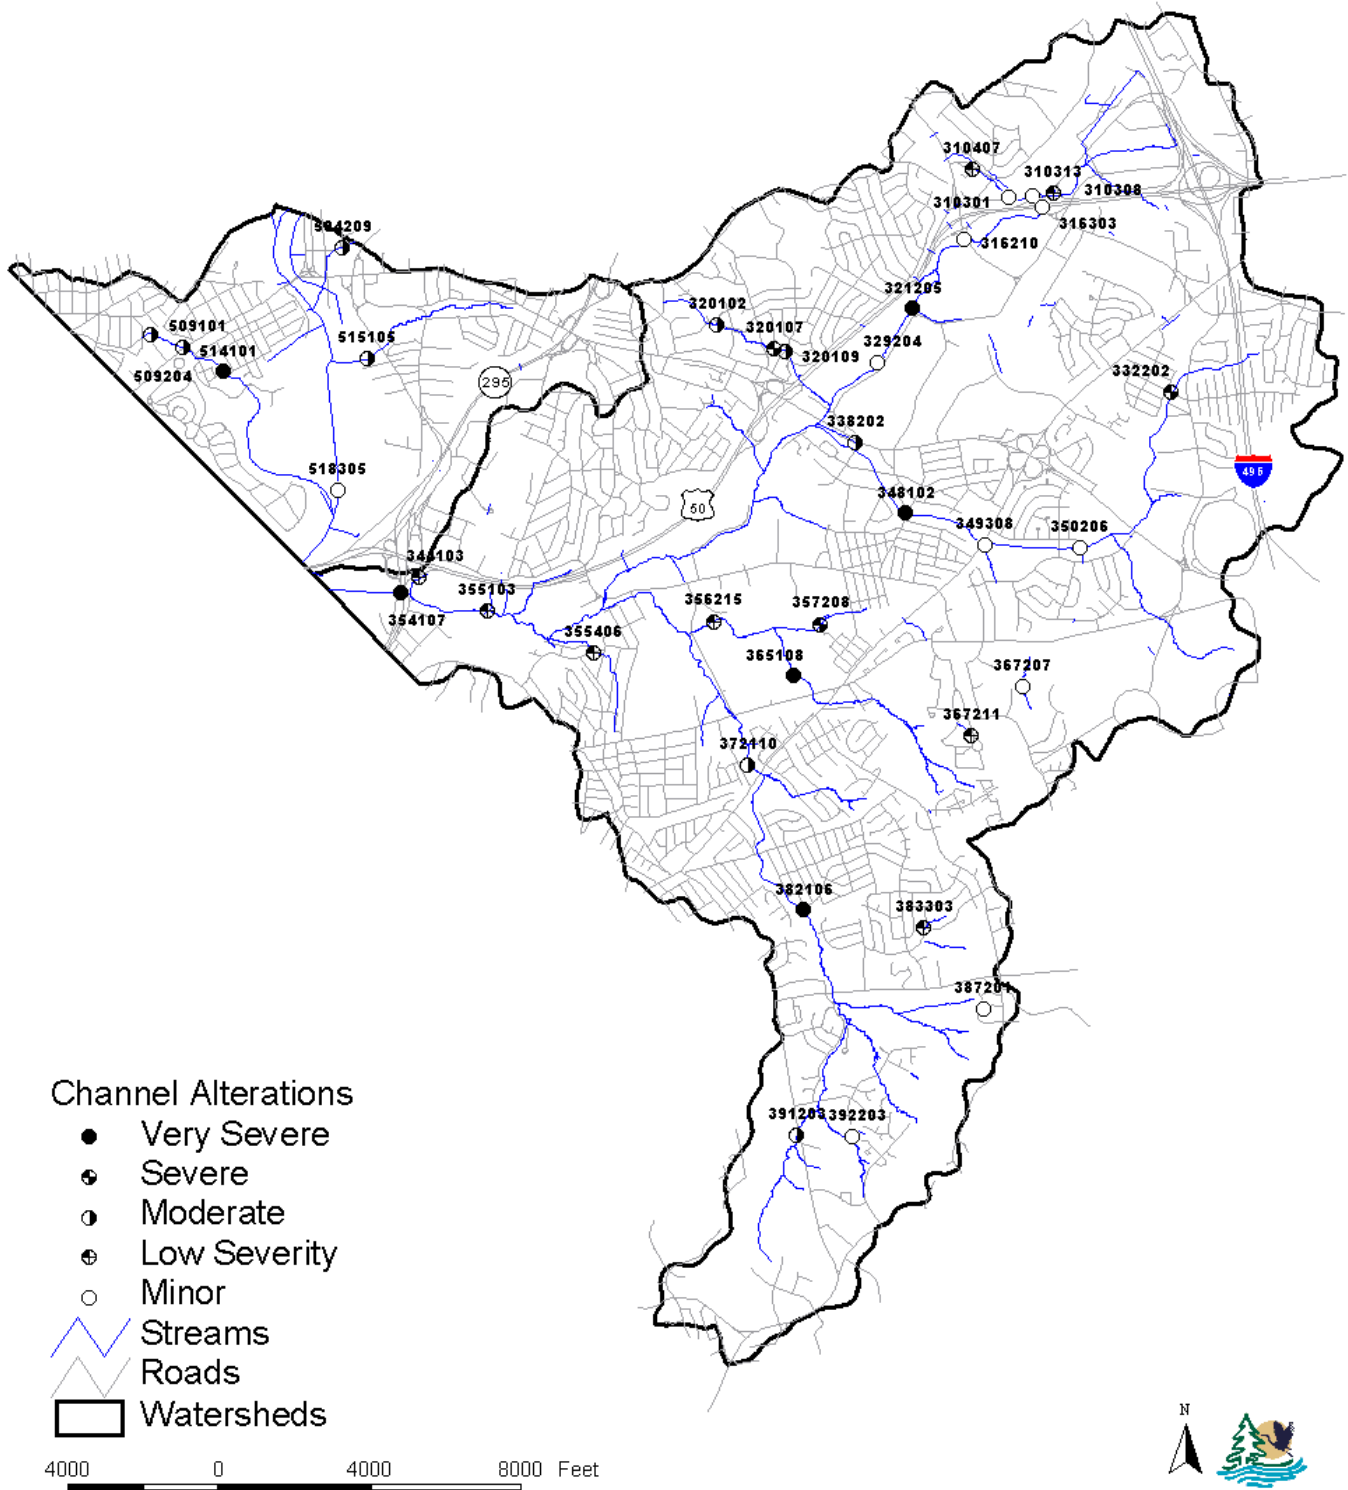
Figure 9b: Map showing the channel alterations in Indian Creek sub-watershed of the Anacostia River

Results of this survey show recognizably altered stream channels at 62 sites. The severity and location of channel alteration sites is shown in Figure 9b and 9c. The total length of stream affected by channelization is estimated to be 50,258 feet (9.5 miles), or 13 percent of streams surveyed. Channel alteration sites occur with inadequate forest buffer sites at 36 sites, or for 58 percent of the channelized stream length. The majority of sites, 42 out of 62, are concrete channels, areas where the stream is straightened and/or placed in trapezoidal channels to increase water passage.
