Anacostia River Stream Corridor Survey

Maryland Department of Natural Resources
Watershed Services
June 2005

ANACOSTIA RIVER STREAM CORRIDOR ASSESSMENT

Robin Pellicano & Ken Yetman
Watershed Assessment and Targeting Division
Watershed Services Unit
Maryland Department of Natural Resources

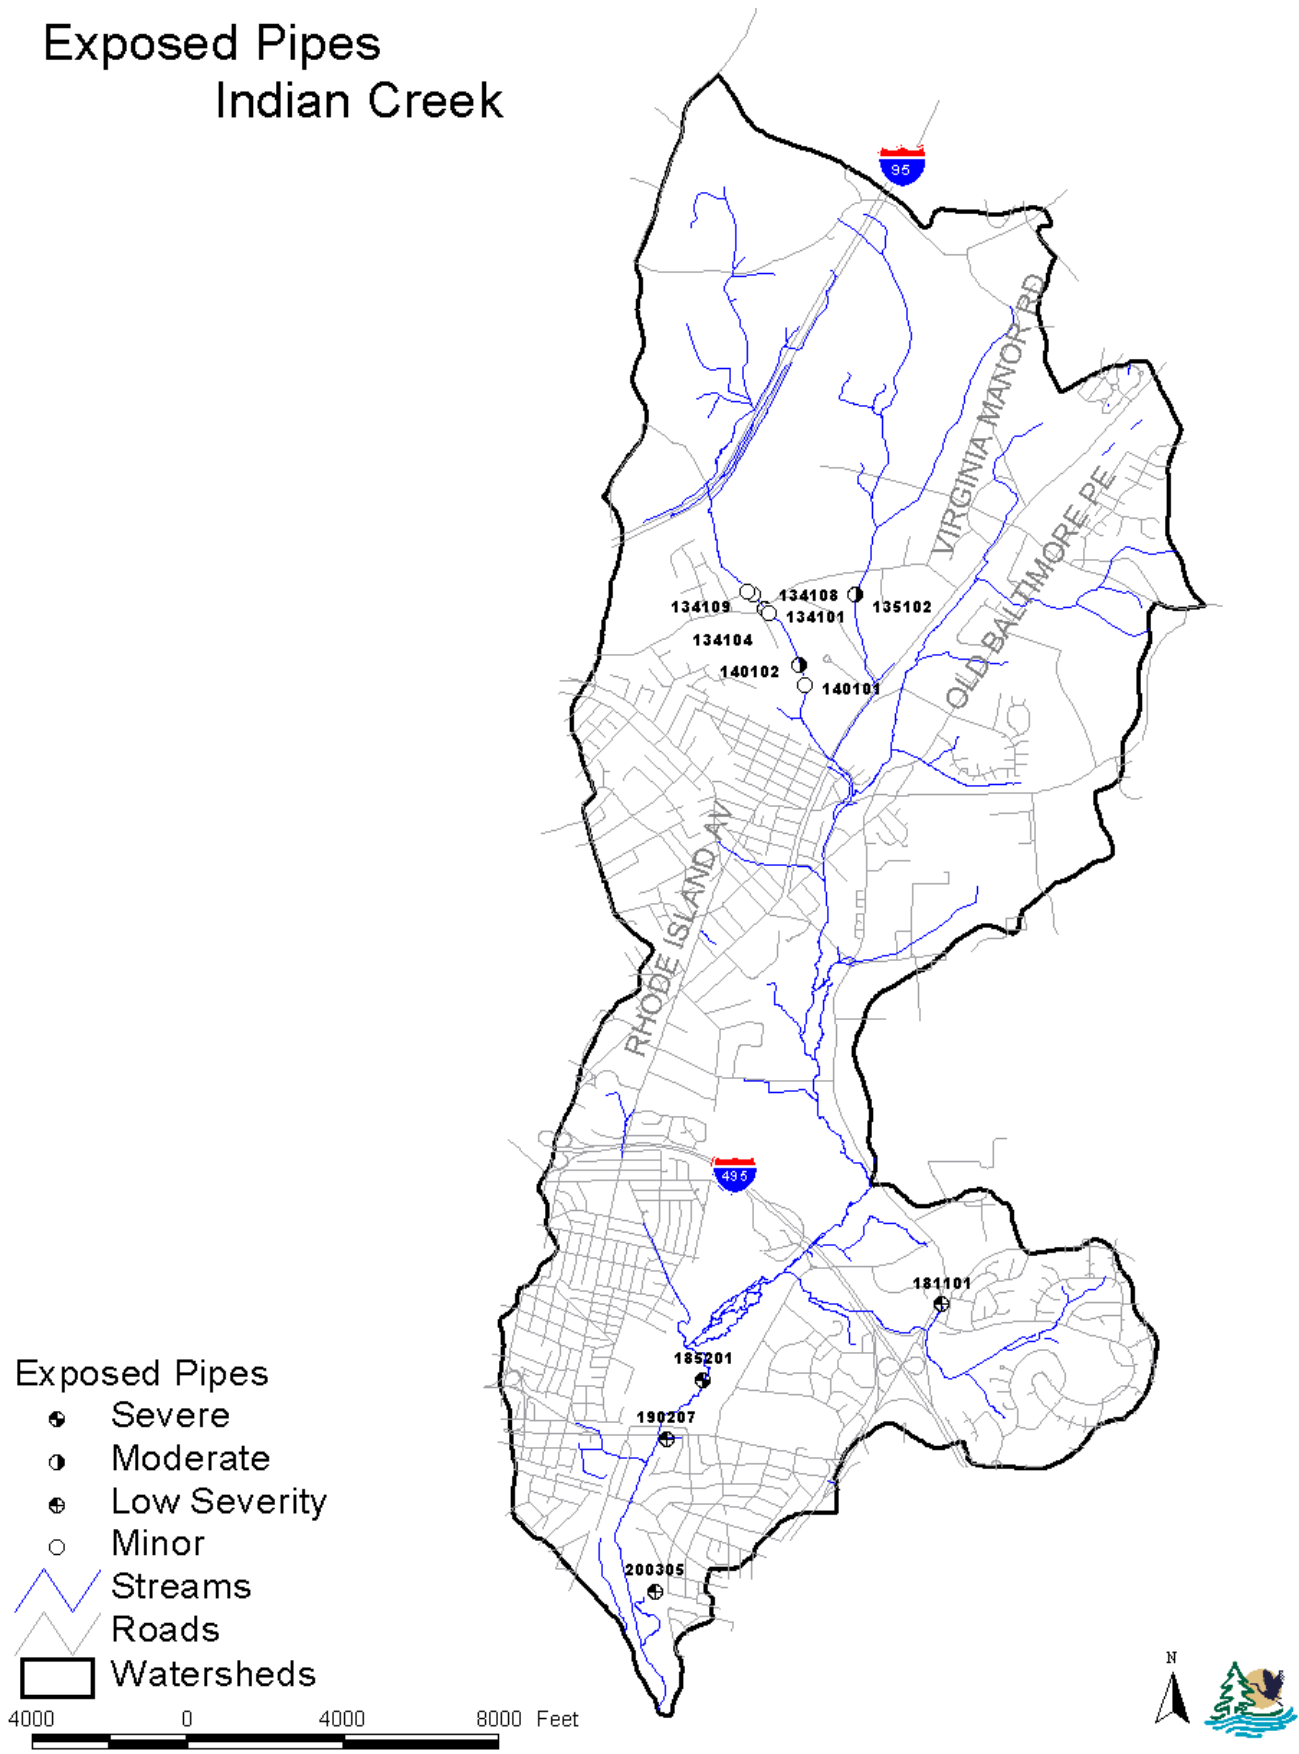
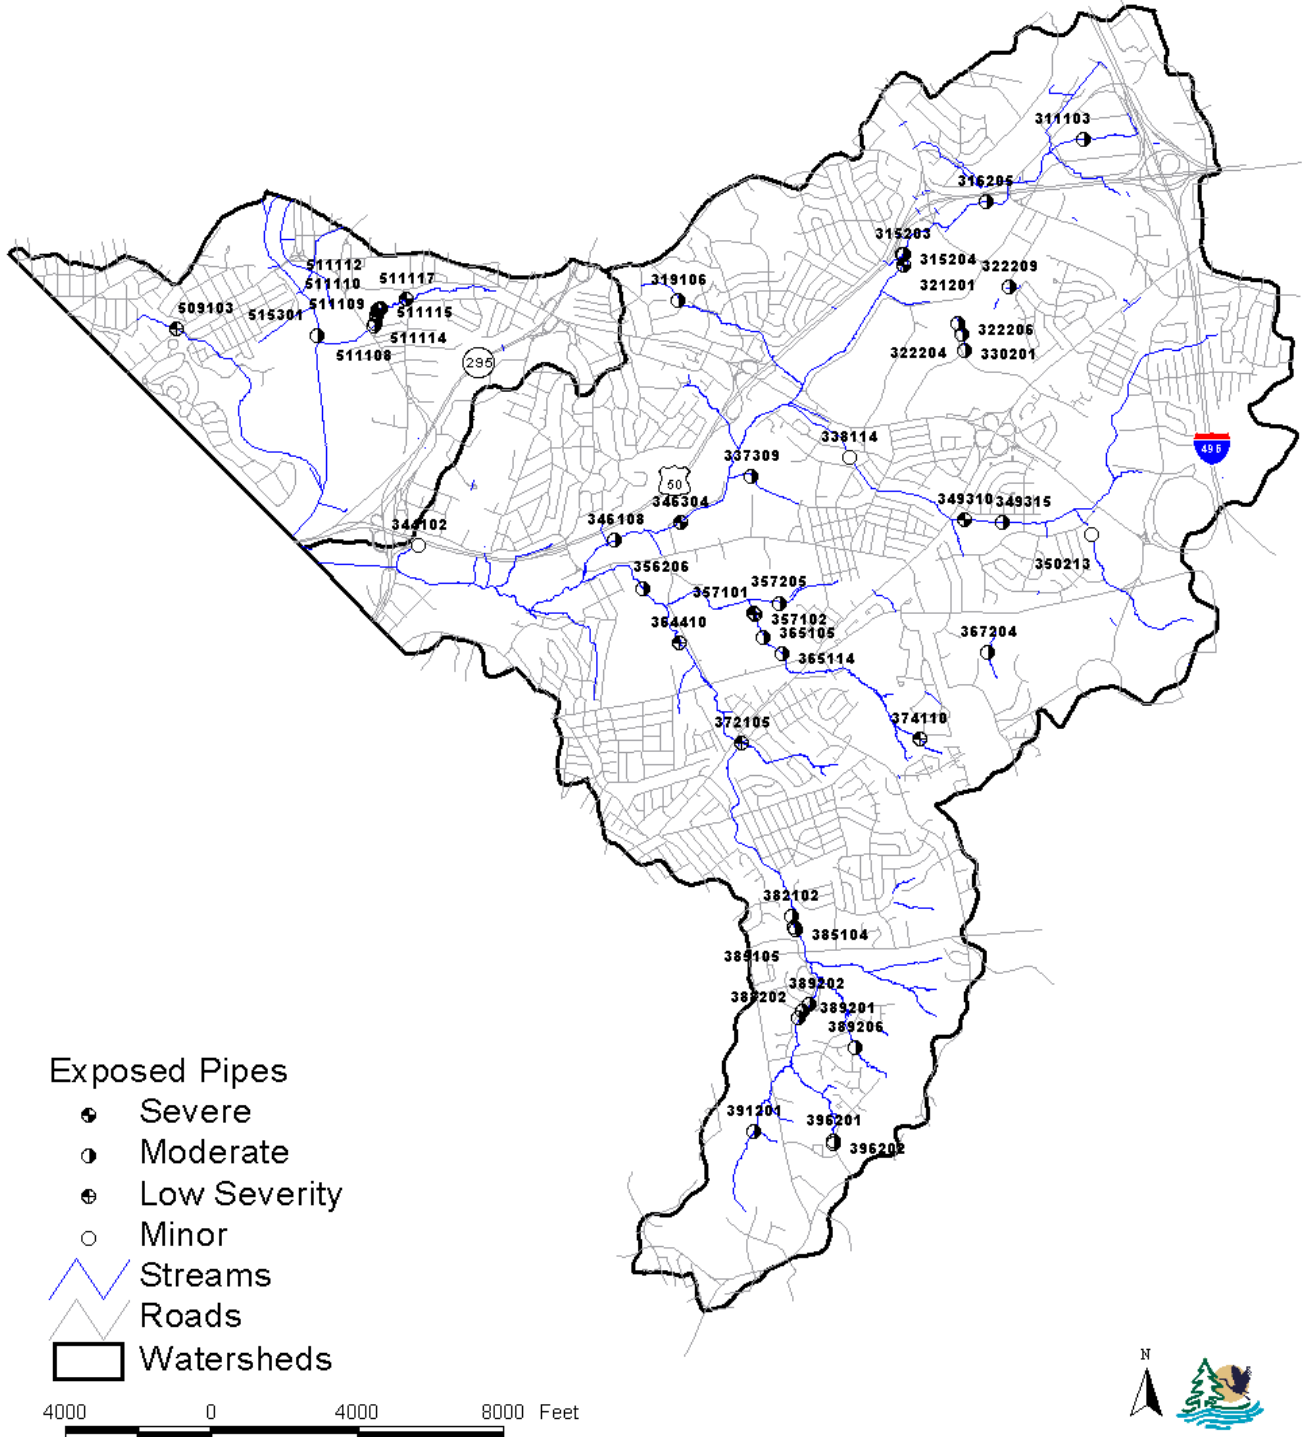
Figure 10b: Map showing the exposed pipes in Indian Creek sub-watershed of the Anacostia River

Field crews observed 58 exposed pipes during the survey. Seven were rated as severe, the rest were rated moderate to minor in severity (Figure 10a). The pipes were rated as severe because most of the pipes are being undermined by erosion and may collapse. One of the severe sites, 346304, is a manhole stack that is damaged and open to the elements. Locations of these sites are shown in Figures 10b and 10 c. The lengths observed ranged from half a foot to 250 feet. The majority (34) of the 58 exposed pipes are manhole stacks located in or along the stream channel. Follow-up visits should be made to evaluate its severity and a means for repairing or replacing the pipes.

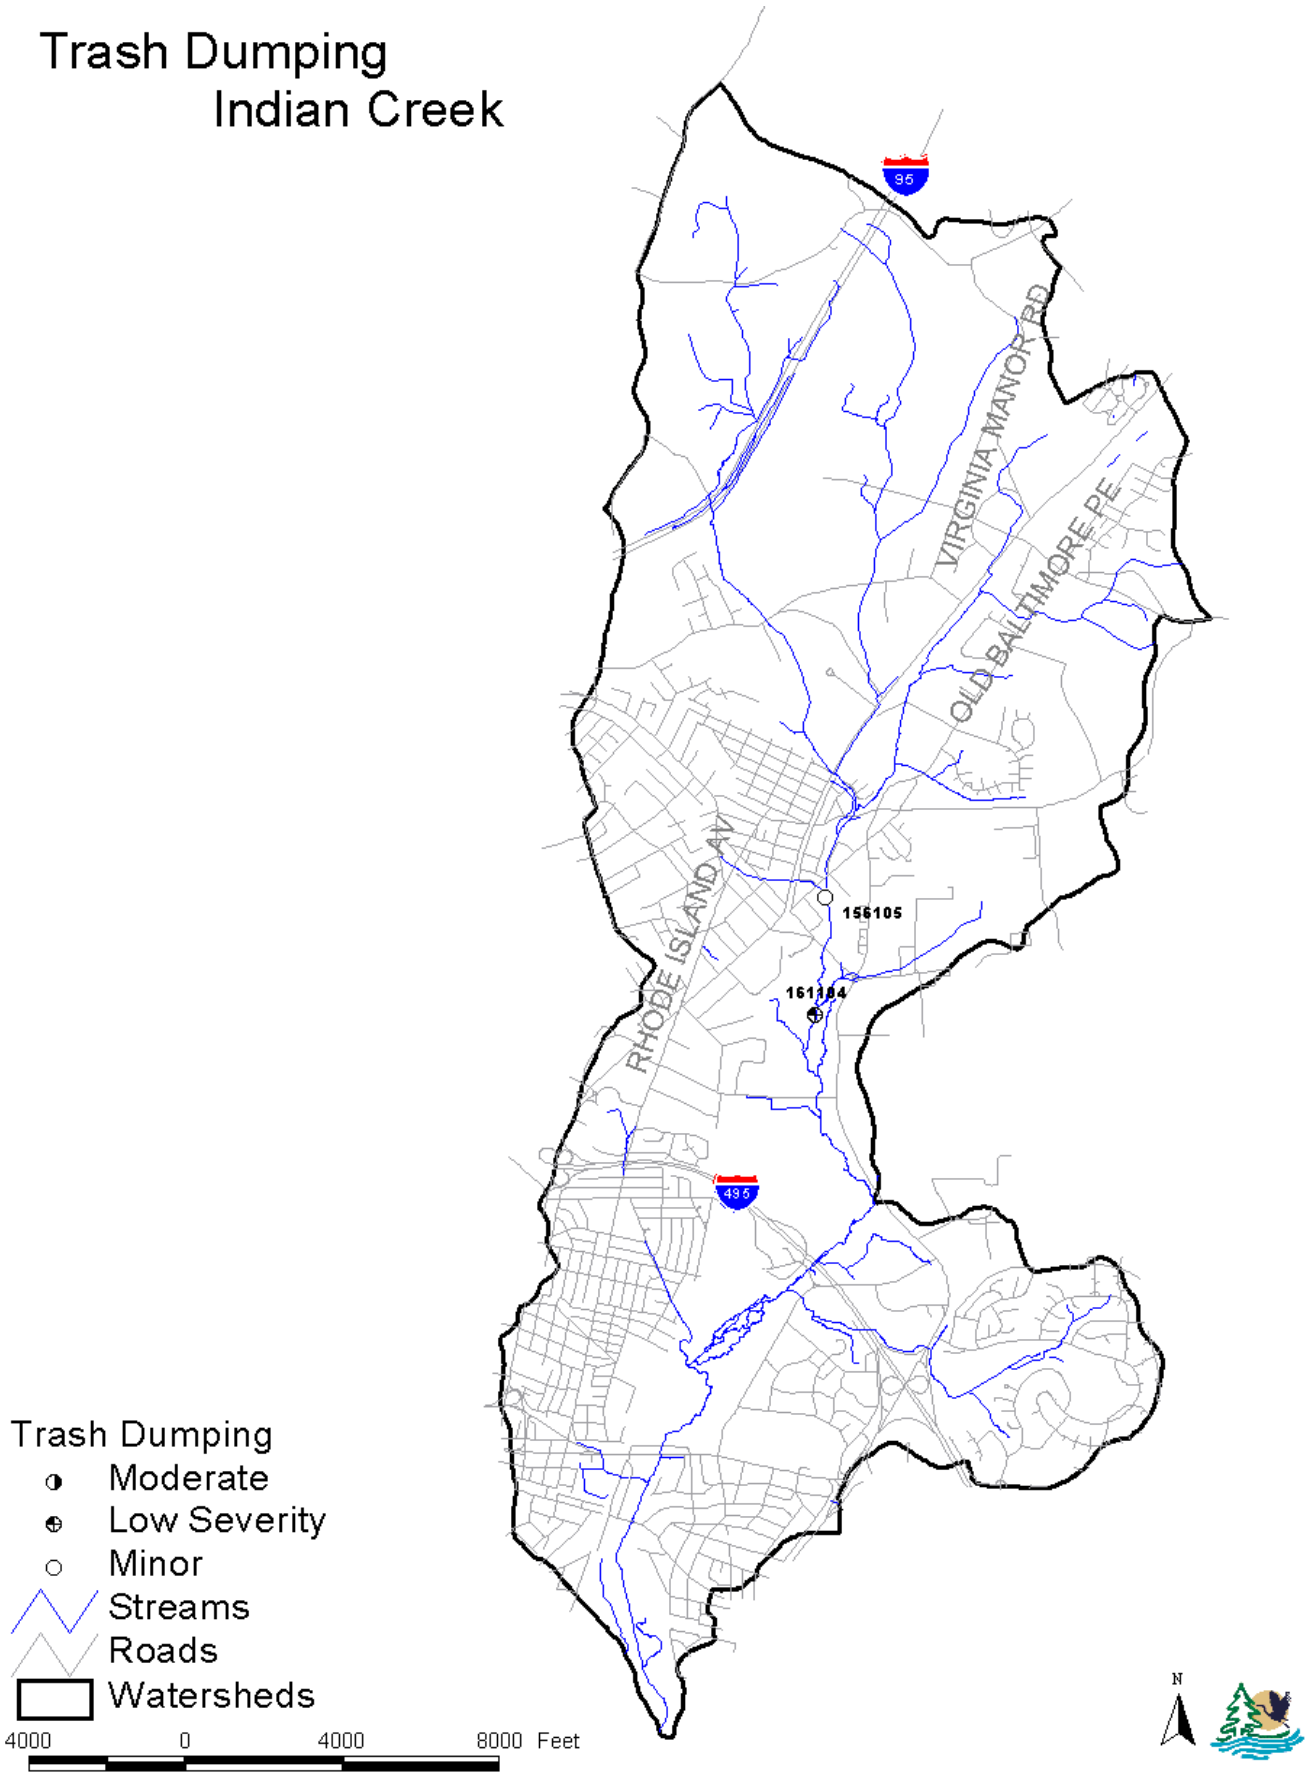
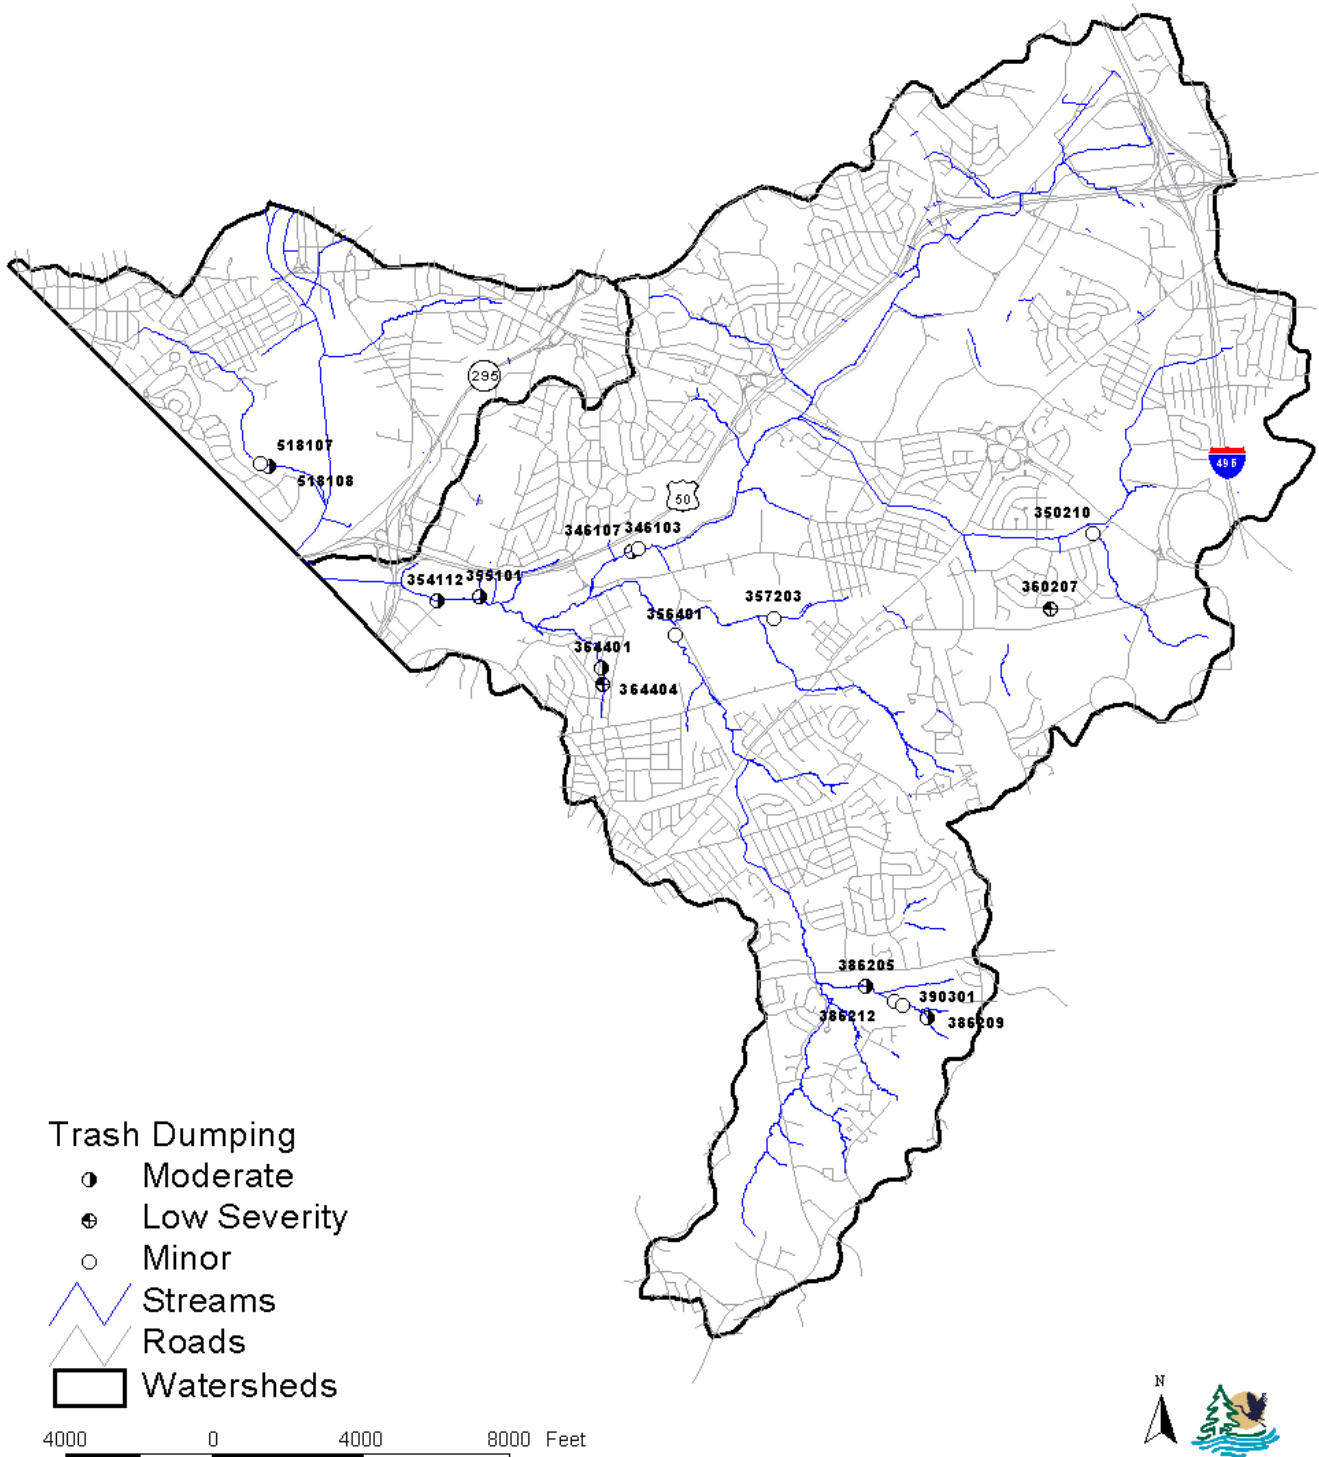
Figure 11b: Map showing the trash dumping sites in Indian Creek sub-watershed of the Anacostia River

Survey crews found eighteen trash dumping sites (Figure 11b and 11c). In terms of severity, the eighteen sites are ranked as moderate (7), low severity (3), and minor (8), as shown in Figure 11a. The sites contained residential waste (5), mixed types (4), yard waste (1), construction (1), floatables (2), industrial (2), tires with floatables (1), cars (1) and casket liners (1).

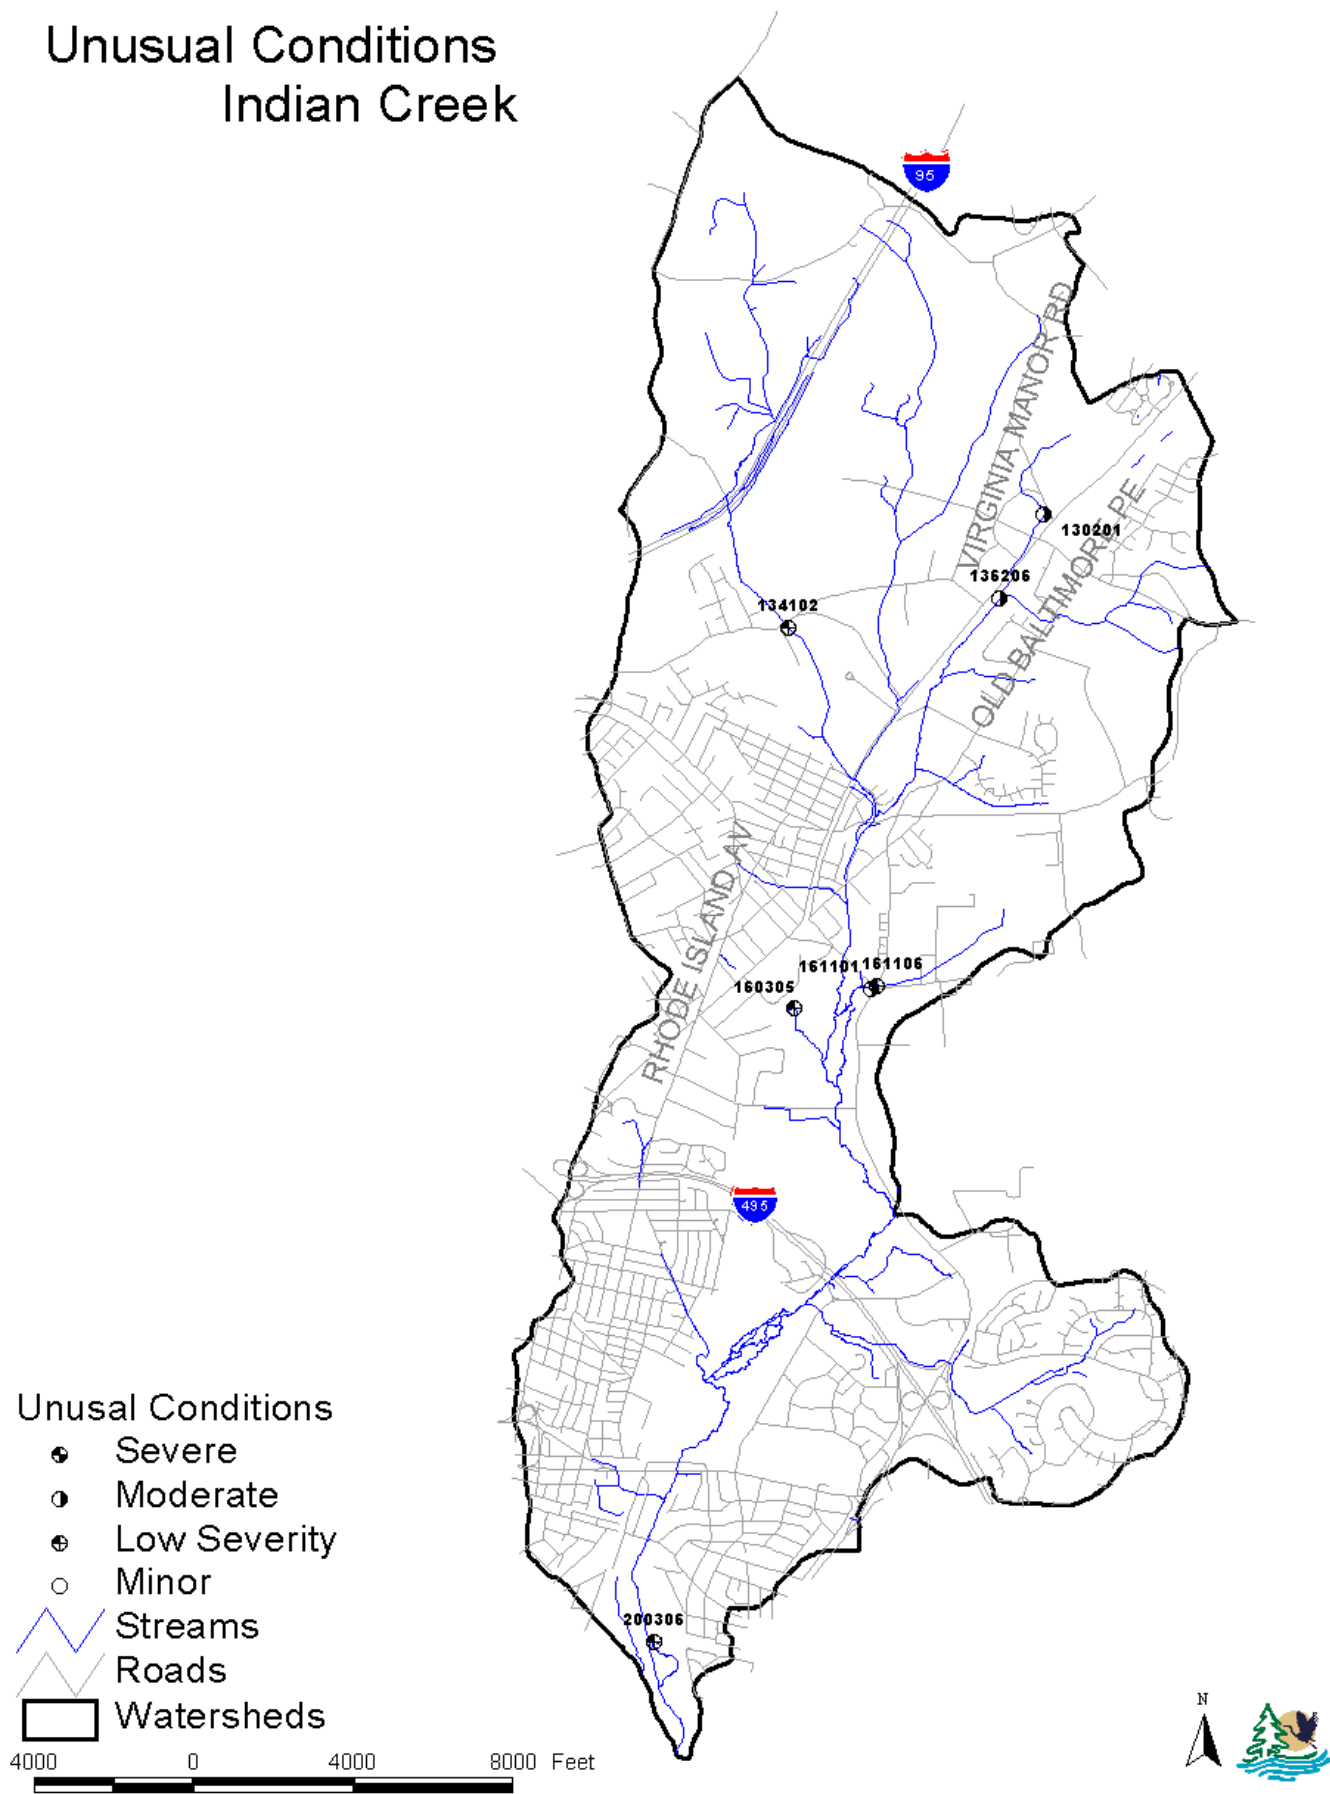
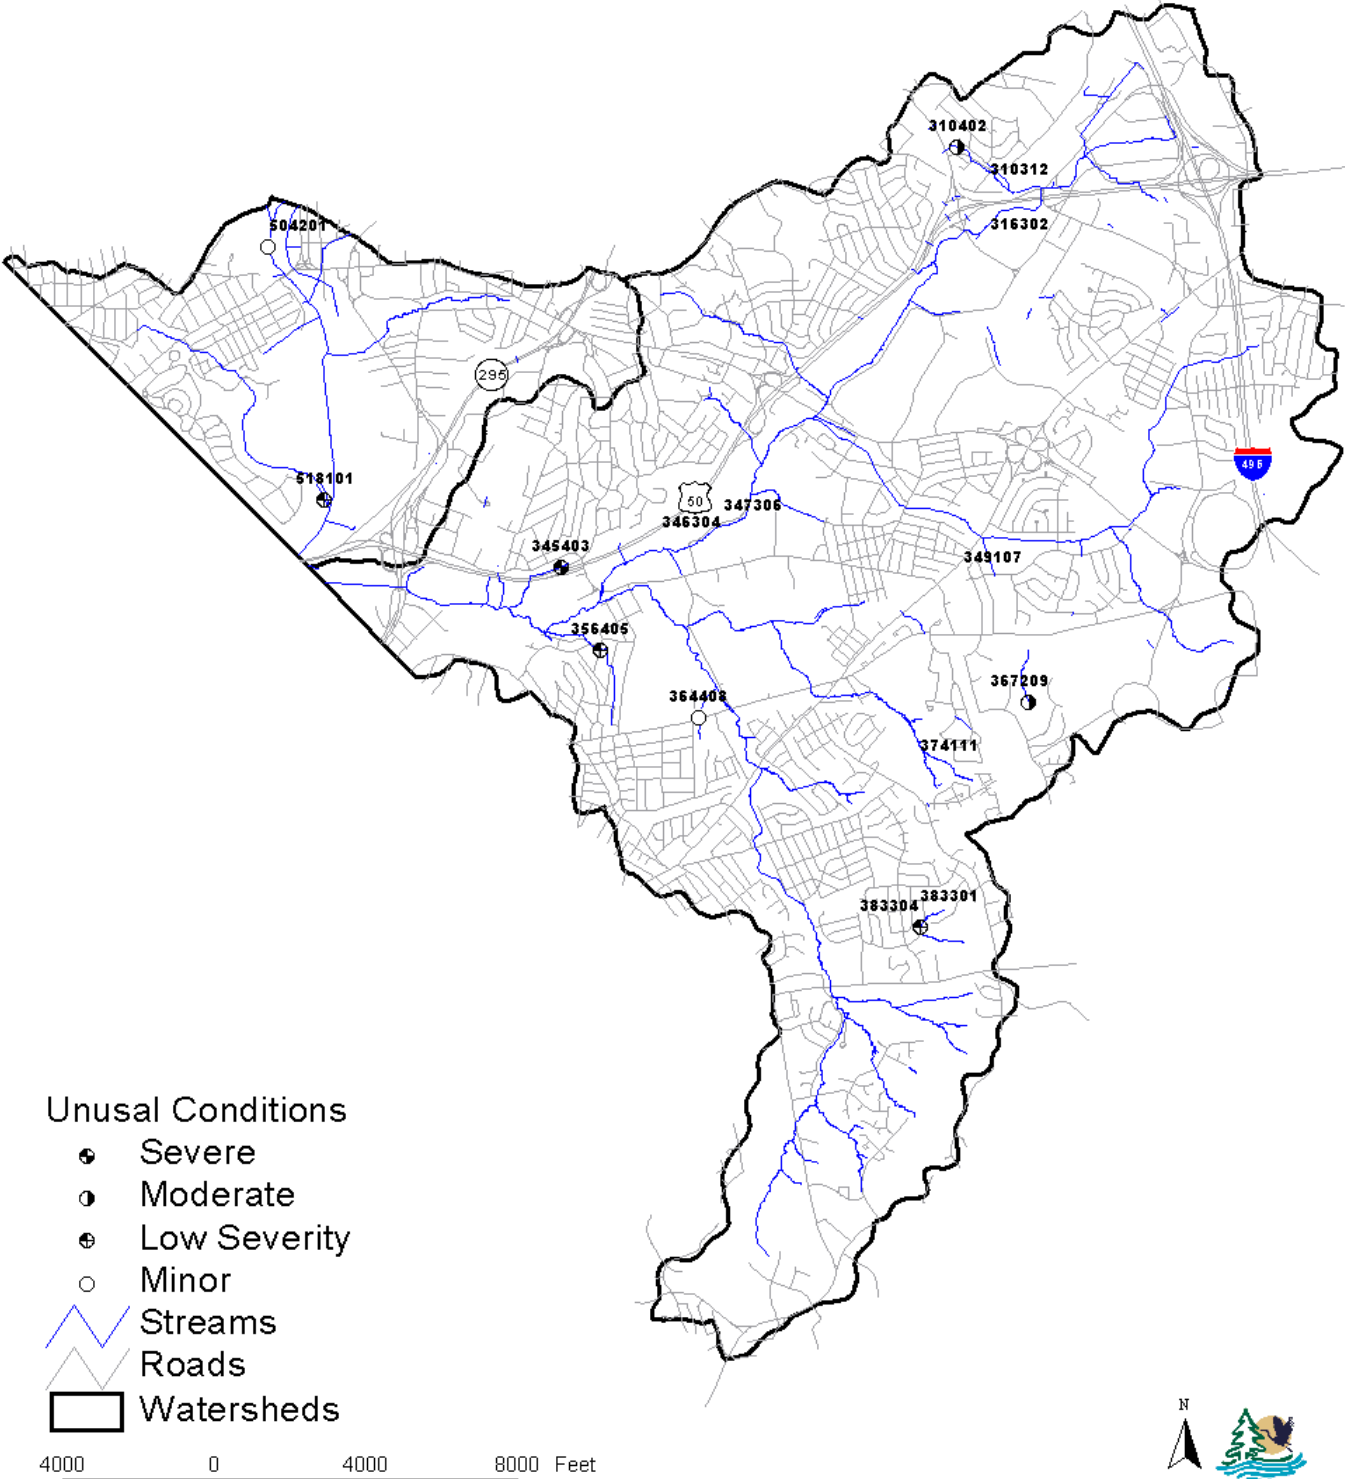
Figure 12b: Map showing the unusual condition sites in Indian Creek sub-watershed of the Anacostia River

The fifteen unusual conditions included sites with red flock (2), sediment accumulation (1), excessive algae (3), a culvert with debris (1), possible sewage discharge (1), piped streams (5), and a damaged manhole. Site 345403 is a possible sewage discharge. This site was given a severe rating.

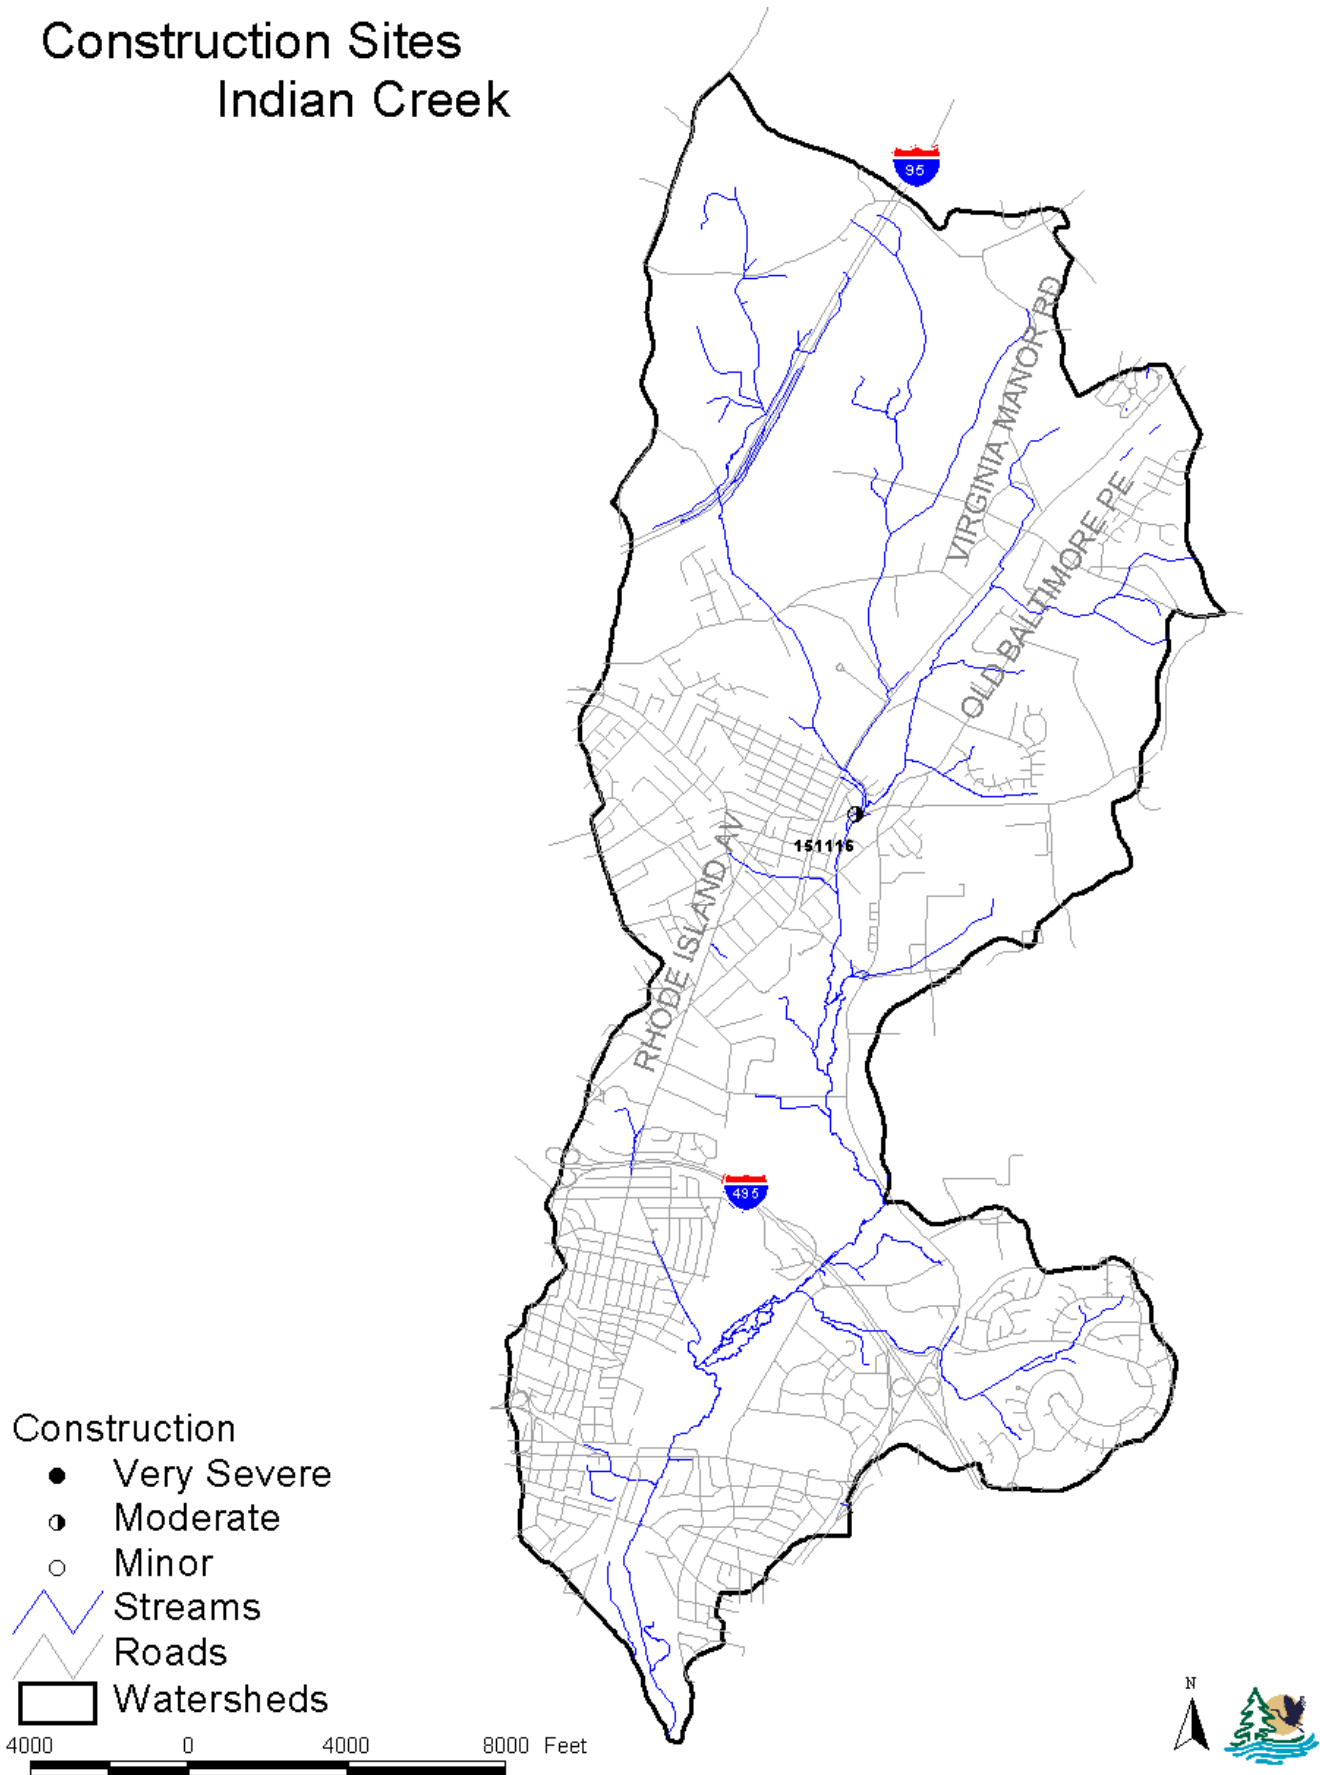
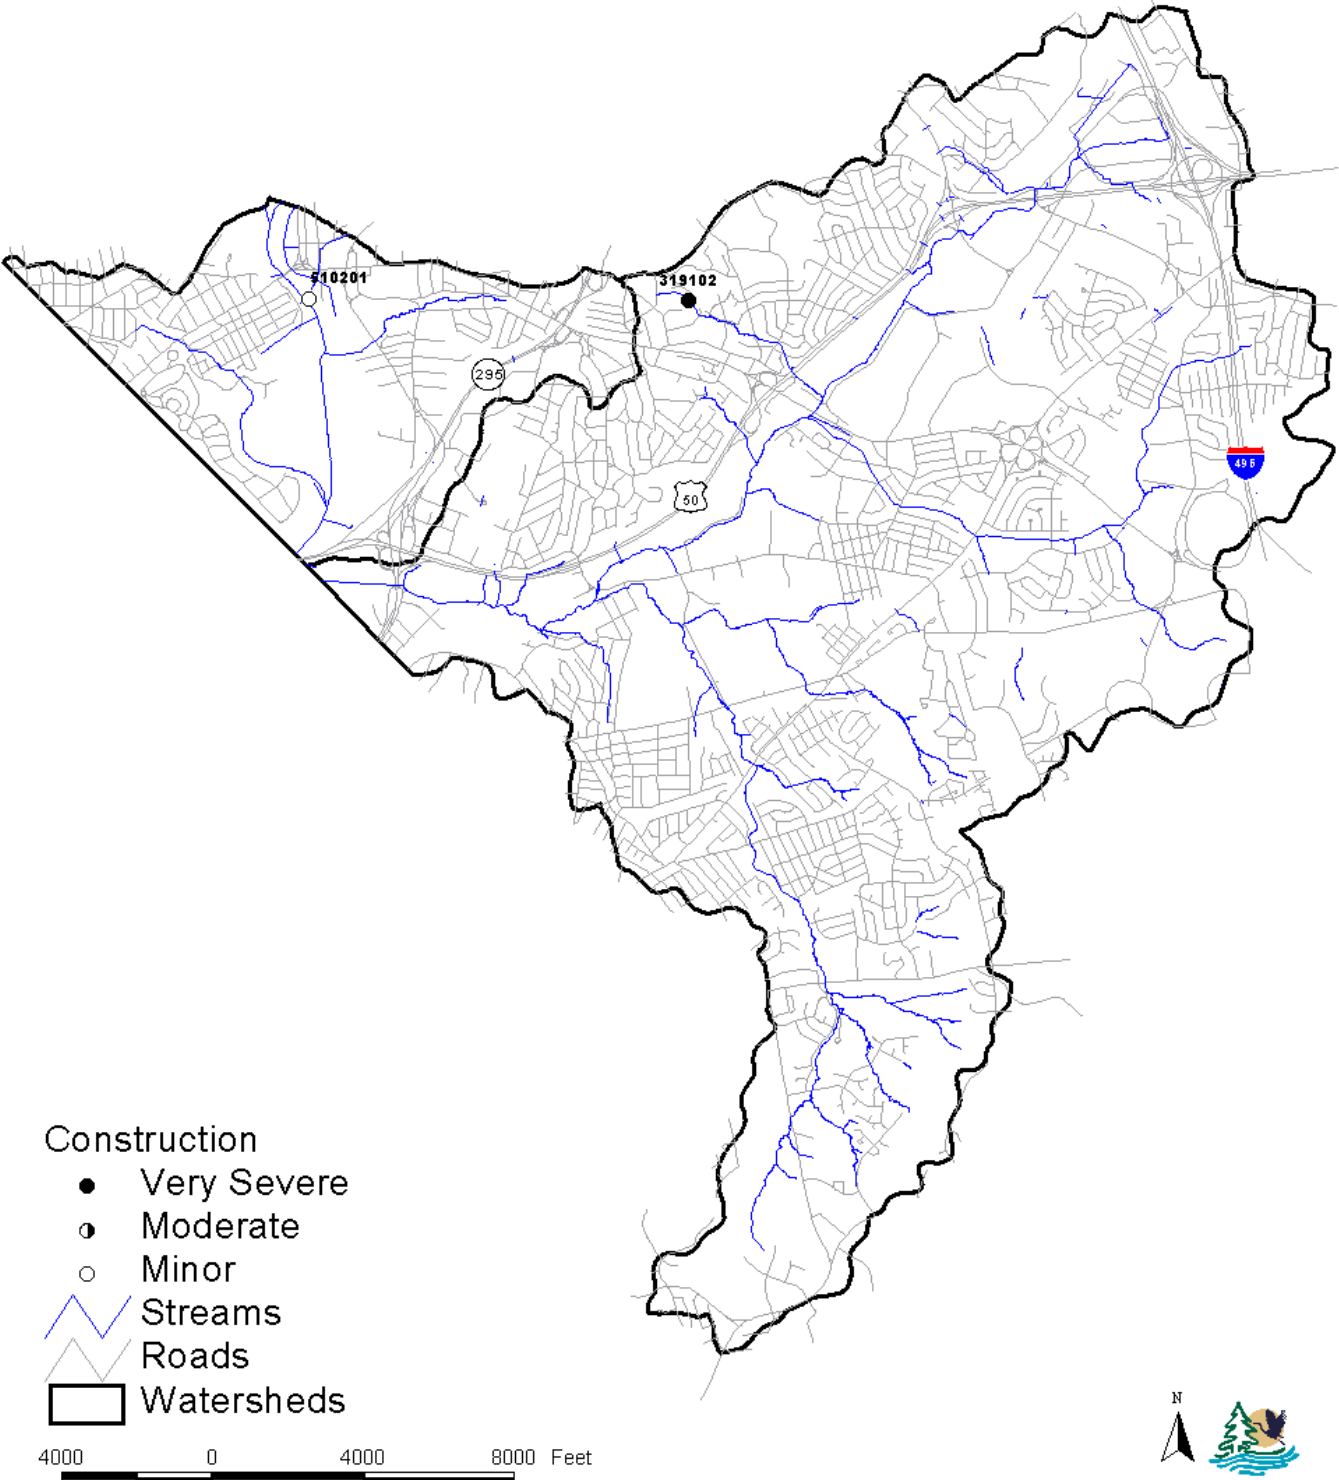
Figure 13b: Map showing the construction sites in Indian Creek sub-watershed of the Anacostia River

In or near stream construction was reported at 3 sites during the survey. The locations of in/near stream construction sites are shown in Figure 13b and 13c. Site 319102 was given a very severe rating. It had inadequate sediment control and sediment was entering the stream. The other sites were 151116, which received a moderate rating and site 510201, which received a minor rating.
