**Stream Corridor Assessment Survey for the Assawoman Bay Watershed,  
Worcester County, Maryland**

**April 2006**

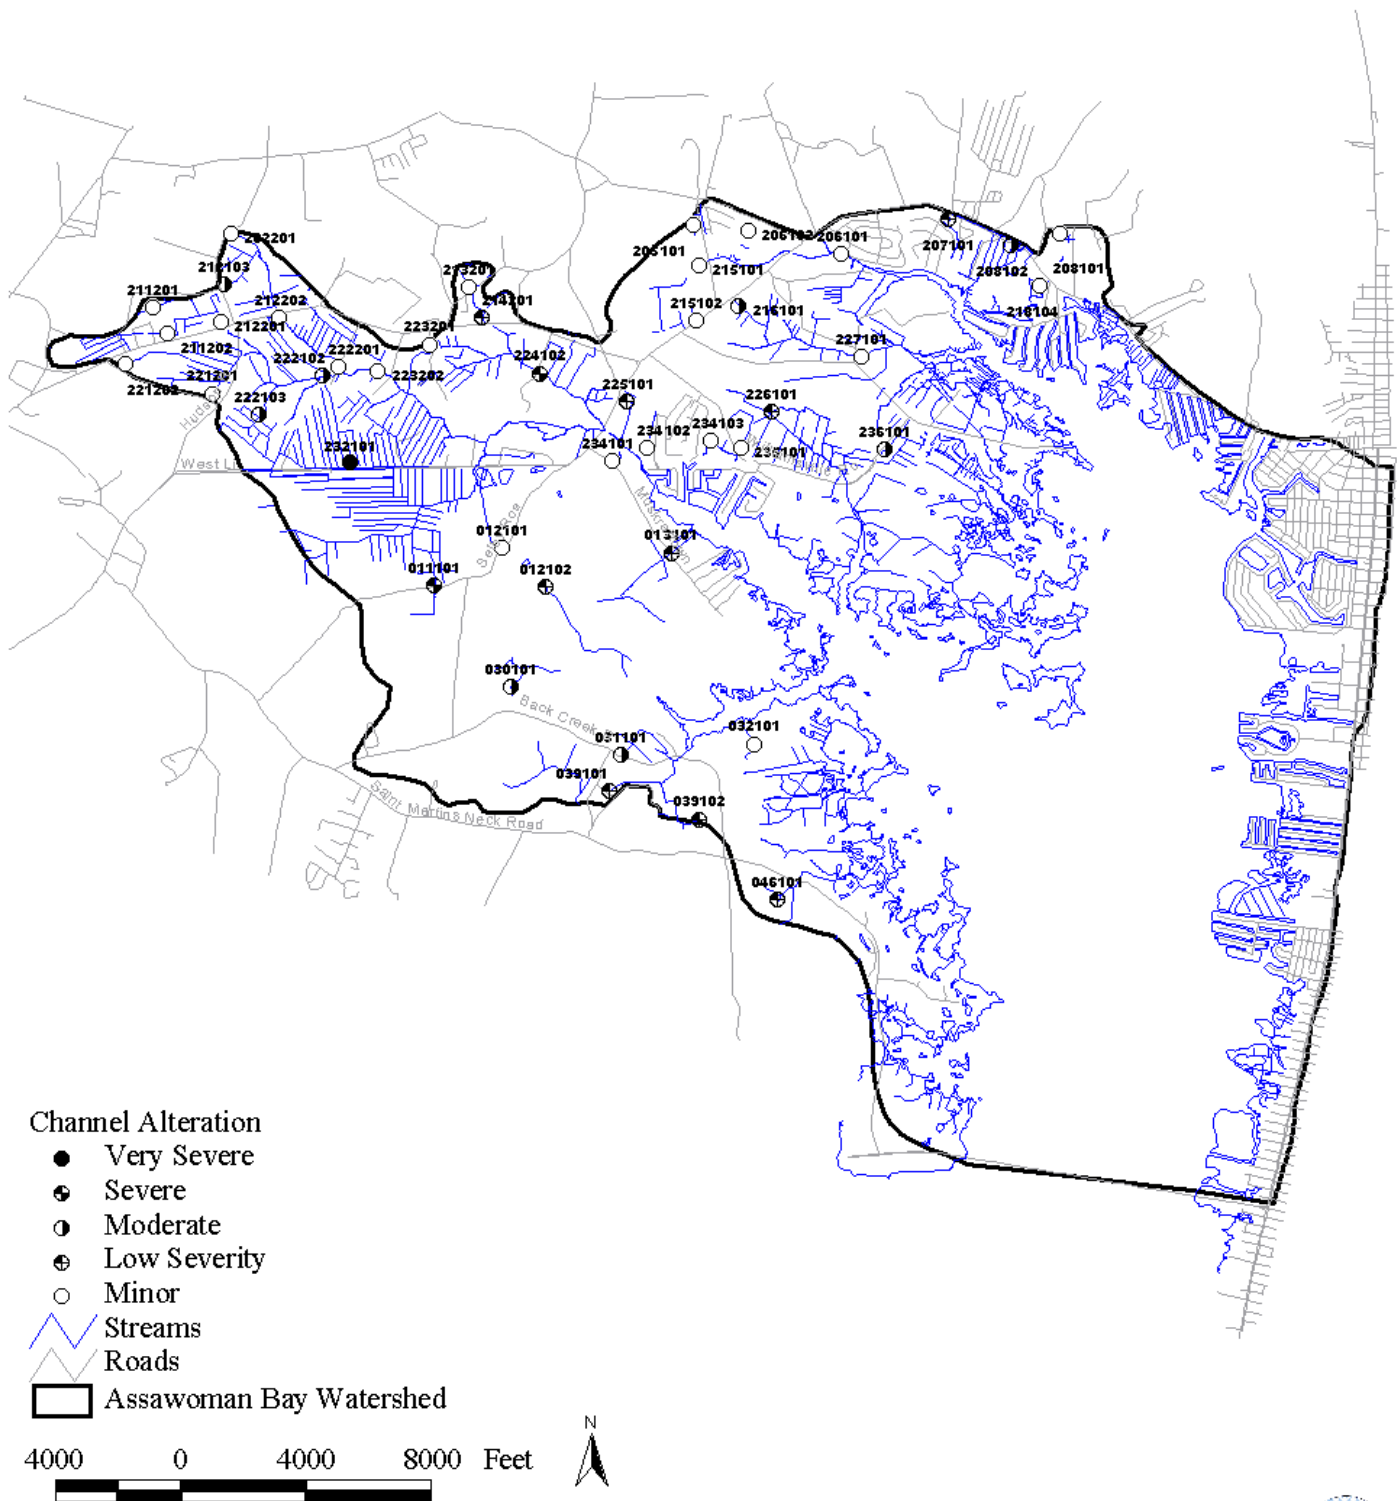
Figure 5b: Map showing the locations of the channel alterations in the Assawoman Bay Watershed

Results of this survey show recognizably altered stream channels at 45 sites. The severity and location of channel alteration sites is shown in Figure 5b. The total length of stream affected by channelization is estimated to be 216,950 feet (41 miles). Severity rankings for the sites are shown in Figure 5a.

Restoring channel alteration sites can increase fish and wildlife habitat and may allow for more time for nutrient uptake in the waterway. In its simplest form, restoration for earth channels would include allowing vegetation and/or tree roots to stabilize the sediment along the channel, causing sinuosity to re-form naturally. This sinuosity may reform within the bed of the channelization or along its banks, depending on the site and the depth of the channel alteration.

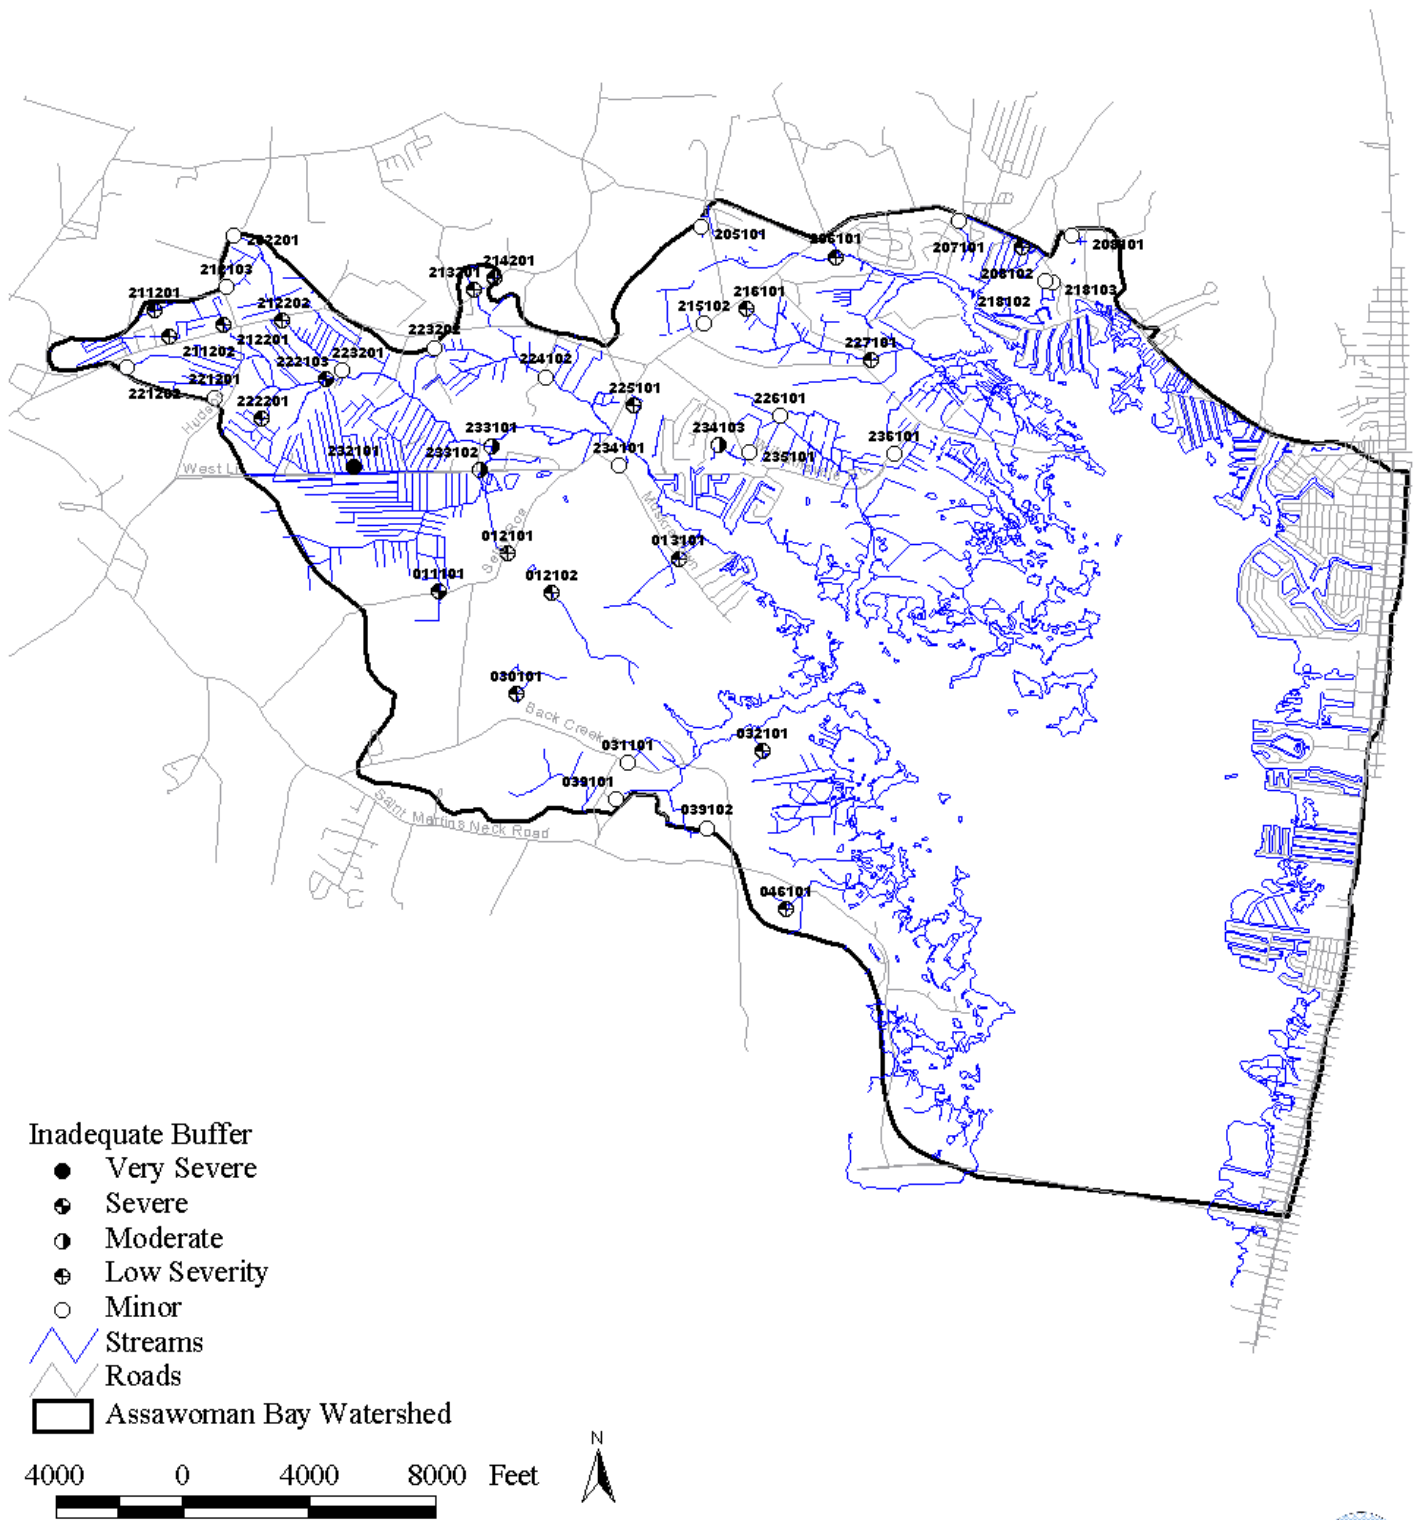
Figure 6b: Map showing the locations of the inadequate buffers in the Assawoman Bay Watershed

Survey crews identified 44 inadequate buffer sites with a total length of 202,780 feet (38.4 miles). The severity and location of inadequate buffer sites is shown in Figure 6b. Three of these sites are ranked as very severe or severe, while the other sites are moderate, of low severity, or minor (Figure 6a). Land use along the stream at inadequate buffer sites, were reported as mostly crop fields.

Any inadequate buffer site would benefit from the restoration of trees along both stream banks. For sites on agricultural land, farmers also may qualify for federal and state government financial incentives for allowing 50-foot forest buffers to grow on their farmland. Those sites that may have particular natural resource value are headwater streams, or those that form gaps in existing forested buffer areas.

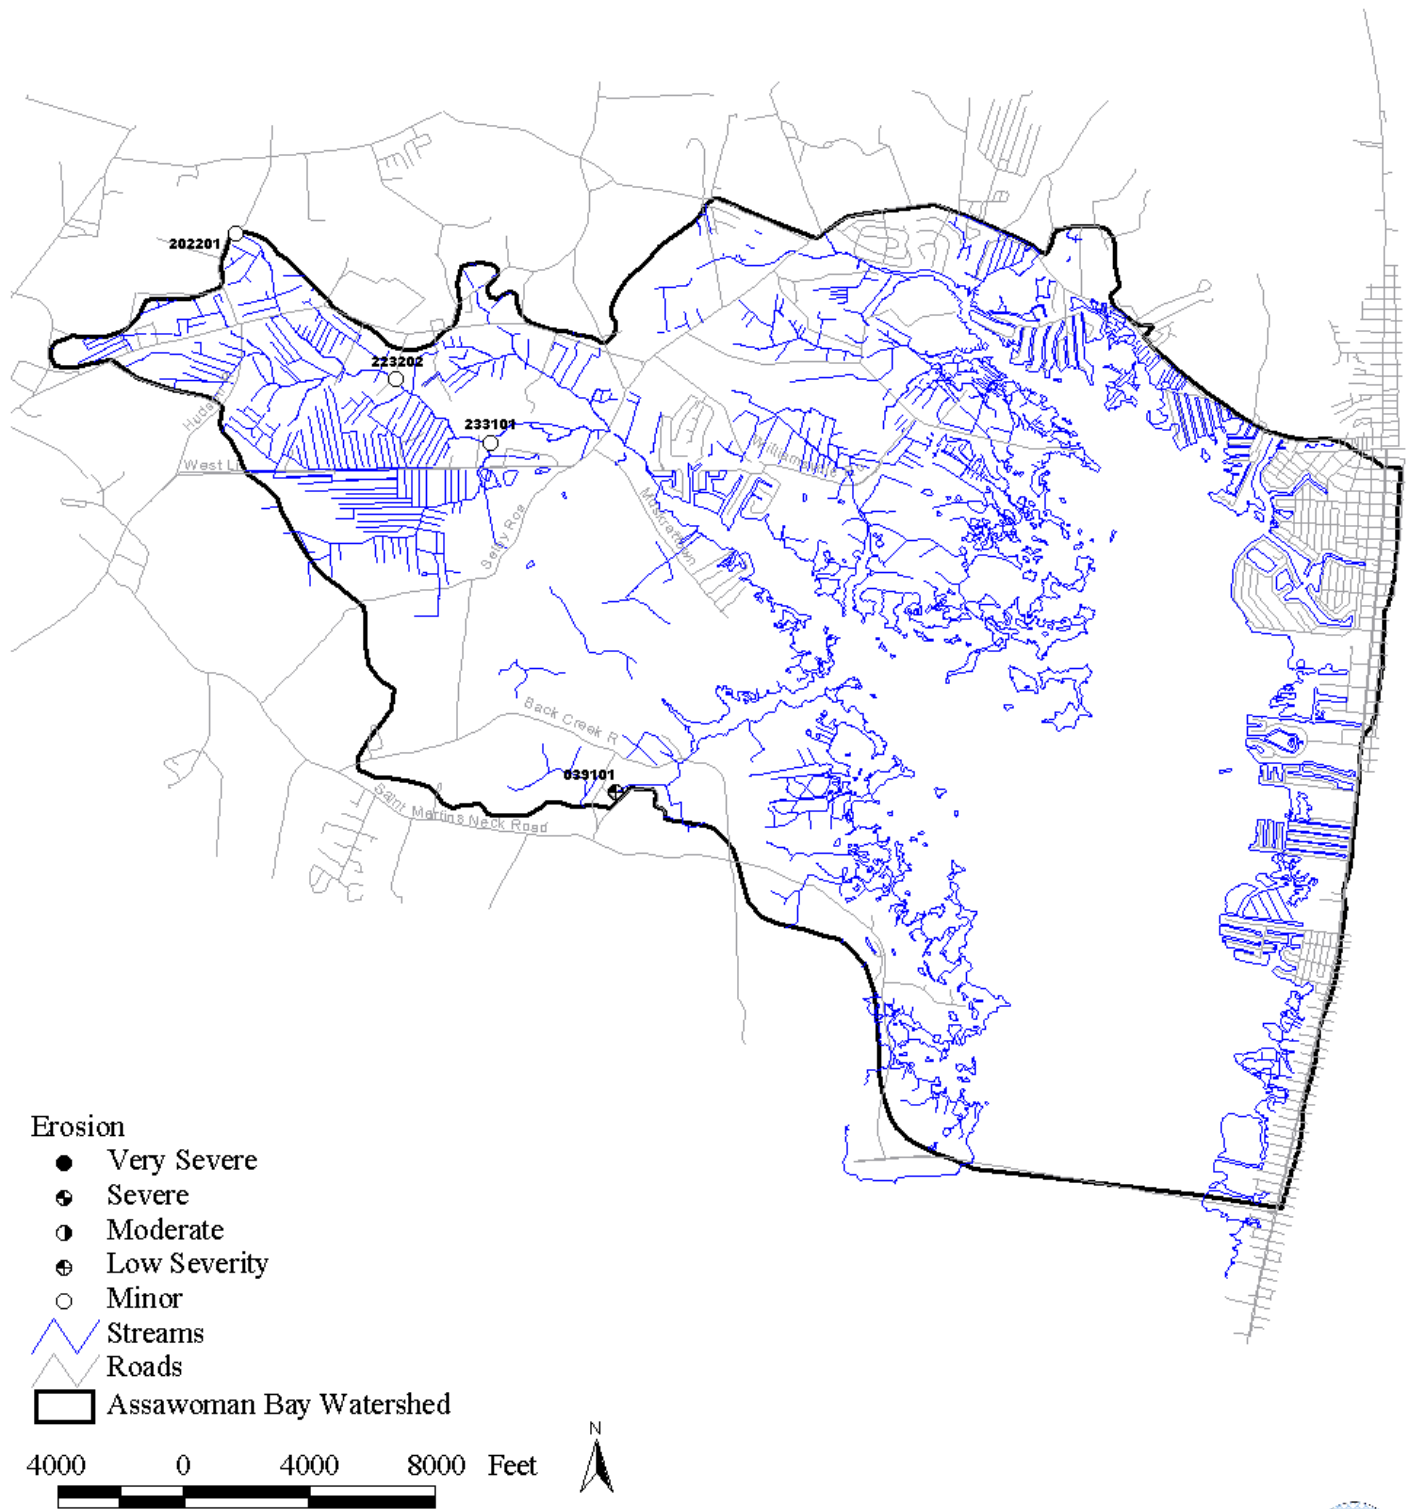
Figure 7b: Map showing the locations of the erosion sites in the Assawoman Bay Watershed

The SCA survey found 4 eroding stream banks over the length of 140 feet (0.027 miles) of stream. The severity and location of erosion sites is shown in Figure 7b. The severity ratings are shown in Figure 7a.

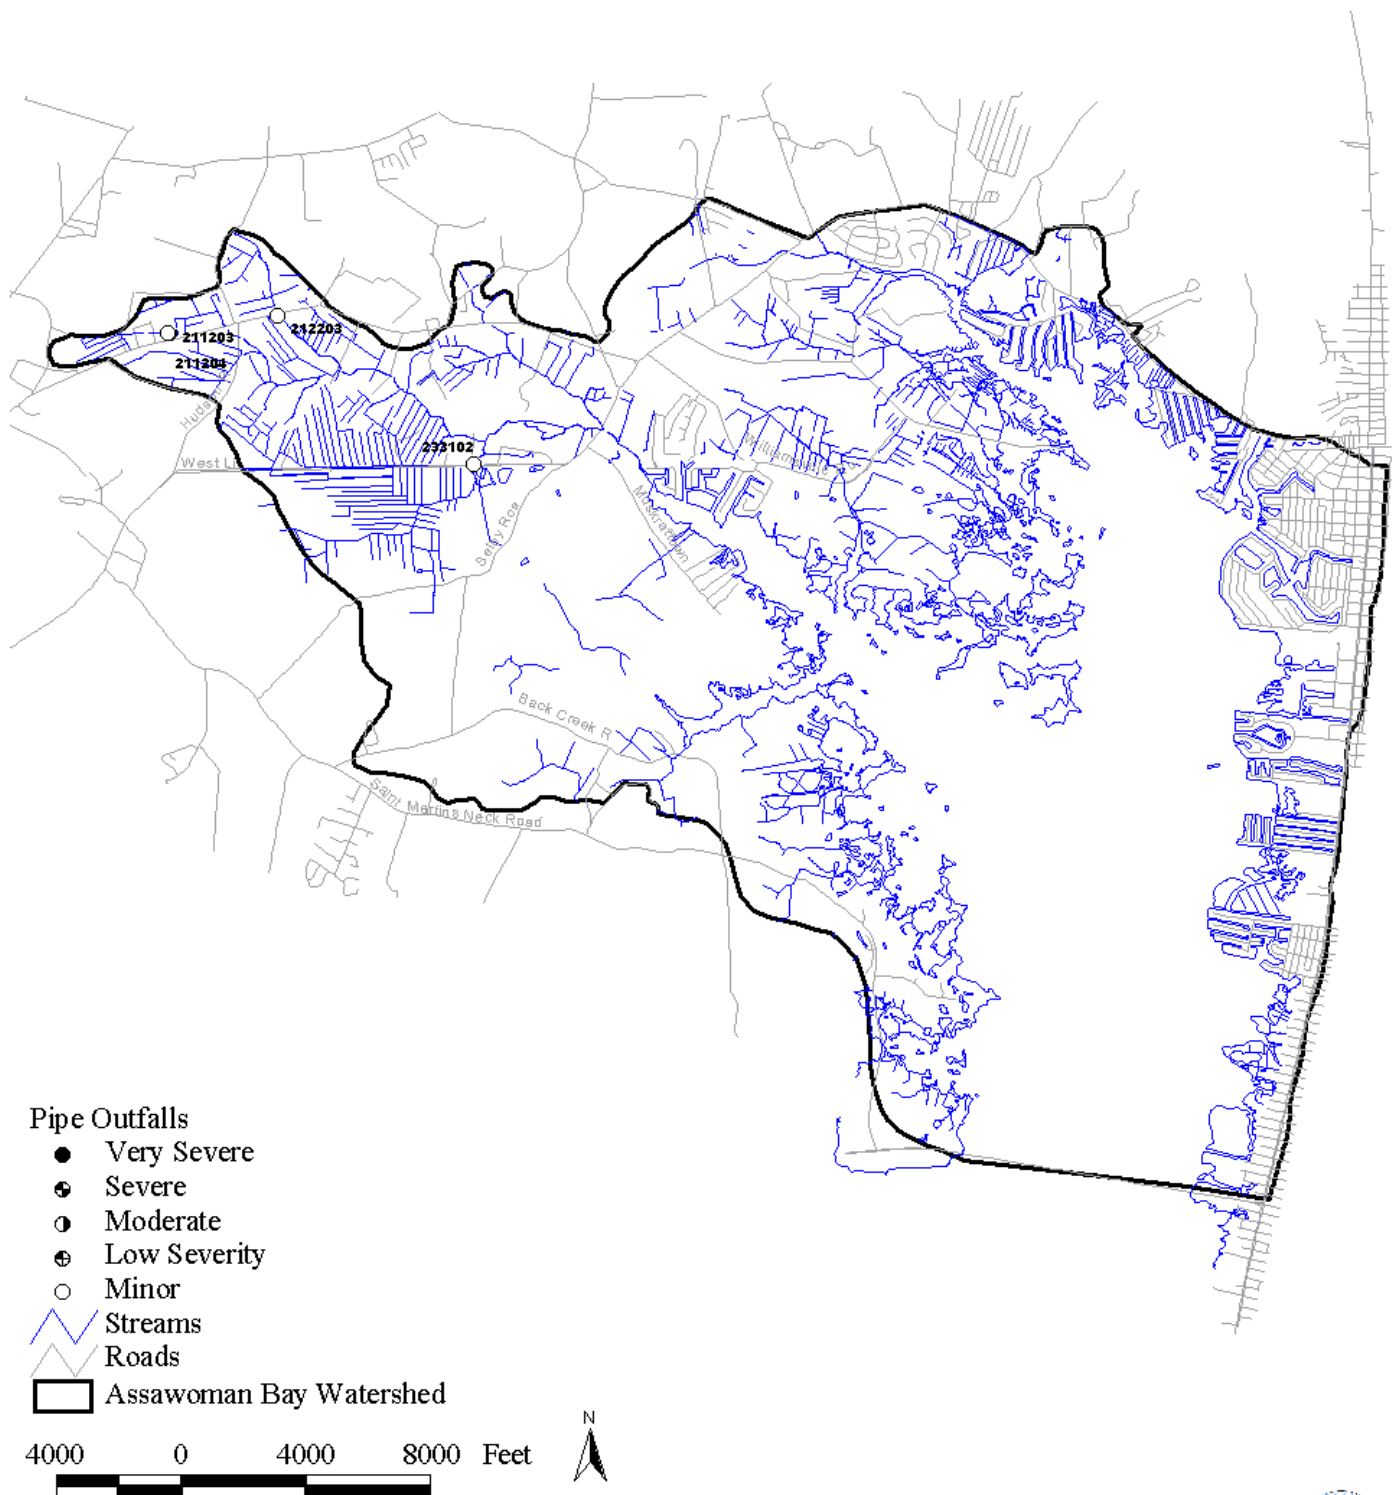
Figure 8b: Map showing the locations of the pipe outfalls in the Assawoman Bay Watershed

The survey crew identified a total of 4 pipe outfalls. The severity and location of pipe outfall sites is shown in Figure 8b. None of the pipes had a discharge. All of the pipes were rated as minor (Figure 8a). All the pipes appear to be for stormwater discharges.

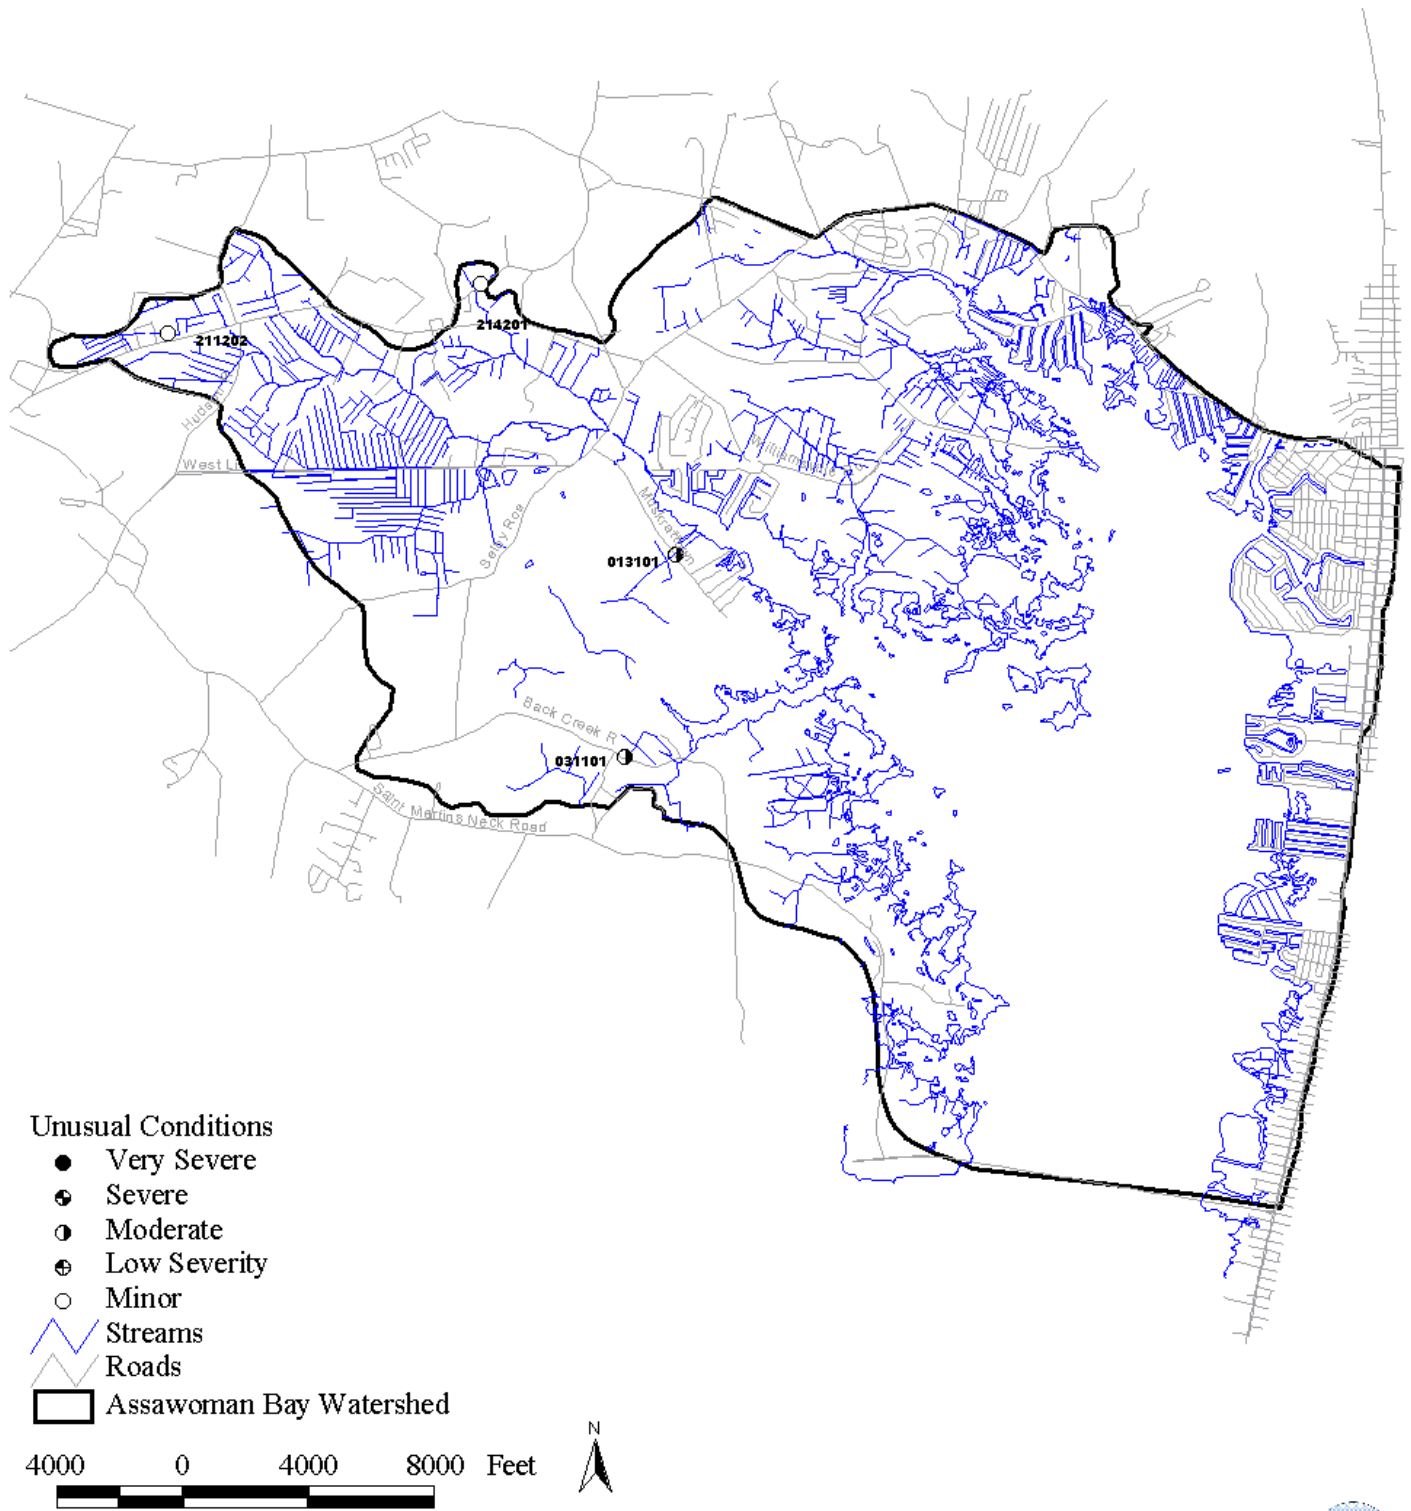
Figure 9b: Map showing the locations of the unusual condition sites in the Assawoman Bay Watershed

The survey crew identified 4 unusual conditions and 4 comments throughout the Assawoman Bay watershed. The severity and location of unusual condition sites is shown in Figure 9b. The four unusual conditions sites were where there was excessive algae.

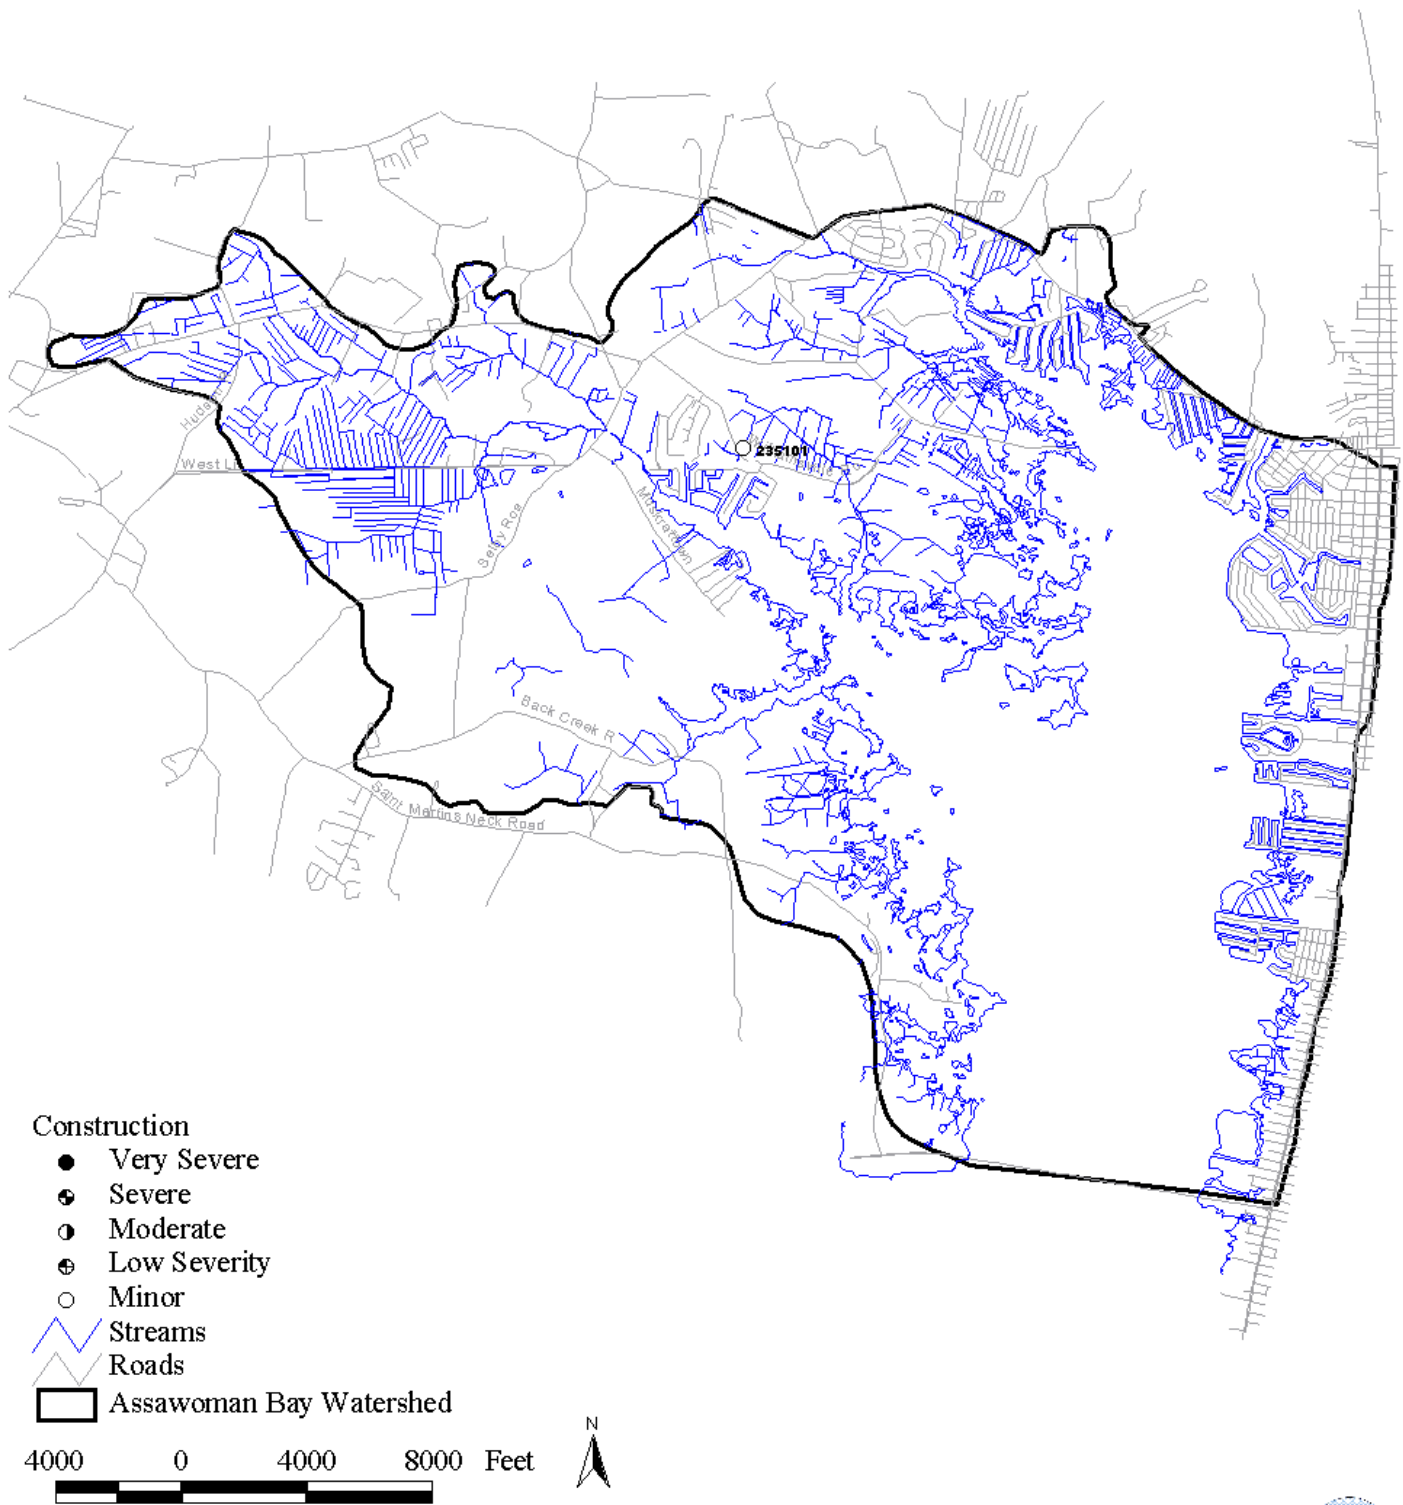
Figure 10: Map showing the locations of the construction site in the Assawoman Bay Watershed

Only one construction sites affected a nearby stream during the time of the survey. This is the site of a new golf course. The site was rated minor in severity and the location is shown in Figure 10.

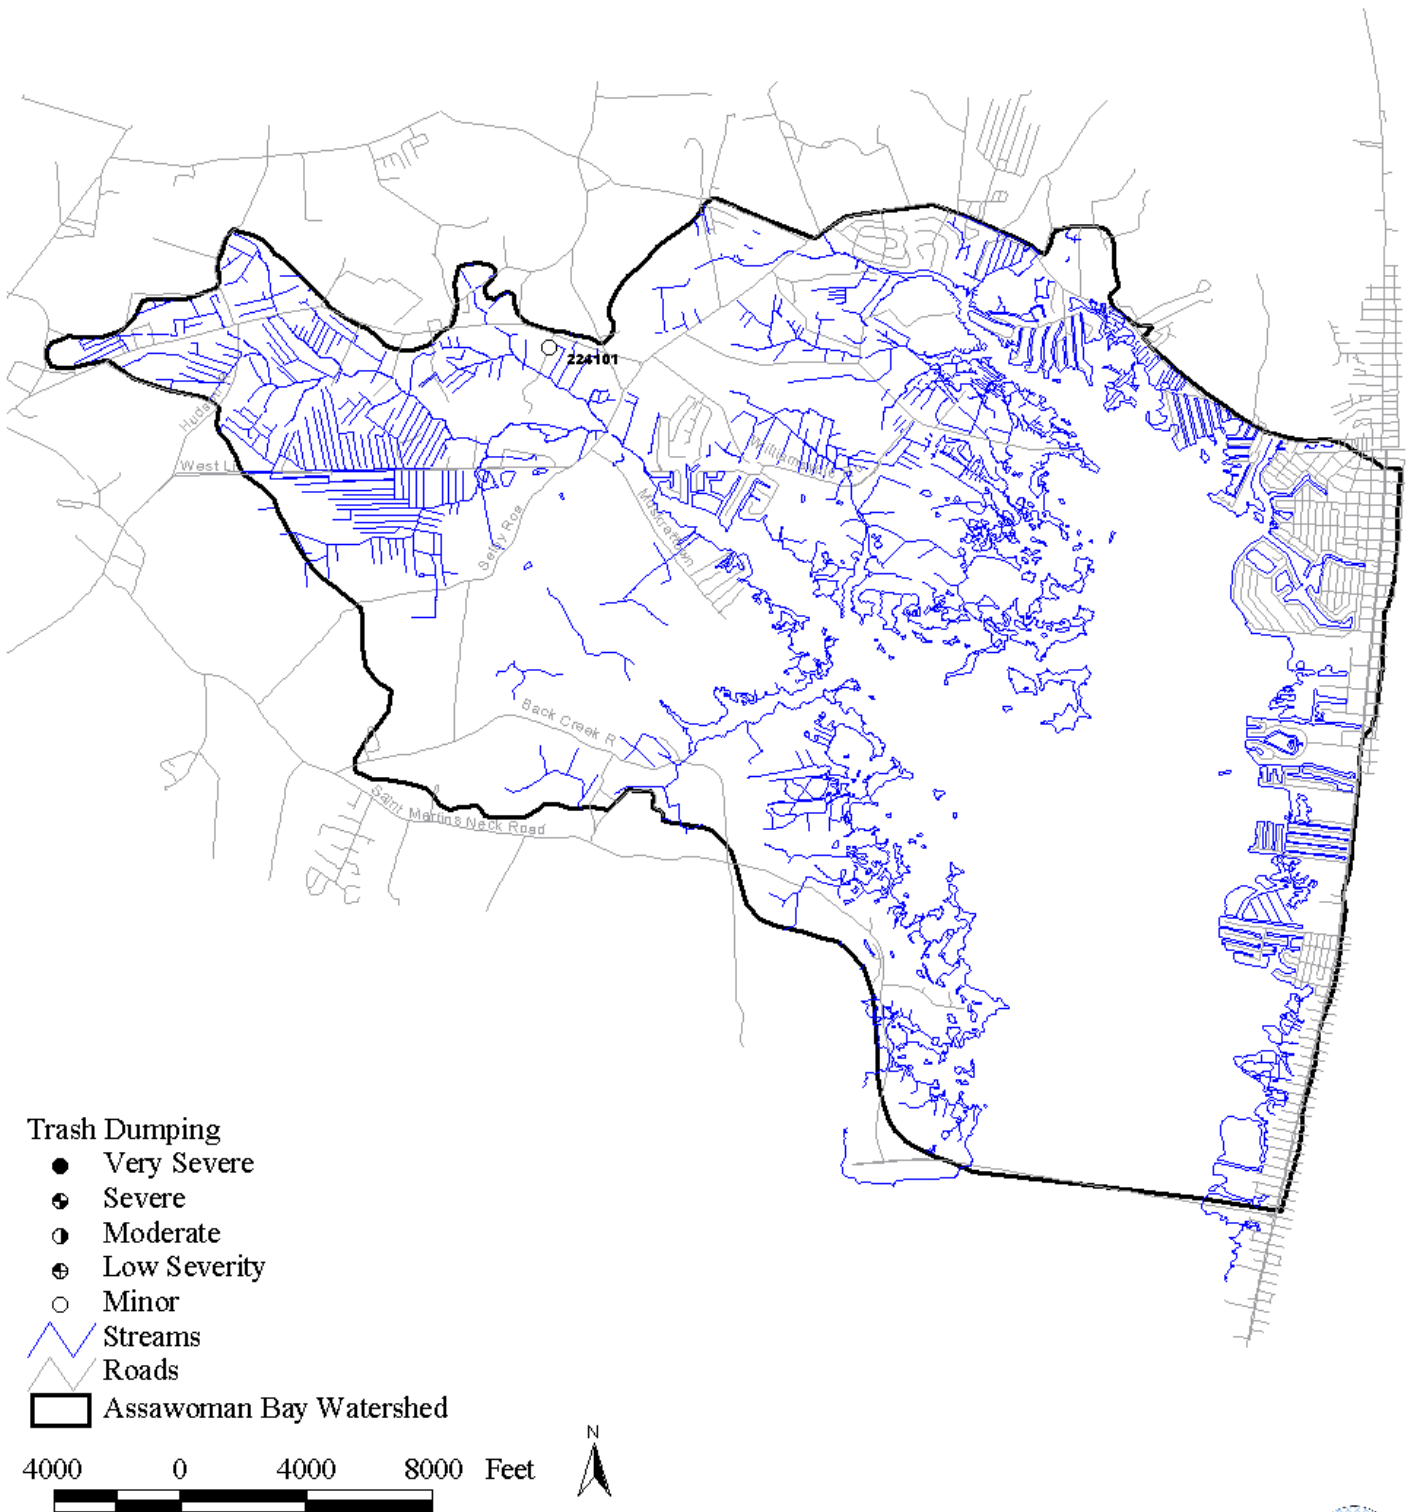
# Trash Dumping

Survey crews found one trash dumping site (Figure 11). Site 224101 was construction trash. It was rated minor in severity.
