LOWER MONOCACY RIVER STREAM CORRIDOR ASSESSMENT

Stephen Czwartacki & Ken Yetman
Watershed Assessment and Targeting Division
Watershed Services Unit
Maryland Department of Natural Resources

November 2004

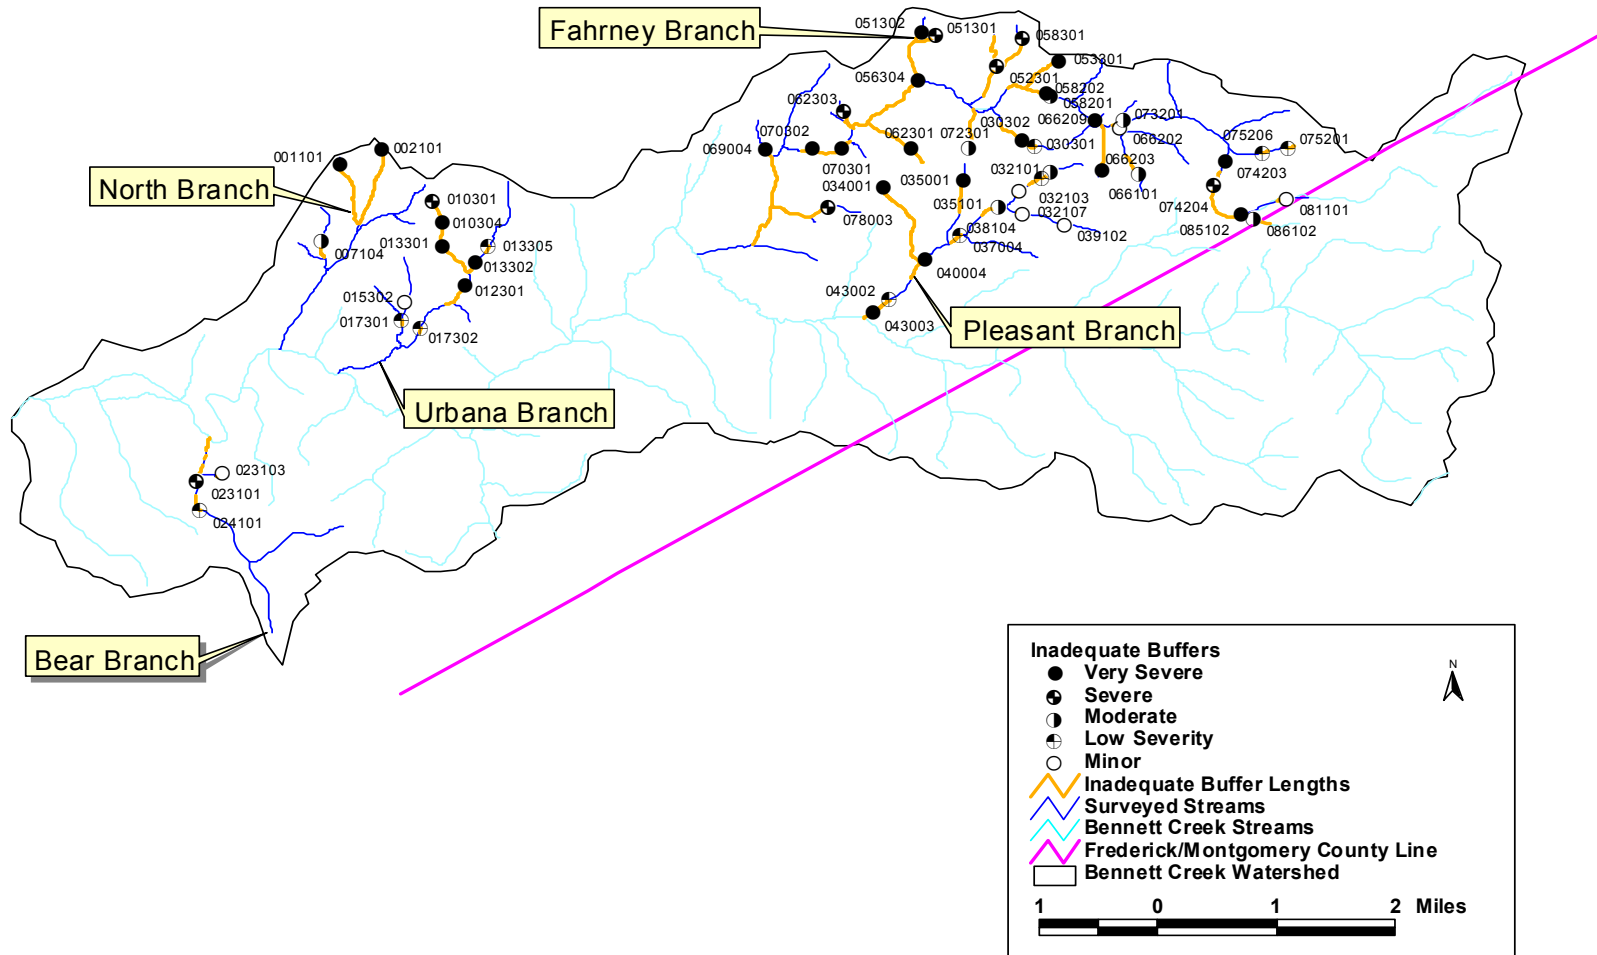
Figure 4b: Bennett Creek Inadequate Buffer Locations.

Fifty-six inadequate buffers were identified in the Bennett Creek sub-watershed. Of these, 23 were rated very severe. The locations of these sites can be seen in Figure 4b. Over 12 miles of inadequately buffered streams were found in the Bennett Creek surveyed areas. Forty-one sites were found to be inadequate on both the left and the right sides. Ten sites are inadequate on the left only, and 5 are inadequate on the right only. Twenty-nine sites were documented as being unshaded on both sides, while 9 are unshaded on the left, and 3 on the right. Fifteen sites have adequate shading on both sides. Land use was documented on both sides of the stream where inadequate buffer sites were found. Land use on both sides of surveyed streams included: lawn (31 sites), pasture (31 sites), crop field (15 sites), forest (9 sites), shrubs and small trees (7 sites), powerlines (6 sites), fallow (2 sites), paved (2 sites), a ballfield (1 site), a wetland (1 site), and a park (1 site). Two sites were found to have buffer restoration projects associated with them. Widths of the buffers found to be inadequate when there was any width at all ranged from 2ft. to 20ft. Lengths of inadequate buffers in the Bennett Creek sub-watershed ranged from 150 ft. to 5,300 ft. Recently established buffers were found at 7 sites. Livestock was found with access to the stream at 15 sites (10 cattle sites and 5 horse sites).

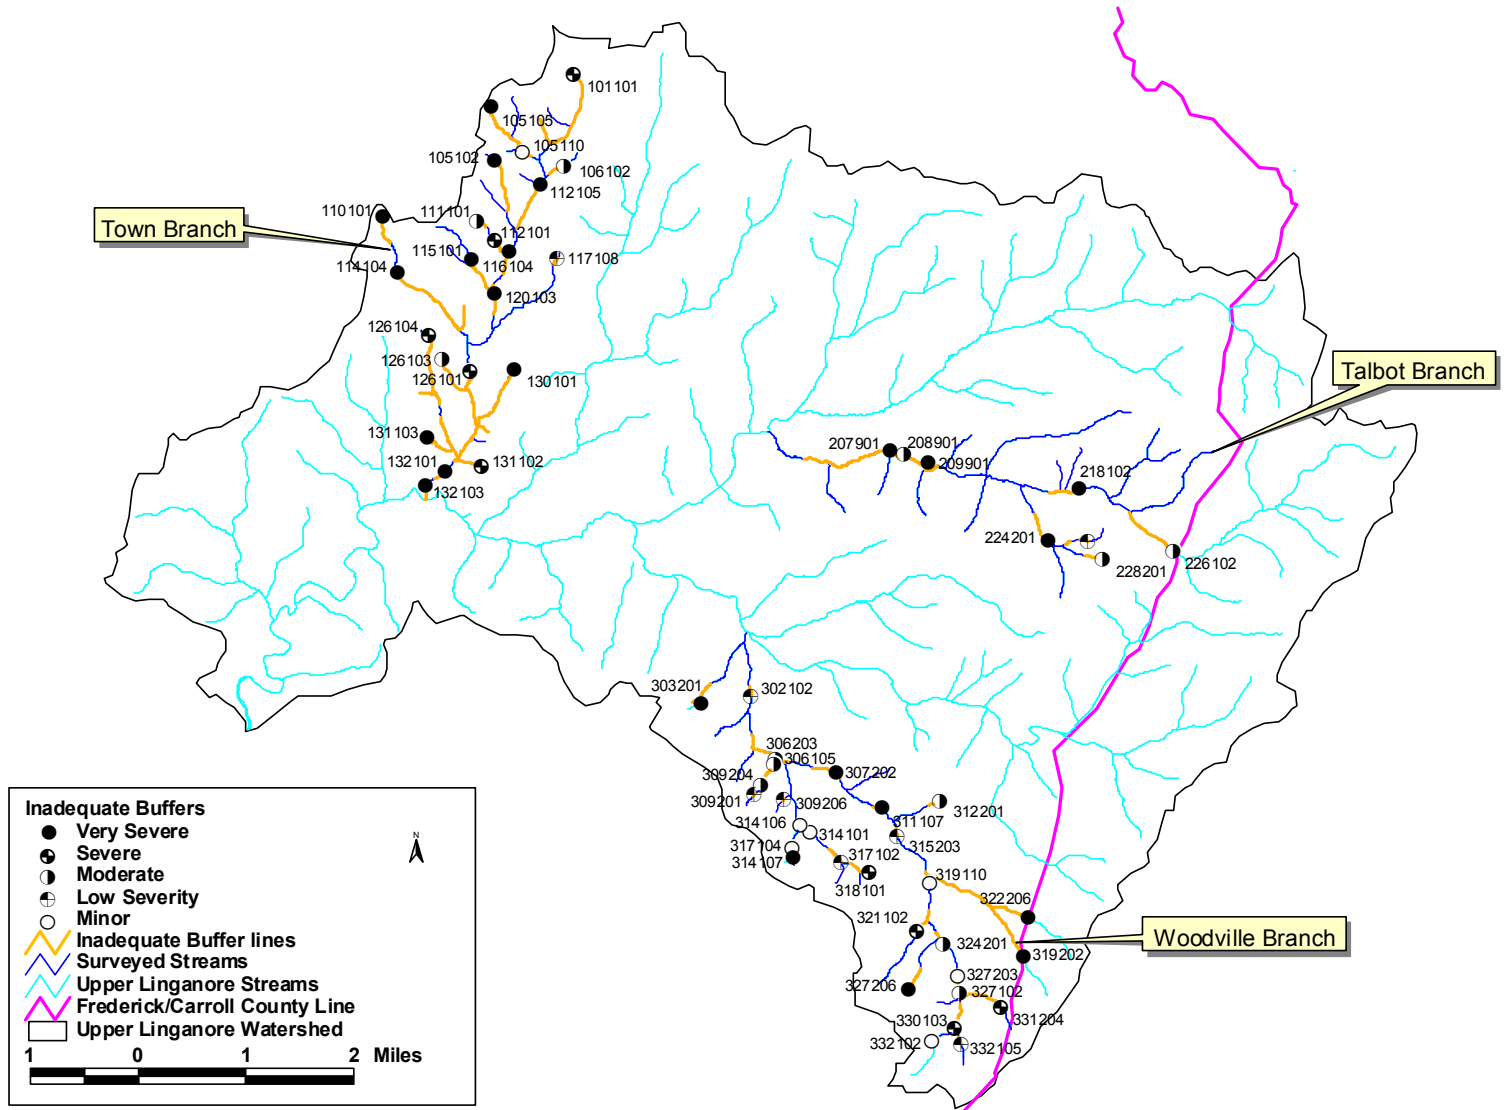
Figure 4c: Upper Linganore Inadequate Buffer Locations.

Fifty-nine inadequate buffer sites were documented in the Upper Linganore sub-watershed (Figure 4c). Twenty-three sites were rated very severe, and 9 sites were rated severe. Fifteen miles of inadequately buffered stream were identified in the Upper Linganore surveyed areas. Forty-two sites were found to be inadequate on both sides of the stream. Nine sites were documented as inadequate on the left side, and 8 sites were inadequate on the right. Thirty inadequate buffer sites were found to be unshaded on both sides, 3 sites unshaded on the left, and 3 sites unshaded on the right. Land use was documented on both sides of the stream and include: pasture (39 sites), lawn (22 sites), crop field (17 sites), forest (16 sites), shrubs and small trees (13 sites), paved (5 sites), powerlines (5 sites). Two sites were found to have buffer restoration sites alongside them. Widths of inadequate buffers ranged from no buffer to 25 ft. Lengths of inadequate buffers ranged from 50 ft. to 6,870 ft. Recently established buffers were found at 3 sites. Livestock with access to the stream were found at 15 sites (12 cattle sites and 3 horses).

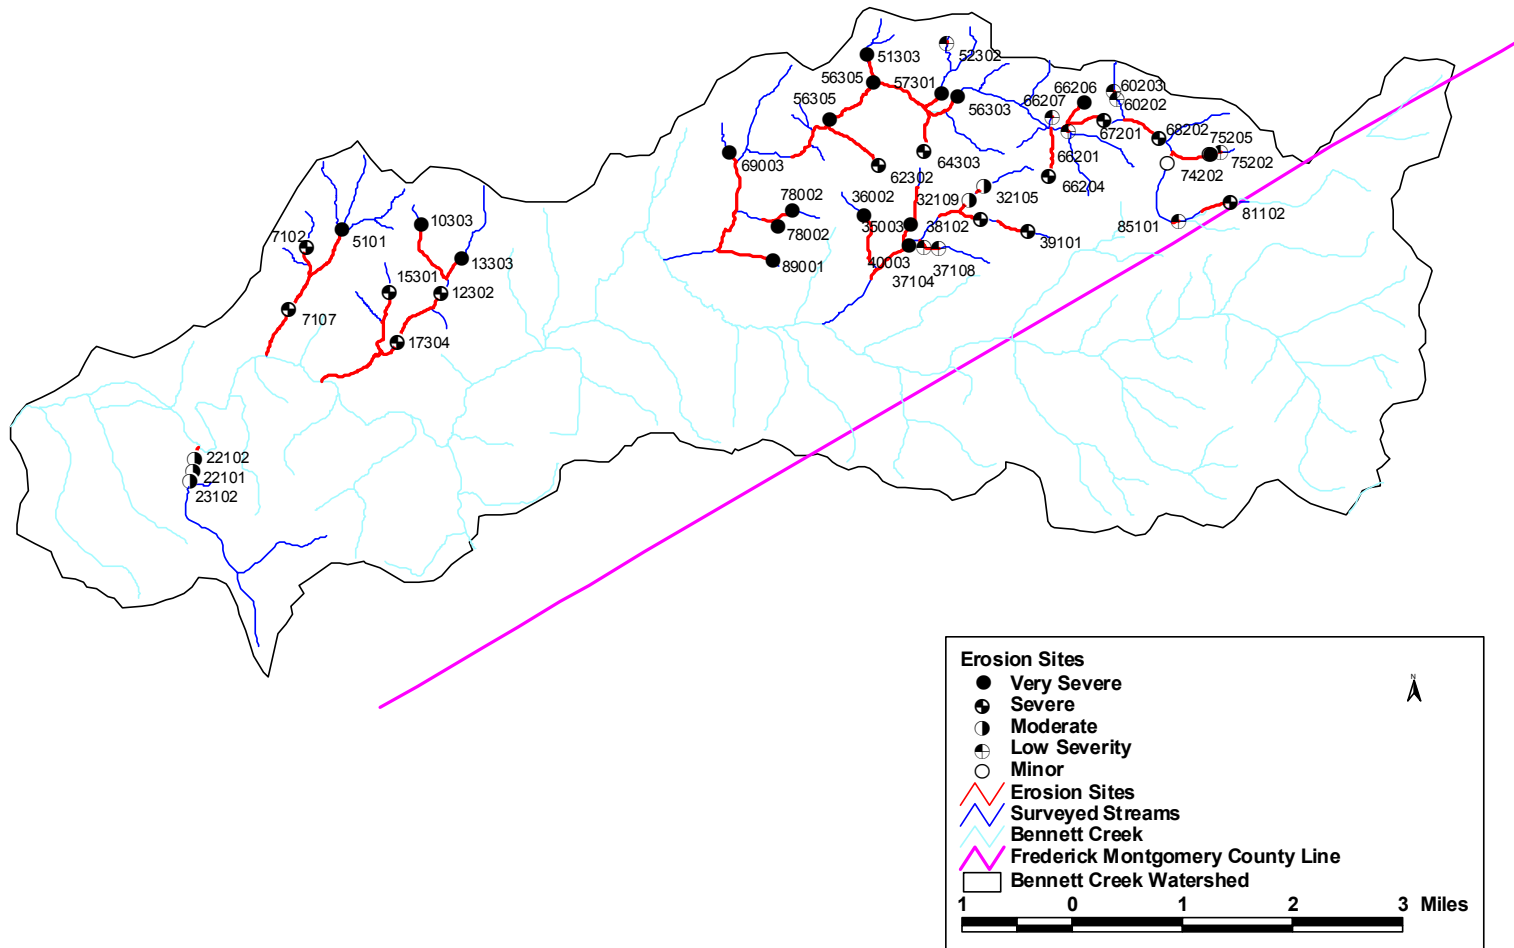
Figure 5b: Bennett Creek Erosion Site Locations.

Bennett Creek contains 44 erosion sites as identified by this survey. The Bennett Creek sub-watershed had 15.3 miles of erosion (about 39% of the surveyed streams) reported during the Lower Monocacy Stream Corridor Assessment Survey. Fifteen of these erosion sites were given very severe ratings, and 13 were given severe ratings. The majority of erosion sites found in the surveyed areas of the Bennett Creek sub-watershed [24 sites (about 55%)] were reported in the Fahrney Branch. Nine erosion sites were observed in Pleasant Branch, 5 in Urbana Branch, 3 in Bear Branch, and 3 in North Branch.

Causes of the erosion sites were documented as: bend at steep slope (14 sites), land use change upstream (11 sites), unknown cause (10 sites), below a road crossing (4 sites), inadequate buffer upstream (2 sites), stormwater runoff upstream (1 site), and highly erodable material (1 site). Causes are documented as the way they appeared to the survey crews at the time of the survey. A more in-depth analysis is needed to determine what the actual causes for erosion are. Lengths of sites observed ranged from 30 ft. to 6,000 ft., and heights ranged from 2 ft. to 15 ft. Land use was documented on both the right and left sides of the stream and were recorded as: forest (41 sites), pasture (15 sites), shrubs and small trees (15 sites), lawn (9 sites), crop fields (6 sites), and pavement (2 sites).

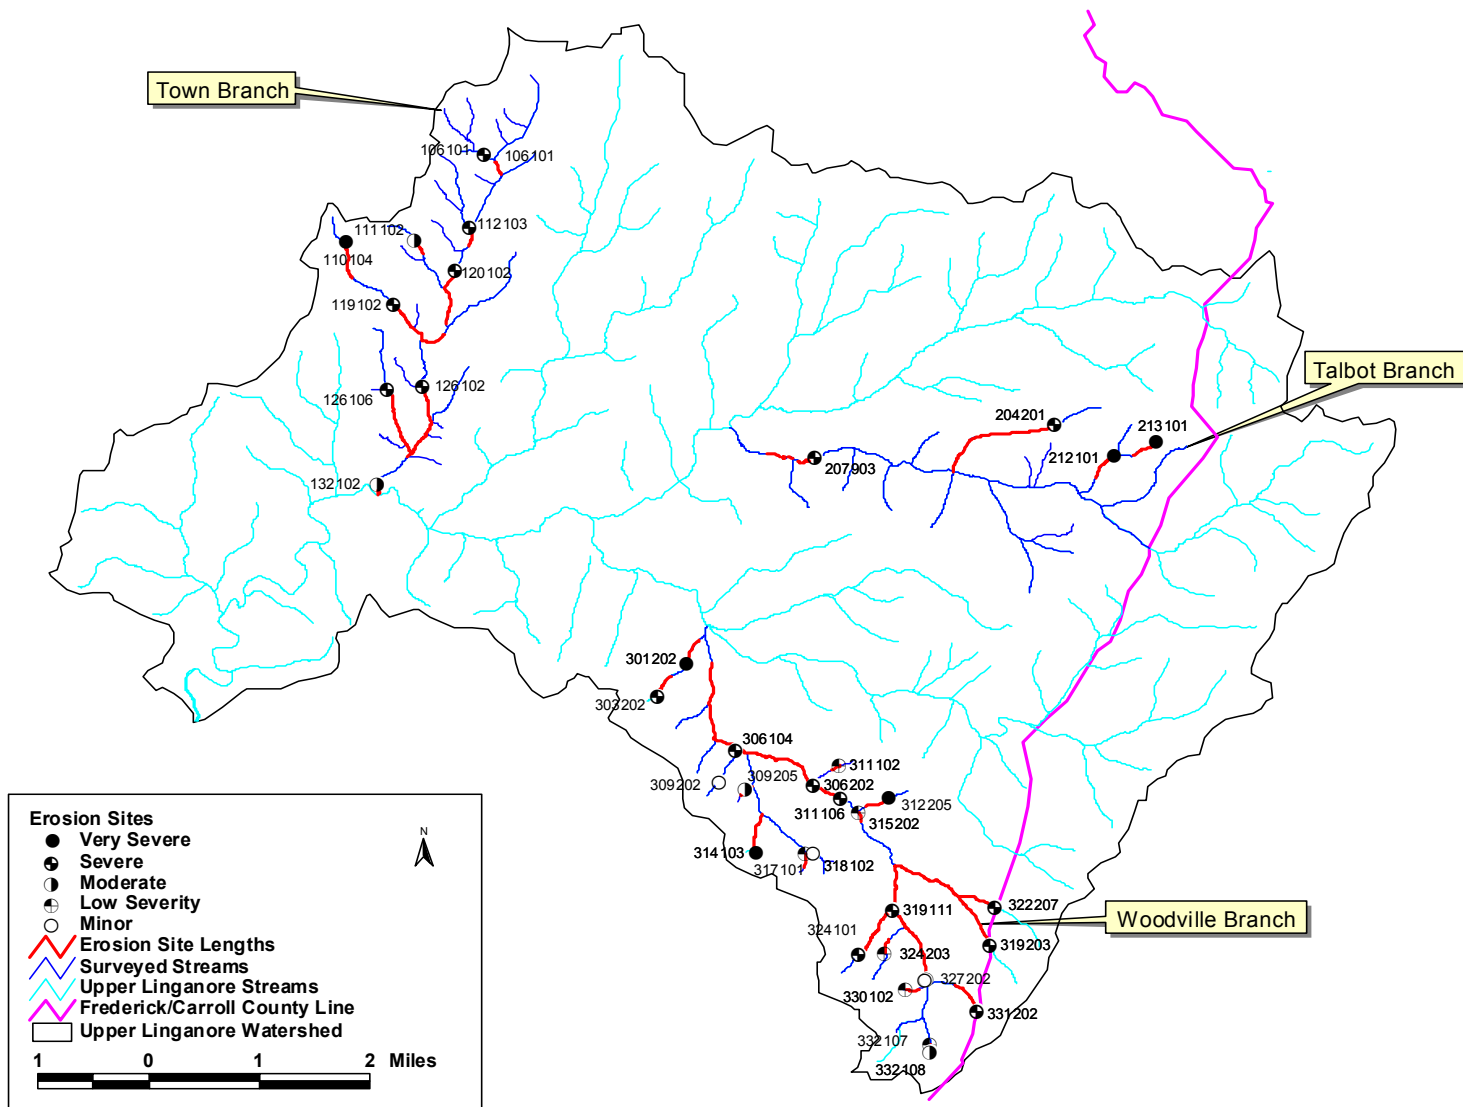
Figure 5c: Upper Linganore Erosion Site Locations.

Thirty-seven erosion sites were found in the Upper Linganore watershed totaling 13.5 miles, or about 30% of the Upper Linganore surveyed streams. Woodville Branch's erosion sites accounted for 68% (24 sites) of erosion sites recorded in the Upper Linganore sub-watershed. Nine erosion sites were observed in Town Branch, and 4 erosion sites were recorded in Talbot Branch.

Causes of the erosion sites in the Upper Linganore sub-watershed were documented as: bend at steep slope (14 sites), unknown (12 sites), land use change upstream (6 sites), livestock (3 sites), and below channelization (2 sites). A more in-depth analysis is needed to determine what the actual causes for erosion are. Lengths of the observed erosion sites were 25 ft. to 6,550 ft. Bank heights of most recorded erosion sites ranged from 2 ft. to 5 ft., however at site 332108, stream bank height was recorded at 30 ft. Land use was recorded on both the left and right sides of each erosion site. Land uses recorded were: forest (37 sites), pasture (22 sites), shrubs and small trees (8 sites), and lawn (7 sites).

Site 112103 was cited as a threat to a road and site 332108 was cited as a threat to a railroad. Six sites in the Upper Linganore watershed were recorded as very severe. Site 110104 is a 1,930 ft. long, 4 ft. high headcut on Town Branch below a channelized stream section with lawn on the left side and forest on the right. Site 212101 is a 1,400 ft. long, 5 ft. high site on Talbot Branch with forest on both sides. Site 213101 is a 1,000 ft. long, 5 ft. high site on Talbot Branch with forest on both sides. Site 301202 is a 1,400 ft. long, 4 ft. high site on Woodville Branch with forest on both sides. Site 312205 is a 1,260 ft.

long, 5 ft. high site on Woodville Branch with forest on both sides. Site 314103 is a 2,150 ft. long, 5 ft. high site on Woodville Branch with forest on both sides. There were also 18 severe sites identified in the Upper Linganore watershed.

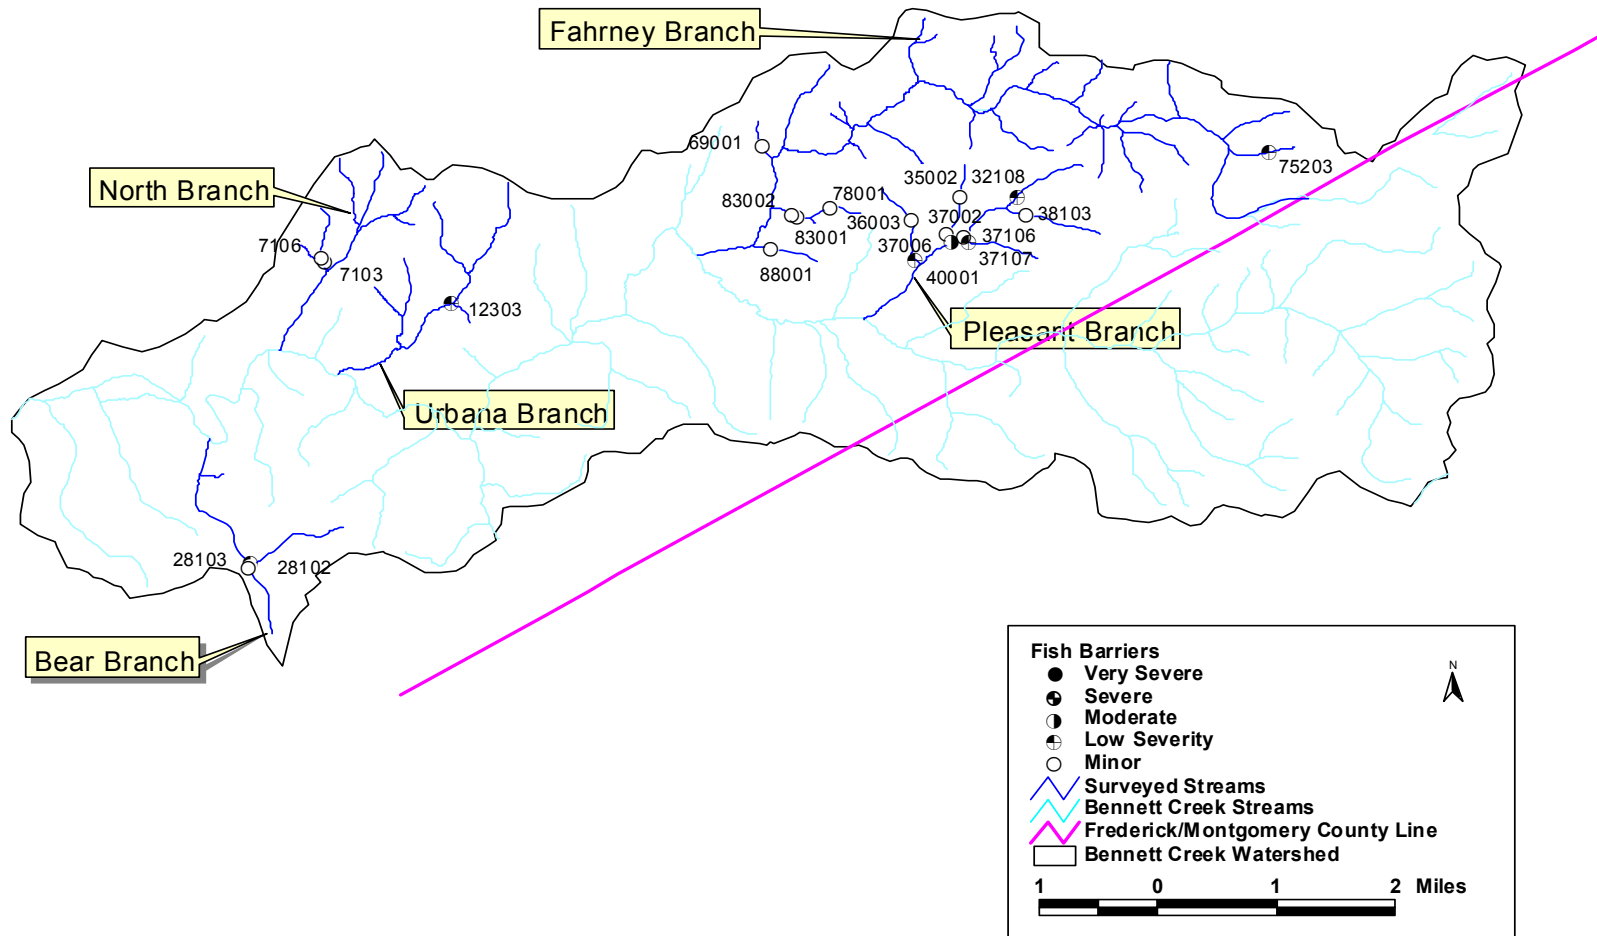
Figure 6b: Bennett Creek Fish Barrier Locations.

Twenty fish blockage sites were found in the Bennett Creek portion of the survey. Causes of fish blockages found in Bennett Creek include: road crossing (9 sites), natural falls (5 sites), instream pond (3 sites), erosion (1 site), headcutting at tree roots (1 site), and rocks across stream (1 site). Blockages were recorded as too high at all 20 sites, and height of blockages ranged from 5 in. to 50 in. Total blockages were recorded at 13 sites, partial blockages recorded at 4 sites, and temporary blockages recorded at 3 sites. No sites in the Bennett Creek sub-watershed were recorded as having very severe or severe ratings (figure 6a). One site was given a moderate rating.

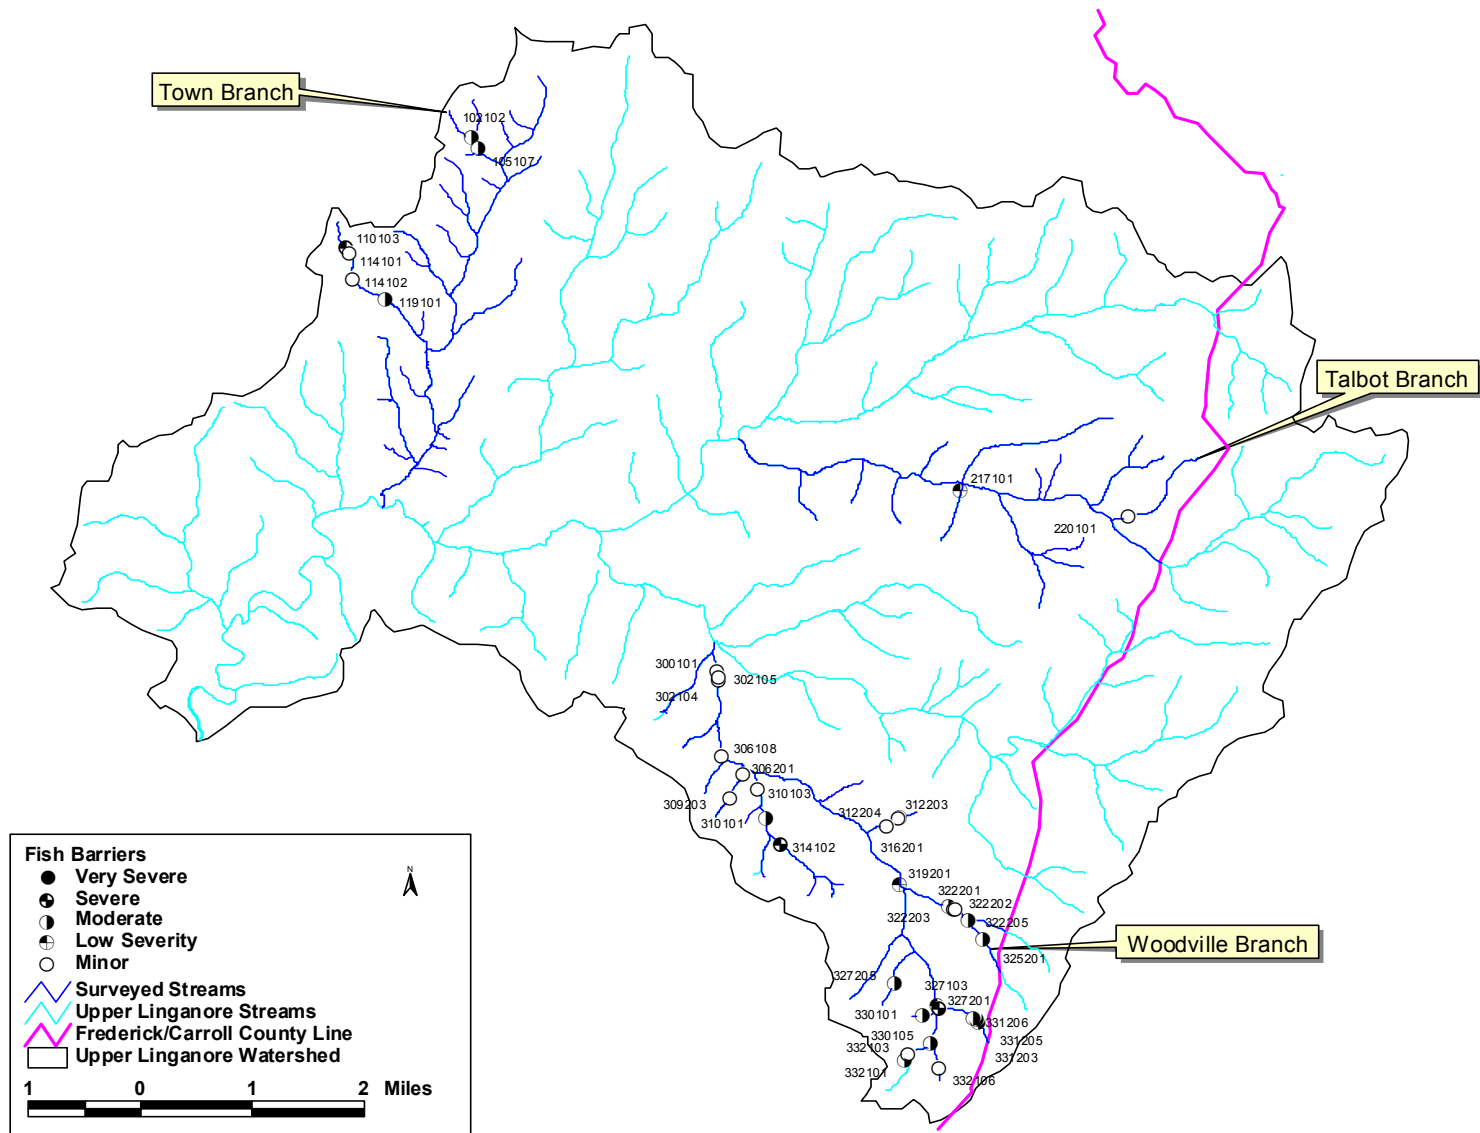
Figure 6c: Upper Linganore Fish Barrier Locations.

Thirty-seven sites were recorded in the Upper Linganore sub-watershed. Causes of these blockages include: natural falls (8 sites), debris dam (7 sites), road crossing (7 sites), channelization (4 sites), dam (4 sites), beaver dam (3 sites), instream pond (2 sites), earth mound (1 site), and fencing (1 site). Blockages were recorded as too high at 36 sites and too shallow at 1 site. Heights of the blockages were recorded as ranging from 7 in. to 60 in. The too shallow site had a depth of less than 1 in. Total blockages were found at 16 sites, temporary at 15 sites, and partial at 6 sites.

Three sites were given a severe rating during the survey. None of the fish blockage sites observed were given a very severe rating. Sites were rated as severe due to their height and location in the watershed. Site 110103 is a 36in. high total blockage on Town Branch caused by channelization. Site 314102 is a 12in. high total blockage on Woodville Branch caused by a dam. Site 327201 is a 30in. high total blockage on Woodville Branch caused by a debris dam. Debris dams are not typically given a severe rating, but due to the position of the total blockage on the Woodville Branch, the committee decided that a severe rating for site 327201 was warranted. The blockage floods an area approximately 1 mile long, and is located near the confluence of Woodville Branch and the mainstem Upper Linganore. This site essentially blocks the migration of fish into the whole Woodville Branch.

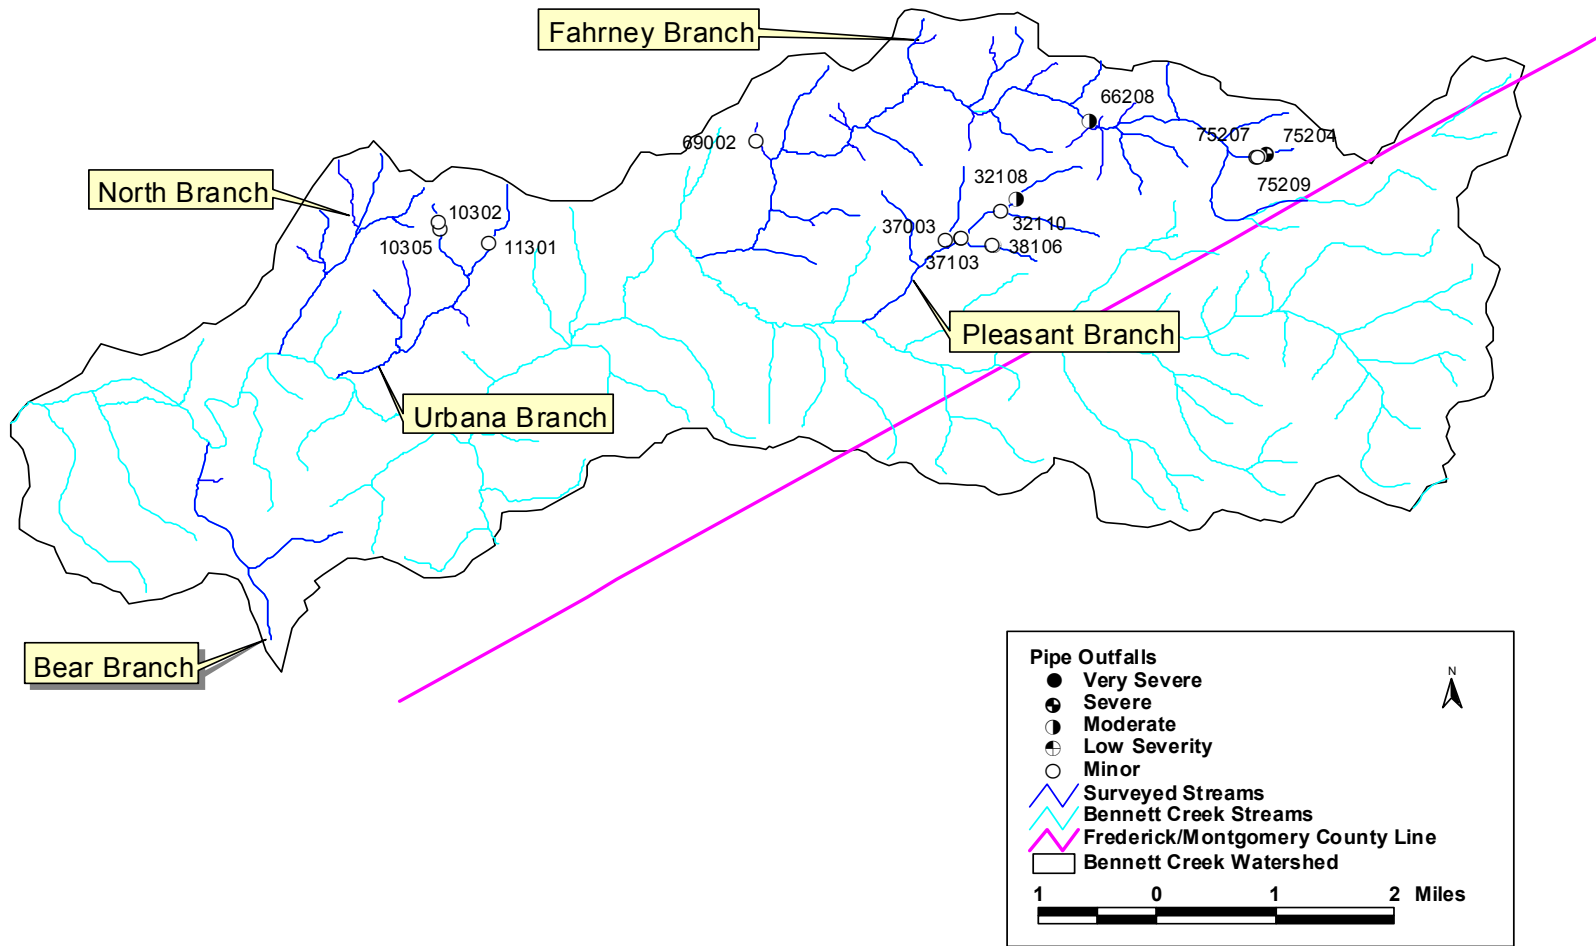
Figure 7b: Bennett Creek Pipe Outfall Locations.

The SCA survey identified 15 pipe outfalls in the Bennett Creek sub-watershed. Pipes were observed on the Fahrney Branch (5 sites), Pleasant Branch (7 sites), and on Urbana Branch (3 sites). Locations of the pipe outfalls observed during the Lower Monocacy survey can be seen in Figures 7b and 7c. One pipe was given a severe rating. No pipes in this sub-watershed were given a very severe rating (Figure 7a). Causes for the pipe outfalls were given as: stormwater (9 sites), pond overflow (4 sites), agriculture (1 site), and road runoff (1 site). Types of pipes found included corrugated metal (5 sites), rip-rap (5 sites), plastic (3 sites), concrete channel (1 site), and concrete pipe (1 site). Diameters of pipes found ranged from 2 in. to 30 in. Channels created by pipe outfalls ranged in width from 1 ft. to 60 ft. Locations of pipes observed were on the right bank (7 sites), on the left bank (4 sites), off the stream (3 sites), and the head of stream (1 site). Six sites were found to have a clear discharge, and one site had an orange discharge.

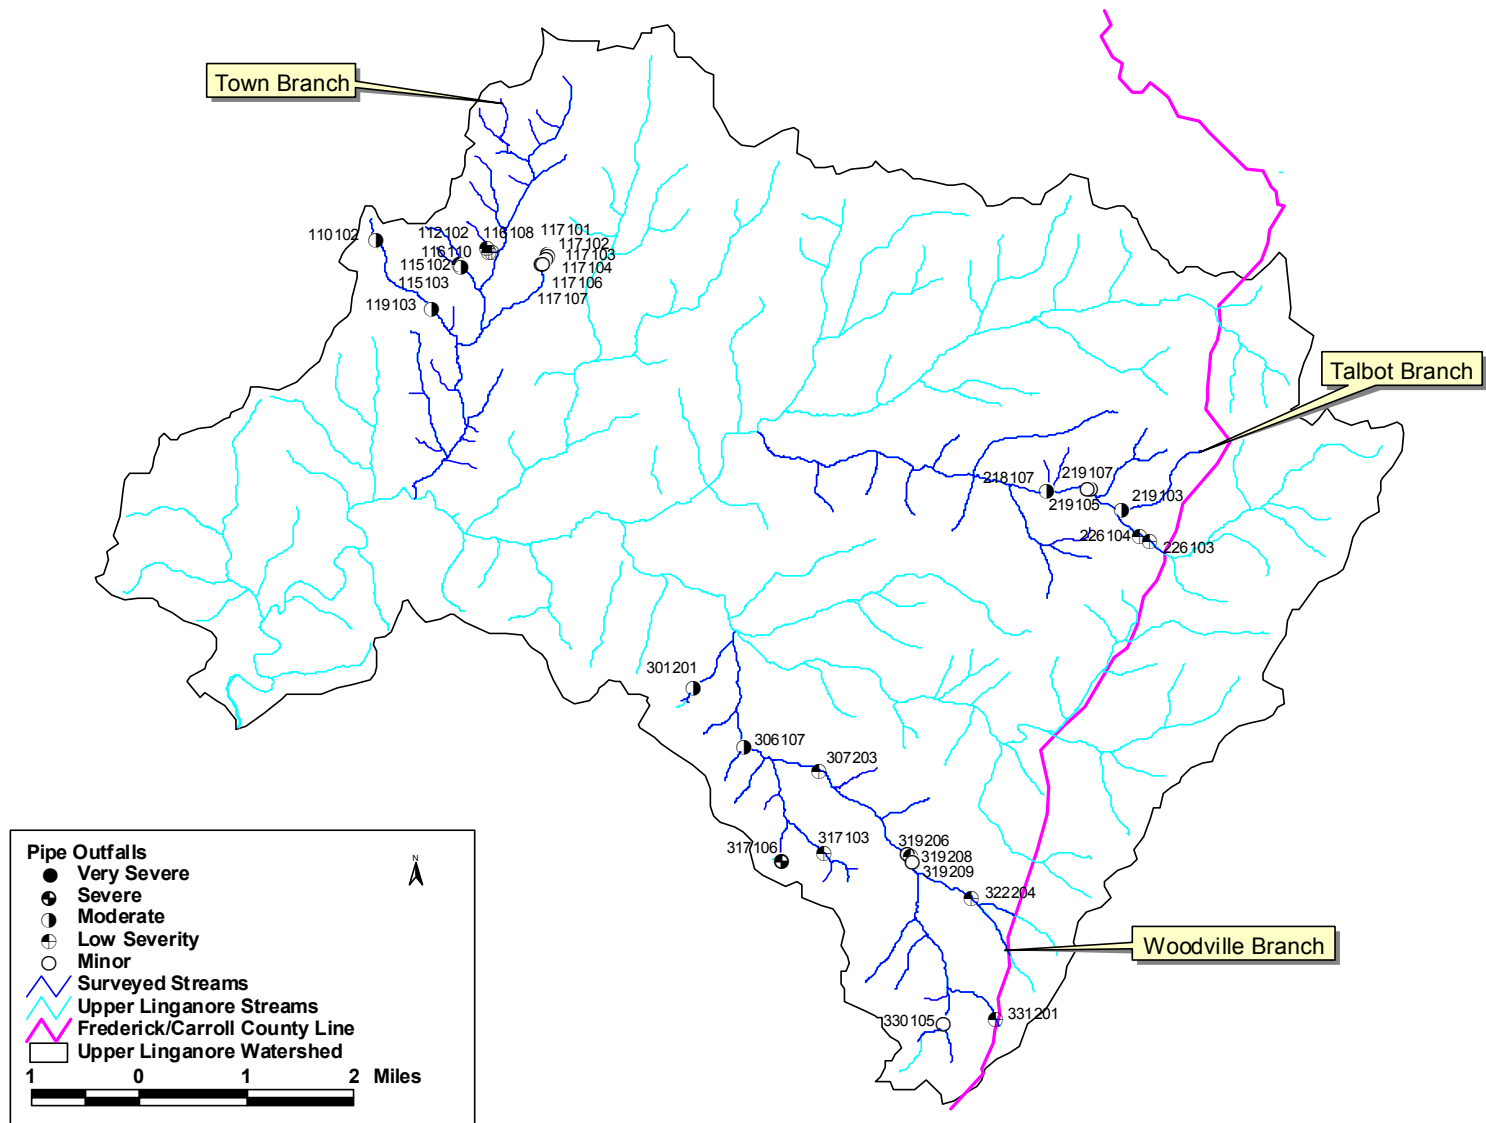
Figure 7b: Upper Linganore Pipe Outfall Locations.

Thirty pipe outfalls were observed in the Upper Linganore sub-watershed. These pipes were located on Town Branch (13 sites), Woodville Branch (11 sites), and the Talbot Branch (6 sites). One pipe was given a severe rating (figure 7a). None of the sites observed were given very severe ratings. Causes for the pipe outfalls observed in the Upper Linganore surveyed areas included: stormwater (12 sites), unknown (7 sites), agriculture (2 sites), sewage overflow (2 sites), overflow treatment (1 site), pond overflow (1 site), road runoff (1 site), and underground stream (1 site). Types of pipe found include: plastic (11 sites), corrugated metal pipe (10 sites), smooth metal pipe (4 sites), concrete channel (3 sites), and concrete pipe (2 sites). The pipe outfalls identified in the Upper Linganore were located on left banks (14 sites), right banks (11 sites), and at the head of streams (5 sites). Diameters of pipes found ranged from 2 in. to 24 in. Channels created by the pipe outfalls were found to be 2 ft. to 15 ft. wide. Sixteen pipes were found to have a clear discharge. Pipe 317106 had a medium brown discharge with a musky odor associated with it

One pipe was observed as a severe pipe in the Upper Linganore sub-watershed. Site 317106 is a 12 in. corrugated metal pipe with a 2 ft. wide concrete channel, found at the head of the Woodville Branch. This pipe was observed discharging orange road runoff with a musky smell. Locations of the Upper Linganore pipe outfalls are located in Figure 7c.

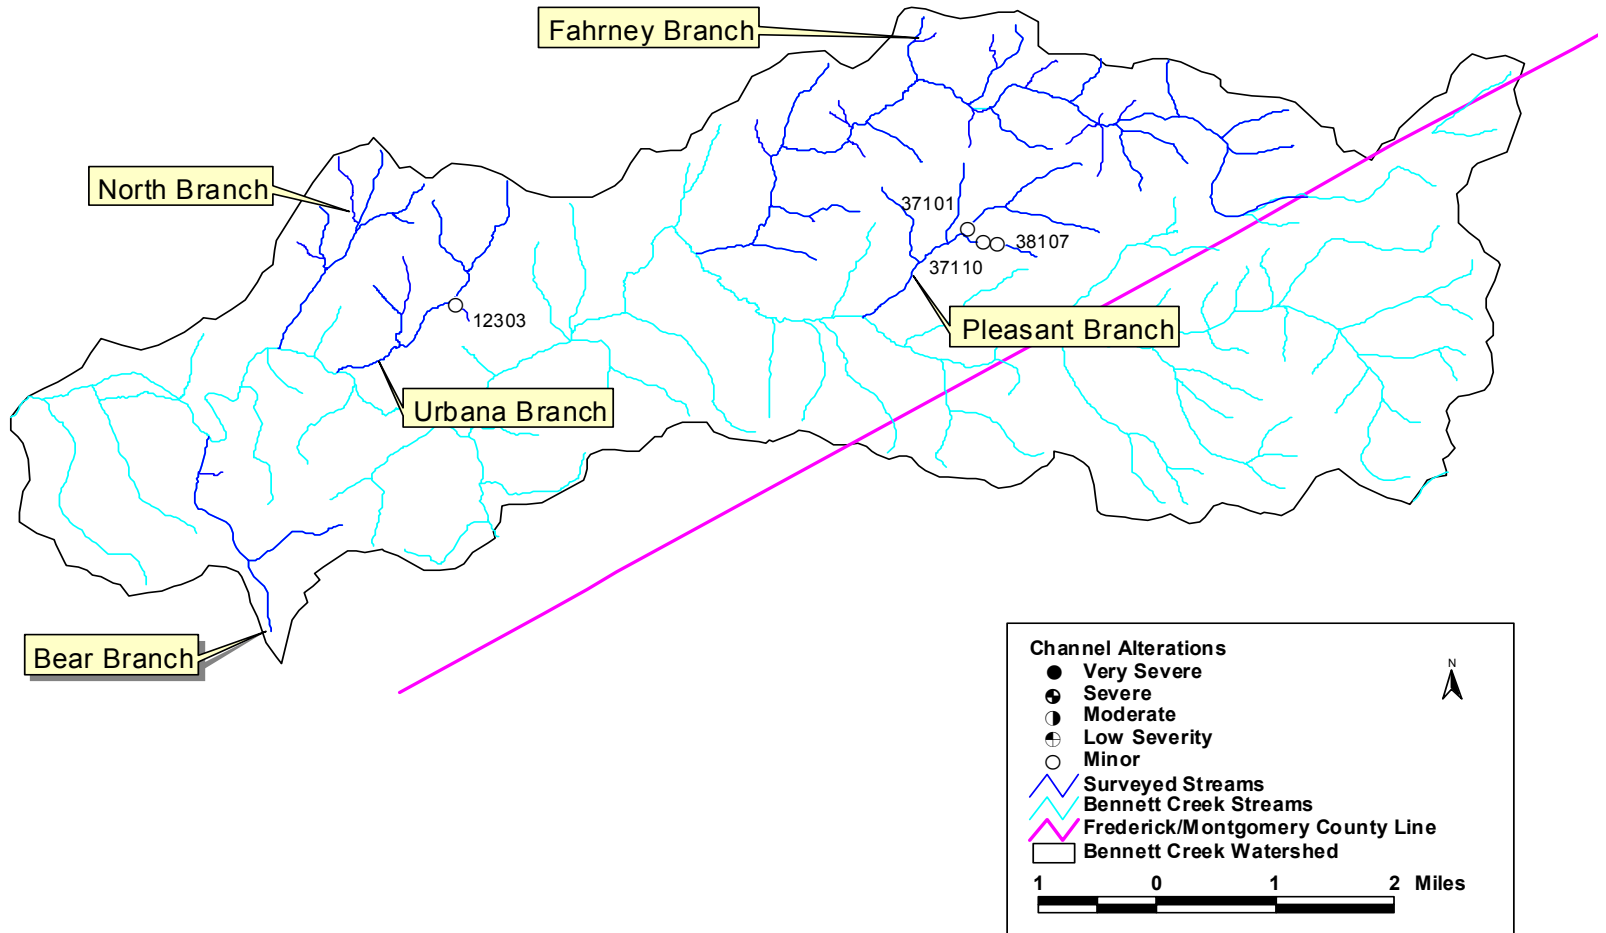
Figure 8b: Bennett Creek Channel Alteration Locations.

Four minor channel alteration sites were reported in the Bennett Creek sub-watershed. Three sites are located on Pleasant Branch, and one site was observed on the Urbana Branch. All four sites observed in Bennett Creek were made of rip-rap. Lengths of the four sites ranged from 50 ft. to 200 ft., and totaled 425 ft. Widths of the sites ranged from 24 in. to 36 in. All four sites had perennial flow. Deposition of sediment and vegetation growing in the channel were both reported at two sites. Two sites were reported below a road crossing.

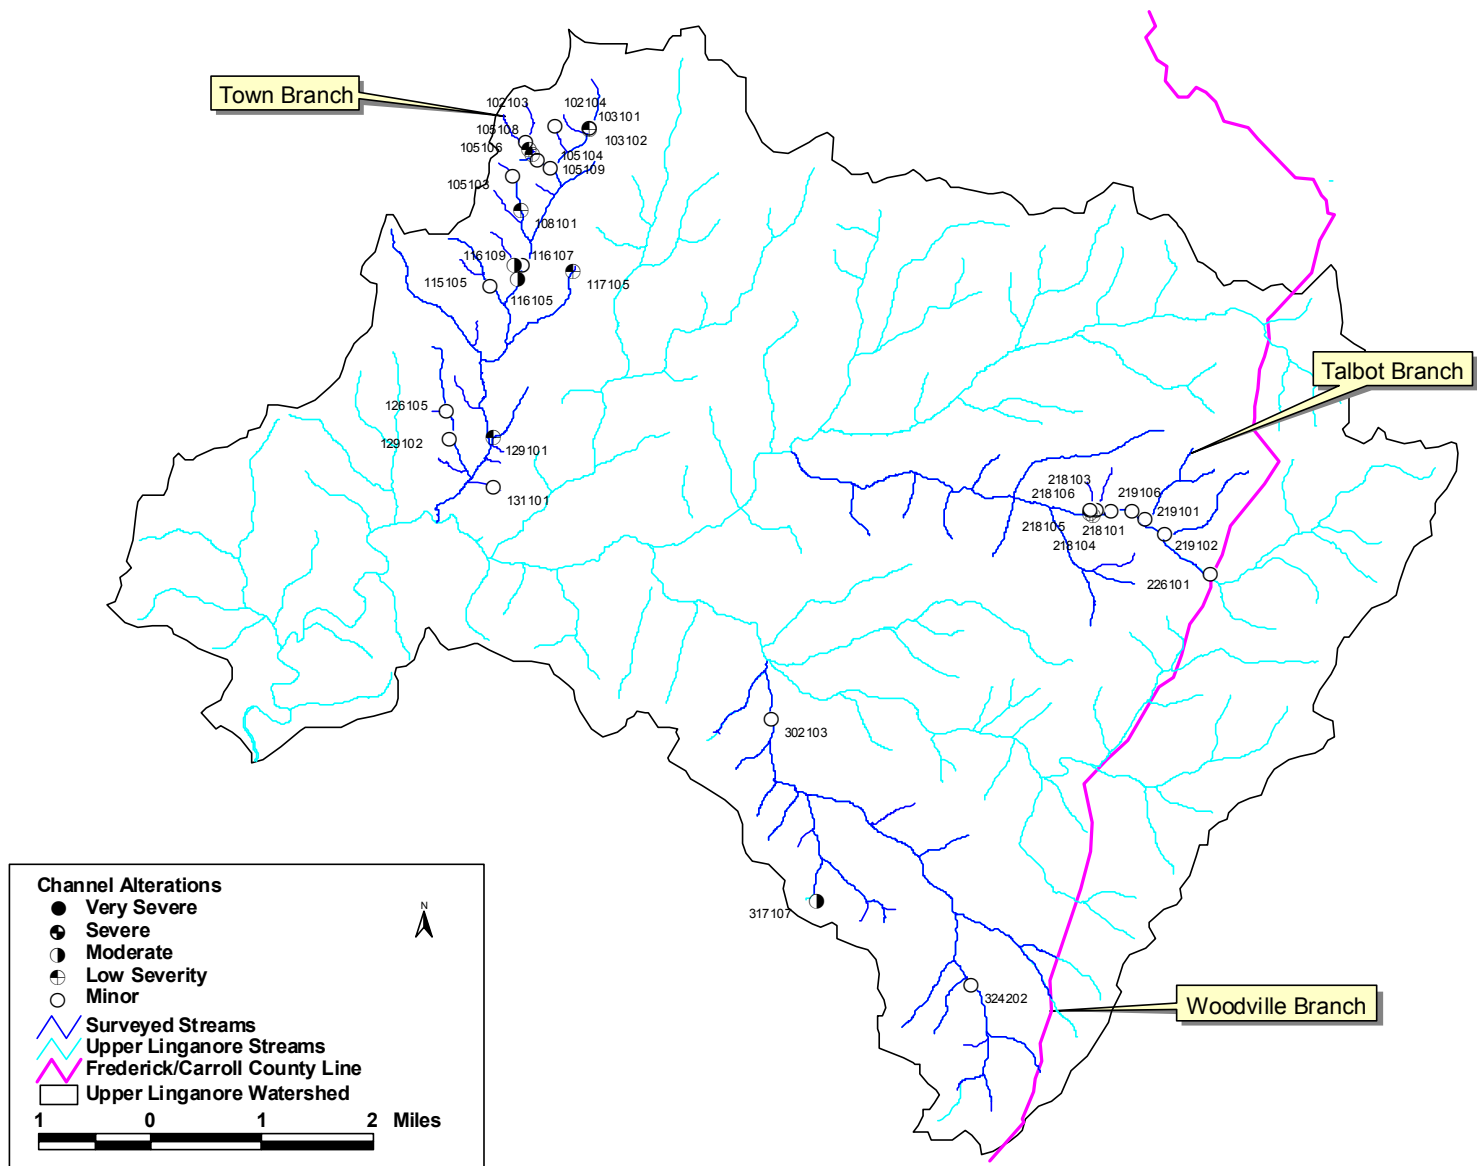
Figure 8c: Upper Linganore Channel Alteration Locations.

Thirty-one channel alteration sites were observed in the Upper Linganore surveyed areas. These sites are located in Town Branch (19 sites), and Talbot Branch (12 sites). The majority of these sites (20 sites or 57%) were rated minor. A total of 1,167ft of channel alterations were found in the Upper Linganore surveyed areas. Types of channel alterations observed in the Upper Linganore surveyed areas included: concrete (11 sites), corrugated metal (11 sites), rip-rap (4 sites), earth channel (2 sites), gabion baskets (1 site), and steel pipe (1 site). Channel width of streams at channel alteration sites ranged from 4in. to 96in. Lengths of these sites ranged from 8ft. to 300ft. Perennial flow was found in all but two of the sites. Deposition in the channel was found in 54% (17 out of 31 sites) of the channel alteration sites. At 39% of the sites (12 out of 31 sites), vegetation was observed in the stream channel. Eight sites were part of a road crossing: 5 below a road and 3 above and below.

There were no very severe or severe sites found in the Lower Monocacy (Figure 8a). Three moderate sites were observed during the Upper Linganore survey. Site 116105 is a 200ft. long concrete channel alteration site with perennial flow, deposition and vegetation in the 4 ft. wide channel on Town Branch. Site 116109 is a 300ft. long concrete armored site with perennial flow on Town Branch, with a 24in. channel. Site 317107 is a 100ft. long, 24in. wide concrete channel alteration site with sedimentation in the channel. The locations of channel alteration sites found in the Upper Linganore sub-watershed can be found in figure 8c.

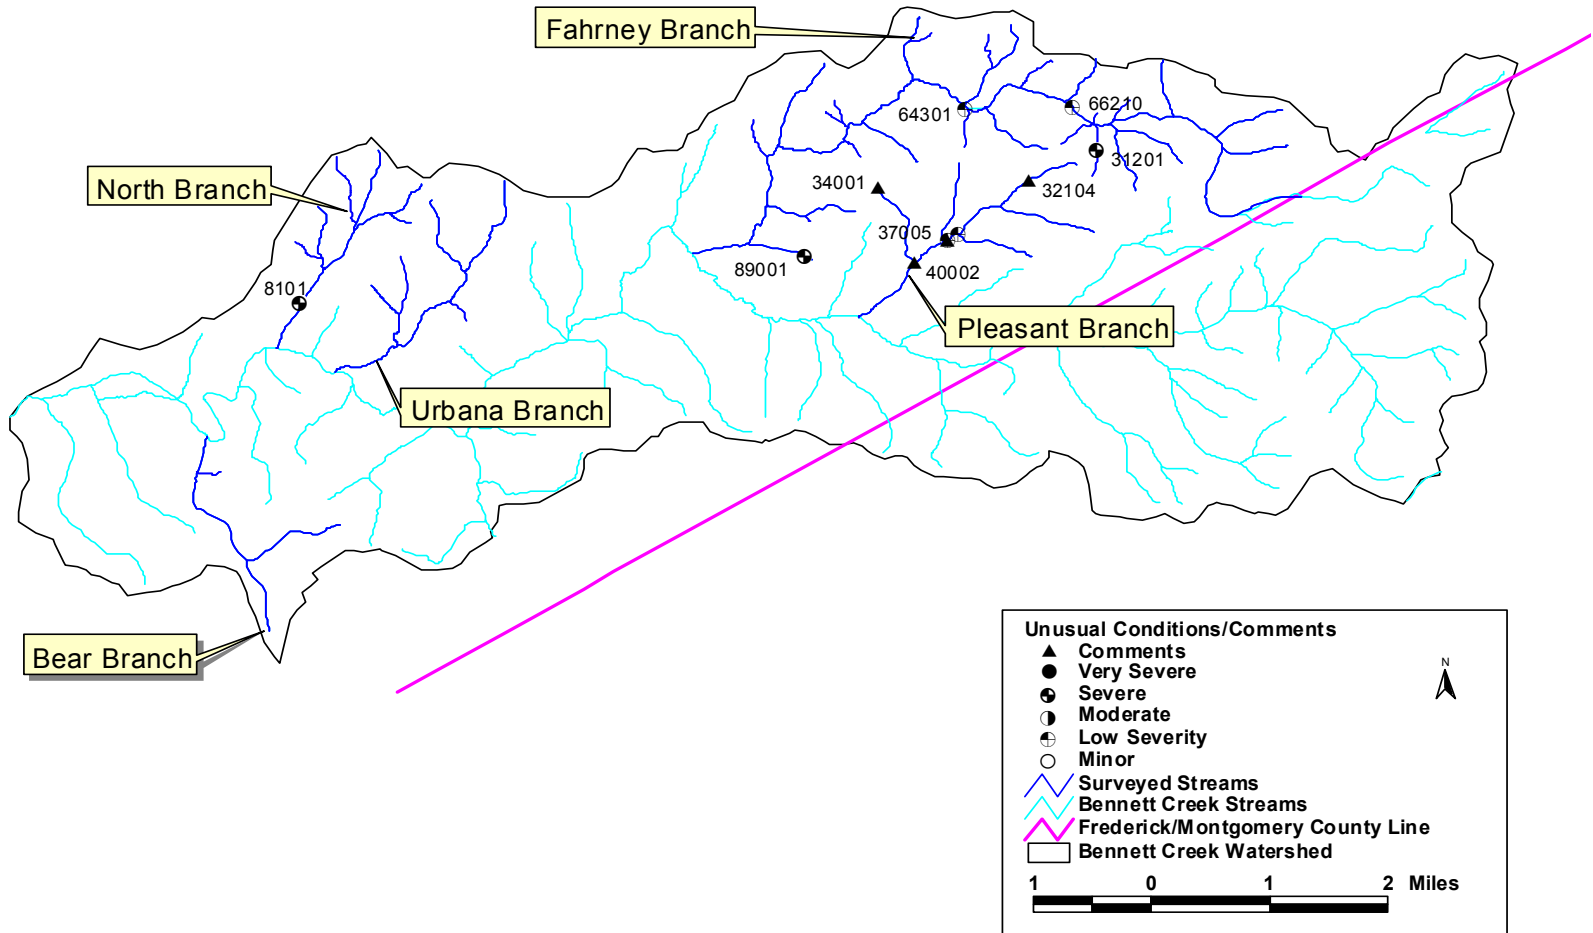
Figure 10b: Bennett Creek Unusual Conditions/Comment Locations.

Eight unusual conditions were recorded in the Bennett Creek sub-watershed. Unusual condition sites in the Bennett Creek surveyed areas include red flock and livestock access to the stream. The red flock sites were all given low severity ratings, and the livestock accessing the stream sites were all given severe ratings. At site 008101, cows have access to the stream on the North Branch. Site 031201 has cows accessing the Pleasant Branch. Site 037005 is a red flock site on Pleasant Branch. Site 037105 is a red flock site that is caused by stormwater overflow upstream on Pleasant Branch. At site 040002, horses have access to Pleasant Branch. Sites 064301 and 066201 are red flock sites on the Fahrney Branch. Site 089001 has cows accessing the Fahrney Branch.
