LOWER MONOCACY RIVER STREAM CORRIDOR ASSESSMENT

Stephen Czwartacki & Ken Yetman
Watershed Assessment and Targeting Division
Watershed Services Unit
Maryland Department of Natural Resources

November 2004

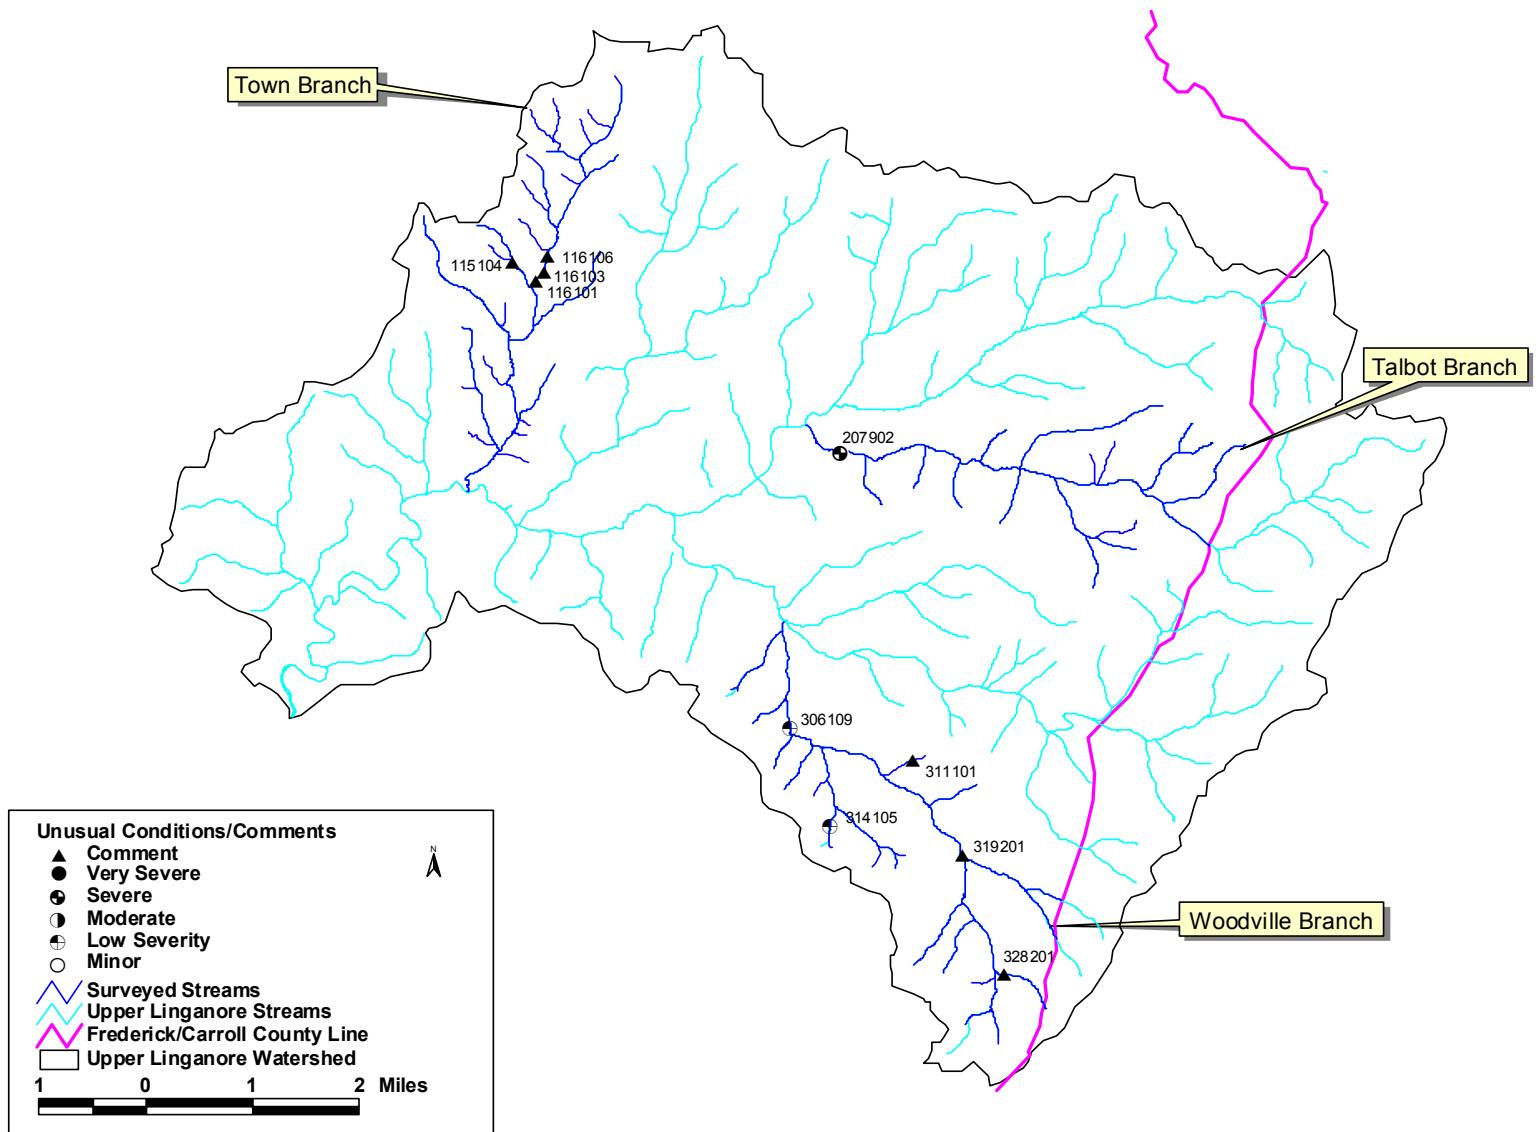
Figure 10c: Upper Linganore Unusual Conditions/Comment Locations.

Three unusual condition sheets were recorded in the Upper Linganore sub-watershed. Two sites are red flock sites that were given low severity ratings, and one site is a livestock access to the stream site that was given a severe rating. At site 207902, cows were seen accessing Talbot Branch. Sites 306109 and 314105 are red flock sites on Woodville Branch.

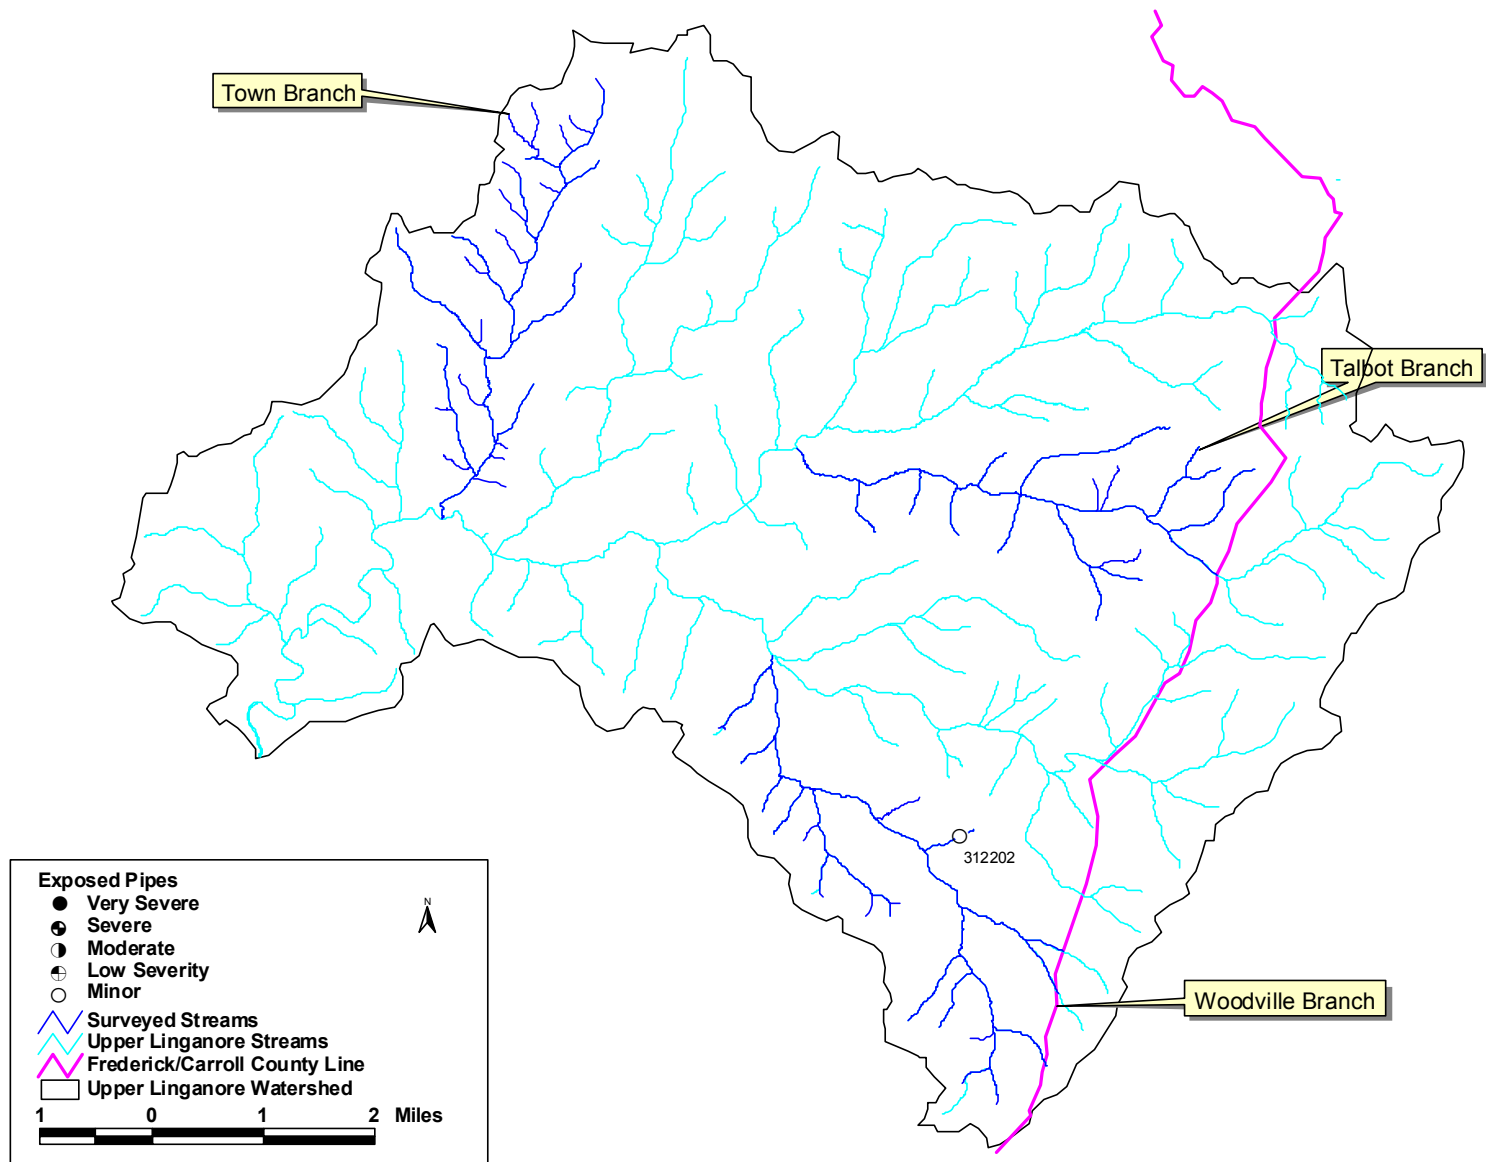
Figure 11b: Upper Linganore Exposed Pipe Locations.

Exposed pipes were reported at 1 site during the Lower Monocacy survey. The location of this site is shown in Figure 11b. Site 312202 is an 8 in. diameter smooth metal pipe exposed for 4 ft. across the bottom of Woodville Branch. The purpose of the pipe is unknown and there is no discharge.
