UPPER PATUXENT RIVER WATERSHED RESTORATION ACTION STRATEGY (WRAS) FORM 1 -- Catchment Information

UPPER PATUXENT RIVER WATERSHED RESTORATION ACTION STRATEGY (WRAS) FORM 2 -- Site Information

Site Name:	Address: 2130 Priest Bridge Drive
Site Owner:	
State Plane Coordinates of Site Centroid:	X: <u>1398409</u> Y: <u>481682</u> Date: <u>5/28/03</u>
Personnel: PM	Weather: <u>cloudy</u> , 70F deg
Area (ac): <u>6</u>	Impervious Area (ac): <u>0.8</u>
Percent Impervious: 14%	Soil Recharge Factor (S): 0.38
WQ _v (required): 0.09	Re_v (required): 0.03
Property Area (ac): 6.4	Property Area Included in Site: 93%
Amount of Catchment Occupied by Site:	100%
Storm Drainage System Within Site	
Piped: <u>100%</u> Open Channels:	0% Area Drained by System: 75%
Open Channel Lining - Vegetation: 0%	Riprap: 0% Concrete: 0% Other: 0%
Existing IMP(s) / RMP(s) (Indentified (on Page 1, FORM 1, Catchment Information)
	Condition: Excellent Good Average Fair Poor
	Condition: Excellent Good Average Fair Poor
SDI ID:	Condition: Excellent Good Average Fair Poor
Site Information	
Type of Pavement: Bituminous Conc	rete Gravel Grid Pavers Other

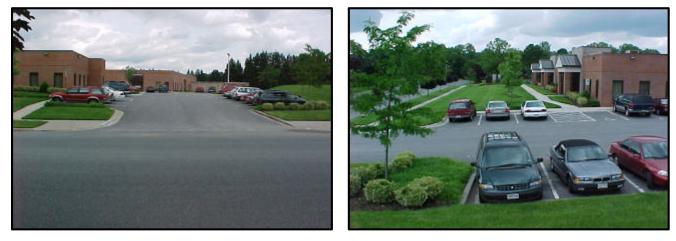
No.	205	Description: looking north to SWM riser
No.	206	Description: looking east across SWM pond
No.	207	Description: looking south along west side of property
No.	208	Description: looking east along north side of property
No.	209	Description: looking east along south side of property
No.	210	Description: looking north along west side of property
No.	211	Description: looking north along east side of property
No.	212	Description: looking south along east side of property
No.	213	Description: looking west along north side of property
No.	214	Description: looking west along south side of property

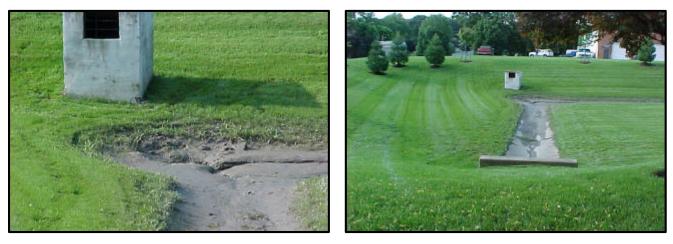
No.	225	Description:	riser and low-flow orifice
No.	226	Description:	looking north across pond
No.	227	Description:	looking east across pond
No.	228	Description:	looking south across pond
No.	229	Description:	looking west at embankment
No.		Description:	
No.		Description:	
No.		Description:

CommentsAdditional storage capacity can be obtained by grading to the north and to the east.Property and ownership must be confirmed. Pond could be sized to overcontrol because of absenceof SWM throughout the area. Sediment appears to be coming from the Patuxent Materials, Incfacility - possibly from washing vehicles. Riser low-flow inlet is partially blocked. Riser is cracked andconcrete is flaking. Facility will need to be sized to current requirements and to meet dam regulations.
