UPPER PATUXENT RIVER WATERSHED RESTORATION ACTION STRATEGY (WRAS) FORM 1 -- Catchment Information

UPPER PATUXENT RIVER WATERSHED RESTORATION ACTION STRATEGY (WRAS) FORM 2 -- Site Information

Site Name:		Address: 2101 Defense	Hwy & 211	1 Baldwin Ave
Site Owner:				
State Plane Coordinates of Site Centroid:	X:_	1398822 Y:	482579	Date: <u>5/29/03</u>
Personnel: PM		Weather: <u>cloudy, rain</u> ,	70F deg	
Area (ac): <u>1.4</u>	I	Impervious Area (ac):	1.3	}
Percent Impervious: 96%	;	Soil Recharge Factor (S):		0.38
WQ _v (required): 0.1		Re _v (required):	0.04	
Property Area (ac): 1.4		Property Area Included in	Site:	100%
Amount of Catchment Occupied by Site:	93%			
Storm Drainage System Within Site				
Piped: <u>100%</u> Open Channels:	0%	Area Drained by	System:	100%
Open Channel Lining - Vegetation:	Riprap:	Concrete:		Other:
Existing IMP(s) / BMP(s) (Indentified	-			
SDI ID:			- -	Fair Poor
SDI ID:			- -	Fair Poor
SDI ID:	Condition	Excellent Good /	Average	Fair Poor
Site Information				
Type of Pavement:	crete	Gravel Grid Pavers	Other	
Pavement Condition:	Good	✓ Average Fair	Poor	
Underdrains can be easily directed to exis	ting storm	drains or daylighted:	YES	✓ NO

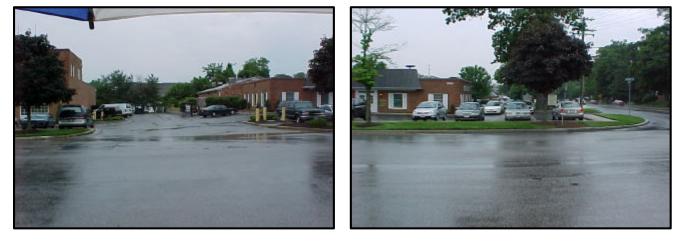
No.	287	Description: looking north along west side of property
No.	288	Description: looking east along south side of property
No.	289	Description: looking north along east side of property
No.	290	Description: looking west along south side of property
No.	291	Description: looking west between buildings
No.	292	Description: looking west along north side of property
No.	293	Description: looking south along east side of property
No.	294	Description: looking east along north side of property
No.	295	Description: looking south along west side of 2101
No.	296	Description: looking south along west side of 2111
