**UPPER PATUXENT RIVER WATERSHED RESTORATION ACTION STRATEGY (WRAS)
FORM 1 -- Catchment Information**

**UPPER PATUXENT RIVER WATERSHED RESTORATION ACTION STRATEGY (WRAS)
FORM 2 -- Site Information**

Site Name: US301/MD3 and Medford Road Address: Medford Road

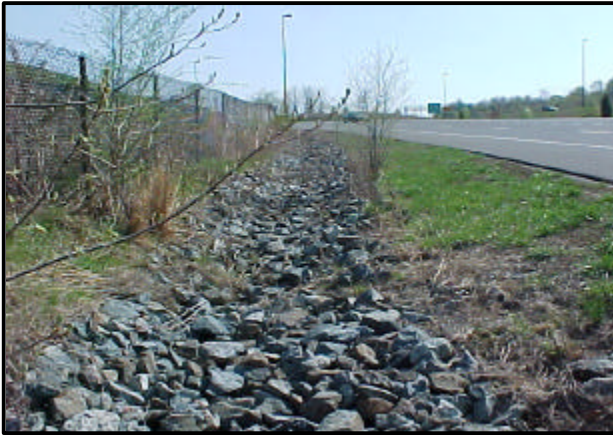
- No. 602 Description: looking south along ditch on east side of ramp
- No. _____ Description: _____
- No. _____ Description: _____
- No. _____ Description: _____
- No. _____ Description: _____
- No. _____ Description: _____
- No. _____ Description: _____
- No. _____ Description: _____
- No. _____ Description: _____
- No. _____ Description: _____
