## ANNEX 3 – Peristaltic Units

### Annex 3.1 - General Information

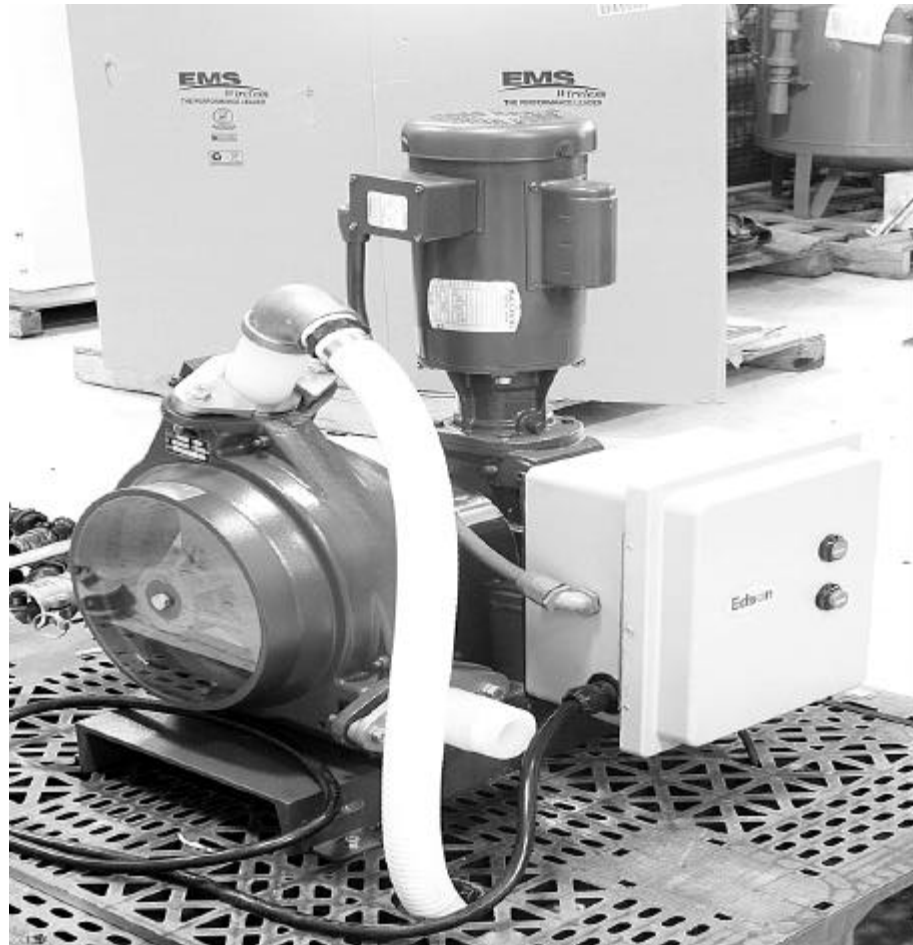
**Internal View**

The Edson International 286EP-40 Pump-Out unit operated for a total of 918.0 hours in the life-cycle testing set-up and suffered two failures during testing:

1. Tubular element failure – internal tube developed a leak;
2. Failure of the rubber coupling between the speed reducer and the peristaltic pump

<b>Repair Required</b>	<b>Run Time on Unit (hours)</b>	<b>Repair Parts Required</b>	<b>Cost of repair parts</b>	<b>Time required to receive parts (days)</b>	<b>Time required to make repair (hours)</b>	<b>Total Time Off-Line (days)</b>
Replace internal hose	579.4 <b>Note 1</b>	Internal hose	\$440.00	1	1	18 <b>Note 2</b>
Replace rubber coupling between speed-reducer and pump	918.0	Rubber coupling	\$48.00	<b>Note 3</b>	0.75	<b>Note 3</b>

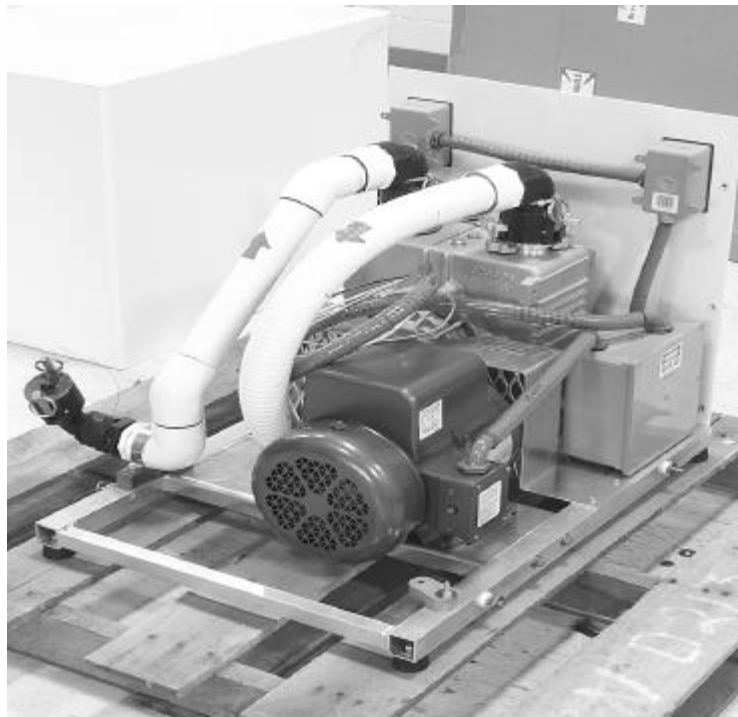
**Internal View**

The EMP Industries Sanisailor Sentinel – M300 Pump-Out unit operated for a total of 651.6 hours in the life-cycle testing set-up, and suffered two failures during testing (See *Summary of Repairs* below):

1. A failure of the time delay relay in the control circuit for the unit – This failure of the time delay relay also caused a failure of the following components: unit timer, secondary transformer, and relay contactor in the control circuit.
2. Tubular element failure – internal tube developed a leak

<b>Repair Required</b>	<b>Run Time on Unit (hours)</b>	<b>Repair Parts Required</b>	<b>Cost of repair parts</b>	<b>Time required to receive parts (days)</b>	<b>Time required to make repair (hours)</b>	<b>Total Time Off-Line (days)</b>
Time delay relay failed - causing failure of secondary components	108.1 <b>Note 1</b>	Time delay relay, transformer, timer, relay contactor	\$234.85	1	2 <b>Note 2</b>	85 <b>Note 3</b>
Replace internal tube	651.6 <b>Note 4</b>	Internal tube replacement kit	\$496.00	<b>Note 5</b>	2.0	<b>Note 5</b>

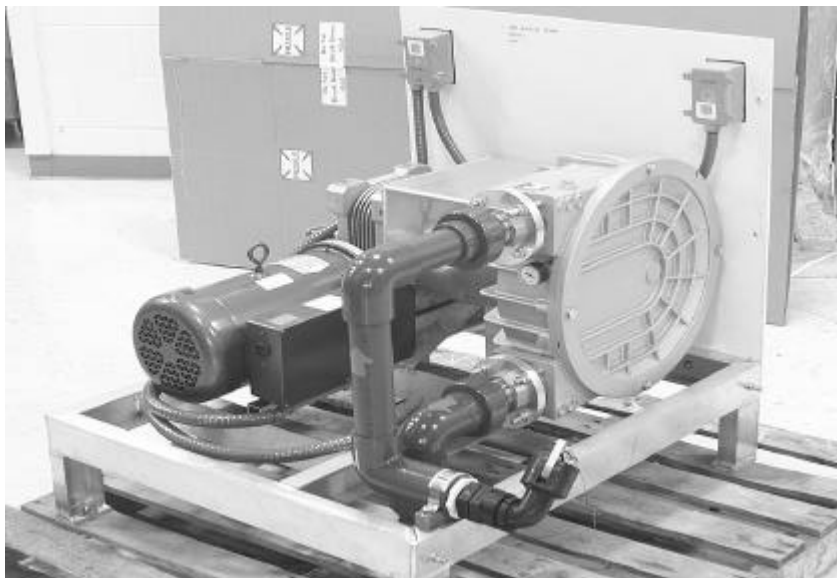
**Internal View**

The EMP Industries Sanisailor Sentinel – EV405 Pump-Out unit operated for a total of 706.9 hours in the life-cycle testing set-up and suffered one failure during testing. The discharge union on the pump developed a crack requiring that the union be replaced (See *Summary of Repairs* on page 58).

<b>Repair Required</b>	<b>Run Time on Unit (hours)</b>	<b>Repair Parts Required</b>	<b>Cost of repair parts</b>	<b>Time required to receive parts (days)</b>	<b>Time required to make repair (hours)</b>	<b>Total Time Off-Line (days)</b>
Replace discharge union due to crack	440.7 <b>Note 1</b>	2-inch PVC union	\$21.76	1	1	3

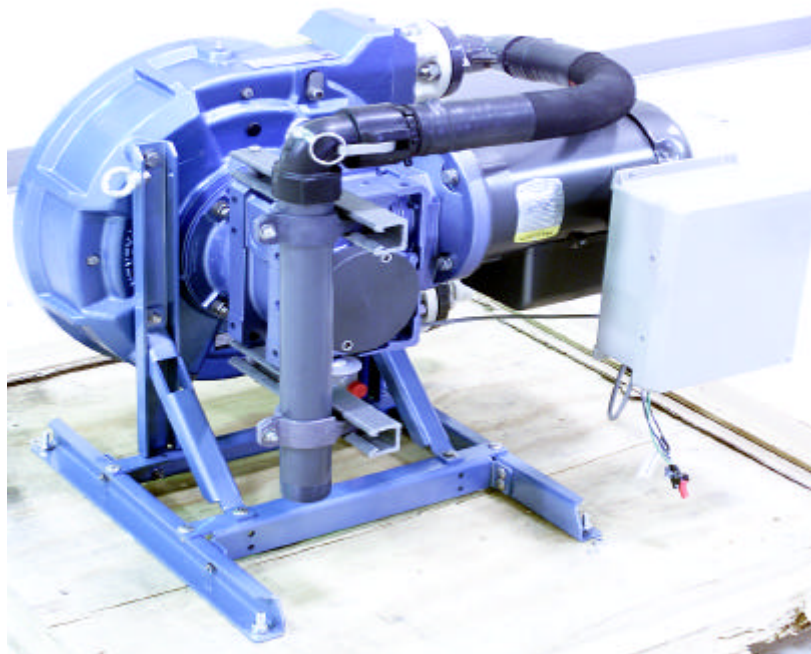
**Internal View**

The Keco PER900.1PH Pump-Out unit completed 1000 hours of operation in the life-cycle testing set-up and suffered one failure of the internal hose (tubular element) during testing (See Summary of Repairs Section on page 61). The Keco Peristaltic unit has a unique leak detector feature that acts to stop the peristaltic pump in the event of a leak on the internal hose. This leak detector is a safety device that is wired to stop the electric motor that drives the pump when a float-switch mechanism is actuated by leakage of liquid into the pump housing. The leak detector functioned as intended in this instance.

1. Corrosion Resistance: A sample of the metal frame was subjected to the Salt-Spray Exposure described in *Section 2.3*. The sample was found to have inferior corrosion resistance. The sample displayed pronounced corrosion on bare metal surfaces of the sample. The painted surfaces of the metal sample also exhibited corrosion under the surface of the paint.
  2. Ultraviolet Exposure Resistance: A sample of the Molded Solid Fiberglass Enclosure for the unit was subjected to the Ultraviolet Exposure described in *Section 2.4*. The sample was found to have superior resistance to fading, cracking, and discoloration due to simulated exposure to sunlight and moisture.
-

<b>Repair Required</b>	<b>Run Time on Unit (hours)</b>	<b>Repair Parts Required</b>	<b>Cost of repair parts</b>	<b>Time required to receive parts (days)</b>	<b>Time required to make repair (hours)</b>	<b>Total Time Off-Line (days)</b>
Replace internal hose	296.8	Internal hose	\$450.00	3	1.75	23 <b>Note 1</b>
