**UPPER PATUXENT RIVER WATERSHED RESTORATION ACTION STRATEGY (WRAS)
FORM 1 -- Catchment Information**

UPPER PATUXENT RIVER WATERSHED RESTORATION ACTION STRATEGY (WRAS) FORM 2 -- Site Information

Site Name: Laurel City Hall Address: 8103 Sandy Spring Road, Laurel MD, 20707
 Site Owner: Mayor and City Council of Laurel
 State Plane Coordinates of Site Centroid: X: 1350196 Y: 523579 Date: 3/12/03
 Personnel: PM, ZJL Weather: overcast, 55F deg
 Area (ac): 3.7 Impervious Area (ac): 2.1
 Percent Impervious: 57% Soil Recharge Factor (S): 0.09
 WQ_v (required): 0.17 Re_v (required): 0.02
 Property Area (ac): 3.8 Property Area Included in Site: 99 %
 Amount of Catchment Occupied by Site: 51 %

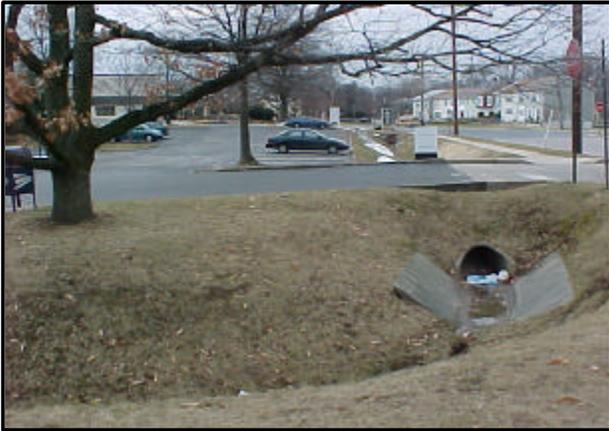
314

| No. <u>314</u> | Description: <u>looking west along parking lot and drainage</u> |

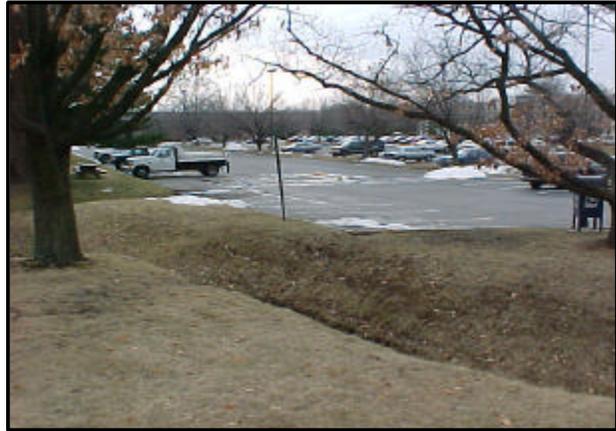
315

| No. <u>315</u> | Description: <u>looking south at potential bioretention area</u> |

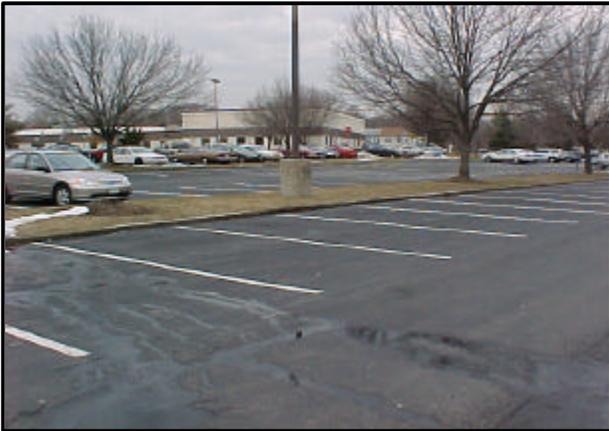
316

| No. <u>316</u> | Description: <u>looking west at parking lot and building</u> |

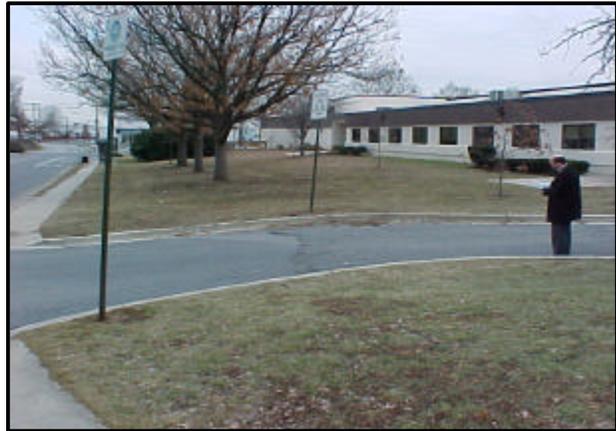
317

| No. <u>317</u> | Description: <u>looking east along north end of building</u> |

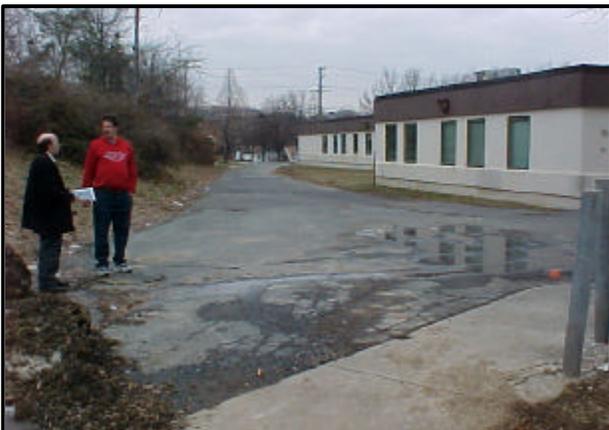
318

| No. <u>318</u> | Description: <u>looking north along west side of building</u> |

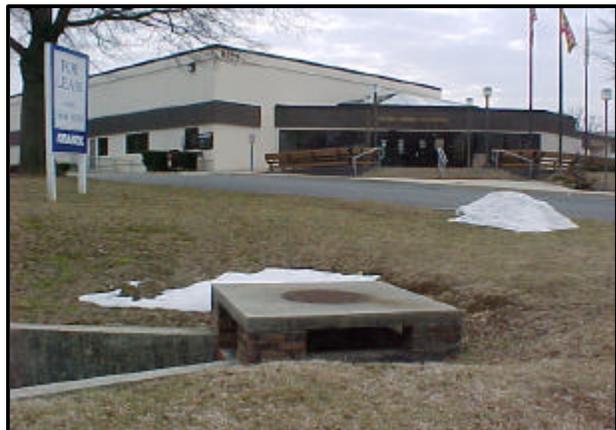
319

| No. <u>319</u> | Description: <u>looking southwest to building</u> |

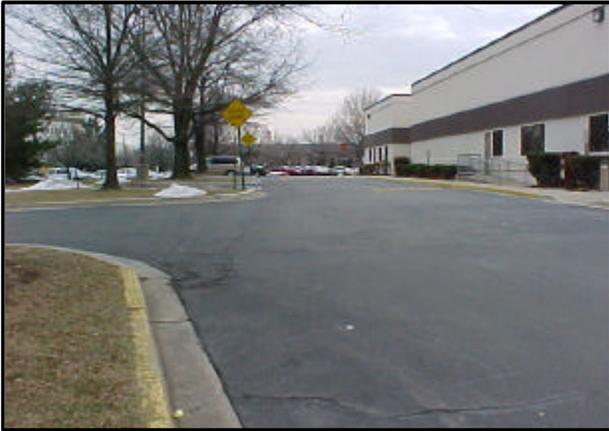
320

| No. <u>320</u> | Description: <u>looking south along east end of building</u> |
