**UPPER PATUXENT RIVER WATERSHED RESTORATION ACTION STRATEGY (WRAS)
FORM 1 -- Catchment Information**

UPPER PATUXENT RIVER WATERSHED RESTORATION ACTION STRATEGY (WRAS) FORM 2 -- Site Information

Site Name: US301/MD3 and Medford Road Address: Medford Road
 Site Owner: State Highway Administration
 State Plane Coordinates of Site Centroid: X: 1393677 Y: 471894 Date: 4/15/03
 Personnel: PM Weather: sunny, 85F deg
 Area (ac): 2.4 Impervious Area (ac): 1.7
 Percent Impervious: 71% Soil Recharge Factor (S): 0.26
 WQ_v (required): 0.13 Re_v (required): 0.04
 Property Area (ac): 2.4 Property Area Included in Site: 100 %
 Amount of Catchment Occupied by Site: 65 %

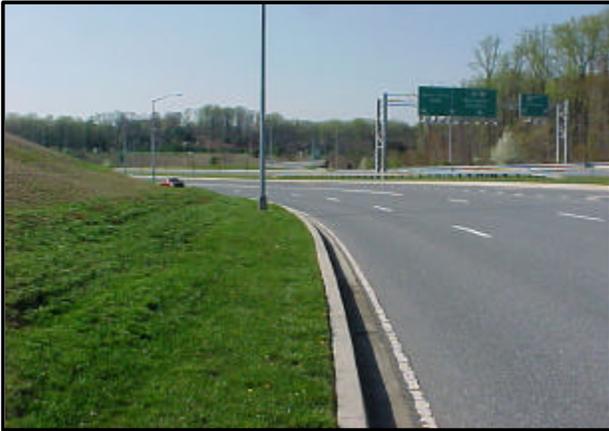
- No. 603 Description: looking north along Medford Drive
- No. _____ Description: _____

Comments Flow is conveyed in gutter
