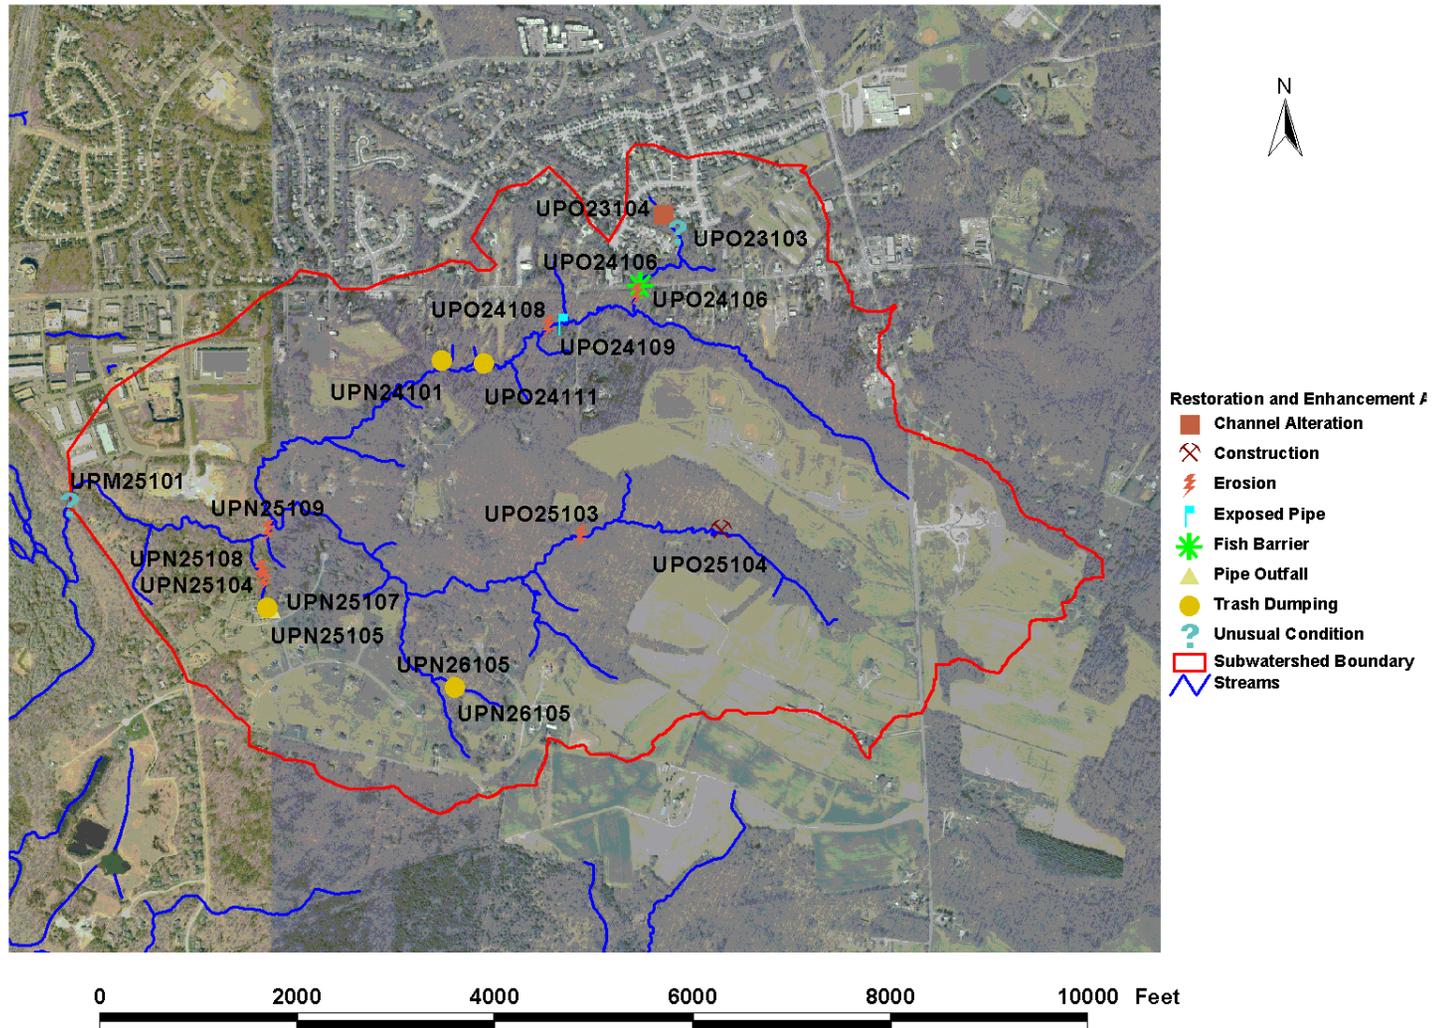
Figure 13. Potential restoration and enhancement sites in UPS1 (Cox Branch).

Specific restoration and enhancement projects for Cox Branch are identified in Table 21 and in Figure 13. In two cases, severe erosion problems may be a result of pipe outfalls or road crossings draining developed areas. Erosion sites UPN25107 and UPN25108 are likely related to the pipe outfall UPN25105. These sites consist of a 500-foot reach with 4-foot high banks leading to an 8-foot headcut. The shallow road crossing (FB UPO24106) is probably causing the erosion described in Table 21 for ES site UPO24106. These projects should be investigated concurrently and solutions should be created that treat the causes (the outfalls) along with the symptoms (the erosion sites).

SCA Site Number	Project Type	Project Description	Subwatershed Priority Ranking	Notes
UPN26105	TD	Large trash dump, mixed appliances, recyclables	1	Moderate severity and ease of access, correctability, put this project on top.
UPN25105	PO	Pipe Outfall	2	Likely responsible for erosion problems (UPN25108, UPN25107) downstream.
UPN25104	TD	Yard waste trash dump	2	Moderate severity and easy access, correctability results in high score.
UPO24106	FB	Shallow Road Crossing	2	Only opens minor amount of habitat, which is not accounted for in SCA scoring. Likely causing UPO24106 ES.
UPO24108	EP	Exposed Pipe	5	Appears to instream cistern, possibly for animal watering. Requires additional investigation.
UPO23104	CA	Channel Alteration	6	300-foot long rip rap pond outfall. Pond is likely related to UPO23103.
UPO24106	ES	3 foot high, 2600 foot long eroding bank	6	Likely related to road crossing described above (UPO24106).

UPO24109	ES	8 foot high, 4800 foot long eroding bank	6	Unknown cause. Requires further investigation to determine solution.
UPM25101	UC	Unusual Condition	6	Collapsing road culvert. Unknown cause. Requires further investigation to determine solution.
UPO25103	ES	8 foot high, 5000 foot long eroding bank	10	Unknown cause. Requires further investigation to determine solution.
UPO23103	UC	Cloudy, scummy water	10	Could be water quality problem that requires investigation. Stormwater pond upstream.
UPN25107	ES	4 foot high, 400 foot long eroding bank	12	Likely caused by UPN25105.
UPN25109	ES	4 foot high, 500 foot long eroding bank	12	Unknown cause. Requires further investigation to determine solution.
UPN25108	FB	8 foot high headcut	12	Could be considered erosion site. Likely caused by UPN 25105.
UPN24101	TD	Trash Dumping	15	Difficult access. Volunteer friendly.
UPO24111	TD	Residential trash dump	15	Difficult access. Volunteer friendly.

UPO25104	IC	Construction	17	SCA classified as logging without sediment controls.

- Provide additional stormwater management in unmanaged areas;
- Reduce overall sediment load by repairing unstable stream banks;
- Remove or correct fish passage impediments;
- Investigate the feasibility of wetland restoration on the two hydric soil areas in this subwatershed, and;
- Schedule stream clean-ups.

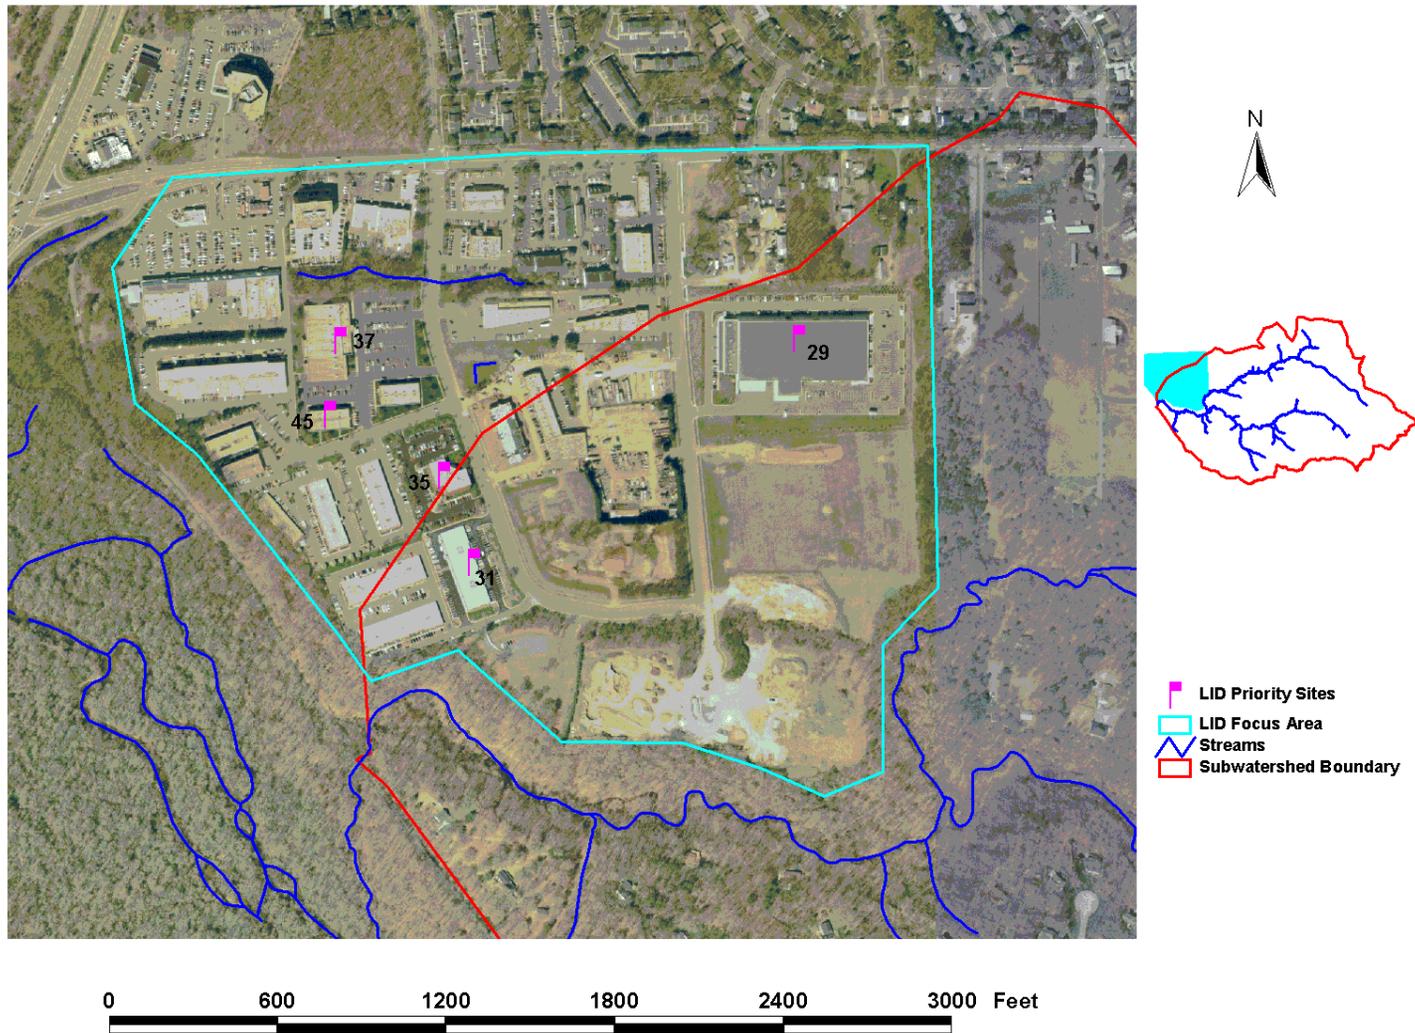
Figure 14. LID focus areas in UPS1 (Cox Branch) — Priority sites denoted with pink flags and site numbers.

As mentioned in Section II, this subwatershed was selected as Anne Arundel County’s LID retrofit priority area. Cox Branch was one of the few locations that had concentrated development areas in the Anne Arundel portion of the Upper Patuxent River watershed. As shown in Figure 14, the area for LID implementation consists of an industrial park in the northwestern portion of the subwatershed. The land use here is mixed commercial and light industrial, most of which was developed during the 1980s and 1990s. Development continues today in the southeastern corner of the area.
