# So You'd Like to Stop Shore Erosion along the Calvert Cliffs. You'd better think before you act.

Curtis Larsen and Inga Clark

U.S. Geological Survey

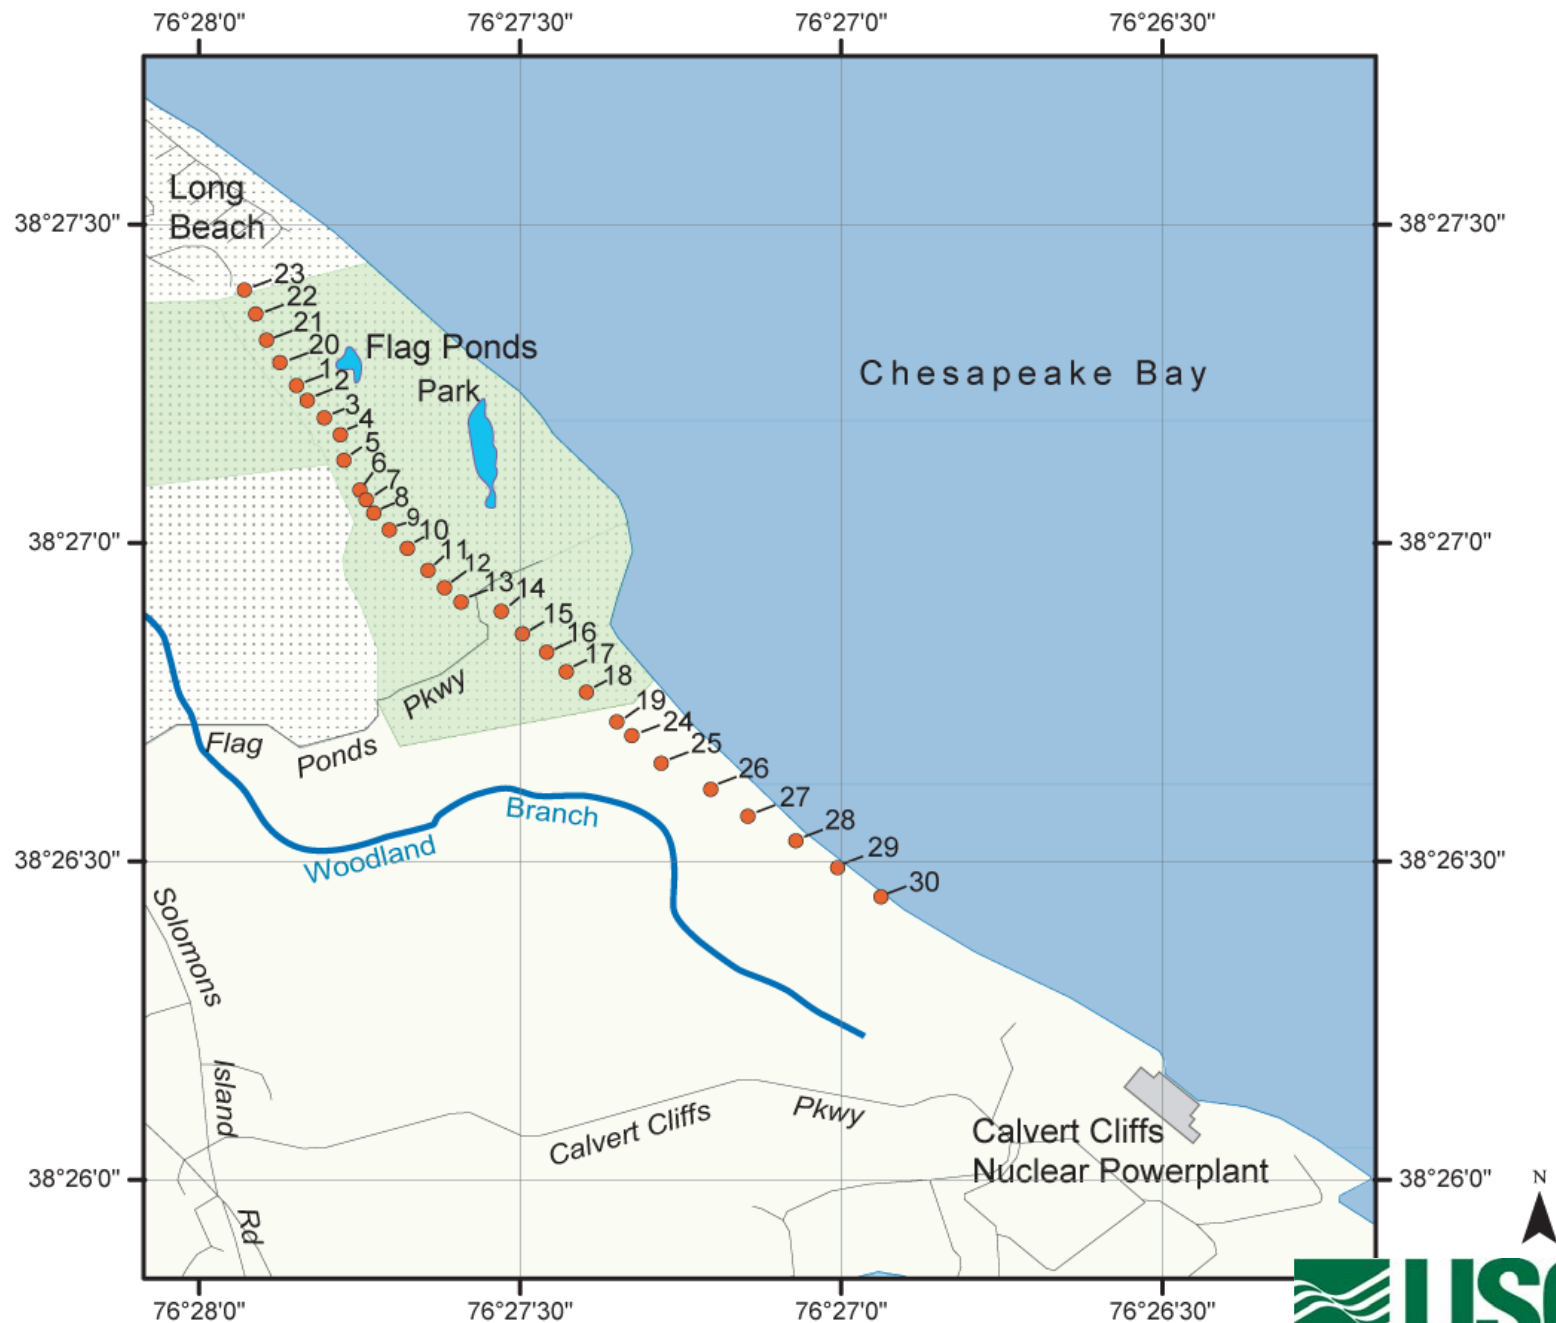
Slope Angles were again  
Measured.

Here again all protected slopes had failed and evolved into stable slopes with a mean slope angle of 35 degrees and Within a time frame of 400 years! Clearly this was a rapid process!

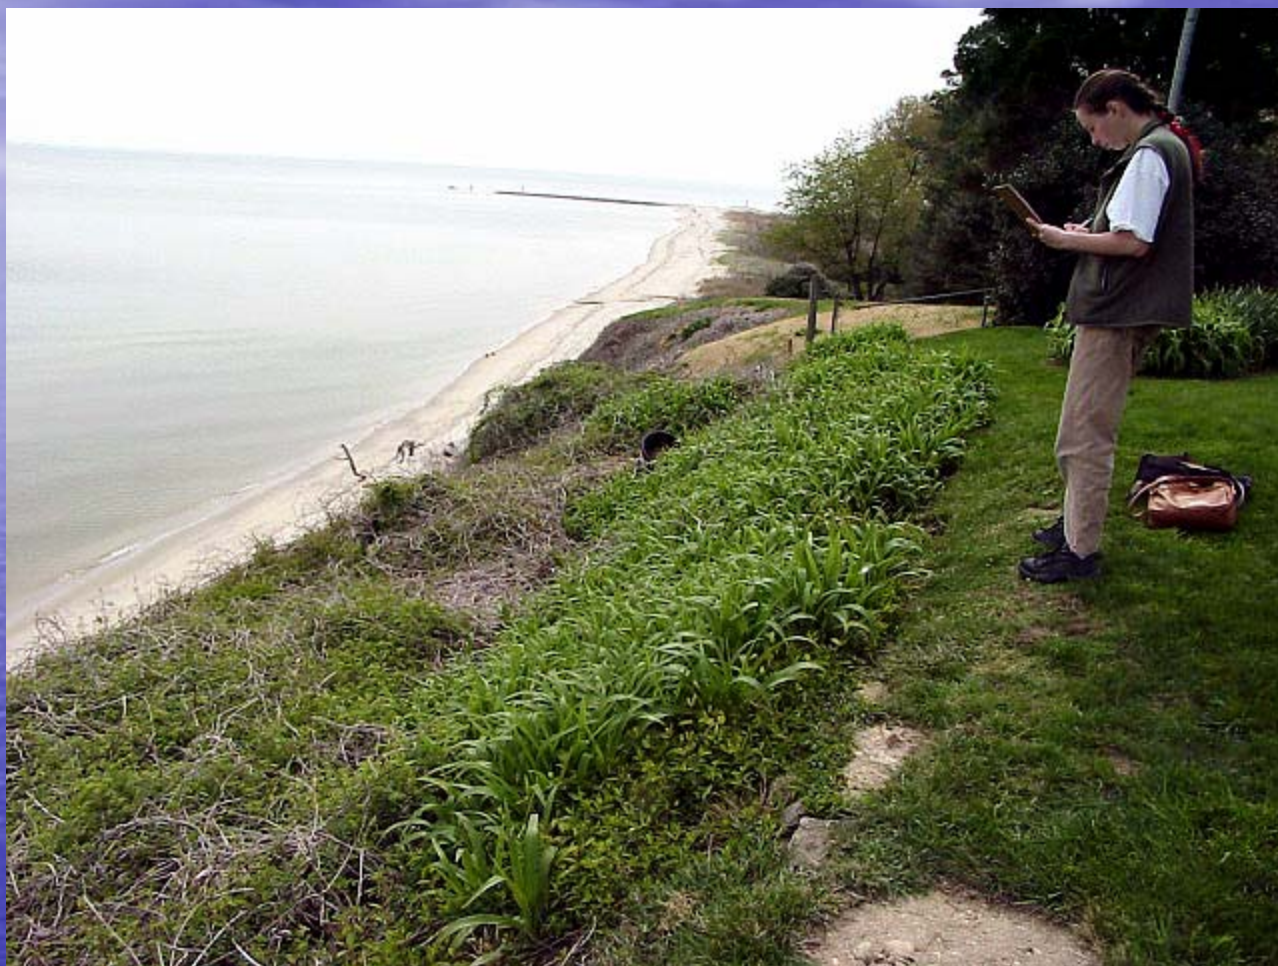
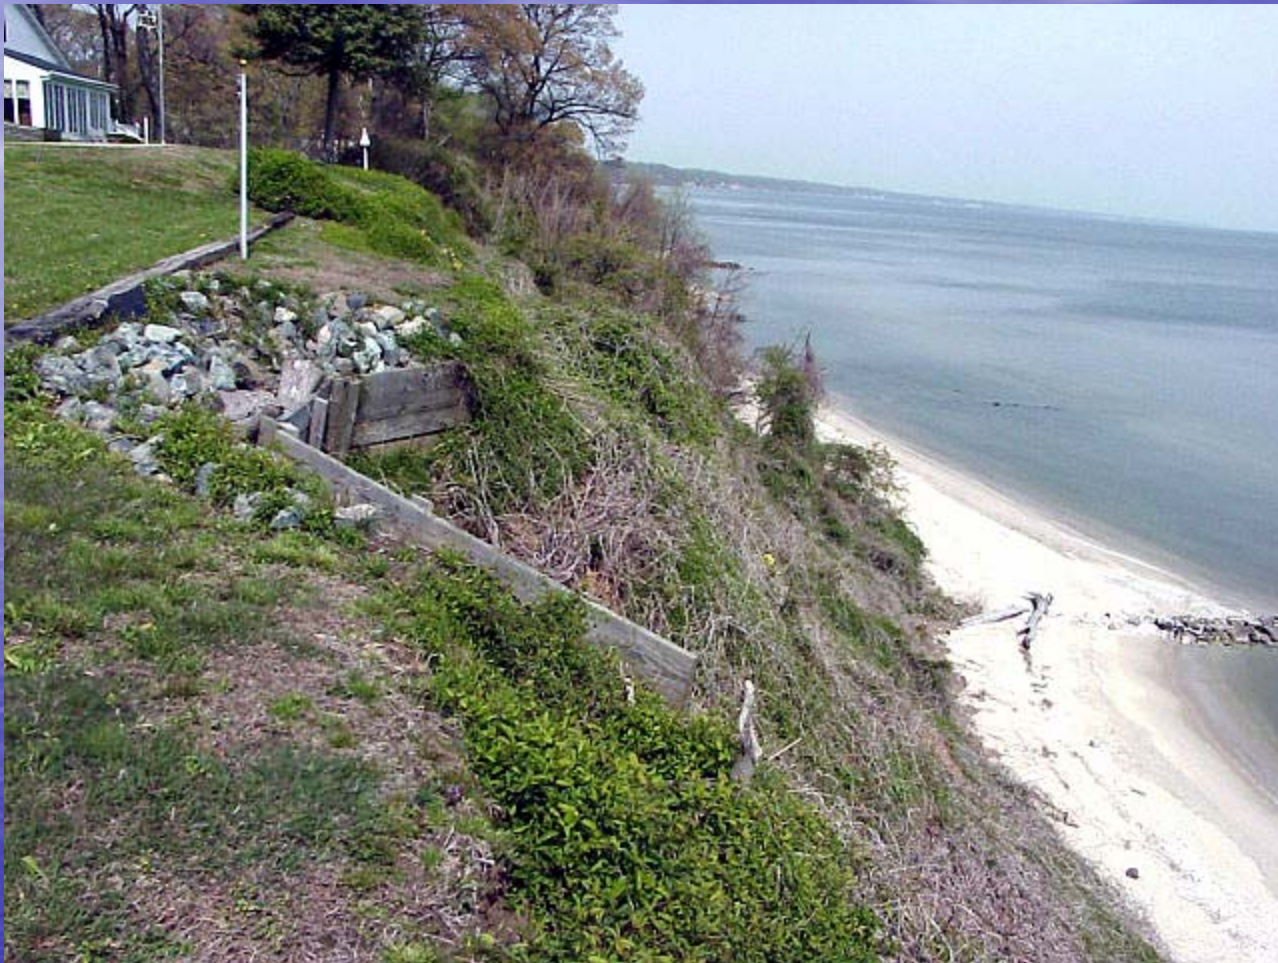
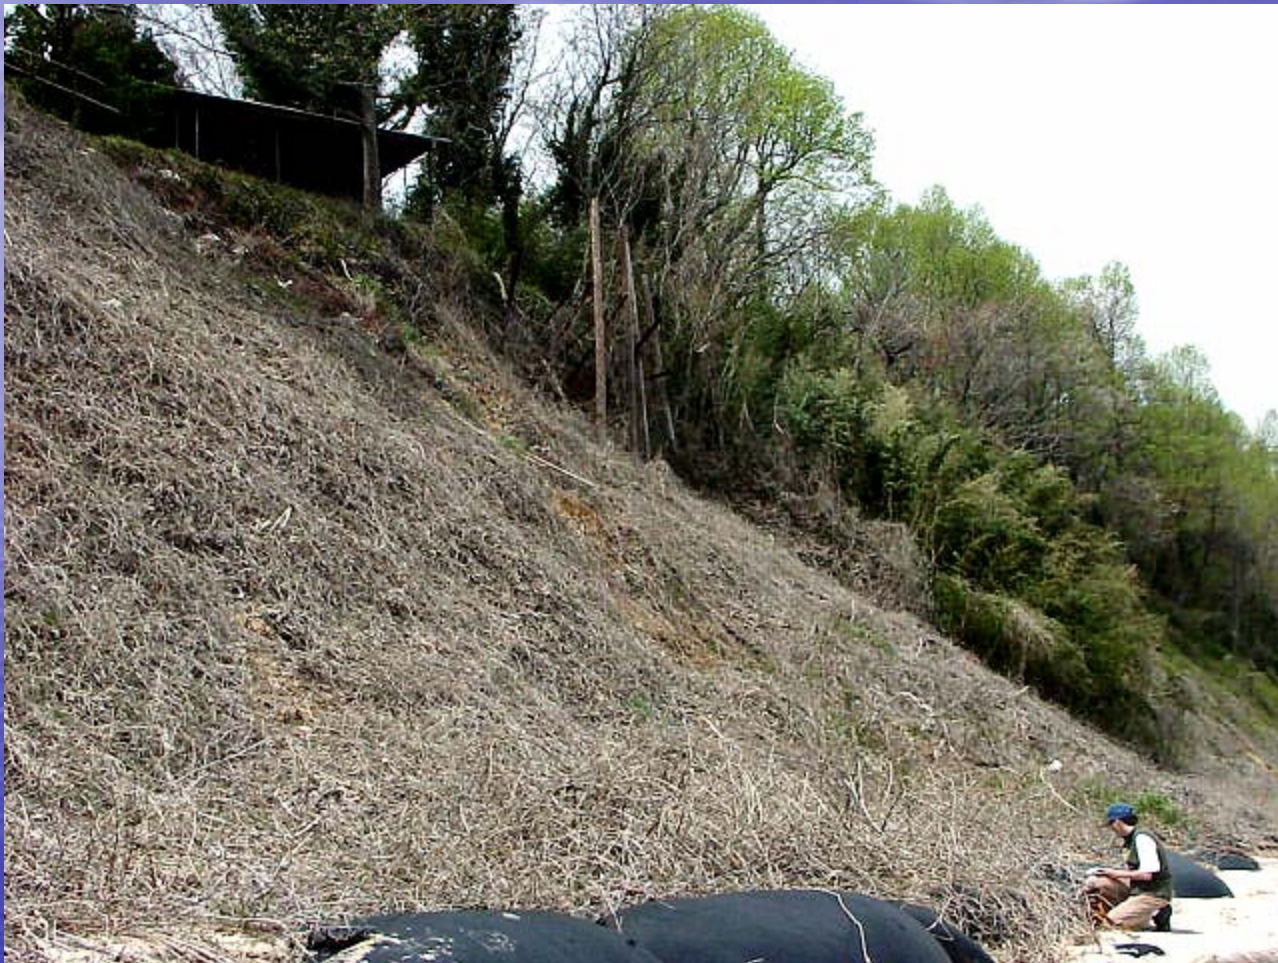
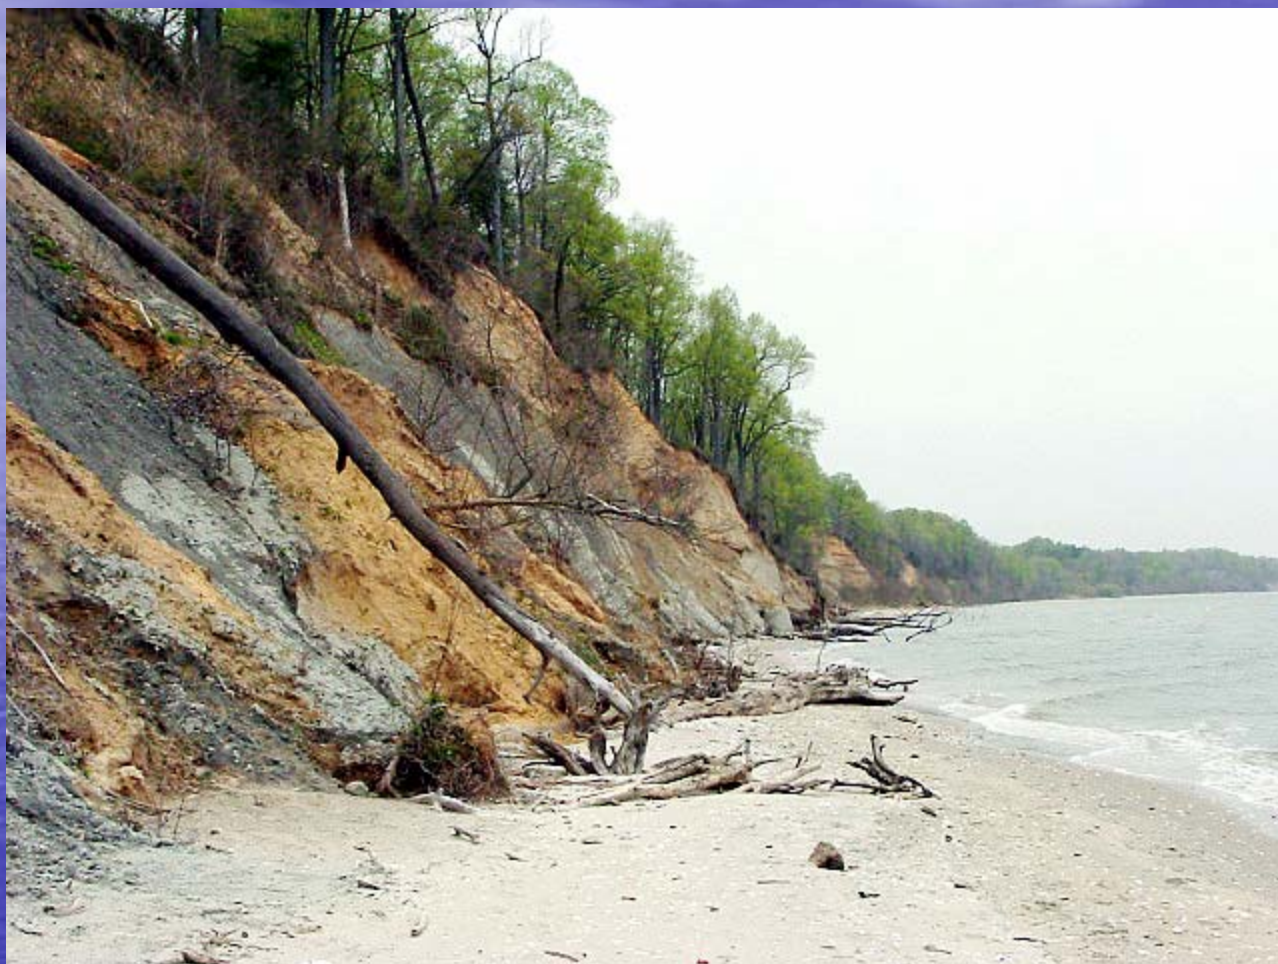
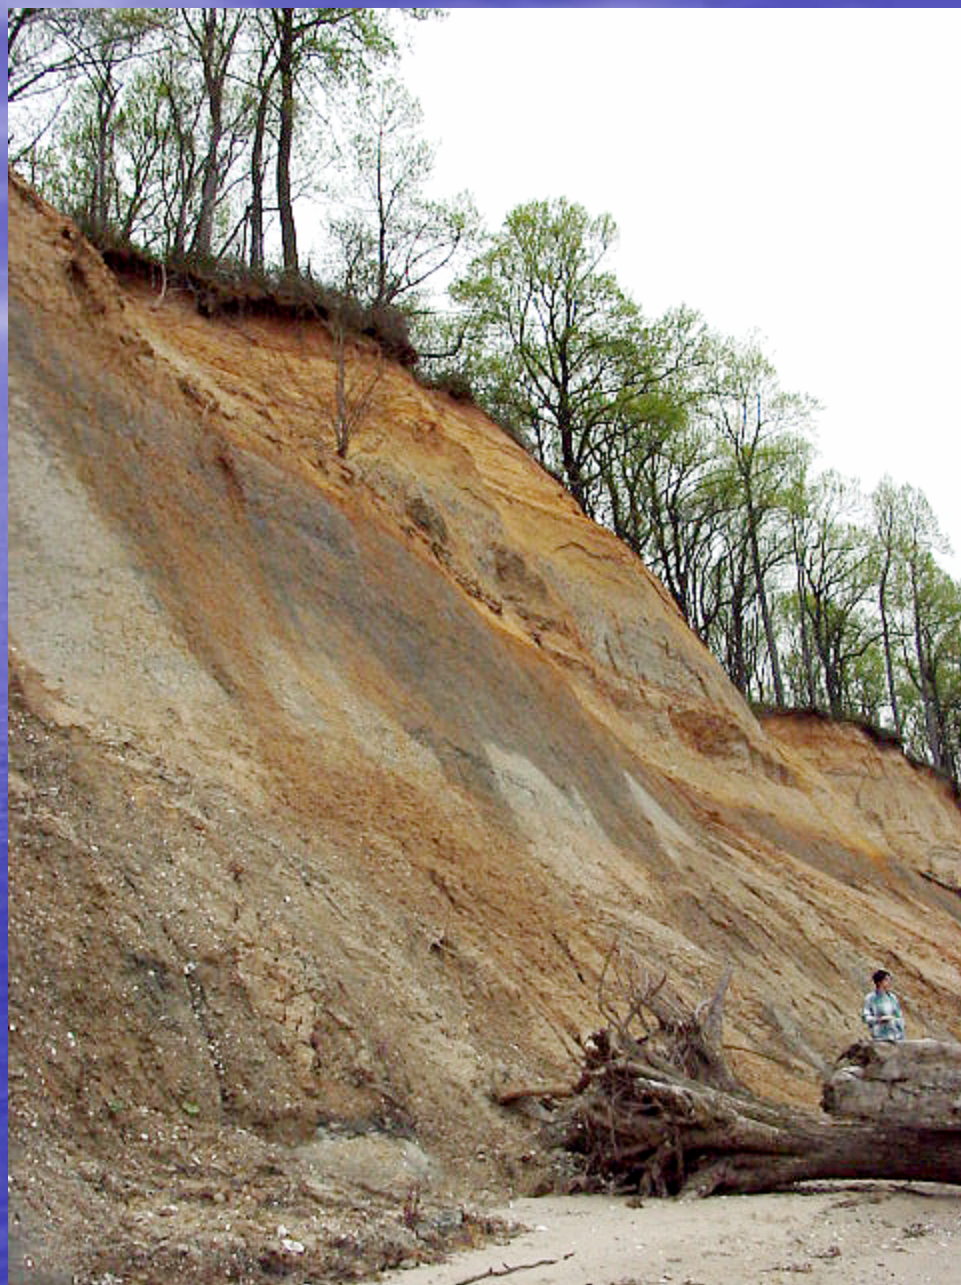
Photos showing a south to  
north progression in slopes.

To the north the progressive change from active wave action and bluff-sloughing to slope retreat through bluff top failure was documented. Once artificially protected, the slope angles changed from 70 degree to 45 degree slopes in 25 years!!
