BLOEDE DAM

ALTERNATIVES ANALYSIS

JUNE 15, 2012

Inter-Fluve Inc.
3602 Atwood Avenue
Madison, WI 53555
608-441-0342

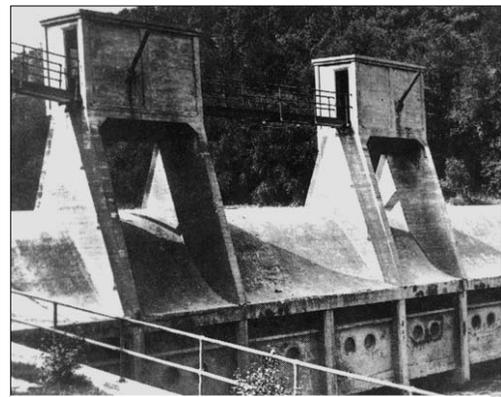
Figure 1. Gate works from an early photo of the Bloede Dam.

original structure included several large abutment structures that held gate works for manipulation of flow and water diversion into a right bank fish ladder, but these were removed following the damage caused by Tropical Storm Agnes in 1972 (Figure 1). The design of the Bloede dam was unique, featuring water intakes below the crest that fed internal turbines. This design was also the reason for the dam's dysfunction, as large amounts of sediment deposited upstream of the dam and clogged the intake pipes. Dredging in the early 1920s temporarily restored power generation to the dam, but subsequent flooding brought more sediment. Hydropower generation was finally discontinued in March 1932 (Figure 2). Since that time, the dam has functioned only as a run-of-river dam. The Maryland DNR installed a fish ladder

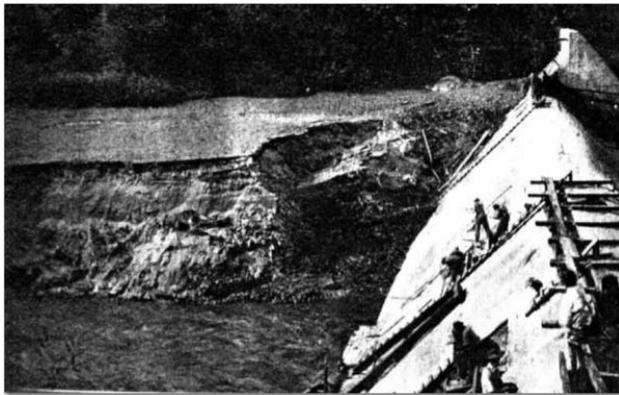
Figure 2. Flushing of accumulated sediment upstream of Bloede (ca 1920).

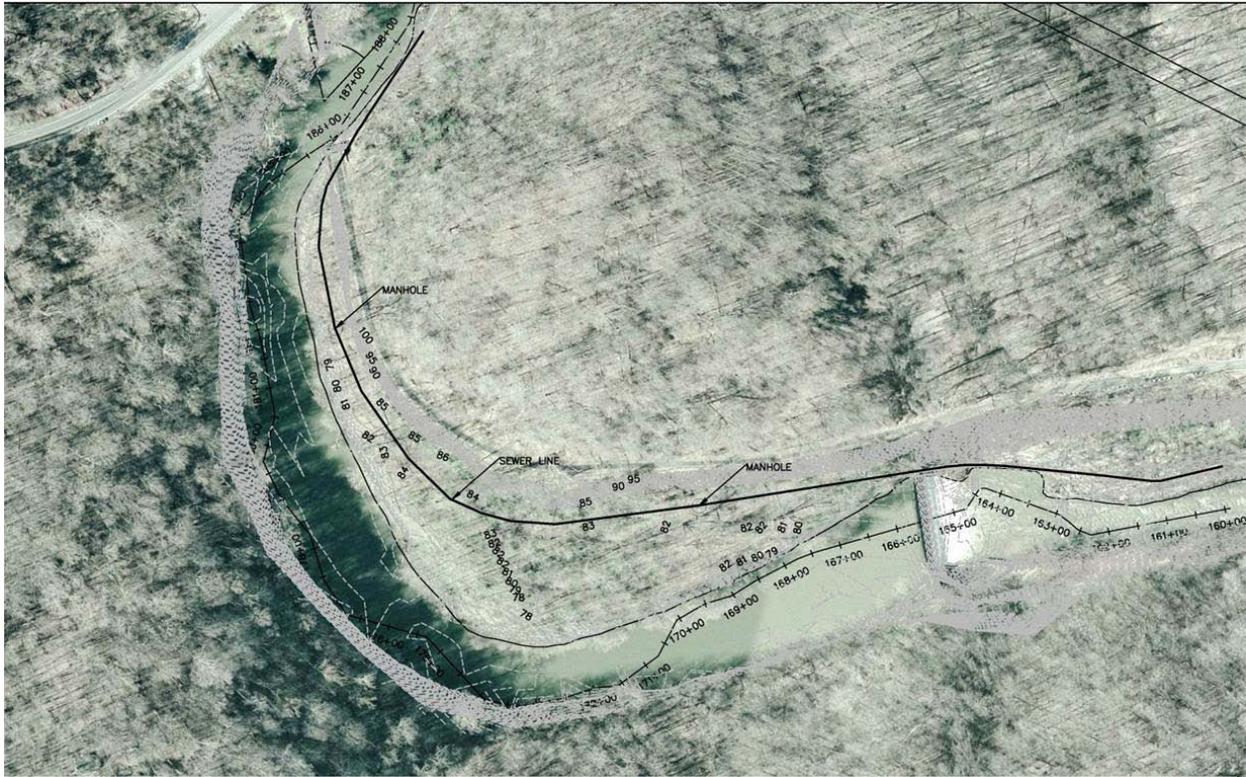
Figure 3. Large point bar upstream of Bloede Dam.

Upstream of the dam, there is a large point bar covered in mature trees. Tree coring of the largest sycamore trees suggest that the most recent sediment deposition occurred in the late 1960s to early 1970s, which corresponds with expected deposition and damage of any existing trees by Tropical Storm Agnes in 1972. Sediment coring and seismic data suggests a hardpan clay layer roughly 3-5 feet below the surface with sand and organic sediment (silt) deposition on top of the clay.

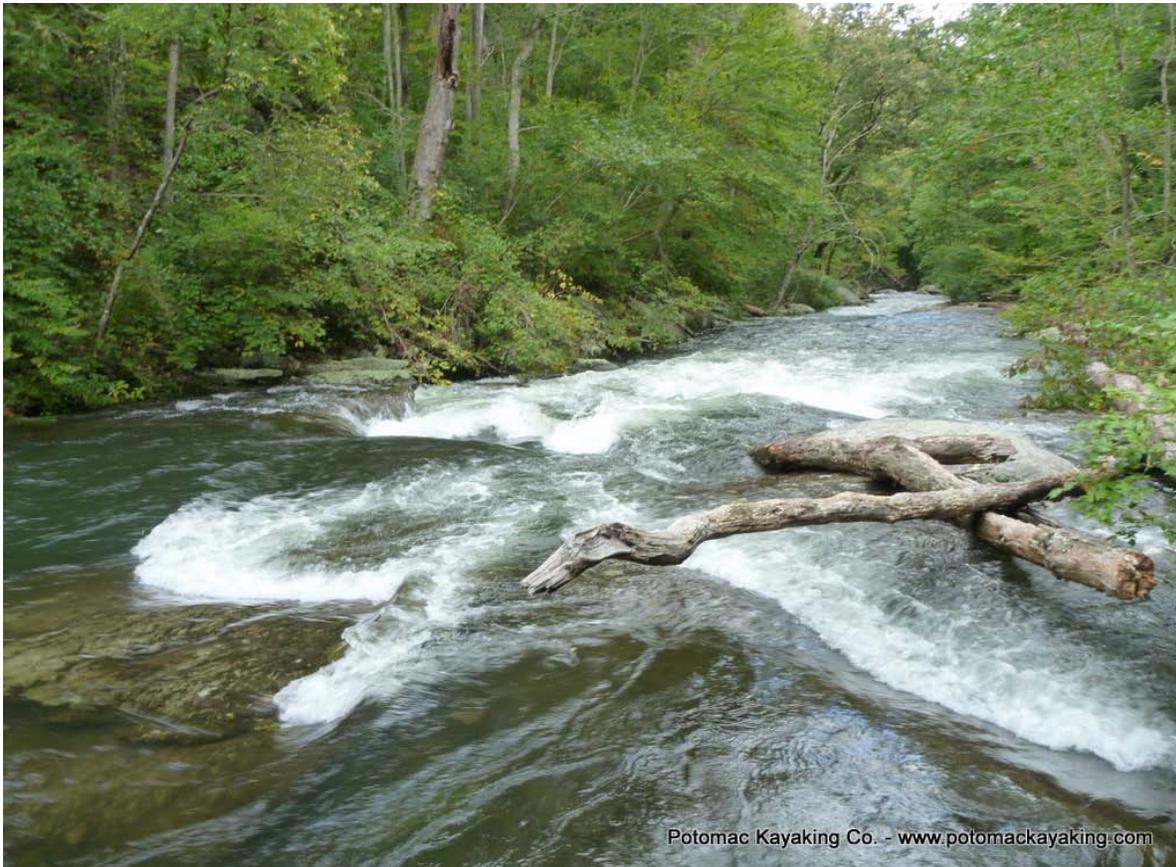
Figure 4. Example of potential viewscape following removal.

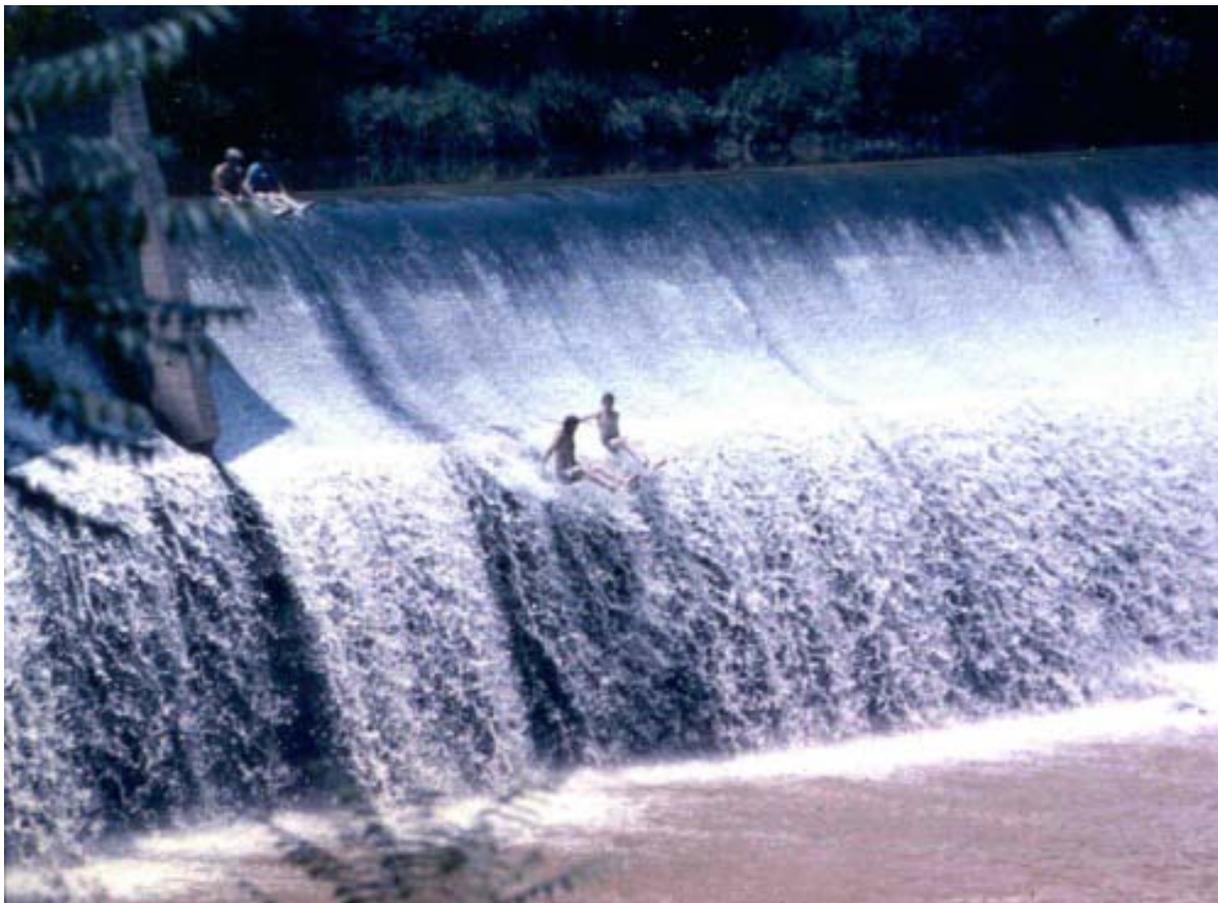
Figure 5. Children sliding off of the Bloede Dam spillway (ca 1980).

Safety – The Bloede dam, like many other dams around the country, is an attractive nuisance. People are attracted to the structure and the sound, and often congregate below the dam, wading in the pools and playing on the rocks. The abutments, sewer pipe and spillway offer a challenging climbing experience that attracts people ignorant of the inherent risks. Despite warning signs posted on both abutments, swimmers, including children, routinely slide down the spillway and jump into the pool below the dam (Figure 5). This pool is small however, and footing on the dam crest is dangerous. In just the period from 2005 to 2011, three people have been killed and numerous others injured at the dam. If no action is taken, these incidents are likely to continue.

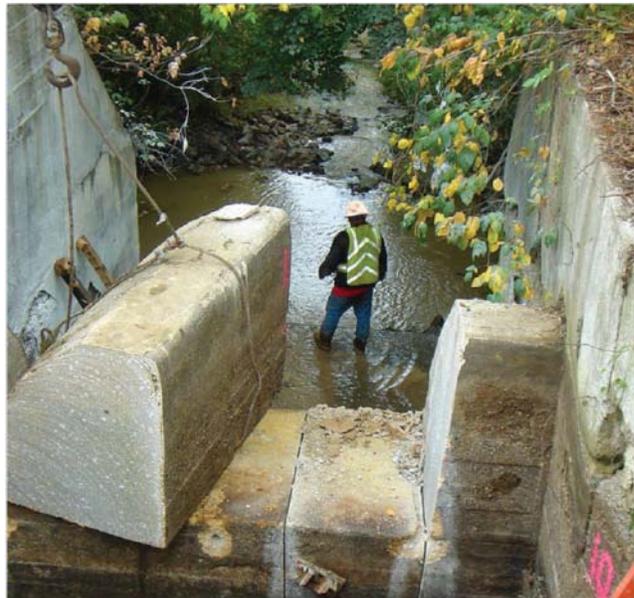
Figure 6. Sawcutting requires crane removal of large cut pieces.

A crane would be required to remove and load the cut sections onto trucks (Figure 6). There would be virtually no harmful vibrations or dust associated with saw cutting. Multiple methods could be used. Hammering is the most efficient way to breach the spillway. To minimize impact to the sanitary sewer, diamond wire cutting and concrete removal by crane is best suited for demolition of the north abutments and sections of the dam located between the sewer main and Grist Mill Trail. The wire saw can be set up by hand and the crane can be set up in the stream channel and reach over the sewer main to remove segments of concrete.

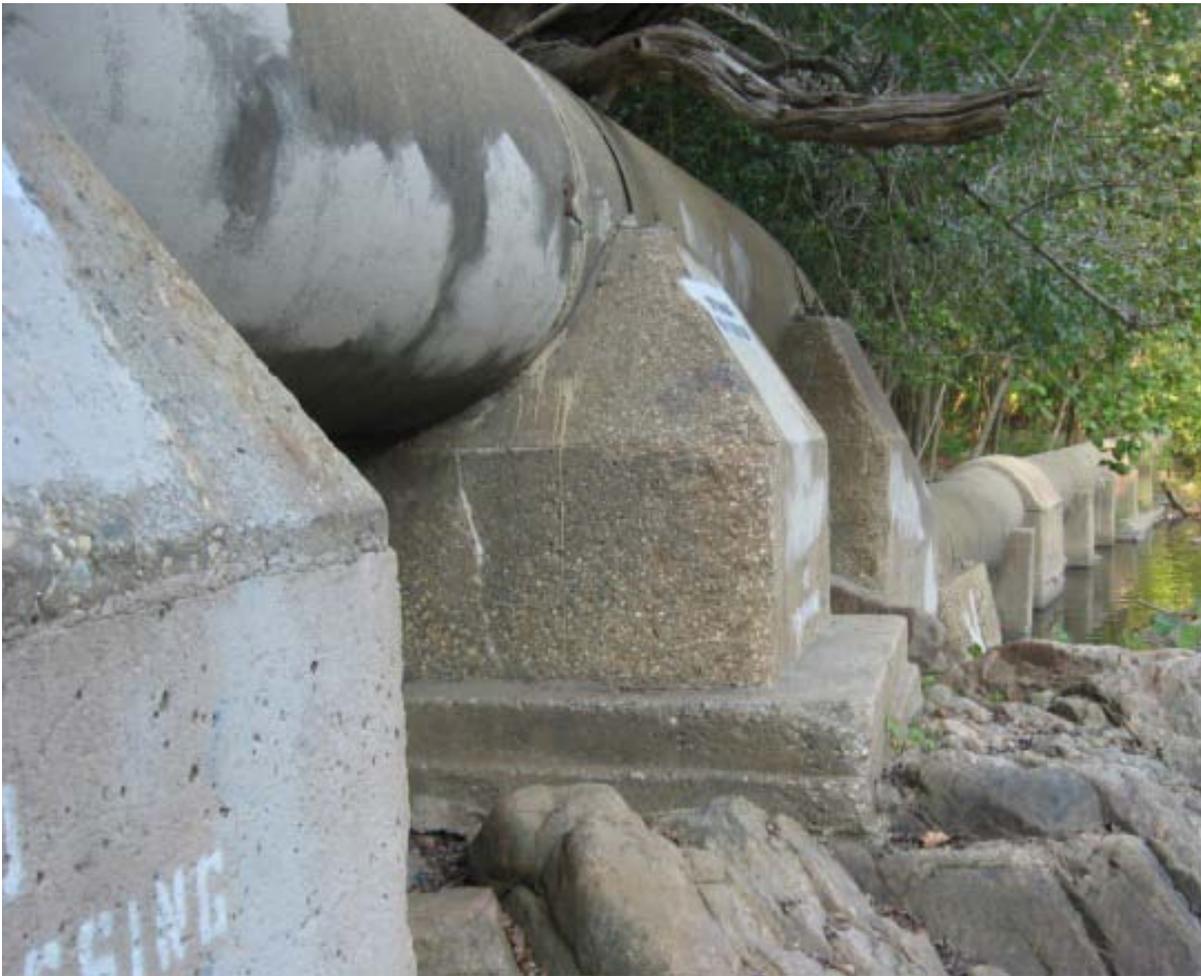
Figure 7. The sanitary sewer pipe and pylons make two steep drops just downstream of the Bloede Dam.

Sanitary Sewer- A 42-inch diameter gravity sewer main extends along the north side of the river channel and penetrates the dam on the left side at the foundation contact. The pipe slope downstream of the dam is 0.28% and the pipe is exposed downstream of the dam and upstream of the impoundment, passing under the point bar area near the base of the walking trail embankment. Downstream of the dam, the pipe runs along mounted concrete supports mounted on bedrock outcrops at the toe of the left valley wall (Figure 7). Upstream of the Bloede Dam, near the upper end of the impoundment, the interceptor is exposed along the left bank. Information regarding the material properties of the sewer pipe is limited. There is no available information regarding pipe wall thickness. Based on typical pipe products sold by the Lock Joint Company at the time of installation, the pipe is probably spiral wound steel with a mortar coating. Any changes in channel bed elevation must consider impacts to the sewer. Project design of any kind must consider pipe support, changes in pipe support due to sediment loss, vibration during construction and countermeasures to avoid damage to the pipe.

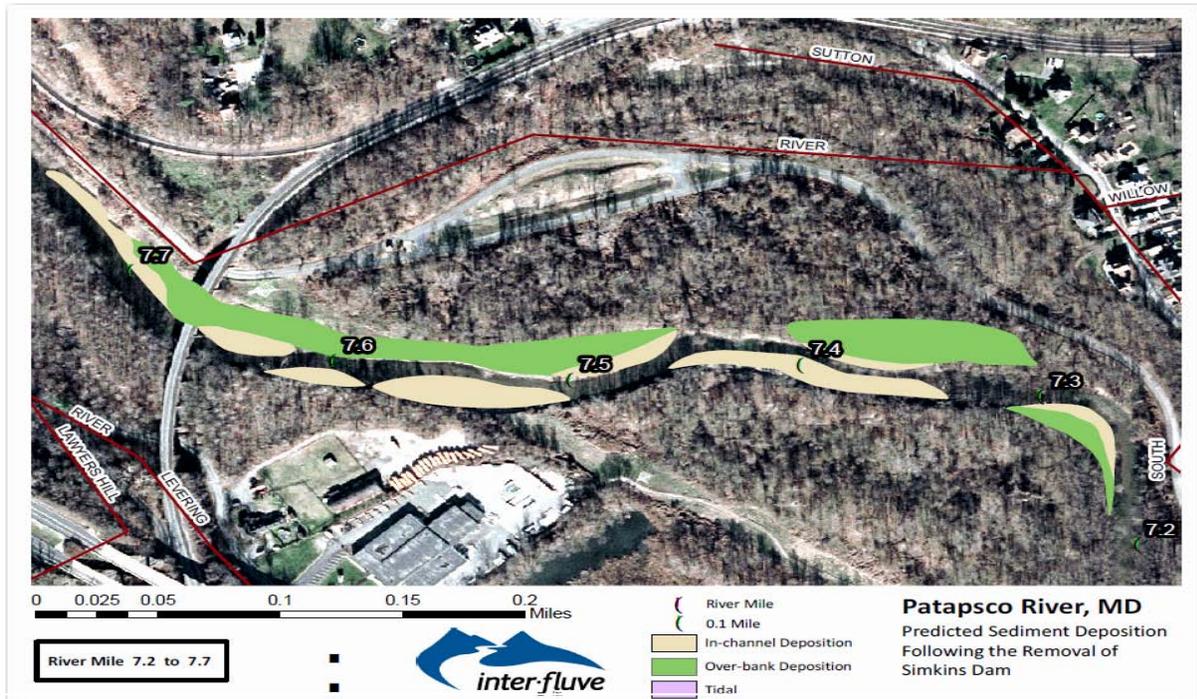
Figure 8. Geomorphic assessment results for predicted depositional areas near the Thomas Viaduct

Large pulses of sediment will move downstream following the Bloede removal and will temporarily inundate natural sediments, potentially suffocating fish eggs and macroinvertebrates, covering pool and riffle habitat, burying redds and increasing overbank deposition. These effects are similar to those caused by dams and reversed by removal, but whereas dam effects last for decades or centuries, the effect of downstream sediment deposition is temporary. Three recent dam removals, the Simkins Dam, Sandstone Dam and Merrimack Village Dam, had sand-filled impoundments prior to removal. After removal, transport occurred in nearly identical ways, with initial headcutting and entrenched channel evacuation, followed by gradual widening. In each case, sand quickly evacuated and is actively moving out of the downstream reaches (Pearson et al. 2011). The DREAM-1 model predicts that the sediment downstream of Bloede will move through the lower Patapsco 10 to 20 years, depending on the flow conditions modeled. A large flood such as a Tropical Storm event could move the sediment out of the lower Patapsco in a very short time, possibly one event. In 2011 and early 2012, sand from the Simkins removal has migrated into the lower reaches of the Patapsco between Bloede Dam and the Bay. After recent floods, some overbank deposition of sand has been observed in the near bank regions, and filling of pools has also been noted. Additional channel aggradation will be one outcome of the Bloede removal, and the channel may take on a braided appearance for several years. Eventually, this sand will move through the system and pool habitat will reform. During the Simkins removal design phase, predicted sediment deposition areas were delineated separately using field geomorphic assessment and also computer modeling (Figure 8). To date, both the DREAM-1 model and the geomorphic assessment results have accurately predicted where sediment deposition will occur. The figure below is an excerpt from the geomorphic assessment showing predicted depositional areas near the Thomas Viaduct.
