2007-2008 Bush River Shallow Water Monitoring Data Report

14 October, 2009

Brian Smith, Diana Domotor, Ben Cole, Mark Trice, and Tom Parham
Resource Assessment Service/Tidewater Ecosystem Assessment
Maryland Department of Natural Resources
Tawes Building, D-2
580 Taylor Avenue
Annapolis, MD 21401

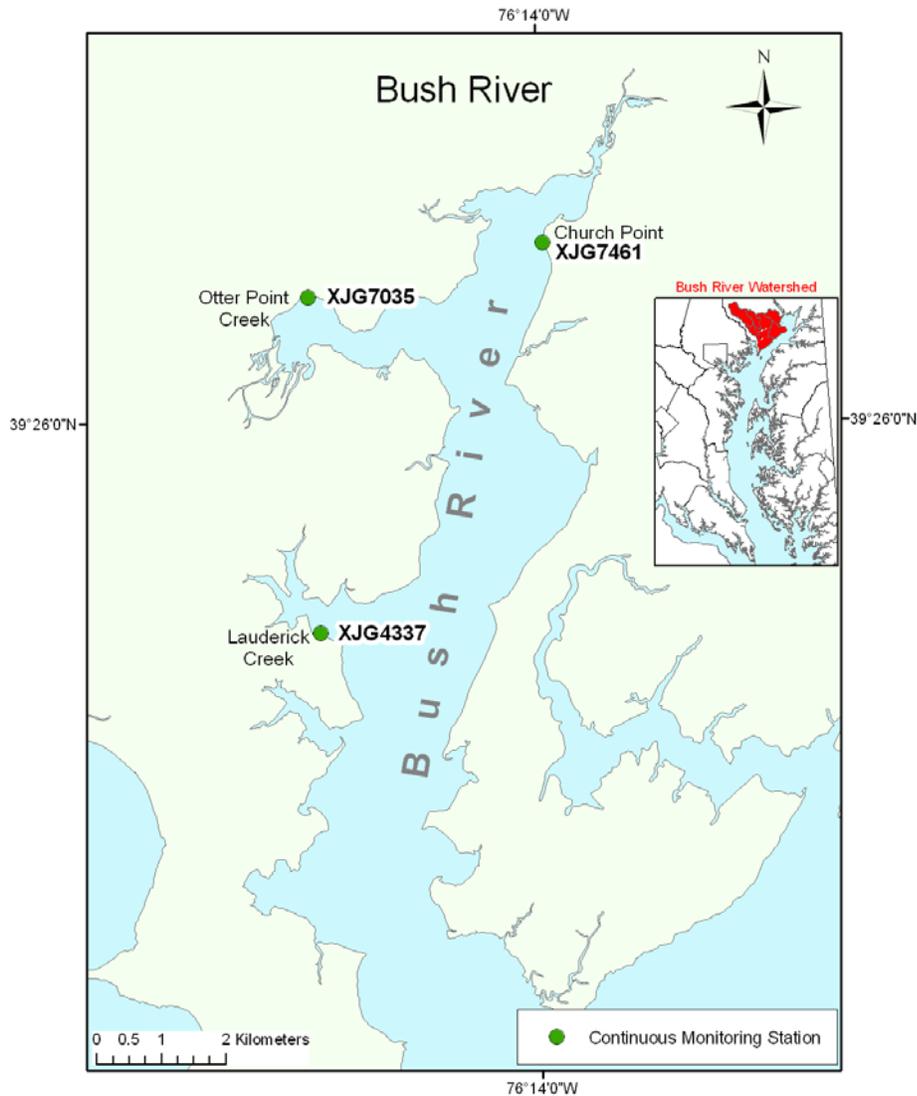
Figure 1. Map of Bush River Continuous Monitoring sites for 2007 (Otter Point & Lauderick Creeks) and 2008 (Otter Point Creek and Church Point).

In 2007, Continuous Monitoring data were collected at two sites in the Bush River: Otter Point Creek (XJG7035) and Lauderick Creek (XJG4337) (Figure 1). The Otter Point Creek Continuous Monitor was fixed 0.3m above the bottom sediments and deployed from January 1st to December 10th (Table 1). A second Continuous Monitor was deployed in Lauderick Creek from March 20th to October 30th (Table 1), and was suspended from a float, 1m below the water's surface.

In 2008, both Continuous Monitoring sites were located relatively closer to the head waters than the mouth of the Bush River (Figure 1) and exhibited similar variability to each other in dissolved oxygen levels (Figure 6b). Otter Point Creek also experienced more days with dissolved oxygen concentrations below 5mg/l (Table 2) than in 2007, perhaps because of the higher levels of precipitation (Figure 2) and more frequent spikes in discharge events (Figure 3) in 2008.

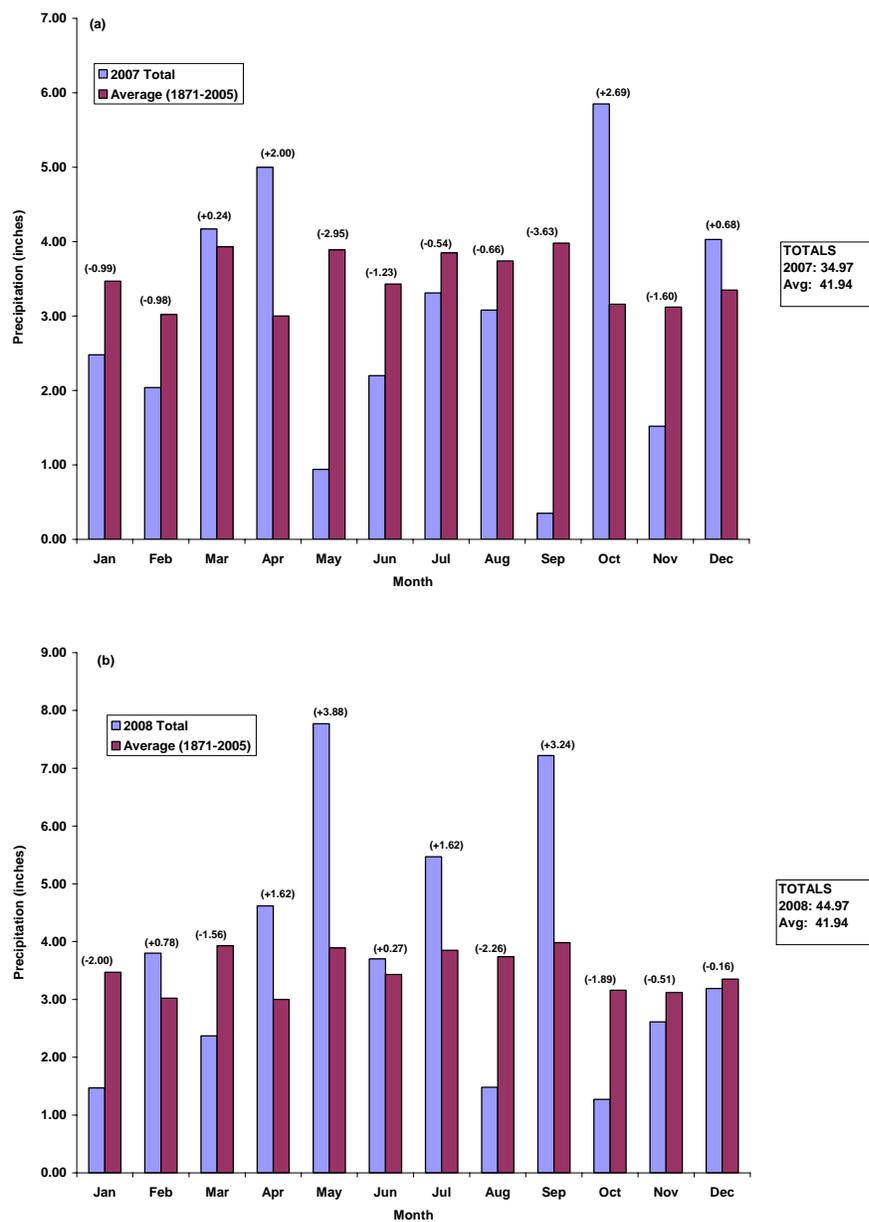
Figure 2. Total monthly precipitation at BWI Marshal Airport compared to 135-year averages for (a) 2007 and (b) 2008. (Values in parentheses indicate departures from average.)

In 2007, precipitation at Baltimore Washington International (BWI) Thurgood Marshal Airport was substantially below normal, totaling approximately 7-inches below the 135-year average

In 2008, total precipitation was approximately 3-inches greater than the 135-year average, with six months experiencing higher than average precipitation (Figure 2b). This pattern translated into an increased number of spikes in discharge for 2008 (Figure 3b) compared to 2007, but the net volume of discharge was lower than that in 2007. The four biggest discharge events at Otter Point Creek Gage Station in 2007 were higher than all discharge events in 2008 (Figure 3) and mean flow of discharge was higher in 2007 (65.0 cubic feet per second – cfs) than in 2008 (53.4 cfs). This pattern also held during the growing season of April through October (2007: 50.9 cfs; 2008: 45.0 cfs), when discharge events can have the greatest effect on SAV growth.

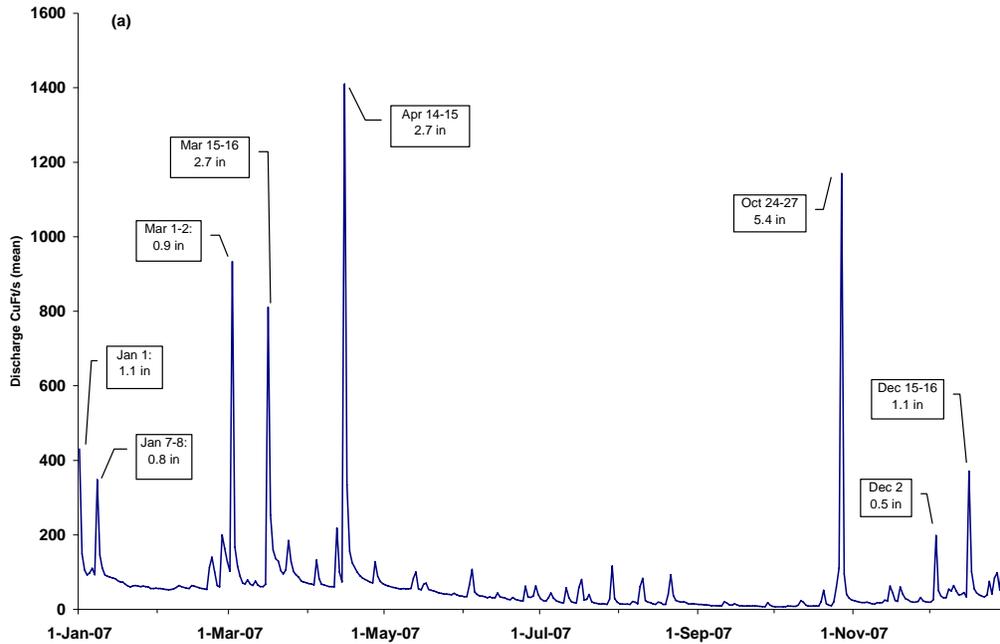
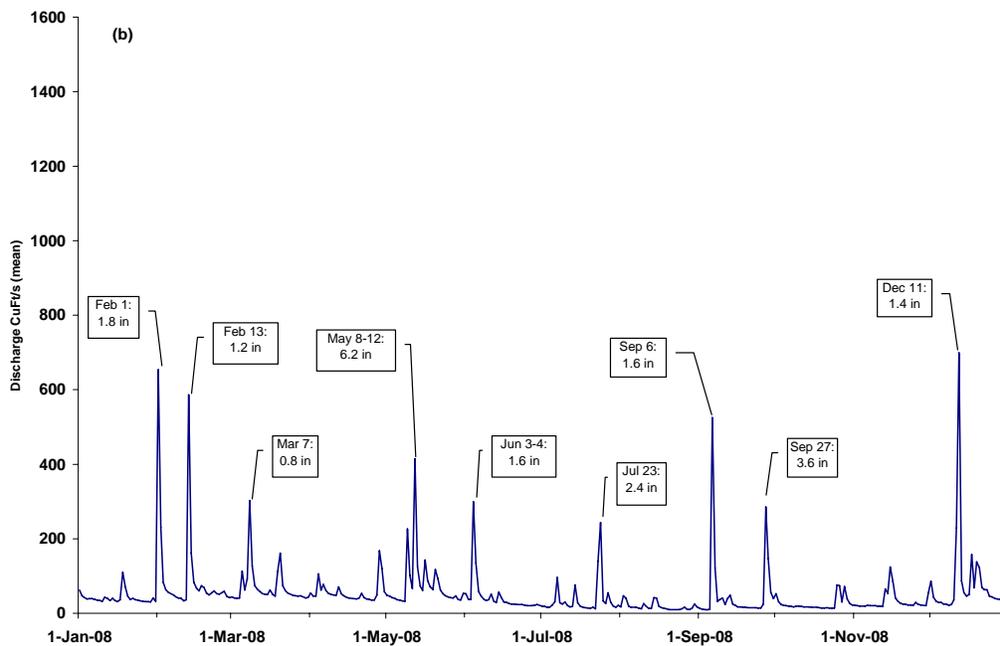
Figure 3. Daily discharge in cubic feet per second measured at USGS Gaging Station 01581757 on Otter Point Creek near Edgewood, MD in (a) 2007 and (b) 2008. (Boxes indicate precipitation events at BWI Marshall Airport that coincided with spikes in discharge.)

Precipitation increases run-off into waterways, which can lead to a higher discharge of nutrients that fuels algal blooms, decreases water clarity, and, therefore, suppresses SAV growth. Precipitation in 2008 was substantially greater than in 2007 (Figure 2), while discharge events into waterways were higher in 2007 (Figure 3).

(Figure 2a). April and October showed the highest amounts of precipitation, which coincided with the two highest discharge events measured at the USGS Otter Point Creek Gage Station near Edgewood, MD. (Figure 3a).

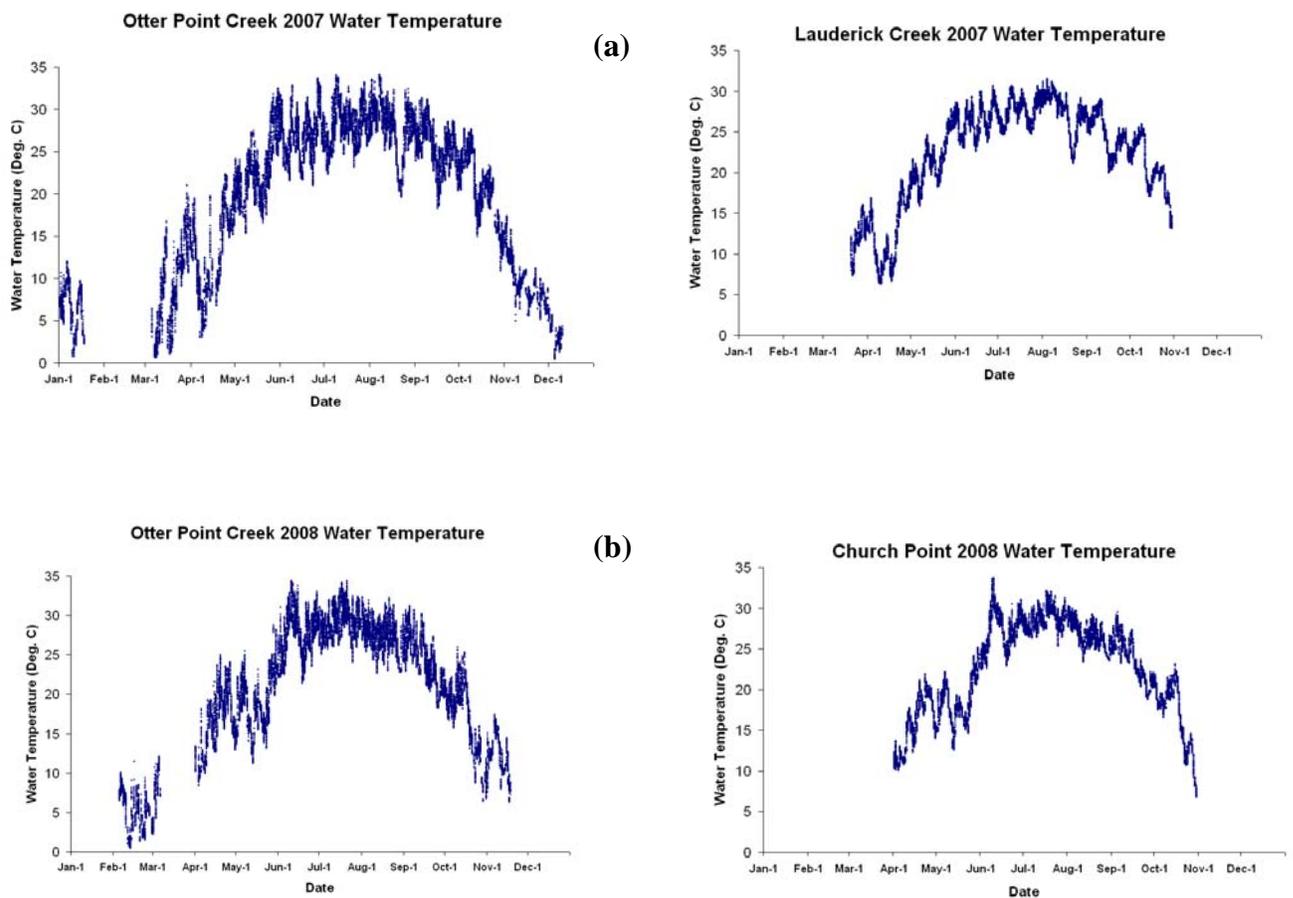
Figure 4. Water temperature at Bush River Continuous Monitoring sites during (a) 2007 and (b) 2008.

In both 2007 and 2008, water temperature at all Bush River Stations rose predictably as air temperatures increased during the summer months (Figure 4). Otter Point Creek reached a peak of approximately 34°C between June and August in both 2007 and 2008. Church Point displayed a similar pattern in 2008 while Lauderick Creek, which is located further downstream than the other two sites and, therefore, receives a greater influx of water from the Chesapeake Bay, peaked at around 31°C in August, 2007.

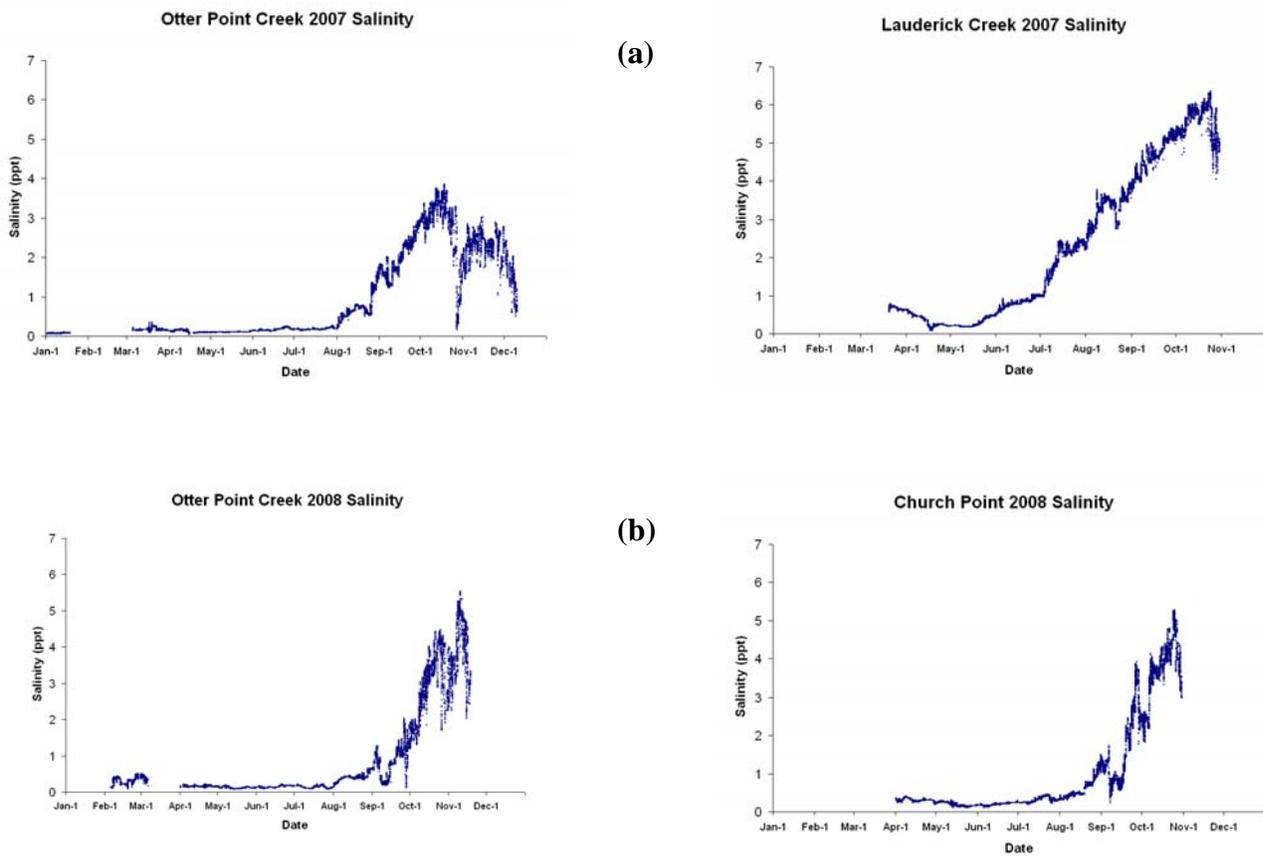
Figure 5. Salinity levels at Bush River Continuous Monitoring sites during (a) 2007 and (b) 2008.

In 2007, salinity levels for both the Otter Point Creek and Lauderick Creek monitoring sites were within their normal annual ranges during the spring and early summer (Figure 5a). Levels then increased substantially during the late summer and early fall as May through September experienced below normal precipitation (Figure 2a), which reduced flow conditions and allowed higher salinity waters from the Chesapeake Bay to move upriver. Salinity levels at Lauderick Creek began steadily increasing around the end of May and peaked at 6.4 parts per thousand (ppt) on October 24th. The Otter Point Creek site is located further upstream (Figure 1) and it, therefore, takes longer for the higher salinity waters of the Chesapeake Bay to influence levels than at Lauderick Creek. Thus, salinity levels at Otter Point Creek did not begin steadily rising until August and peaked at 3.9ppt on October 18th. Levels at both sites decreased following a substantial precipitation and discharge event beginning October 24th (Figure 3a).

In 2008, salinity levels for both the Otter Point Creek and Church Point sites remained low for most of the spring and summer (Figure 5b) as April through July was wetter than normal (Figure 2b). Levels at both sites began increasing during a dry August, dropped slightly following a wet September, and increased steadily through late October and early November. Church Point salinity levels peaked at 5.3ppt on October 25th and Otter Point Creek levels peaked at 5.5ppt on November 10th.

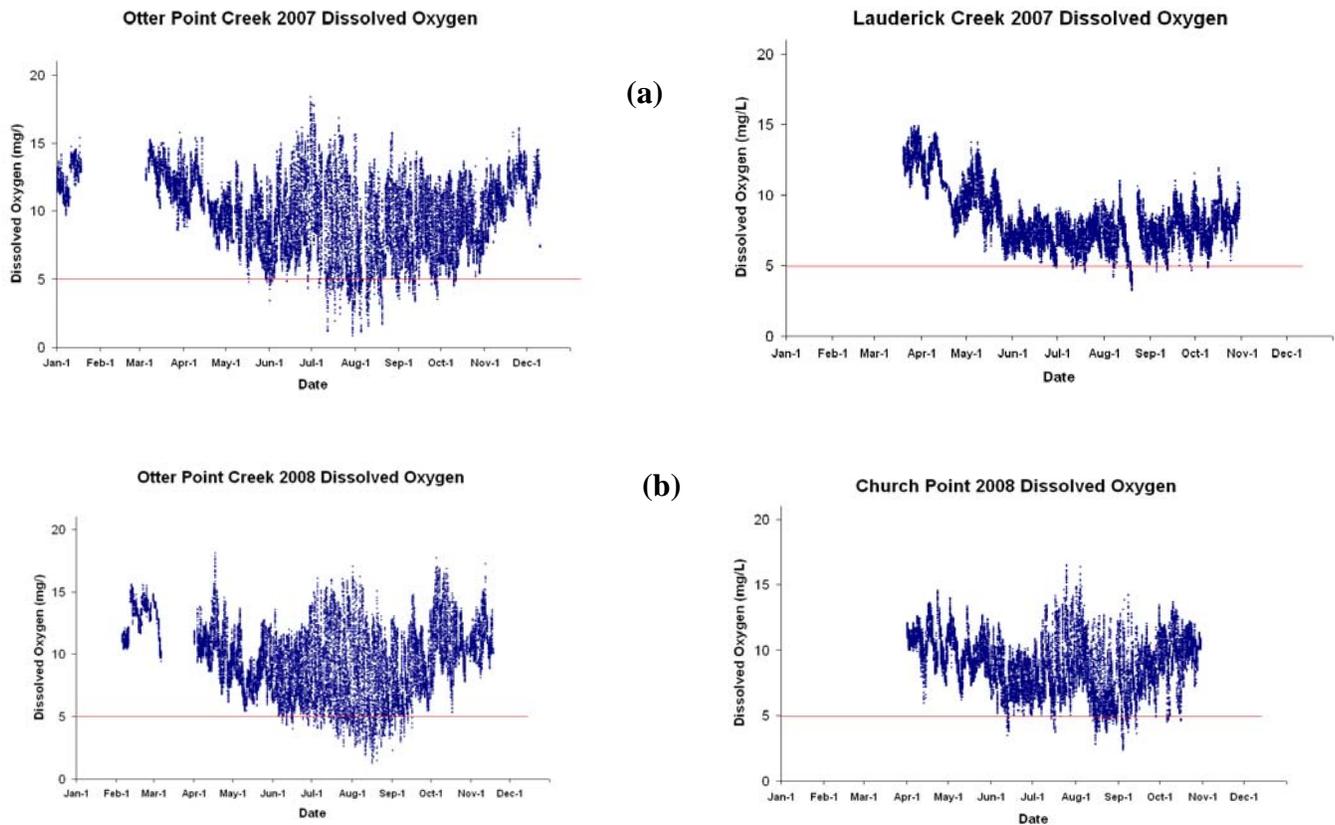
Figure 6. Dissolved oxygen levels at Bush River Continuous Monitoring sites during (a) 2007 and (b) 2008.

(Red line indicates threshold below which levels can lead to ecosystem stress.)

In 2007, dissolved oxygen for both Lauderick Creek and Otter Point Creek exhibited expected declines during the summer months (Figure 6a) because warmer water cannot dissolve oxygen as readily as colder water. Greater variability in dissolved oxygen levels was also seen at Otter Point Creek, indicating that this site is more affected by nutrients and associated algal blooms that affect dissolved oxygen levels than the site at Lauderick Creek, which is further downstream and experiences more mixing with water from the Chesapeake Bay. Both sites, however, experienced relatively few days of dissolved oxygen concentrations below 5 milligrams per liter (mg/l) (Table 2), which can be detrimental to the survival of juvenile fish (US EPA, 2003), perhaps due to the absence of large, harmful phytoplankton blooms such as those seen in 2003 and 2004 on the Bush River.

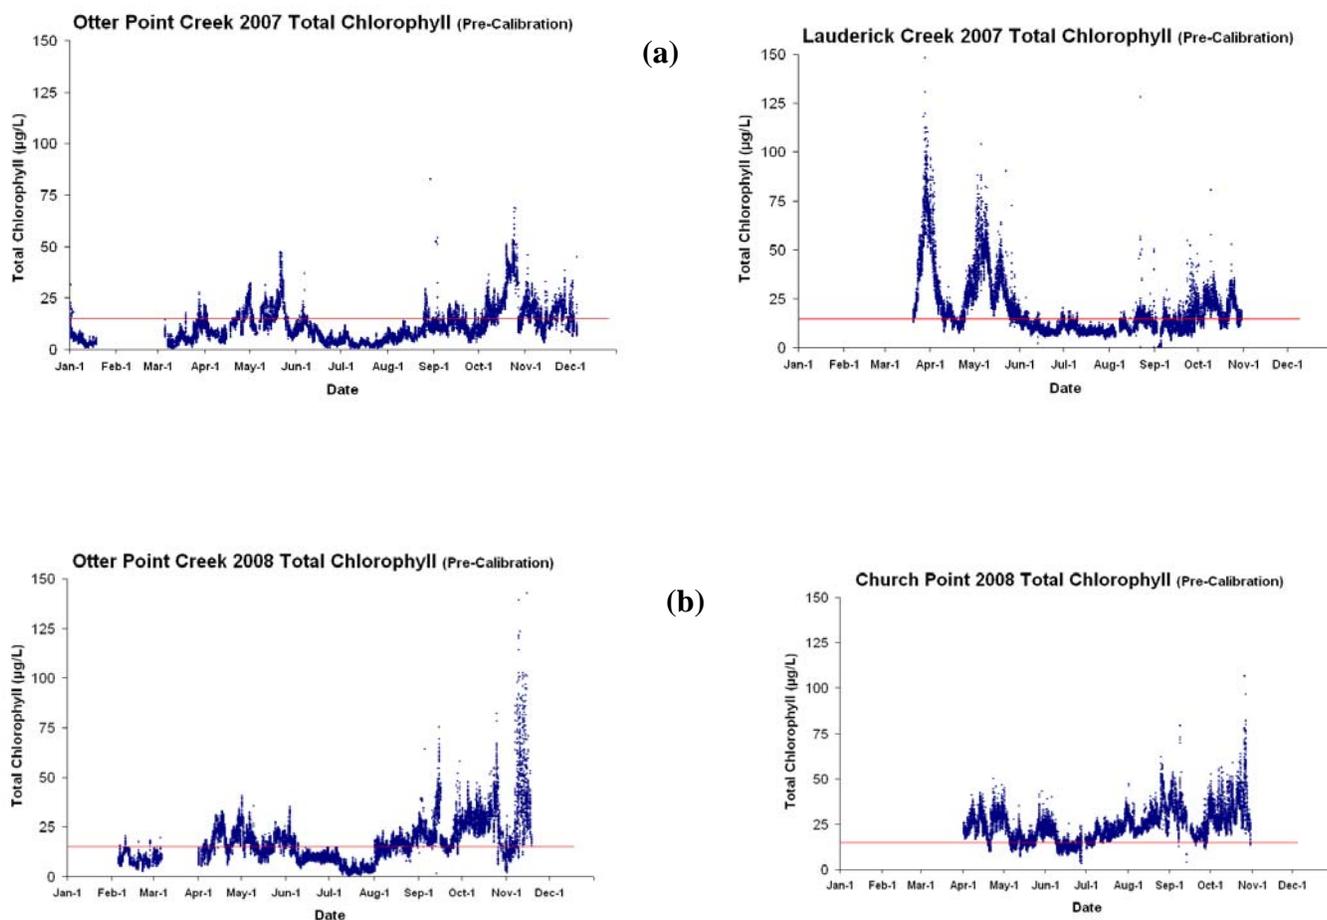
Figure 7. Total chlorophyll levels at Bush River Continuous Monitoring sites during (a) 2007 and (b) 2008.
(Red line indicates threshold above which levels may have harmful effects on aquatic ecosystems.)

In 2007 at both Continuous Monitoring sites, there were very few chlorophyll readings greater than 50 micrograms per liter ($\mu\text{g}/\text{l}$), which are indicative of significant algal blooms, or $100\mu\text{g}/\text{l}$, which indicates severe blooms (Figure 7a and Table 3). Lauderick Creek showed brief spikes in chlorophyll in late March and early May, while Otter Point Creek experienced a brief spike in late October. The late-March peak of approximately $100\mu\text{g}/\text{l}$ at Lauderick Creek coincided with a sanitary sewer overflow on March 28th, and a drop in dissolved oxygen levels in early April (Figure 6a). A substantial proportion of chlorophyll readings during the wet spring, however, were greater than $15\mu\text{g}/\text{l}$ (Table 3), a threshold above which detrimental effects on aquatic ecosystems may occur. Of 6,893 valid readings at Lauderick Creek between March and May, 87% were greater than $15\mu\text{g}/\text{l}$. At Otter Point Creek, 29.8% of 7,103 valid readings between March and May were greater than $15\mu\text{g}/\text{l}$.

In 2008, chlorophyll levels generally remained below 50µg/l until late August and early September when both sites experienced a series of algal blooms that lasted into November (Figure 7b). A much higher proportion of readings at Otter Point Creek were greater than 15µg/l than were measured in 2007 (Table 3). Of 5,740 valid readings between March and May and 8,449 valid readings between July and September, 58.8% and 47.8% respectively were greater than 15µg/l. A peak of greater than 100µg/l in mid-November also coincided with a harmful algal bloom of *Karlodinium veneficum* that was detected at the Otter Point Creek site (Table 1). At Church Point, of 4,864 valid readings between March and May and 8,173 valid readings between July and September, 83.6% and 96.4% respectively were greater than 15µg/l.

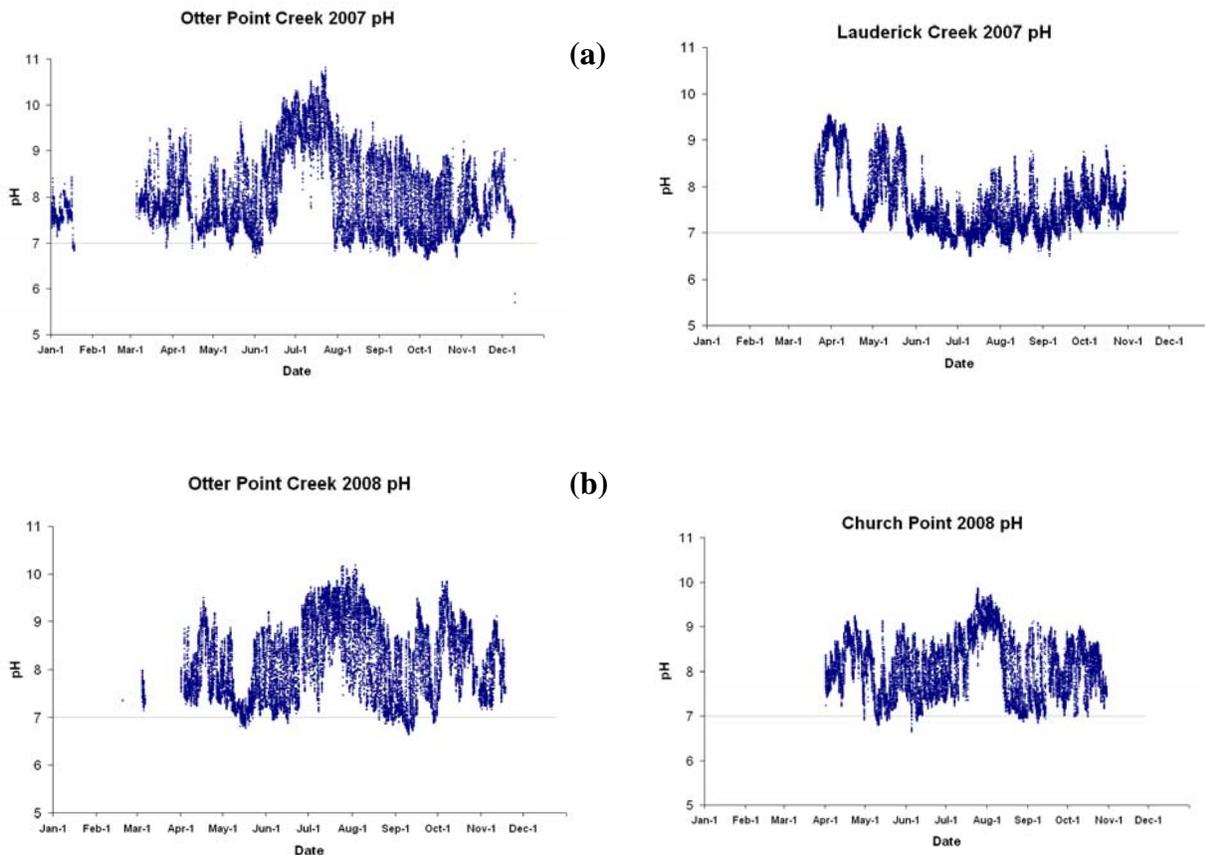
Figure 8. pH levels at Bush River Continuous Monitoring sites during (a) 2007 and (b) 2008.

(Line indicates neutral pH.)

In 2007, the variability of Otter Point Creek pH measurements was larger than the variability at Lauderick Creek (Figure 8a). Otter Point Creek was also generally more alkaline than Lauderick Creek, which follows the pattern seen in previous years. Of note, pH at both sites dropped dramatically in mid-April following an influx of fresh water into the system from a Nor'Easter (Table 1) and associated discharge event (Figure 2). Lauderick Creek dropped from 9.3 on April 10th to 7.1 on April 23rd, while Otter Point Creek dropped from 9.5 on April 10th to 6.9 on April 24th. Also, Otter Point Creek experienced a spike in pH between mid-June and the end of July. Such spikes often indicate the presence of a blue-green (*Microcystis* sp.) algal bloom, which currently cannot be detected with the fluorometers used to measure chlorophyll on the Continuous Monitoring datasondes deployed on the Bush River. However, low dissolved oxygen levels at Otter Point Creek in July and August (Figure 6a) provide further evidence of a phytoplankton bloom and subsequent die-off.

In 2008, Otter Point Creek and Church Point displayed similar variability and pH levels (Figure 8b). Both Continuous Monitoring sites showed a dip in pH in mid-May following a heavy rain (Table 1) and discharge event (Figure 2) and a spike in pH levels in July and August. This spike on Otter Point Creek was lower in magnitude, however, than the one observed in 2007 (Figure 8a).

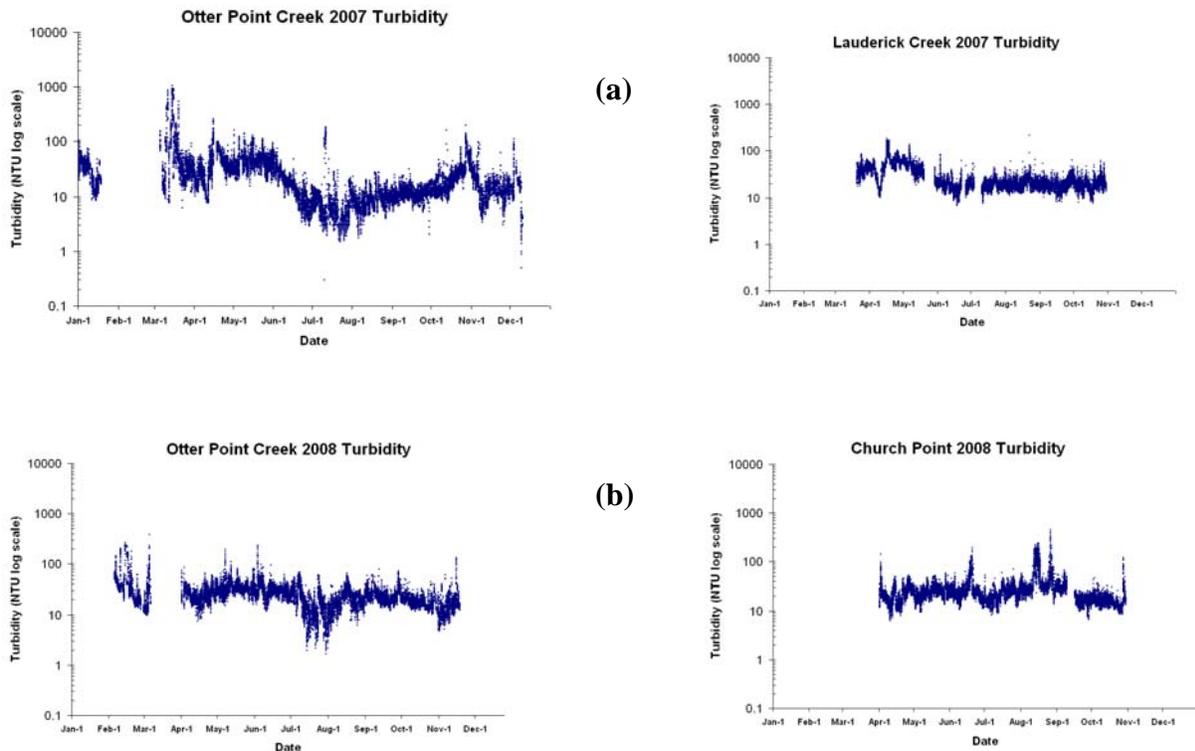
Figure 9. Turbidity levels at Bush River Continuous Monitoring sites during (a) 2007 and (b) 2008.

Turbidity is one parameter of water clarity and is quantified by measuring how much light is reflected from suspended particles in the water. Lower turbidity values indicate less reflection and, therefore, clearer water. In 2007, Lauderick Creek experienced less variability and generally lower overall turbidity levels than Otter Point Creek (Figure 9a). Both Continuous Monitoring sites experienced spikes and declines in turbidity levels following weather patterns and discharge events, although the overall magnitude of change was lower at the Lauderick Creek site. Turbidity levels went above 1000 nephelometric turbidity units (NTUs) once at Otter Point Creek following a winter storm in mid-March (Table 1). A Nor'easter that impacted the mid-Atlantic region in mid-April (Table 1) led to a high volume discharge event (Figure 2a) and a spike in turbidity with levels reaching 185.6 NTUs at Lauderick Creek and 258.1 NTUs at Otter Point Creek. Otter Point Creek also experienced a turbidity spike in mid-July that coincided with a spike in pH (Figure 8a), potentially indicating a blue-green algal bloom. Levels then declined and leveled off through a dry summer and Otter Point Creek experienced spikes again in late October and early December following high volume discharge events (Figure 2a).

Although 2008 was a wetter year than 2007 (Figure 2) leading to more frequent spikes in discharge (Figure 2), overall volume from discharge events was lower in 2008, which may have led to the more consistent levels of turbidity observed at the two Continuous Monitoring sites (Figure 9b). Church Point experienced brief spikes over 100 NTUs in April, June, August, and October and Otter Point Creek dropped to below 10 NTUs in July. Both sites, however, exhibited turbidity levels between 20 and 50 NTUs for the majority of the year.

Furthermore, two autumn sanitary sewer overflows in the Bush River watershed (Table 1) coincided with increases in turbidity at each site. Following a sanitary sewer overflow on September 26th, turbidity levels at Otter Point Creek increased from approximately 14 NTUs on September 24th to 74 NTUs on September 28th. Following a sanitary sewer overflow on October 26th, turbidity levels at Church Point increased from approximately 10 NTUs on October 25th to 121.6 NTUs on October 28th.

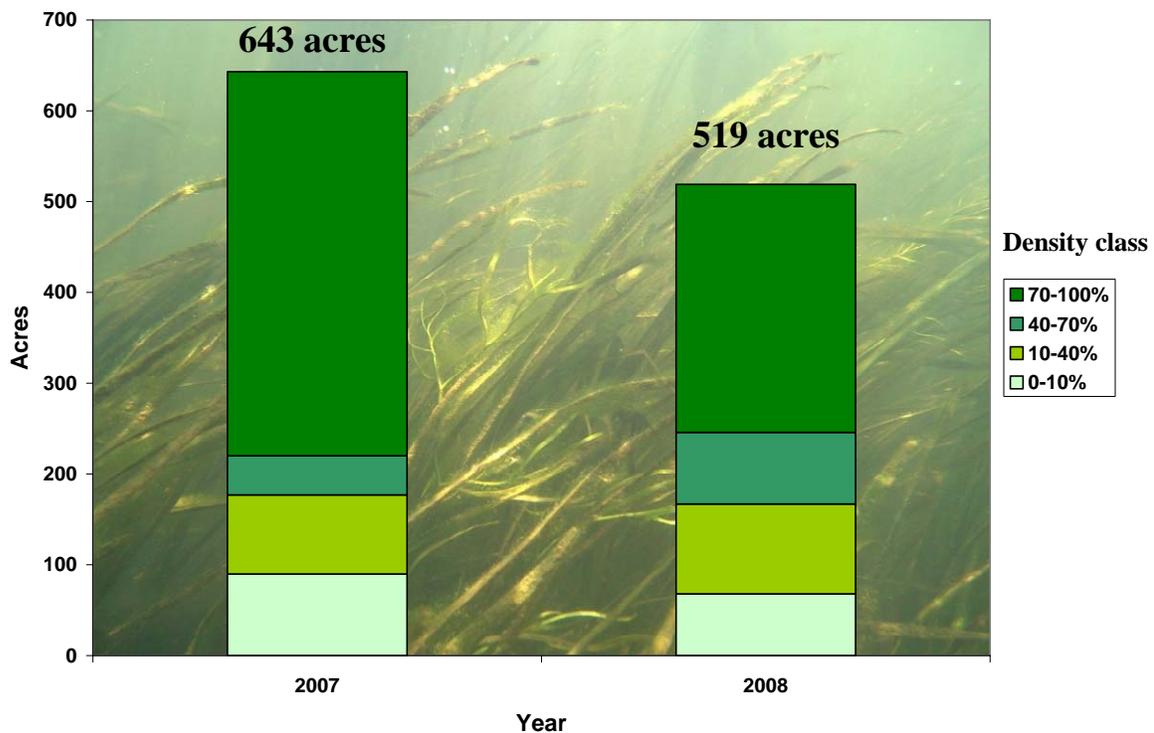
Figure 10. Total area and density of SAV in the Bush River during 2007 and 2008.

Total area of SAV in 2007 increased by 98% from the previous year to 643 acres. Over 65% of this acreage consisted of high density beds (Figure 10) and 6 different species (*Ceratophyllum demersum*, *Elodea canadensis*, *Hydrilla verticillata*, *Myriophyllum spicatum*, *Vallisneria americana*, *Zannichellia palustris*) were present in 2007. Total area decreased by 19% to 519 acres in 2008. Over 52% of this acreage consisted of high density beds and all species from 2007, with the exception of *Zannichellia palustris*, were present.

The decrease in SAV acreage between 2007 and 2008 may be partly explained by greater water clarity in 2007. At the Otter Point Creek Continuous Monitoring site, chlorophyll levels were lower (Table 3) and K_d values indicate there were more optimal light conditions within the water column to facilitate SAV growth (Table 4) in 2007 than in 2008. K_d values in 2007 were also much improved as compared to 2006 (see data supplement for the 2006 Bush River Newsletter: http://mddnr.chesapeakebay.net/eyesonthebay/documents/Bush_River_sup.pdf), which may have facilitated the expansion in SAV acreage.
