# Big Spring Run Monitoring

## Biological and Ecosystem Results

**Pennsylvania Legacy Sediment Workgroup**

**Bureau of Waterways Engineering and Wetlands**

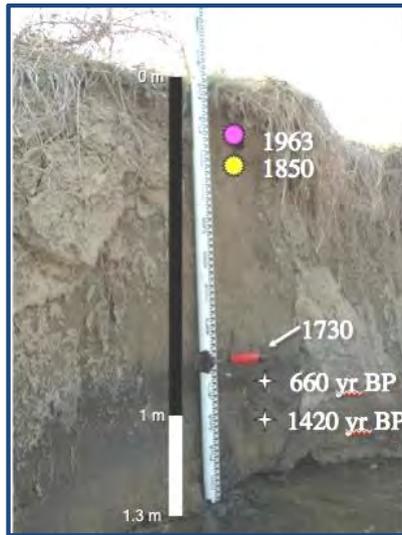
## ~1000 BC – 1730 AD

Diatom assemblage in the hydric paleosol was diverse and dominated by large-celled species of *Pinnularia* and *Stauroneis* that are indicative of low nutrient and wetland conditions.

Before 1700s Big Spring Run was inhabited by diverse diatom communities that are known to prefer slow-moving clean waters with abundant vegetation and wetlands

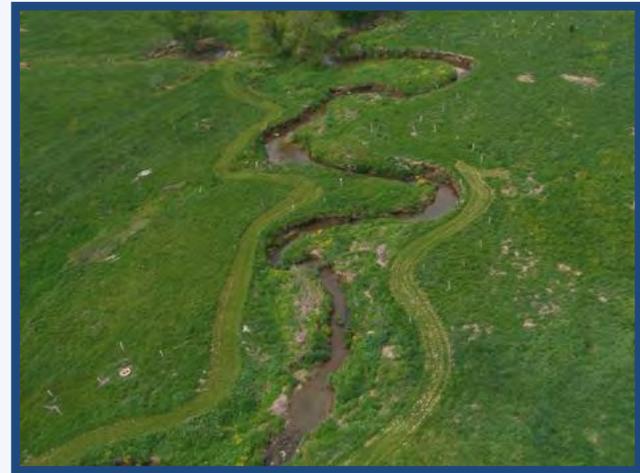
Diatom assemblages similar to those found in 1948 in relatively “healthy” Lancaster County streams.

The overall diatom species composition in the restored reach did not considerably change by December 2015 compared to pre-restoration, which could be expected considering still relatively high nutrient concentrations in the groundwater and surface water.

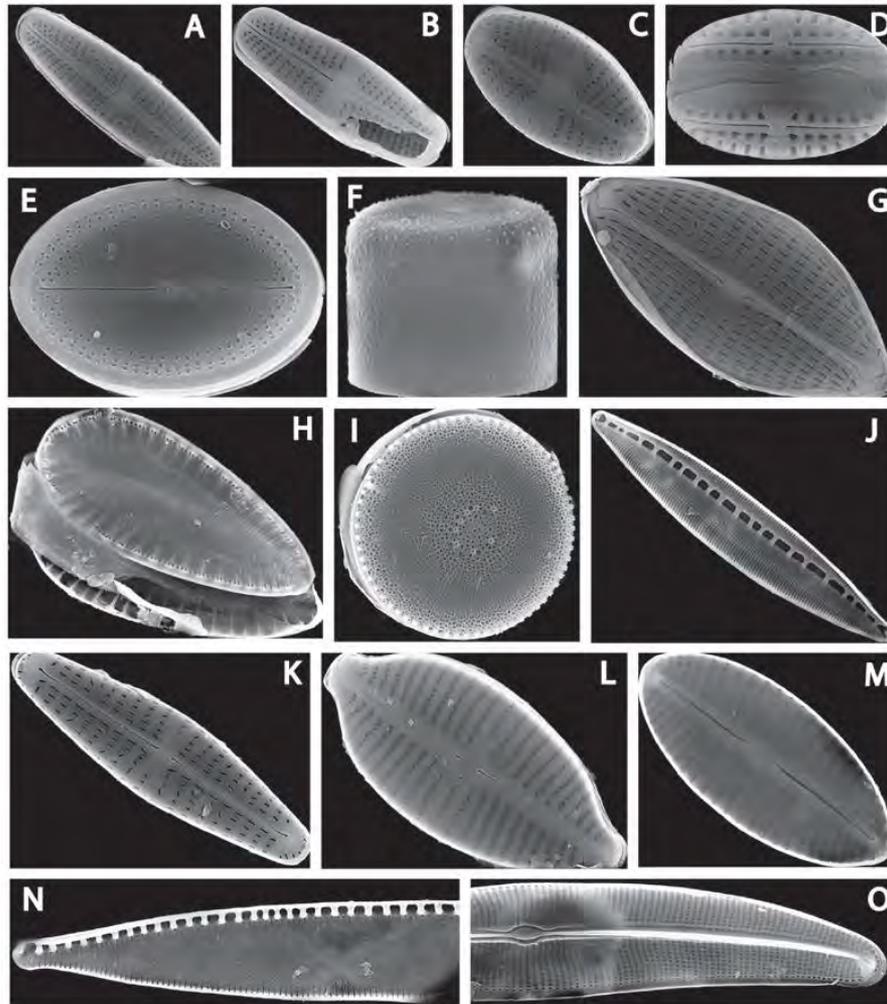
## Common diatoms from Big Spring Run

Figure 1.2. Scanning electron microscopy images of the common diatoms from BSR samples. A – *Achnantheidium minutissimum*, B – *A. saprophilum*, C – *Eolimna minima*, D – *Amphora pediculus*, E – *Cocconeis placentula*, F – *Melosira varians*, G – *Navicula antonii*, H – *Surirella lacrimula*, *Thalassiosira weissflogii*, J – *Nitzschia dissipata*, K – *Hippodonta pseudacceptata*, L – *Gomphonema parvulum* var. *saprophilum*, M – *Craticula subminuscula*, N – *Nitzschia palea*, O – *Gyrosigma obtusatum*.

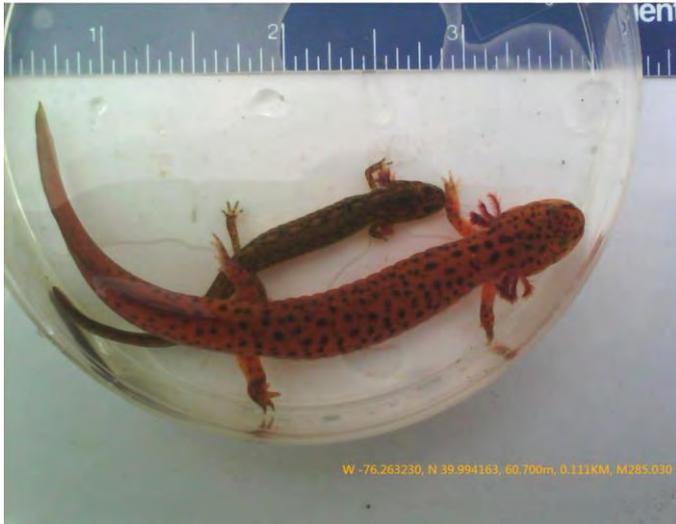
*Eurycea bislineata* (Northern two-lined) and  
*Pseudotriton ruber* (Northern red) larvae

Prior to restoration, the amphibian community at Big Spring Run consisted of only *E. bislineata* and *P. ruber*.

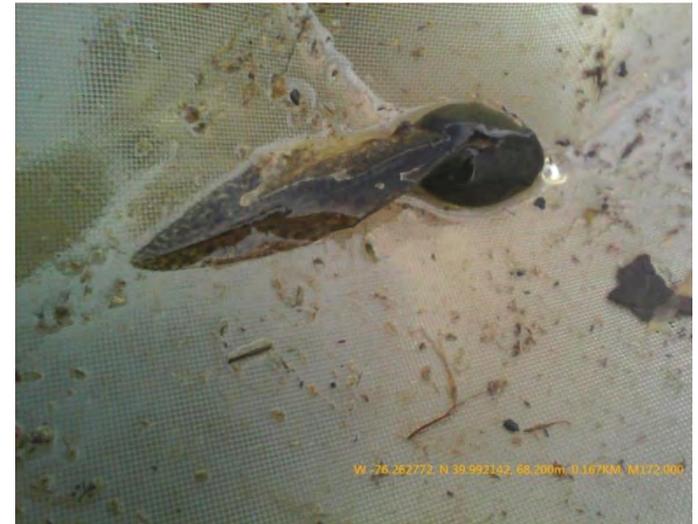
*Lithobates clamitans* (Green frog) tadpole

While *L. clamitans* is a nationally common frog species, it was found residing and breeding at Big Spring Run after restoration and despite the surrounding agricultural landuses.

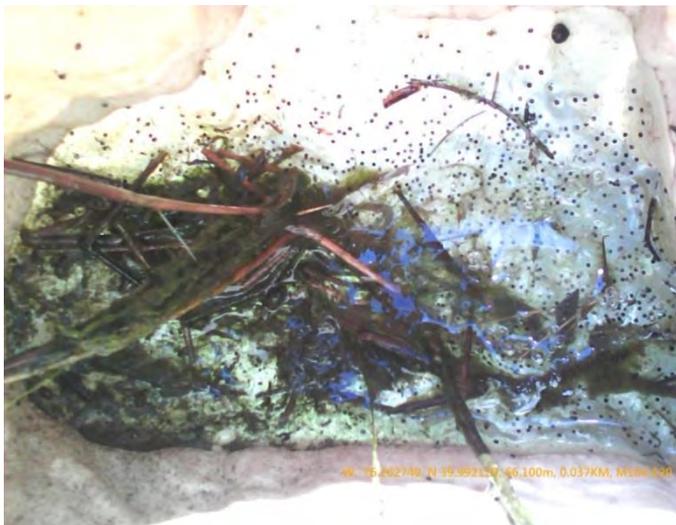
Green frog egg mass

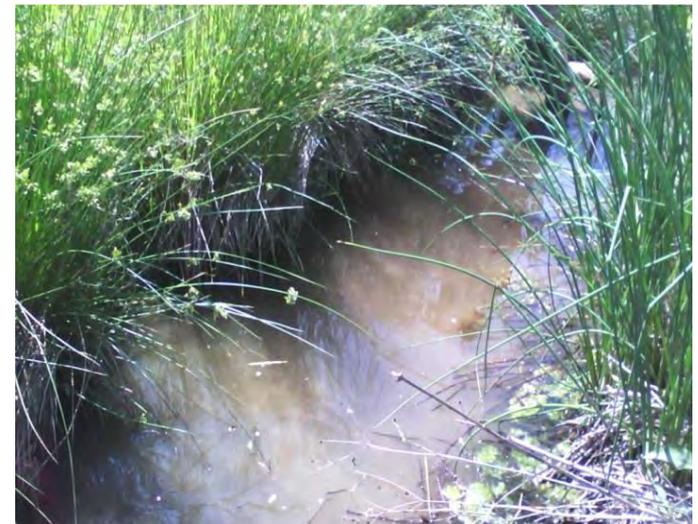
Restored habitat where green frog egg  
mass was found.

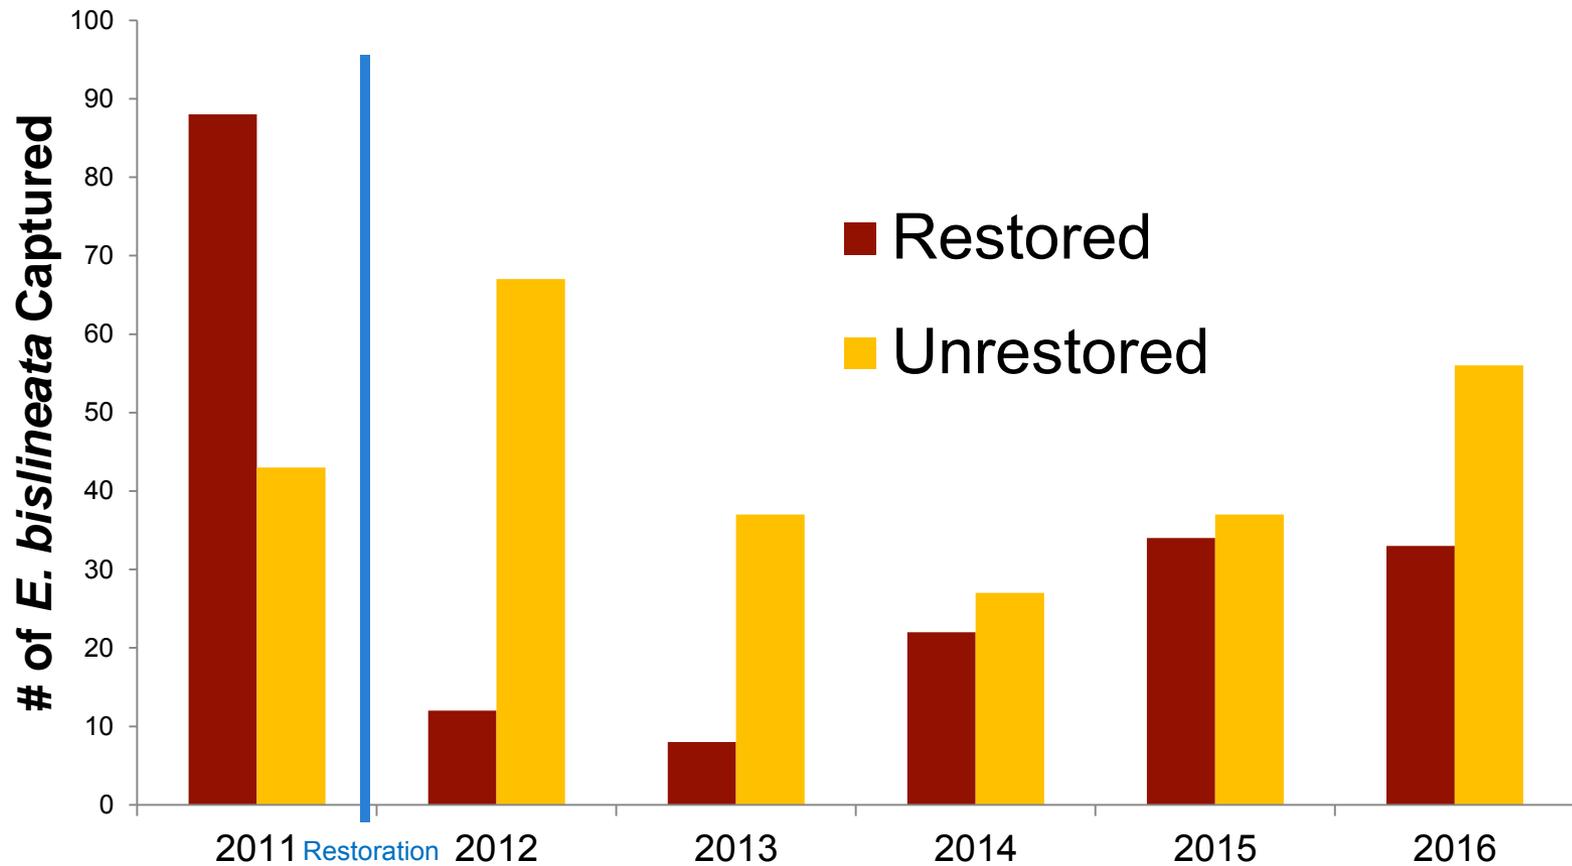
Capture records of *Eurycea bislineata* (northern two-lined salamanders). The data are the sum of trapping efforts with litter bags, kick nets, and dip nets. Capture effort was equal for each branch.

Our finding that captures increased in the unrestored branch of Big Spring Run after the restoration suggested this branch served as refugia for *E. bislineata*.

In the years following the wetland restoration, *E. bislineata* has consistently increased in the restored stretches while its captures in the unrestored stretches have fluctuated.

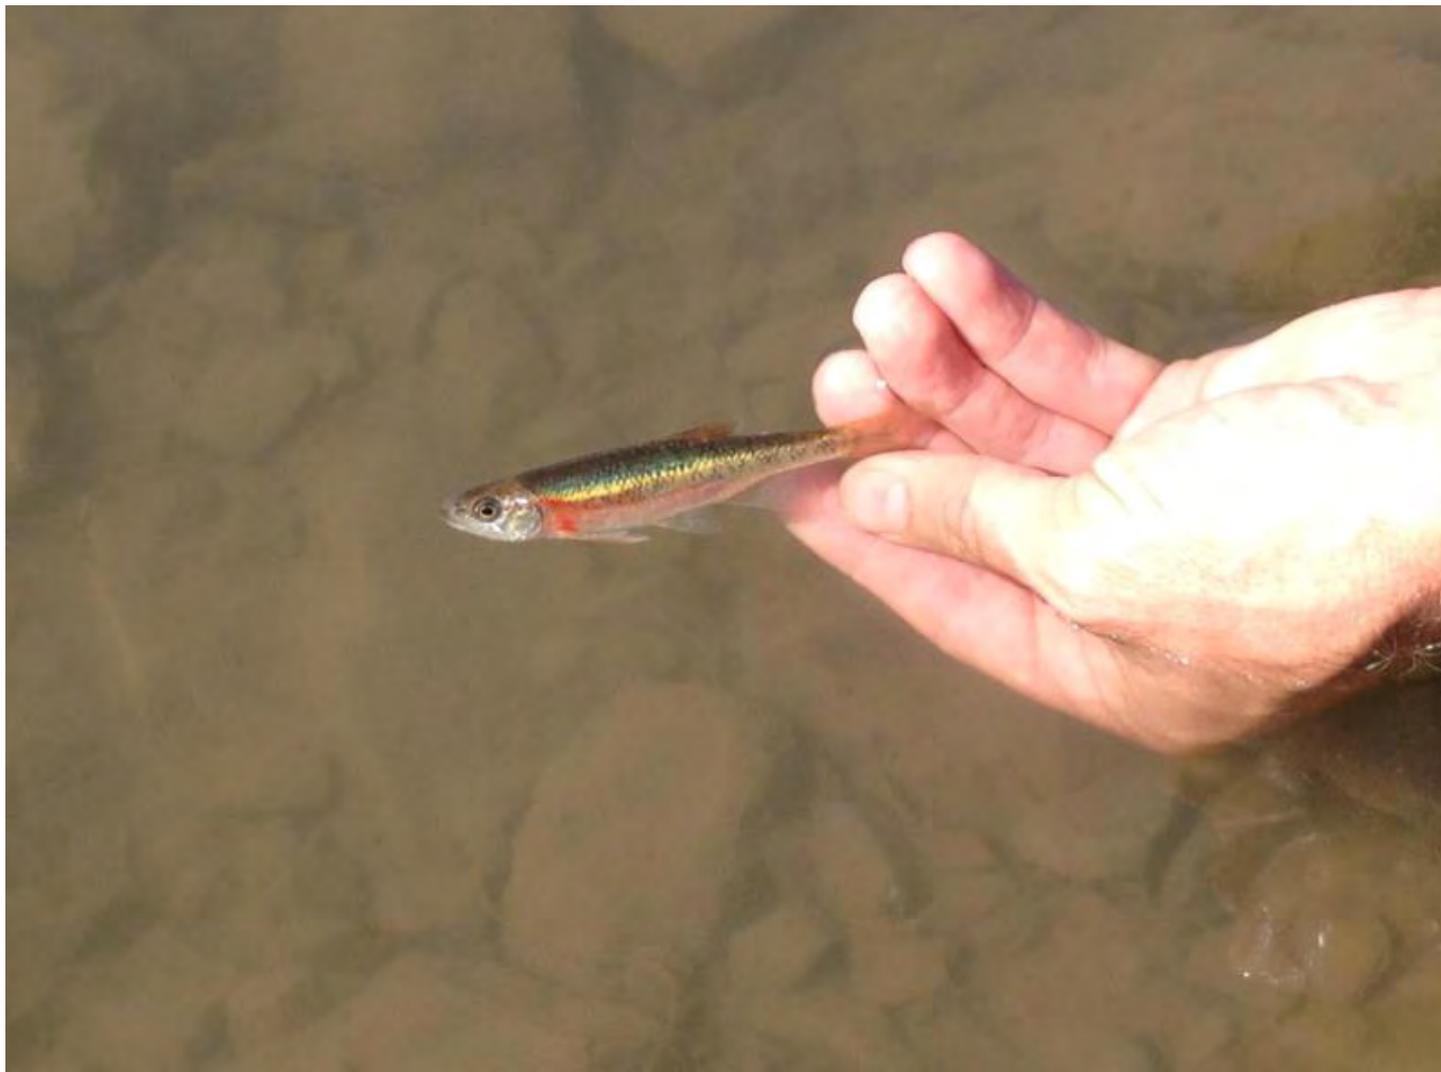
rosyside dace (*Clinostomus funduloides*)

Rosyside dace (*Clinostomus funduloides*) was captured within the restored reach in 2015. This species prefers headwater streams typical of cold water fishes and is an indication of improved water quality in the restored reach. It also prefers gravelly riffles for spawning and typically inhabits rocky streams.

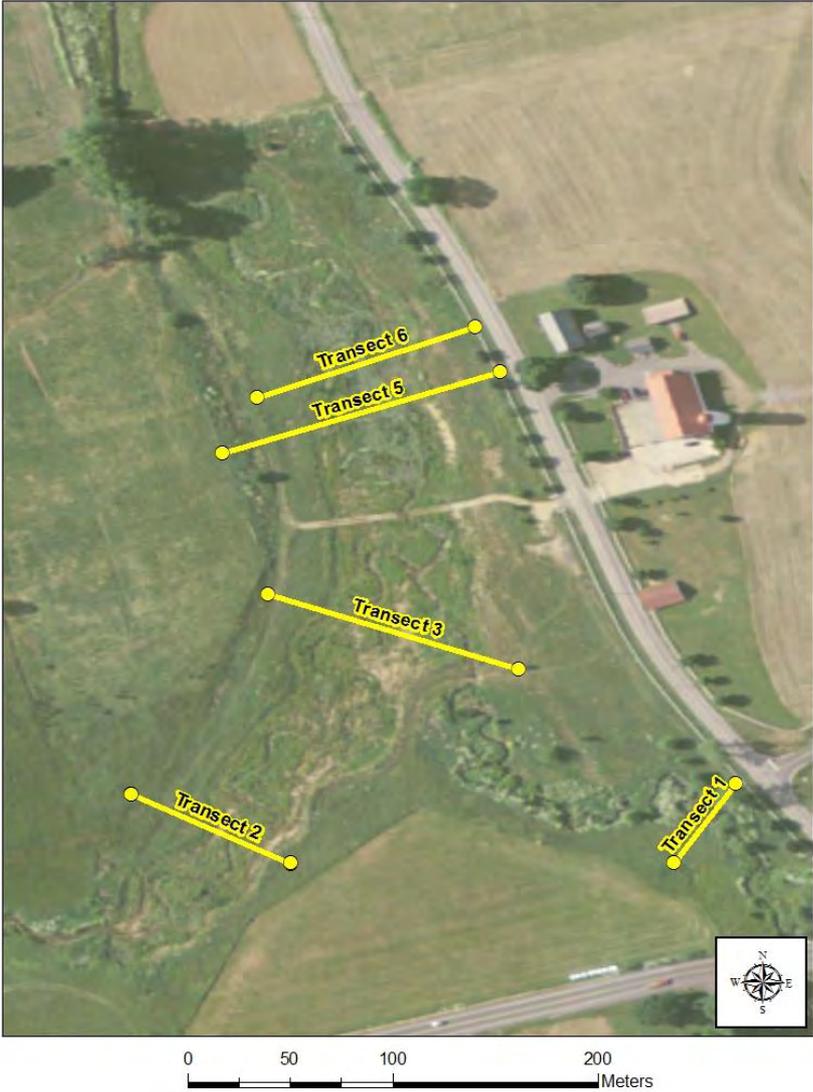
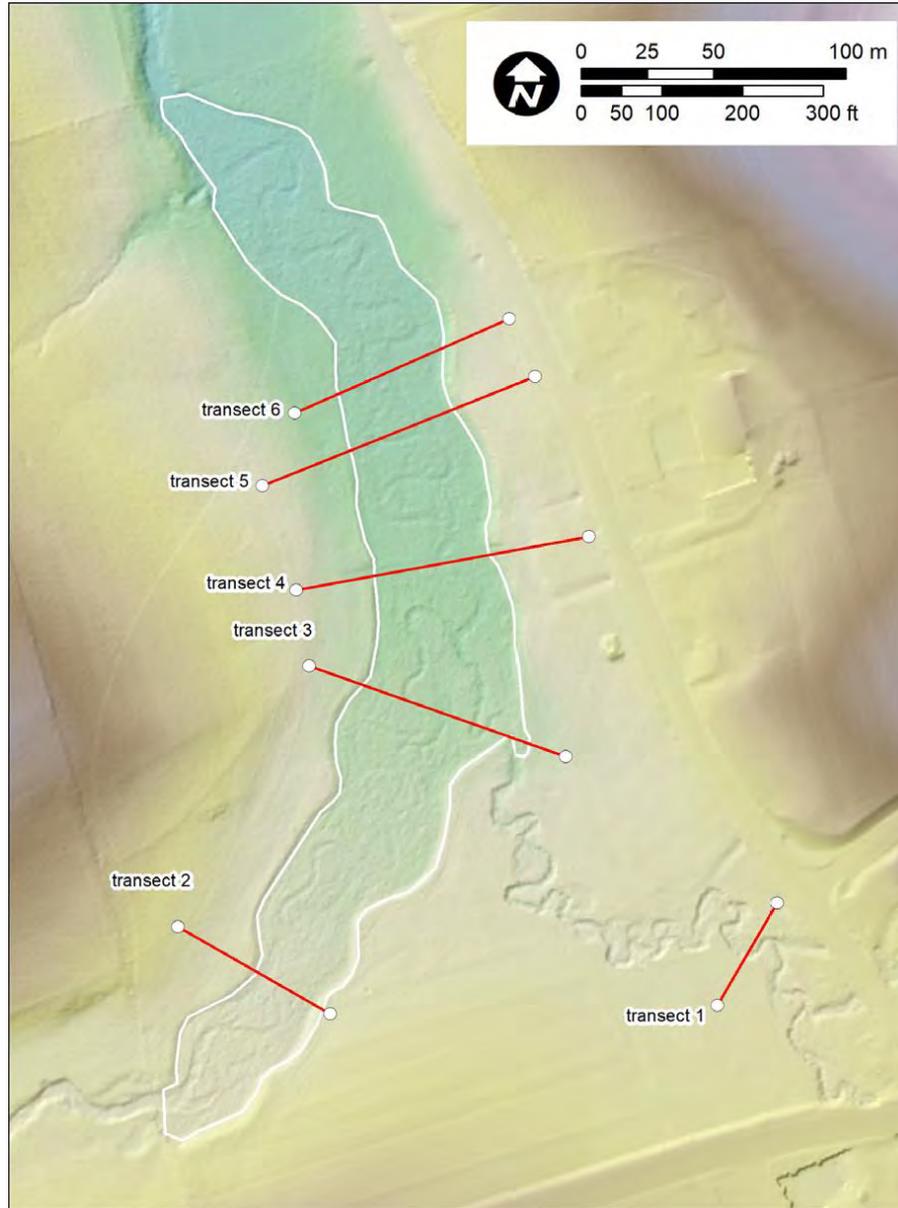
# Vascular plant surveying repeated at fixed locations along transects

1 meter<sup>2</sup> plots at 5 meter intervals repeated along transects

Analysis of vegetation transects before and after restoration reveals a major plant community change in the years following restoration. The plant community shifted from a dry, upland pasture to a hydric, wet meadow that has been sustained for consecutive years.

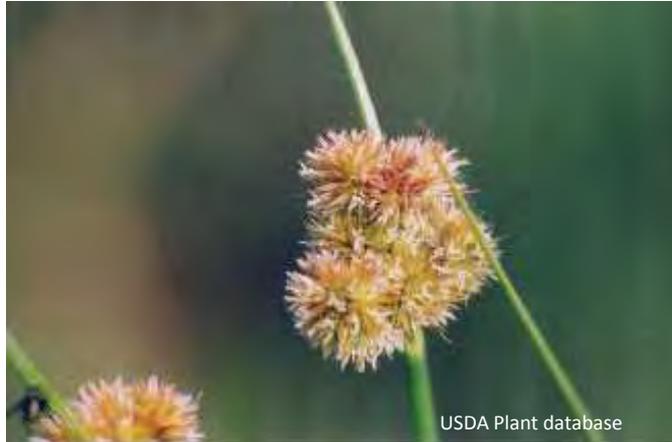
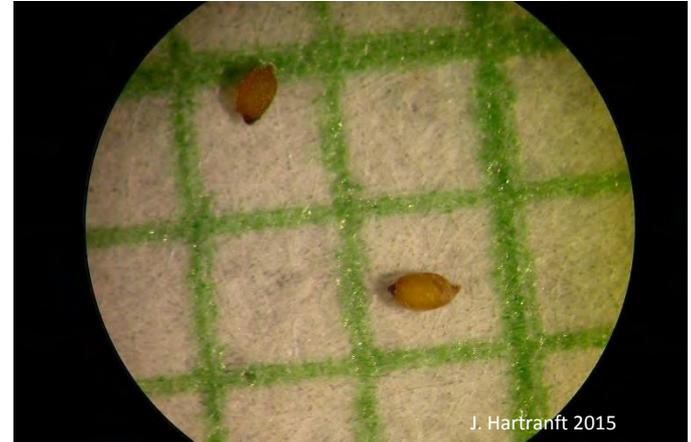
*Juncus torreyi*  
Torrey's rush  
**PA State Threatened**  
Facultative

Hydrophytes are beginning to colonize the restoration area, including the PA Threatened Torrey's sedge (*Juncus torreyi*).

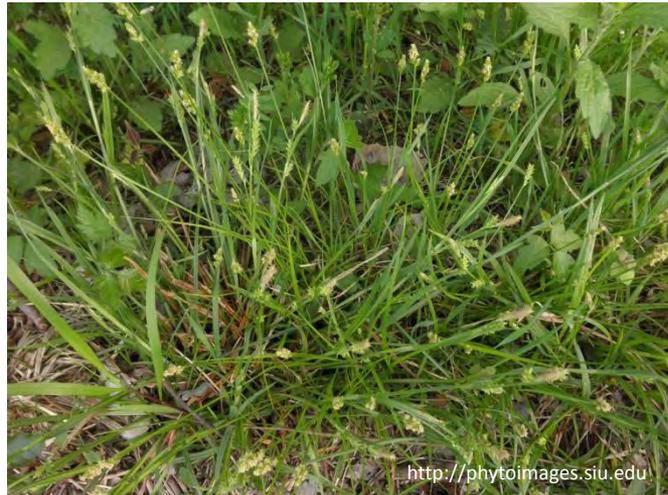
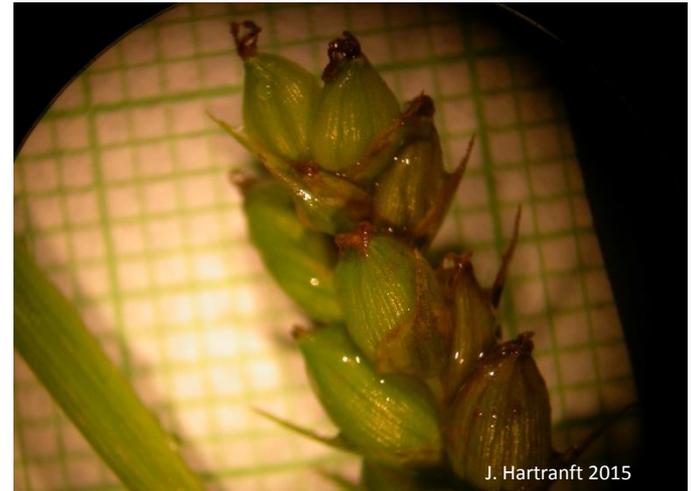
*Carex amphibola*  
narrowleaf sedge  
Facultative

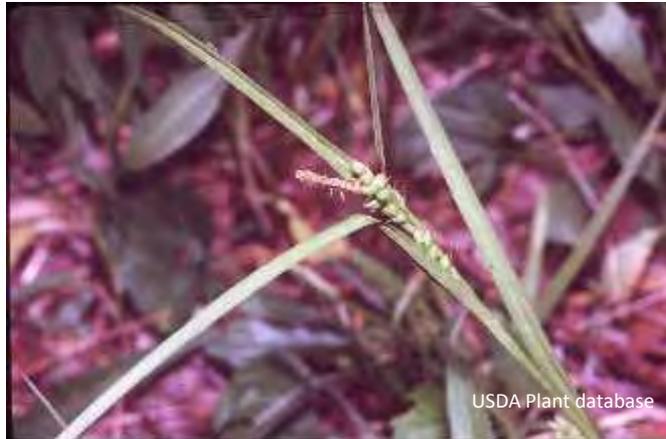
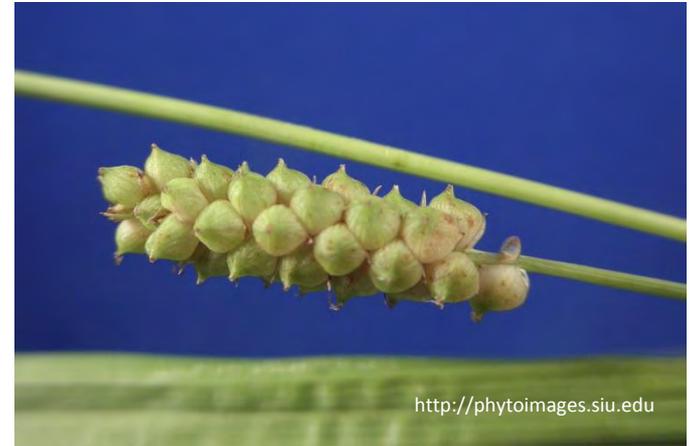
*Carex granularis*  
limestone meadow sedge  
Facultative Wetland

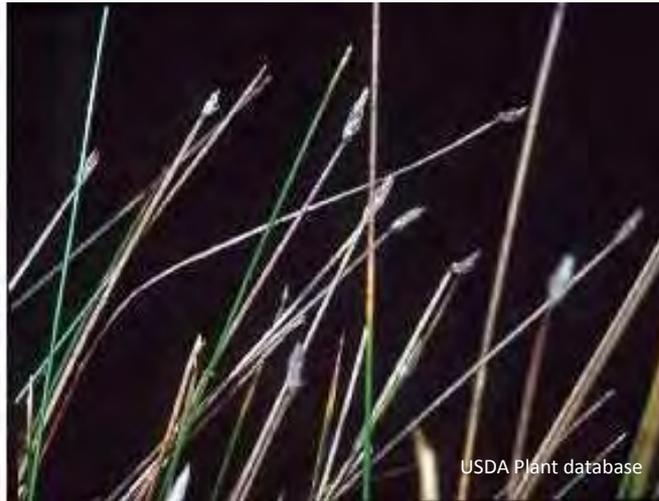
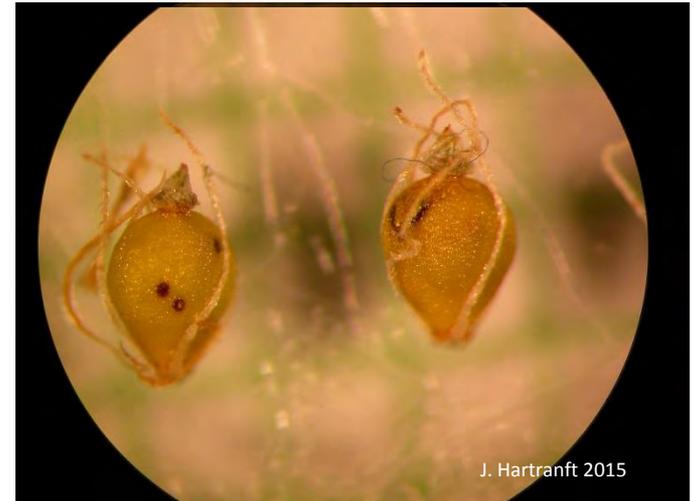
*Eleocharis palustris*  
spikerush  
Obligate

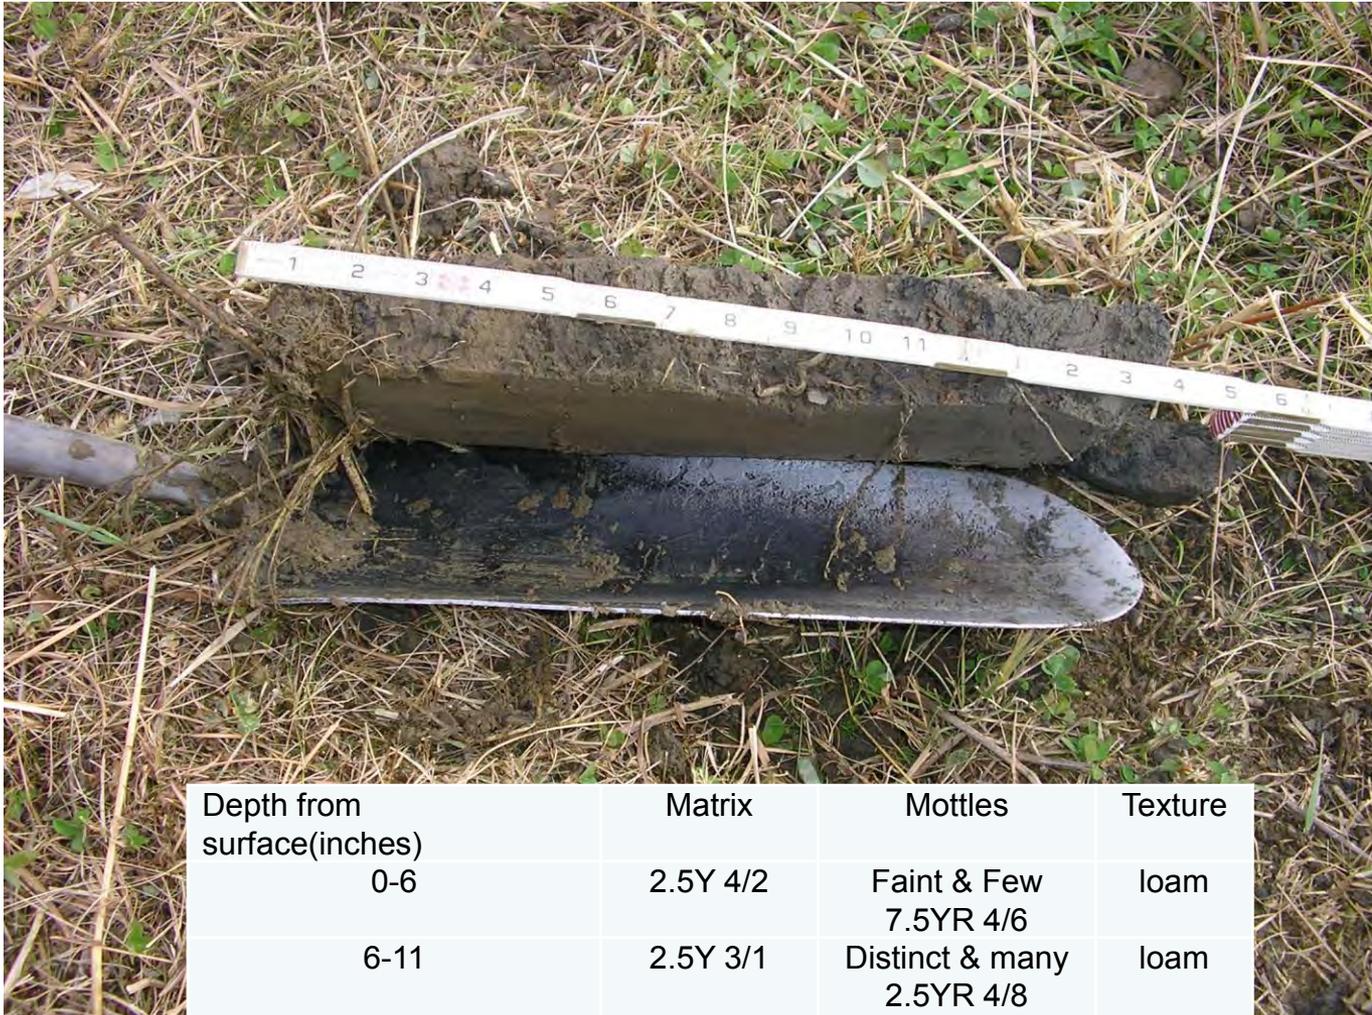
Depth from surface(inches)	Matrix	Mottles	Texture
0-6	2.5Y 4/2	Faint & Few 7.5YR 4/6	loam
6-11	2.5Y 3/1	Distinct & many 2.5YR 4/8 7.5YR 4/6	loam
11-16	2.5YR 3/1	Distinct & many 2.5YR 3/6	loam
16-18	Basal gravels		
18	Bedrock
