Muddy Creek North Branch Restoration

November 15, 2017

Straughan Environmental

- Research project
- 1,500 linear foot stream and valley restoration
- Using Regenerative Stream Channel (RSC) technique
 - Raise eroded/entrenched system to/above the legacy fill terrace

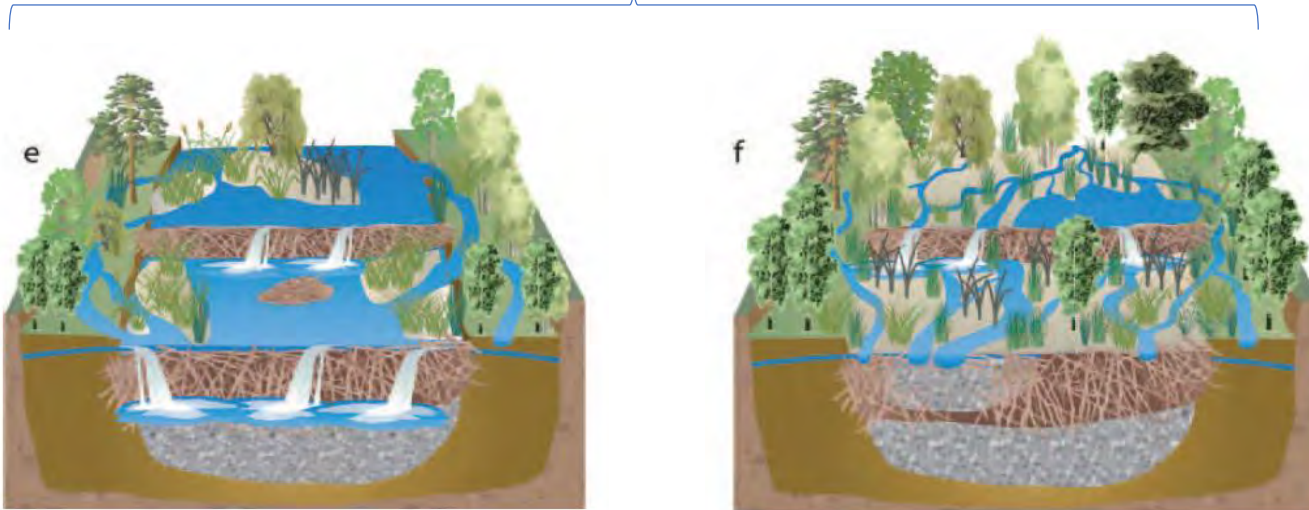
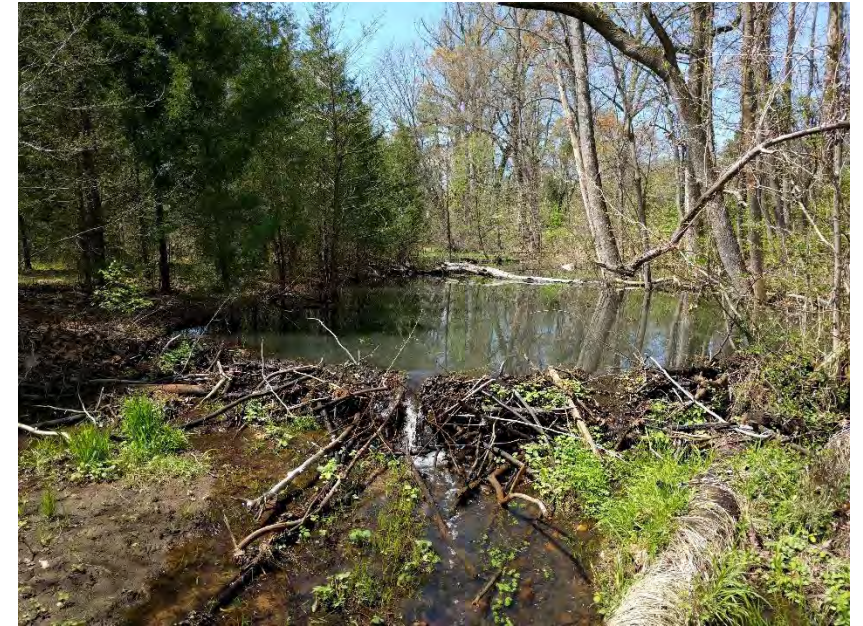
Beaver inspired regeneration

Sand-Seepage Wetland

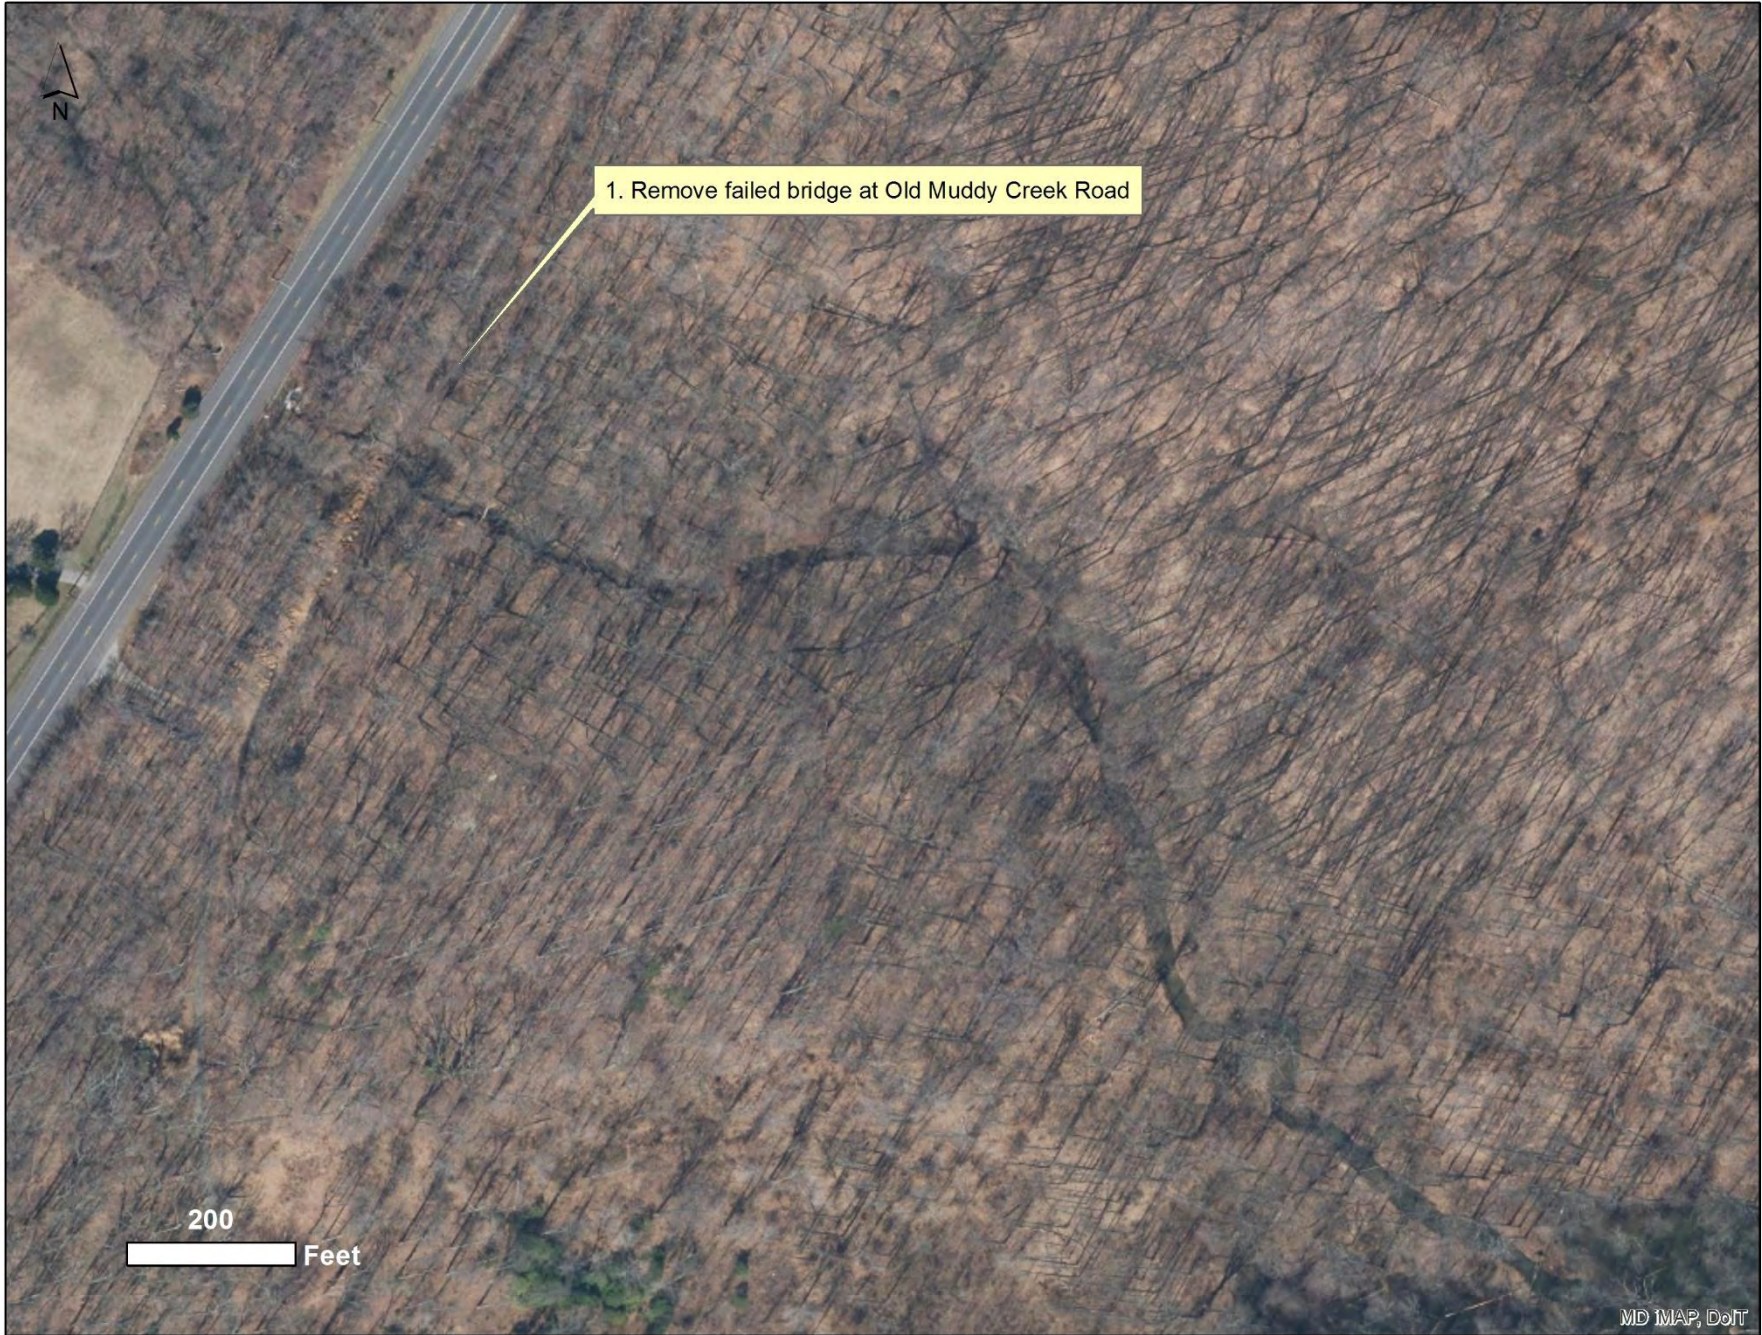
1. Remove failed bridge at Old Muddy Creek Road

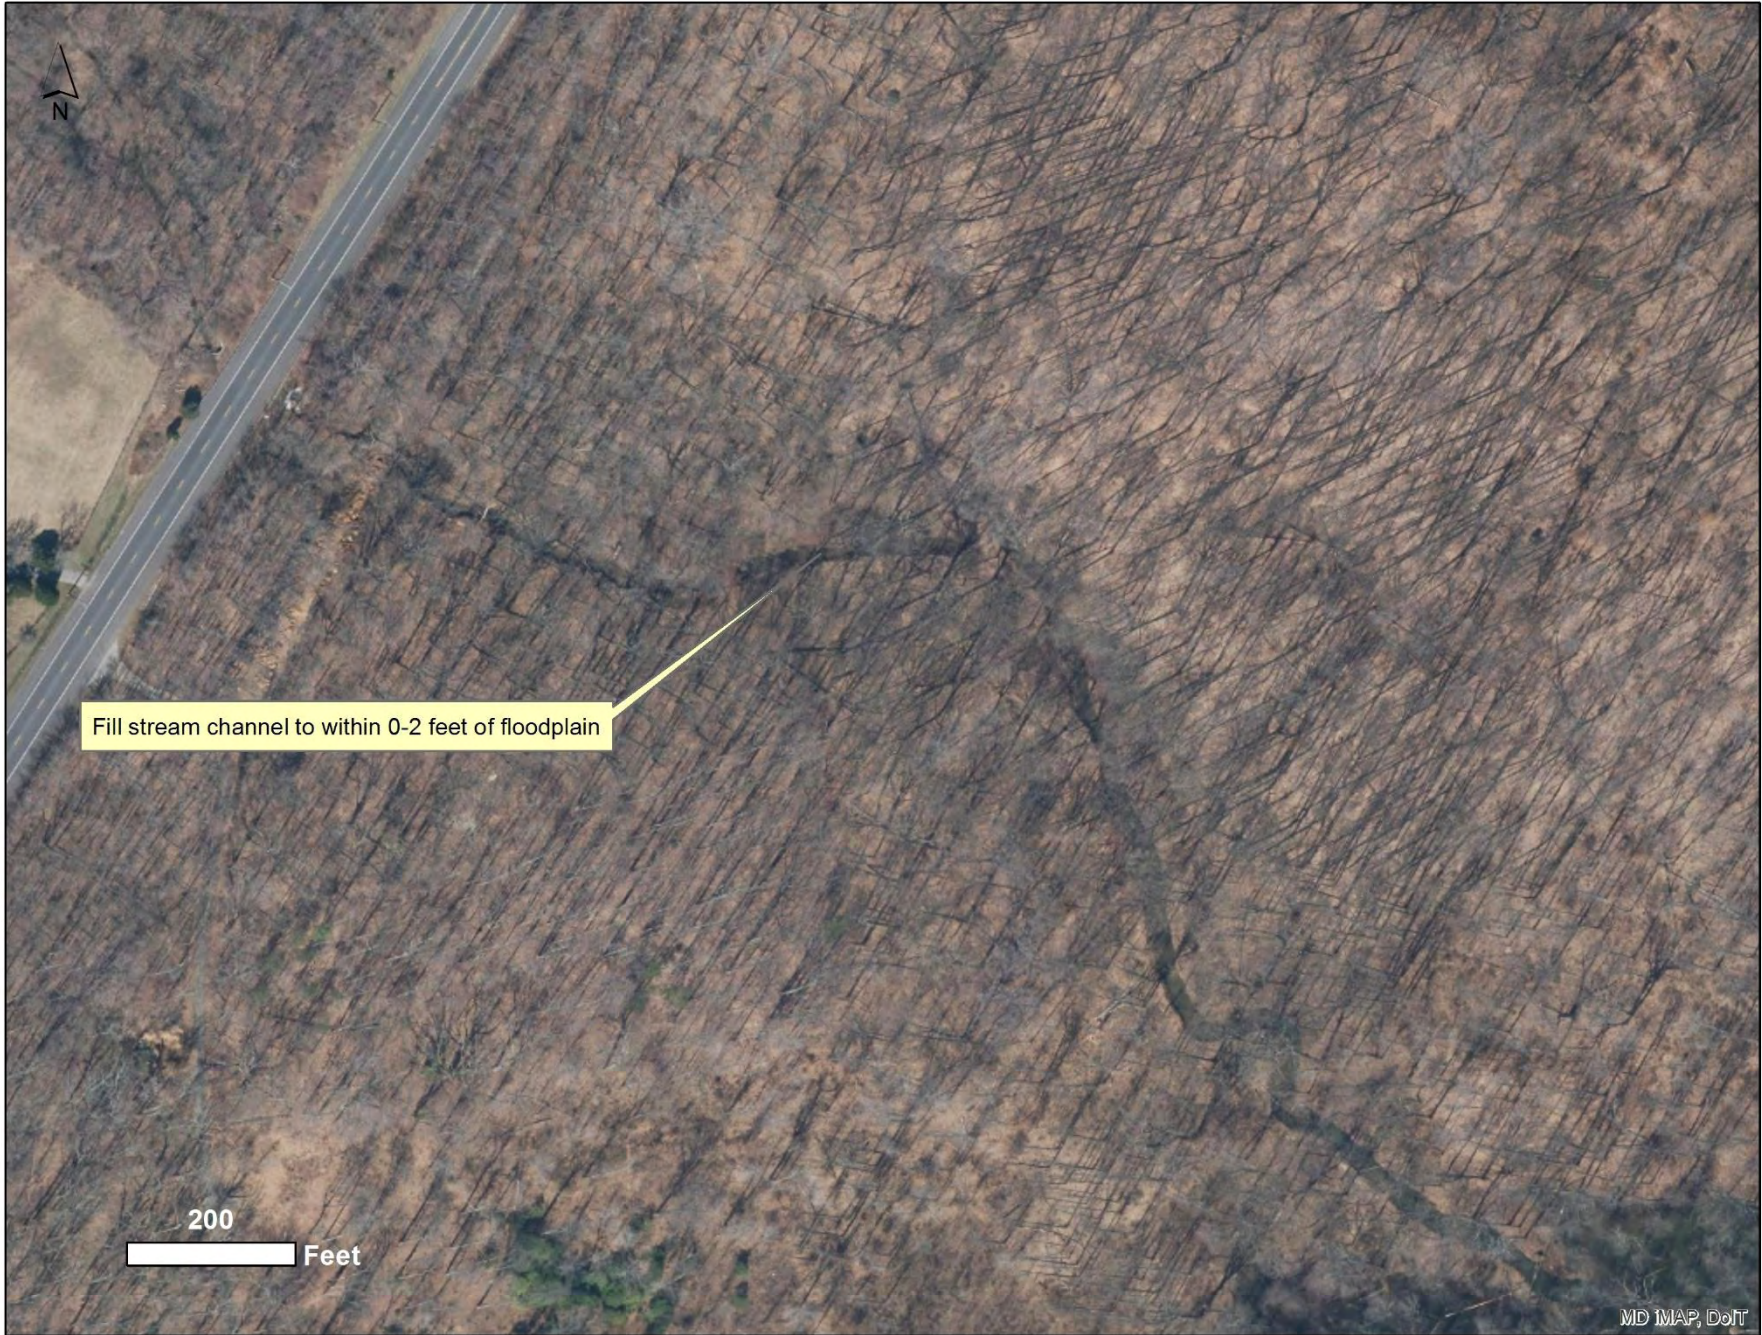
Fill stream channel to within 0-2 feet of floodplain
