2018 Oyster Reef Monitoring Report

*Analysis of Data from Large-Scale Sanctuary
Oyster Restoration Projects in Maryland
Collected from Fall 2018 through Spring 2019*

March 2020

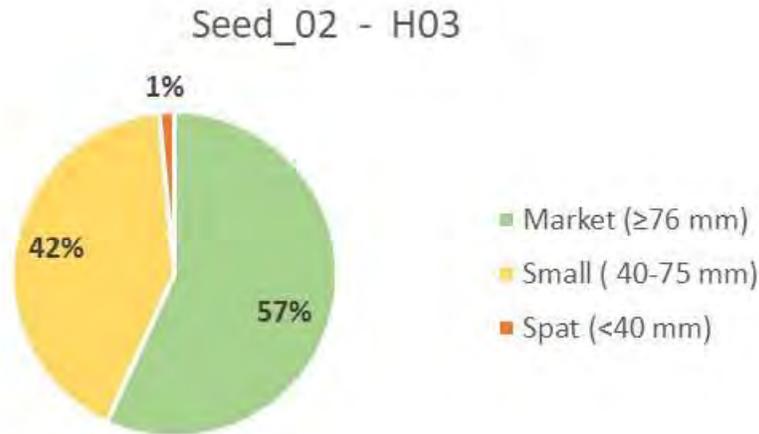
Reef H03 Seed_02

Percent of Measured Oysters in the Market, Small, and Spat Categories

Shell Height of Oysters Measured on Reef

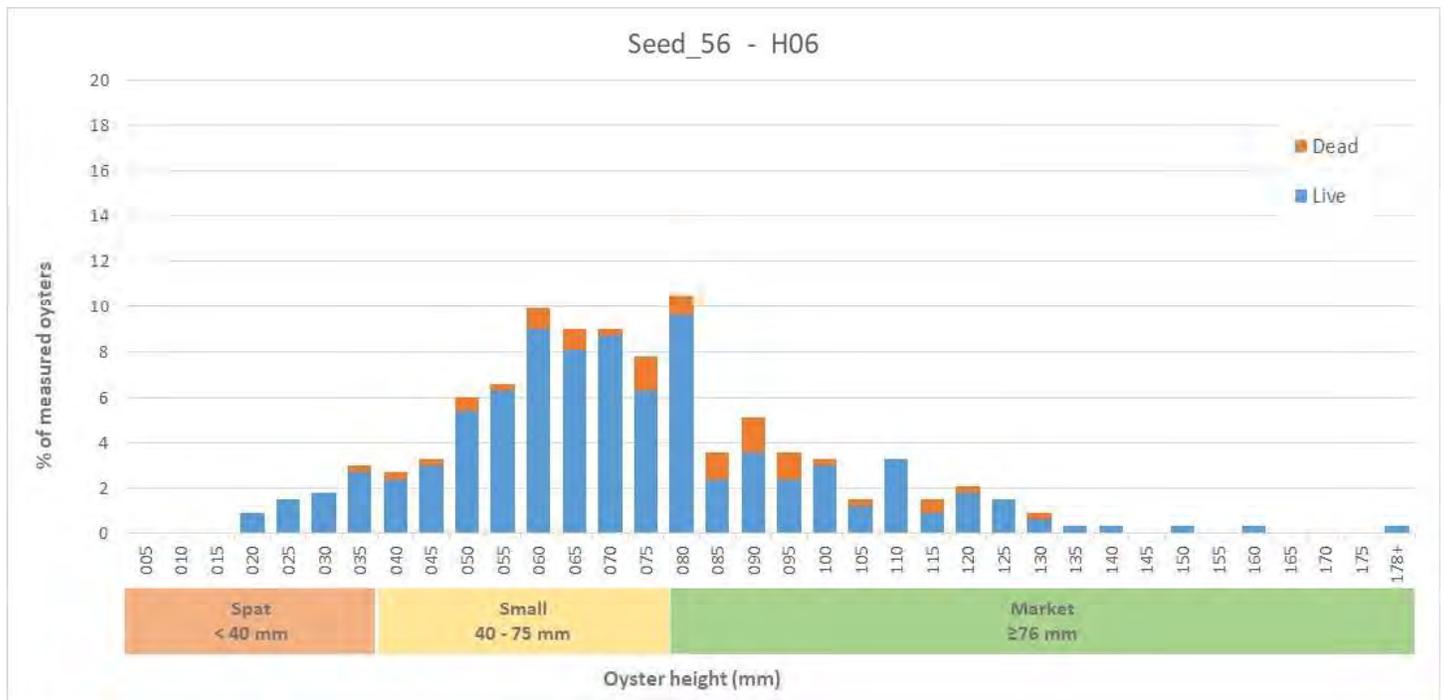
Seed_56 - H06

Percent of Measured Oysters in the Market, Small, and Spat Categories

Shell Height of Oysters Measured on Reef

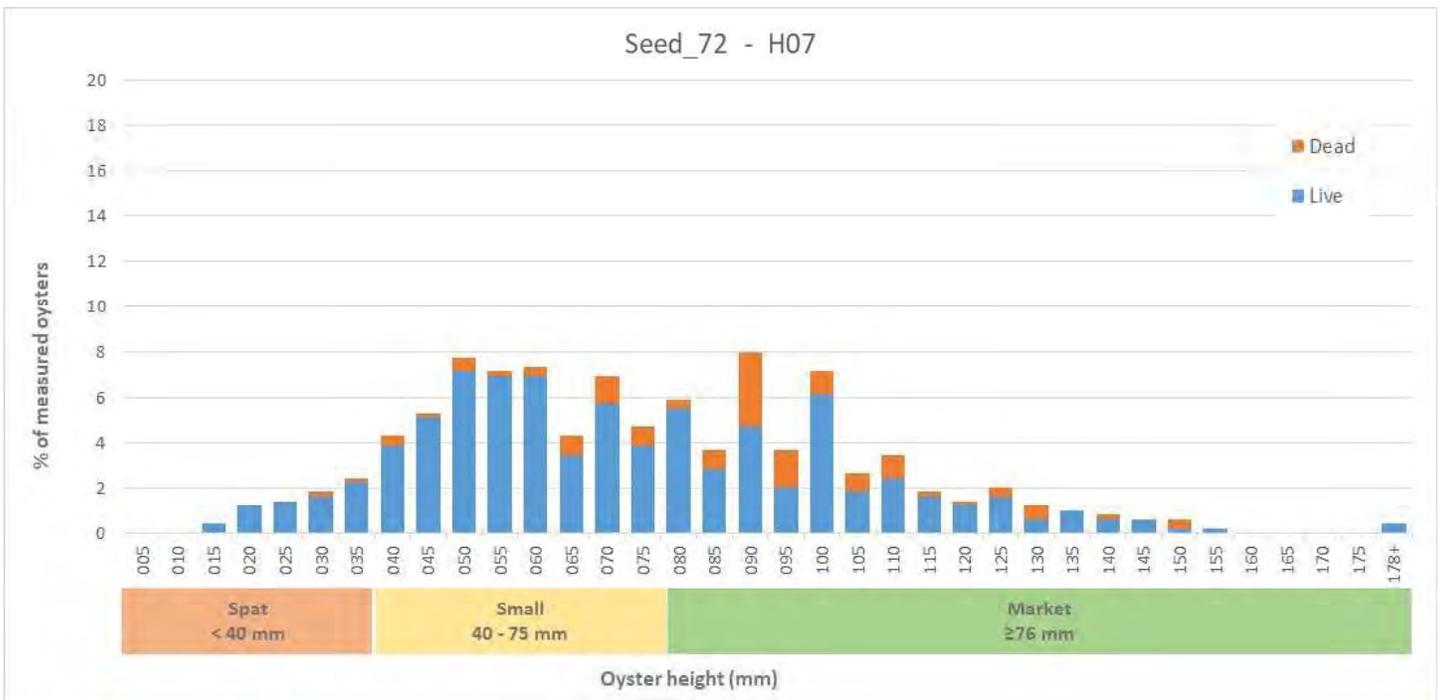
Seed_72 - H07

Percent of Measured Oysters in the Market, Small, and Spat Categories

Shell Height of Oysters Measured on Reef
