HA-570 James Stephenson House - Susquehanna State Park

Sections - Measured and Drawn by Peter Morrill - November 2019

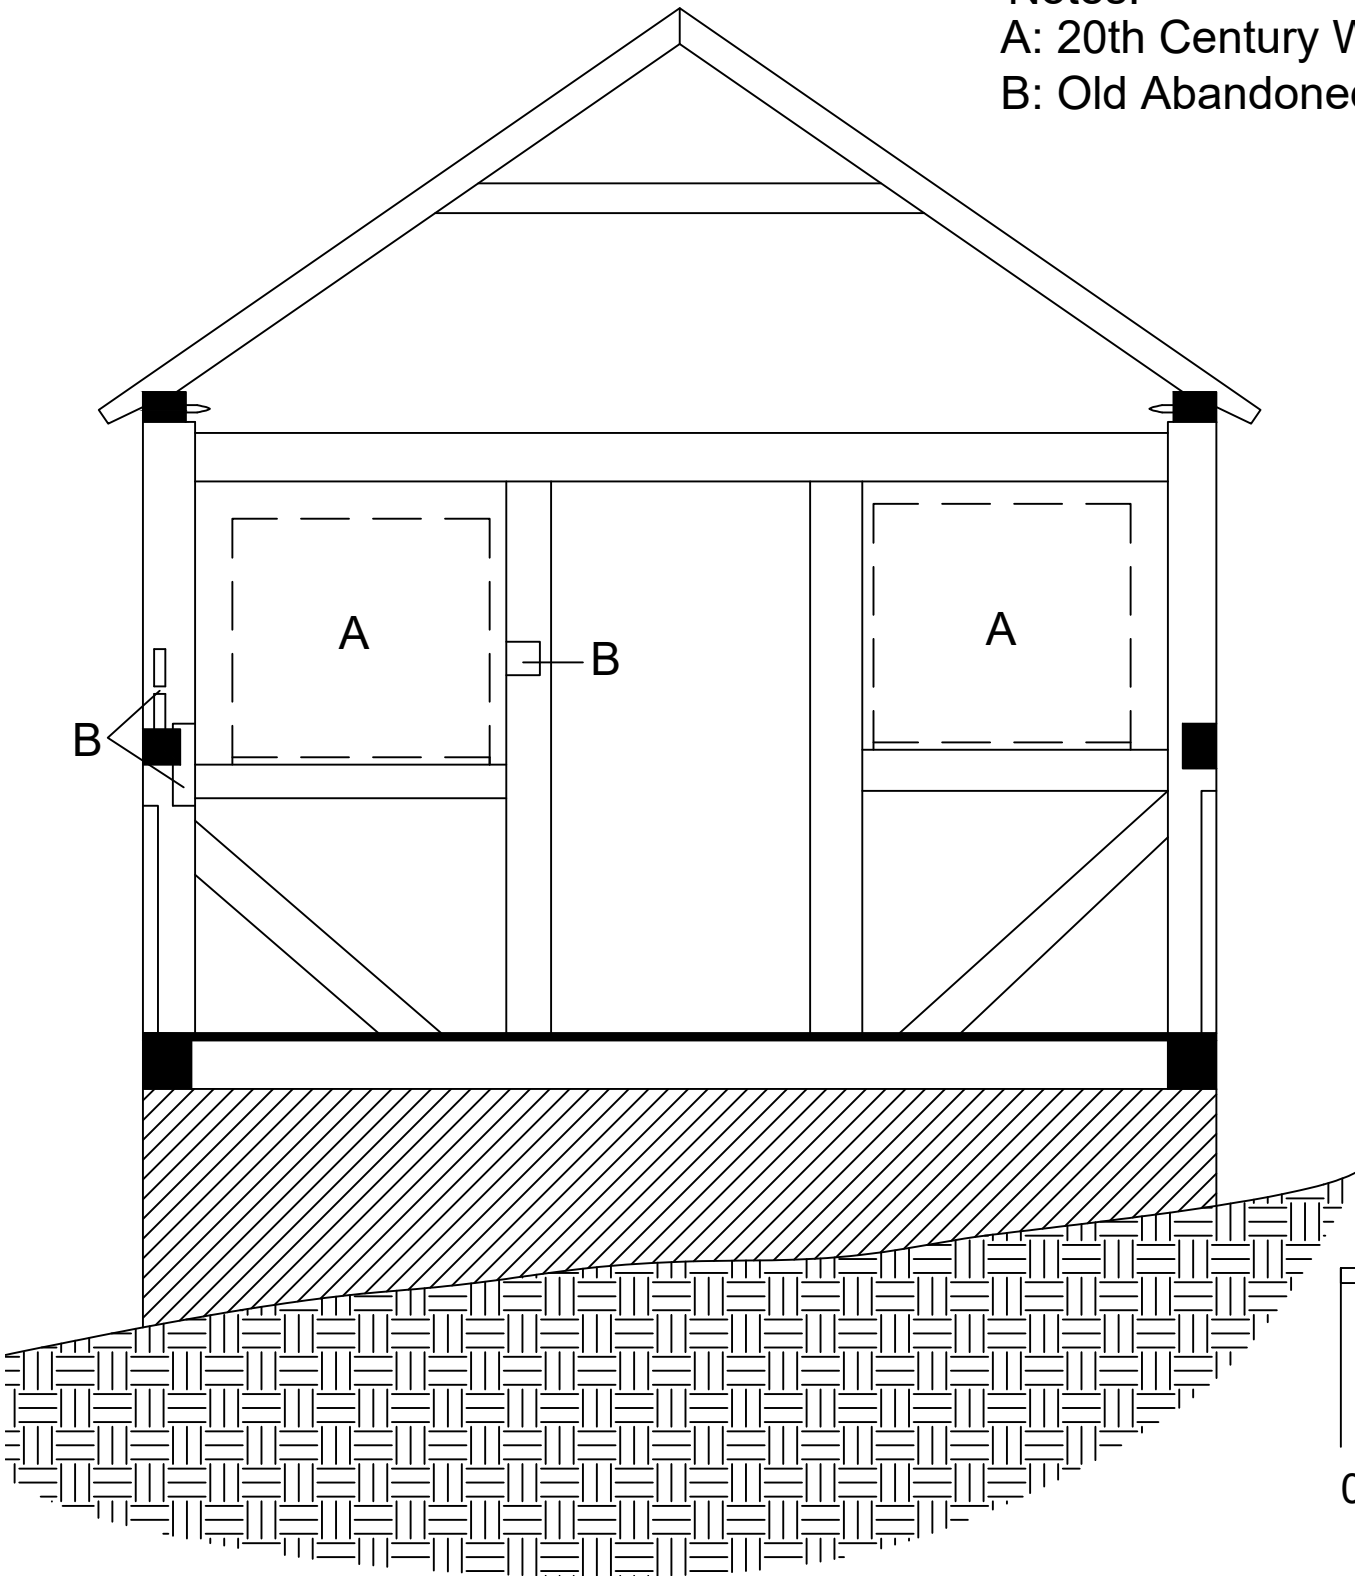
South Wall

Notes:
A: 20th Century Windows
B: Old Abandoned Joinery
