# Doing what rivers do

Franklin & Marshall College

United States Geological Survey

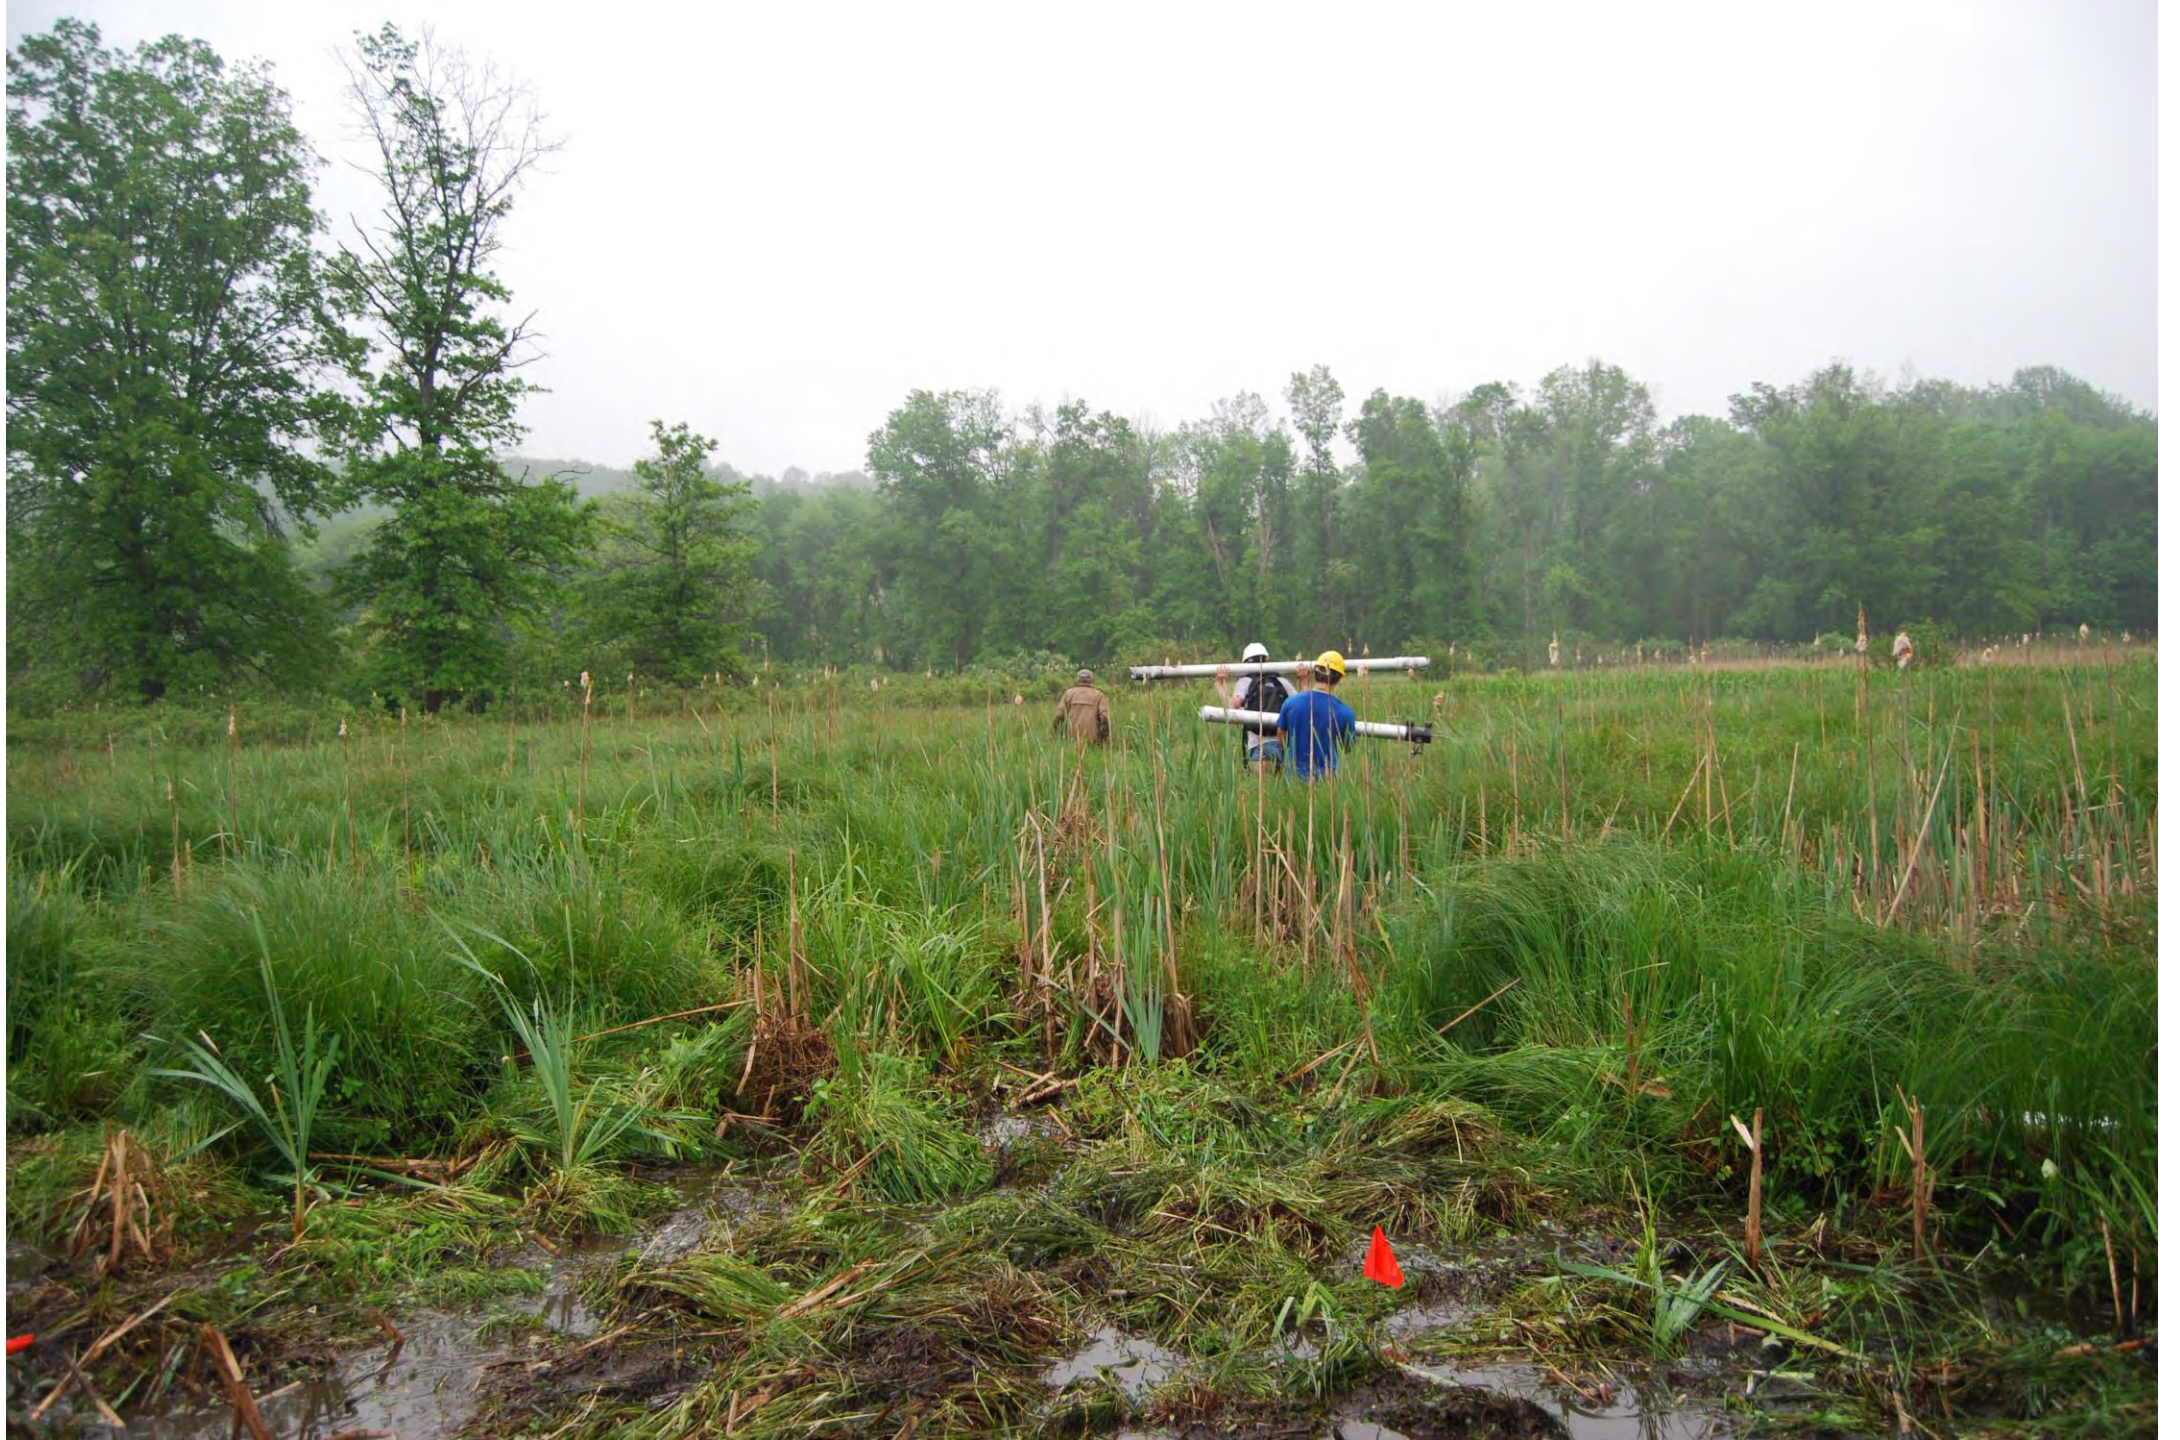
- 1) Pre-restoration fluvial system—incised, single-thread, meandering, high banks, narrow gravel bars
  - (a) Historic sediment, black Holocene hydric soil, blue-gray Holocene hydric soil, Pleistocene periglacial rubble
  - (b) Gravel bars, bed load transport
  - (c) Base flow and high flow conditions
  - (d) Channel cross sections and bank erosion monitoring

- 2) Post-restoration fluvial system-- shallow multi-thread channels, low banks, no gravel bars, wide floodplain
  - (a) Vegetated floodplain and channels
  - (b) Little bed load transport, small particle size ( $D_{50} < 10$  mm)
  - (c) Surface and groundwater connected at base flow
  - (d) Valley cross sections and floodplain-channel erosion and deposition monitoring

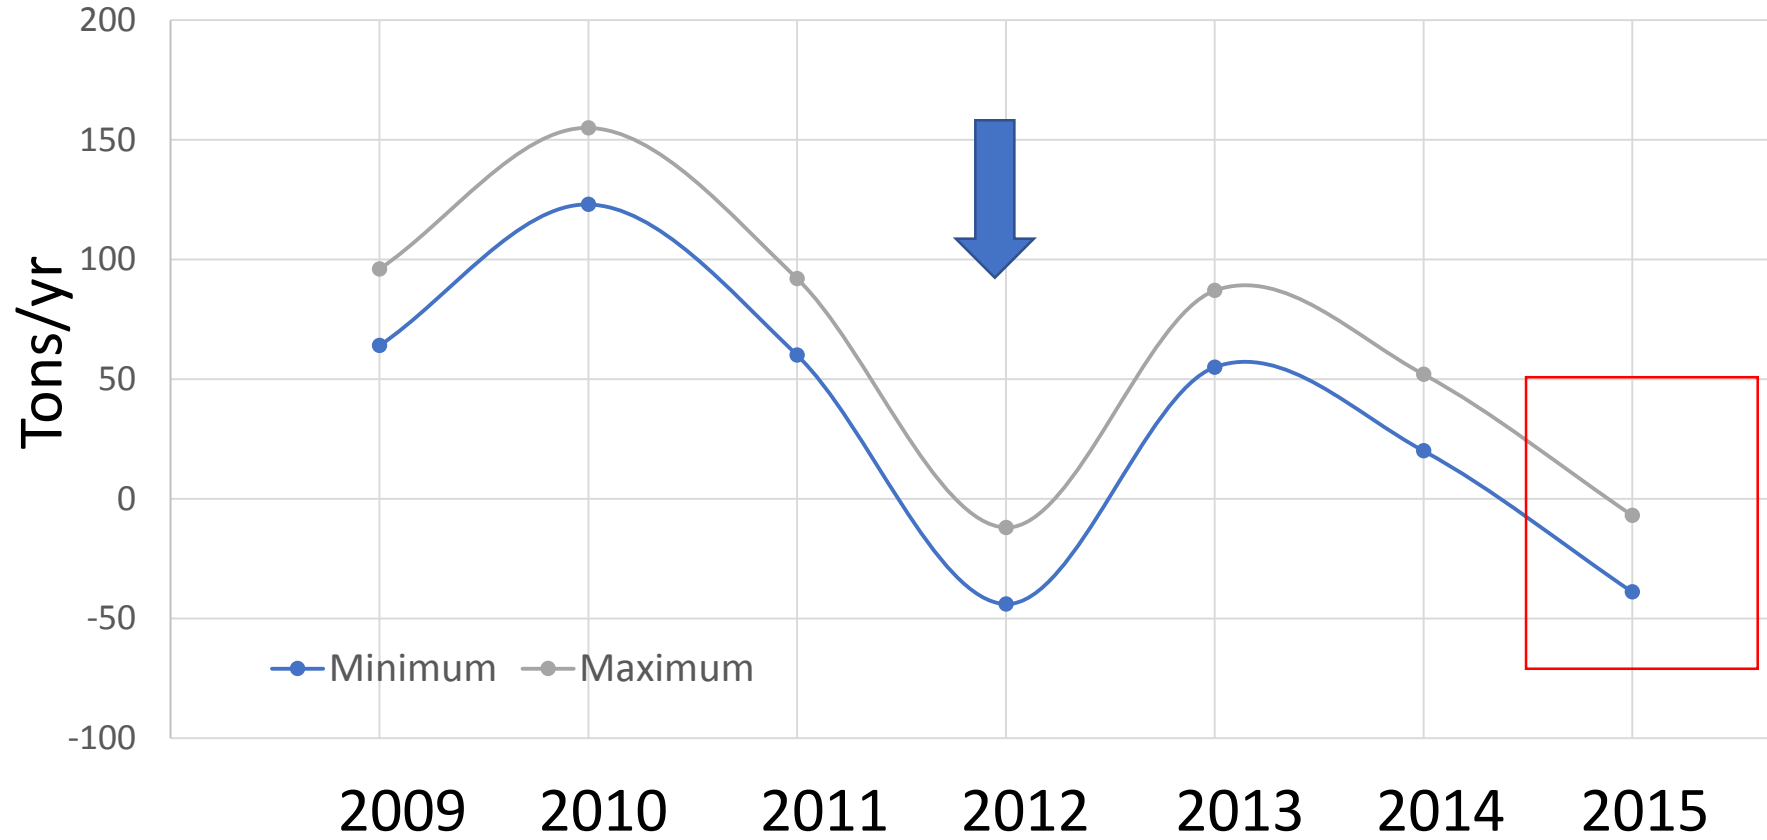
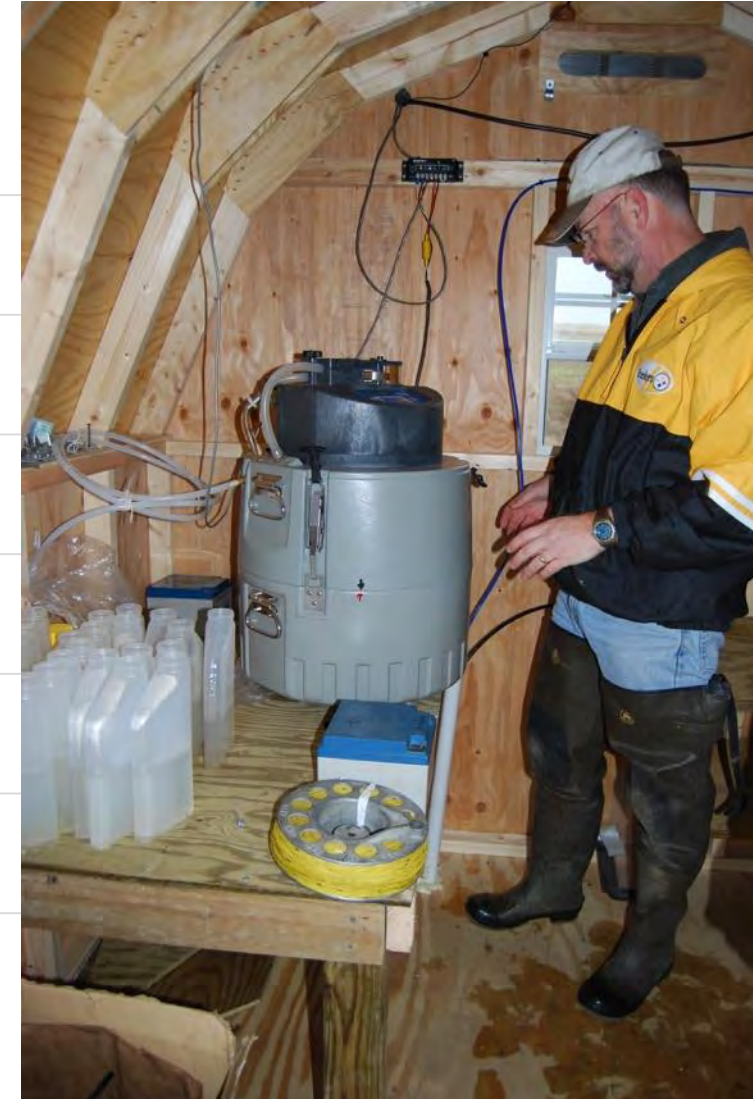
USGS Gage Data + lidar DEM Differencing:  
Sediment eroded from restoration reach

$$\Delta S = O - I_n$$

$$103 \text{ tons/yr} - ((62 \text{ tons/yr} + 16 \text{ tons/yr} + 25 \text{ tons/yr} + 15 \text{ tons/yr} + 23 \text{ tons/yr})) =$$

$$\Delta S = 103 - 141 = -38 \text{ tons/yr (i.e., deposition)}$$

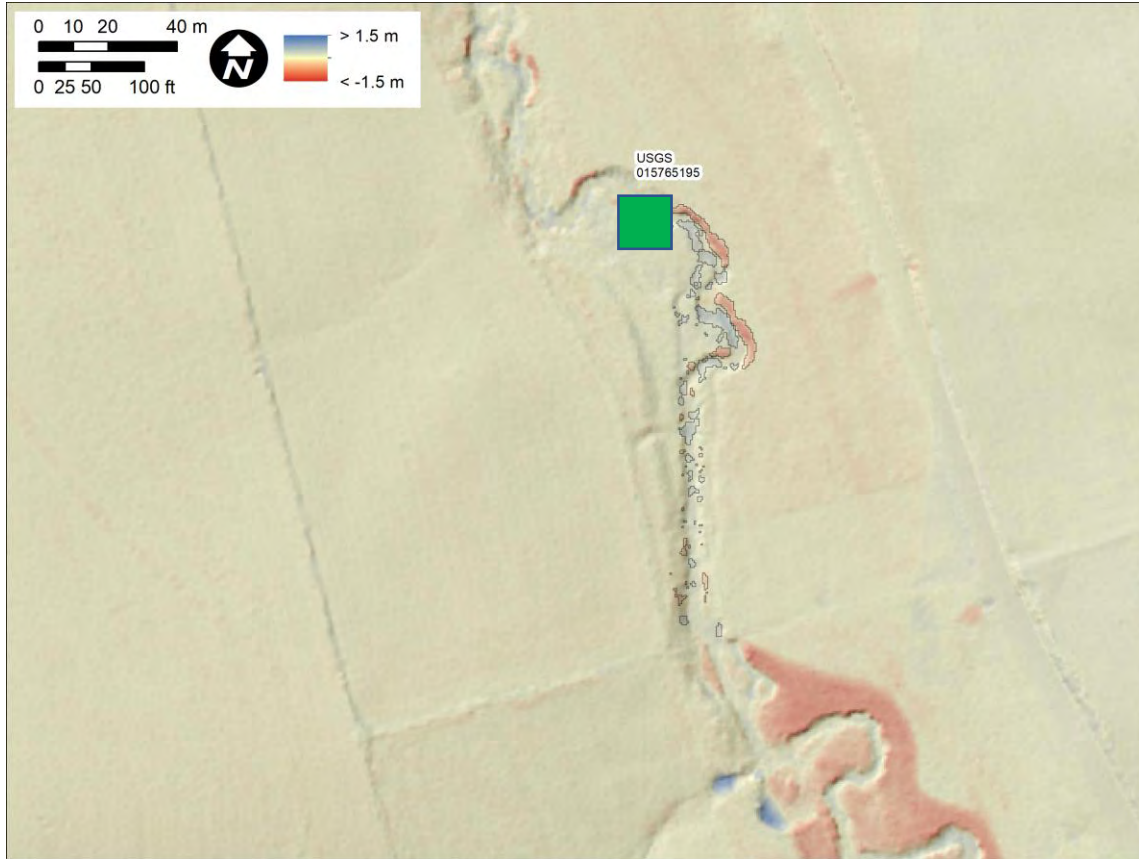
# Lidar DEM Differencing, 2014 - 2008

USGS gage station identifier	Location	Distance to restoration reach, ft
01576516 (In)	Eastern tributary	1017
015765185 (In)	Western tributary	131
015765195 (Out)	Main stem	558

Location	Minimum net change, tons/yr	Maximum net change, tons/yr
Western tributary	-7.8	-16.0
Eastern tributary	-5.2	-15.2
Main stem	-10.2	-23.4
Total	-23.2	-54.6

**~80 to 100 tons/yr per km of stream bank**

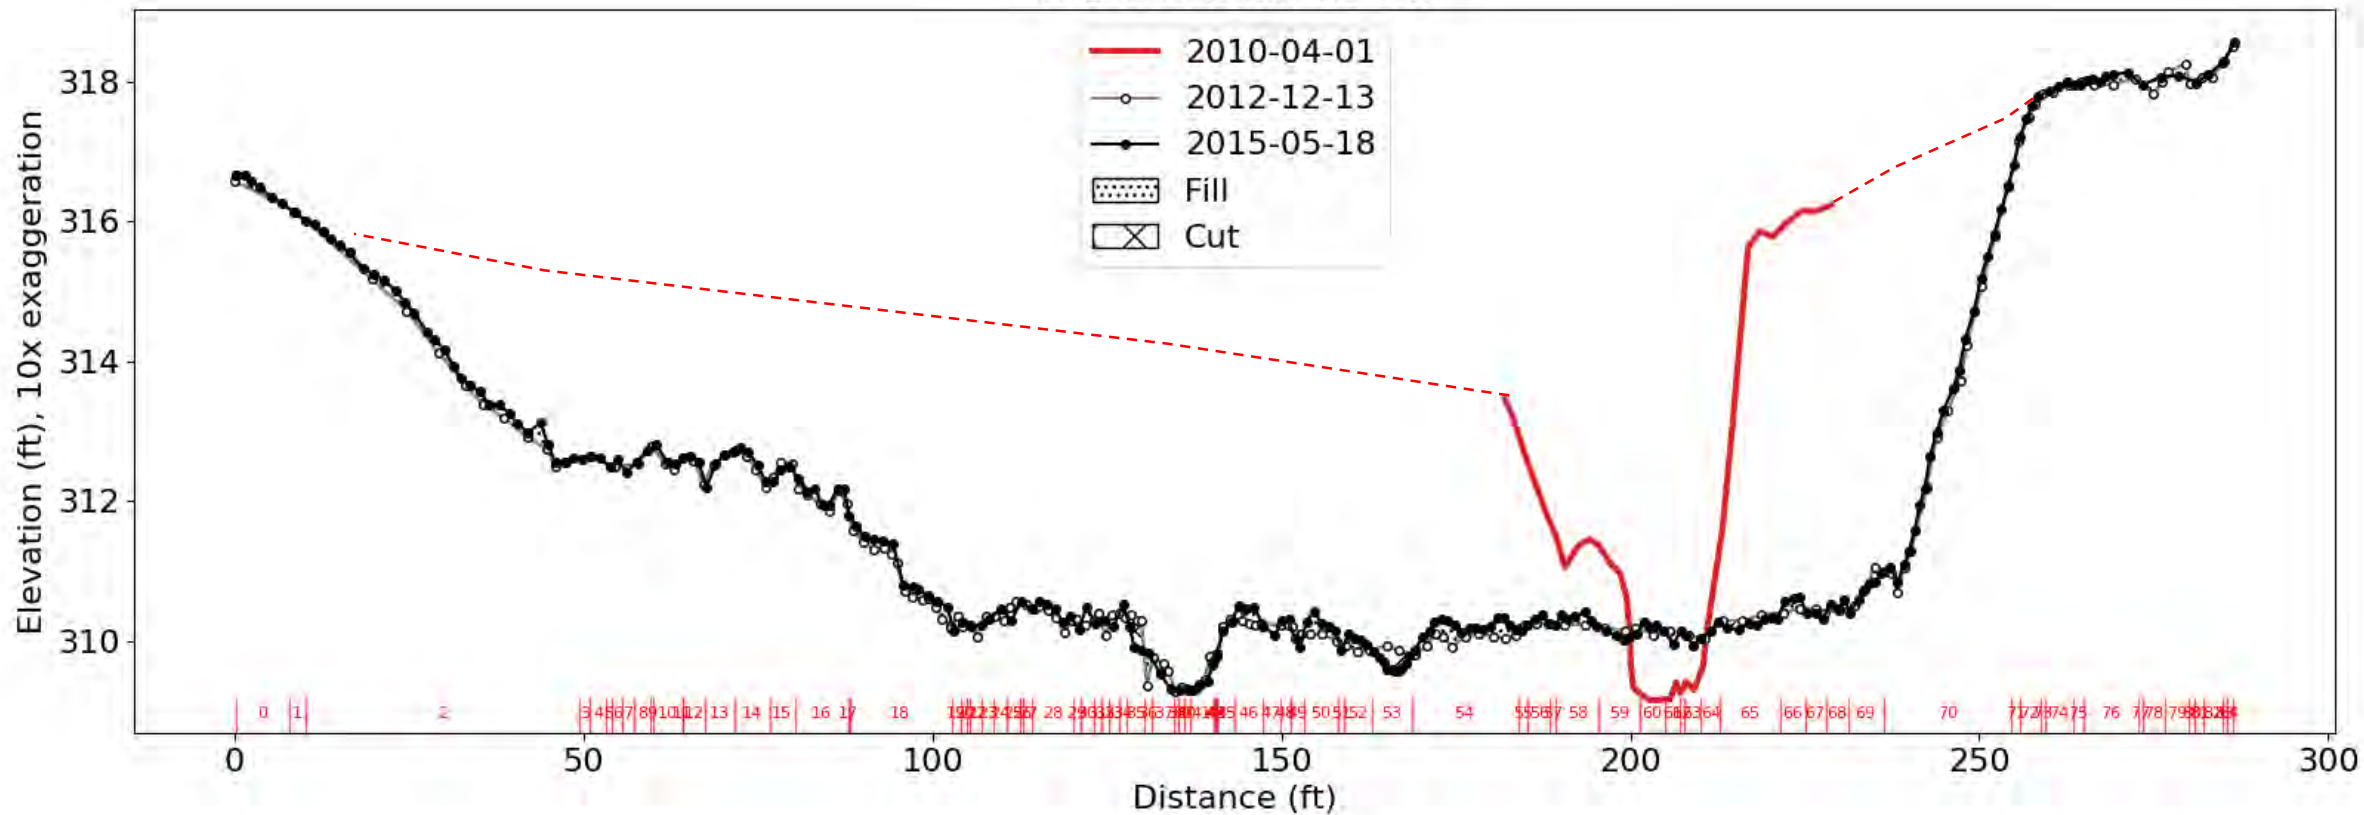
## Cross-section XS-10

# Repeat RTK-GPS Surveying

Section number	Installation date	2nd survey date	Monitoring period yrs	Length ft	Deposition ft <sup>2</sup>	Erosion ft <sup>2</sup>	Net area change ft <sup>2</sup>	Deposition rate ft/yr	Net change rate ft/yr
XS-3	5/14/13	6/9/17	4.07	113.3	43.85	-1.81	42.04	0.10	0.09
XS-4	5/14/13	6/9/17	4.07	55.4	14.55	-0.32	14.23	0.06	0.06
XS-5	5/14/13	5/12/15	1.99	210.1	38.80	-2.34	36.47	0.09	0.09
XS-14	5/18/13	8/4/15	2.21	172.8	14.02	-10.49	3.54	0.04	0.01
XS-6	1/20/14	5/12/15	1.31	145.6	16.04	-1.10	14.94	0.08	0.08
XS-8	8/16/13	5/18/15	1.75	163.0	30.78	-8.52	22.26	0.11	0.08
XS-10	12/13/12	5/18/15	2.43	244.4	17.23	-6.76	10.47	0.03	0.02
Average			2.55	157.8	25.04	-4.48	20.56	0.07	0.06
1 S. D.					12.58	4.04	14.03	0.03	0.03

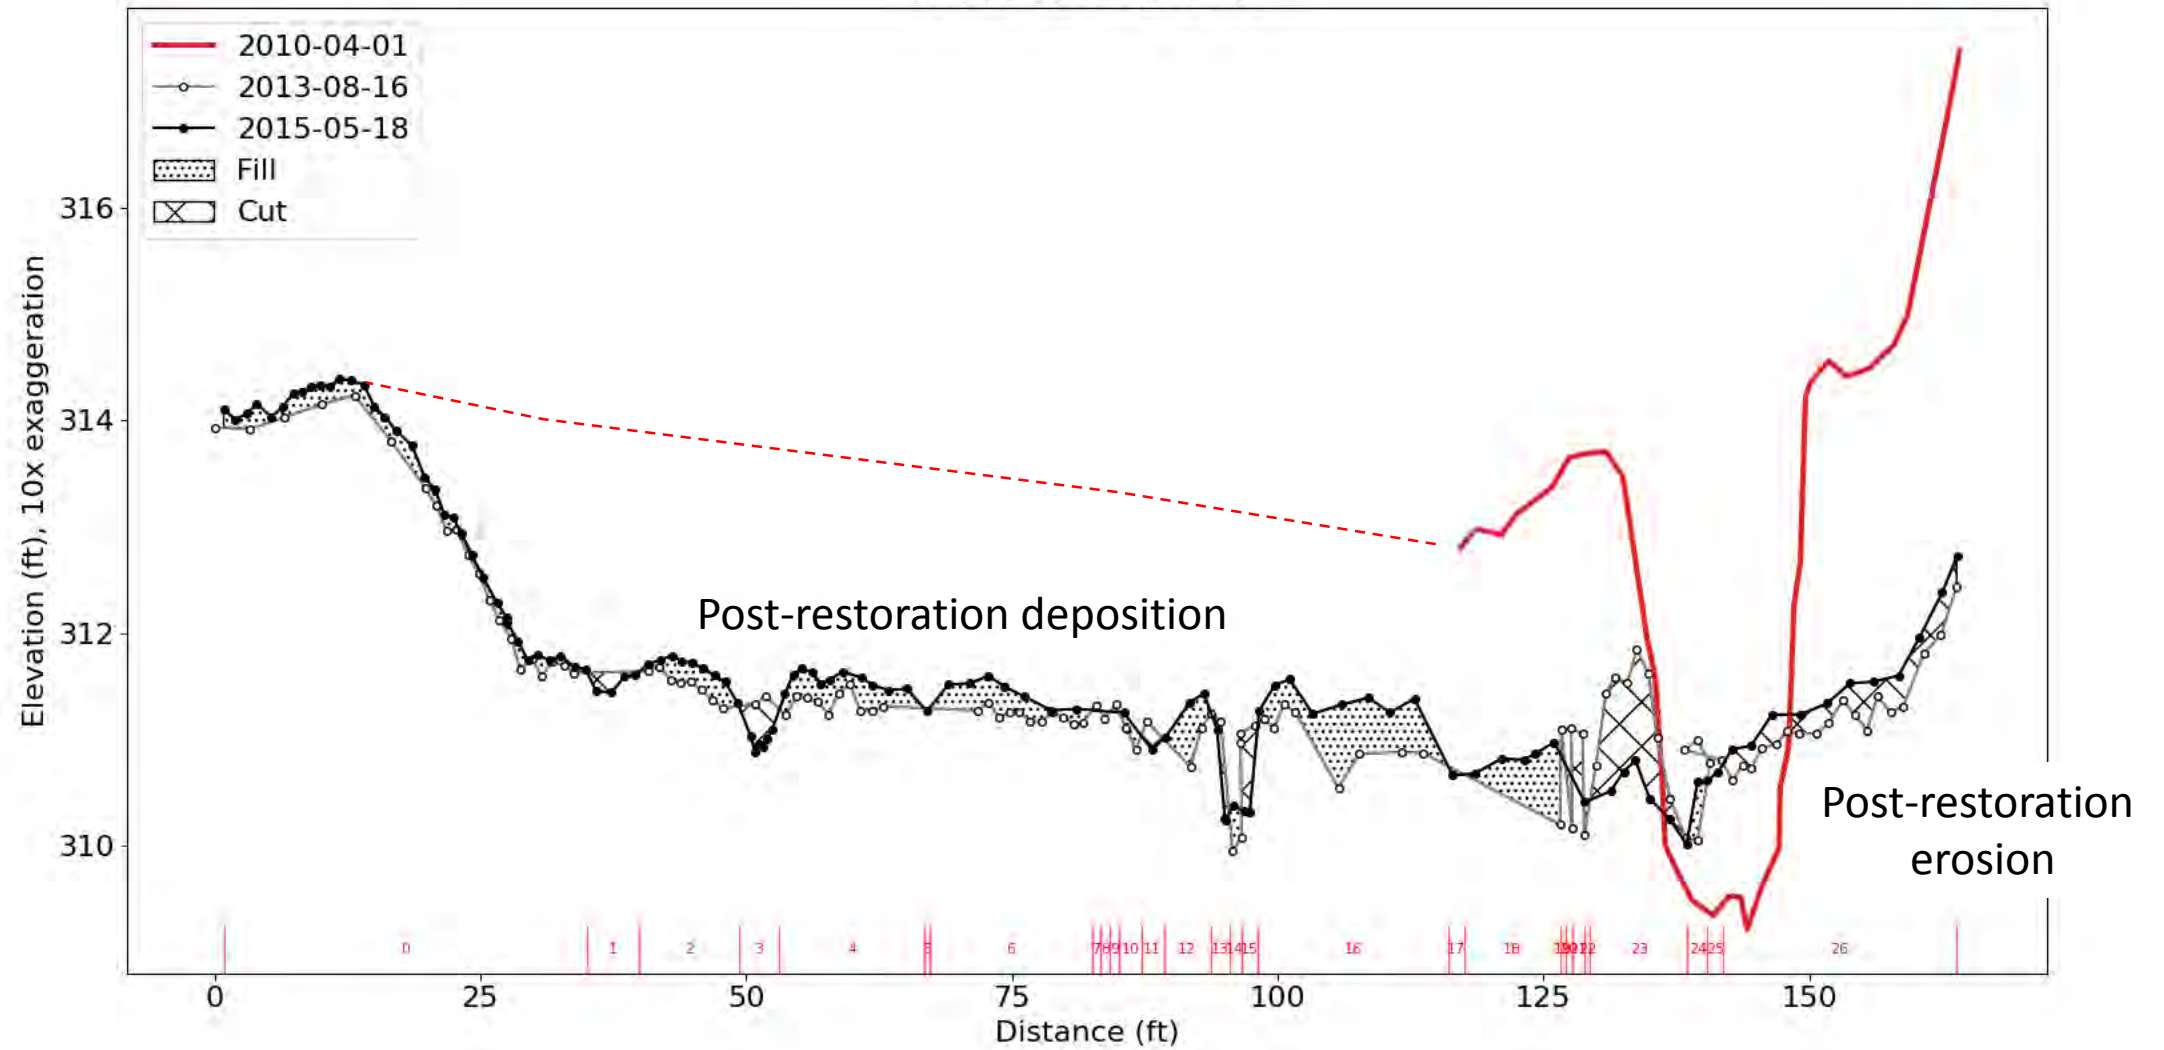
## Cross-section XS-8

# Repeat RTK-GPS Surveying

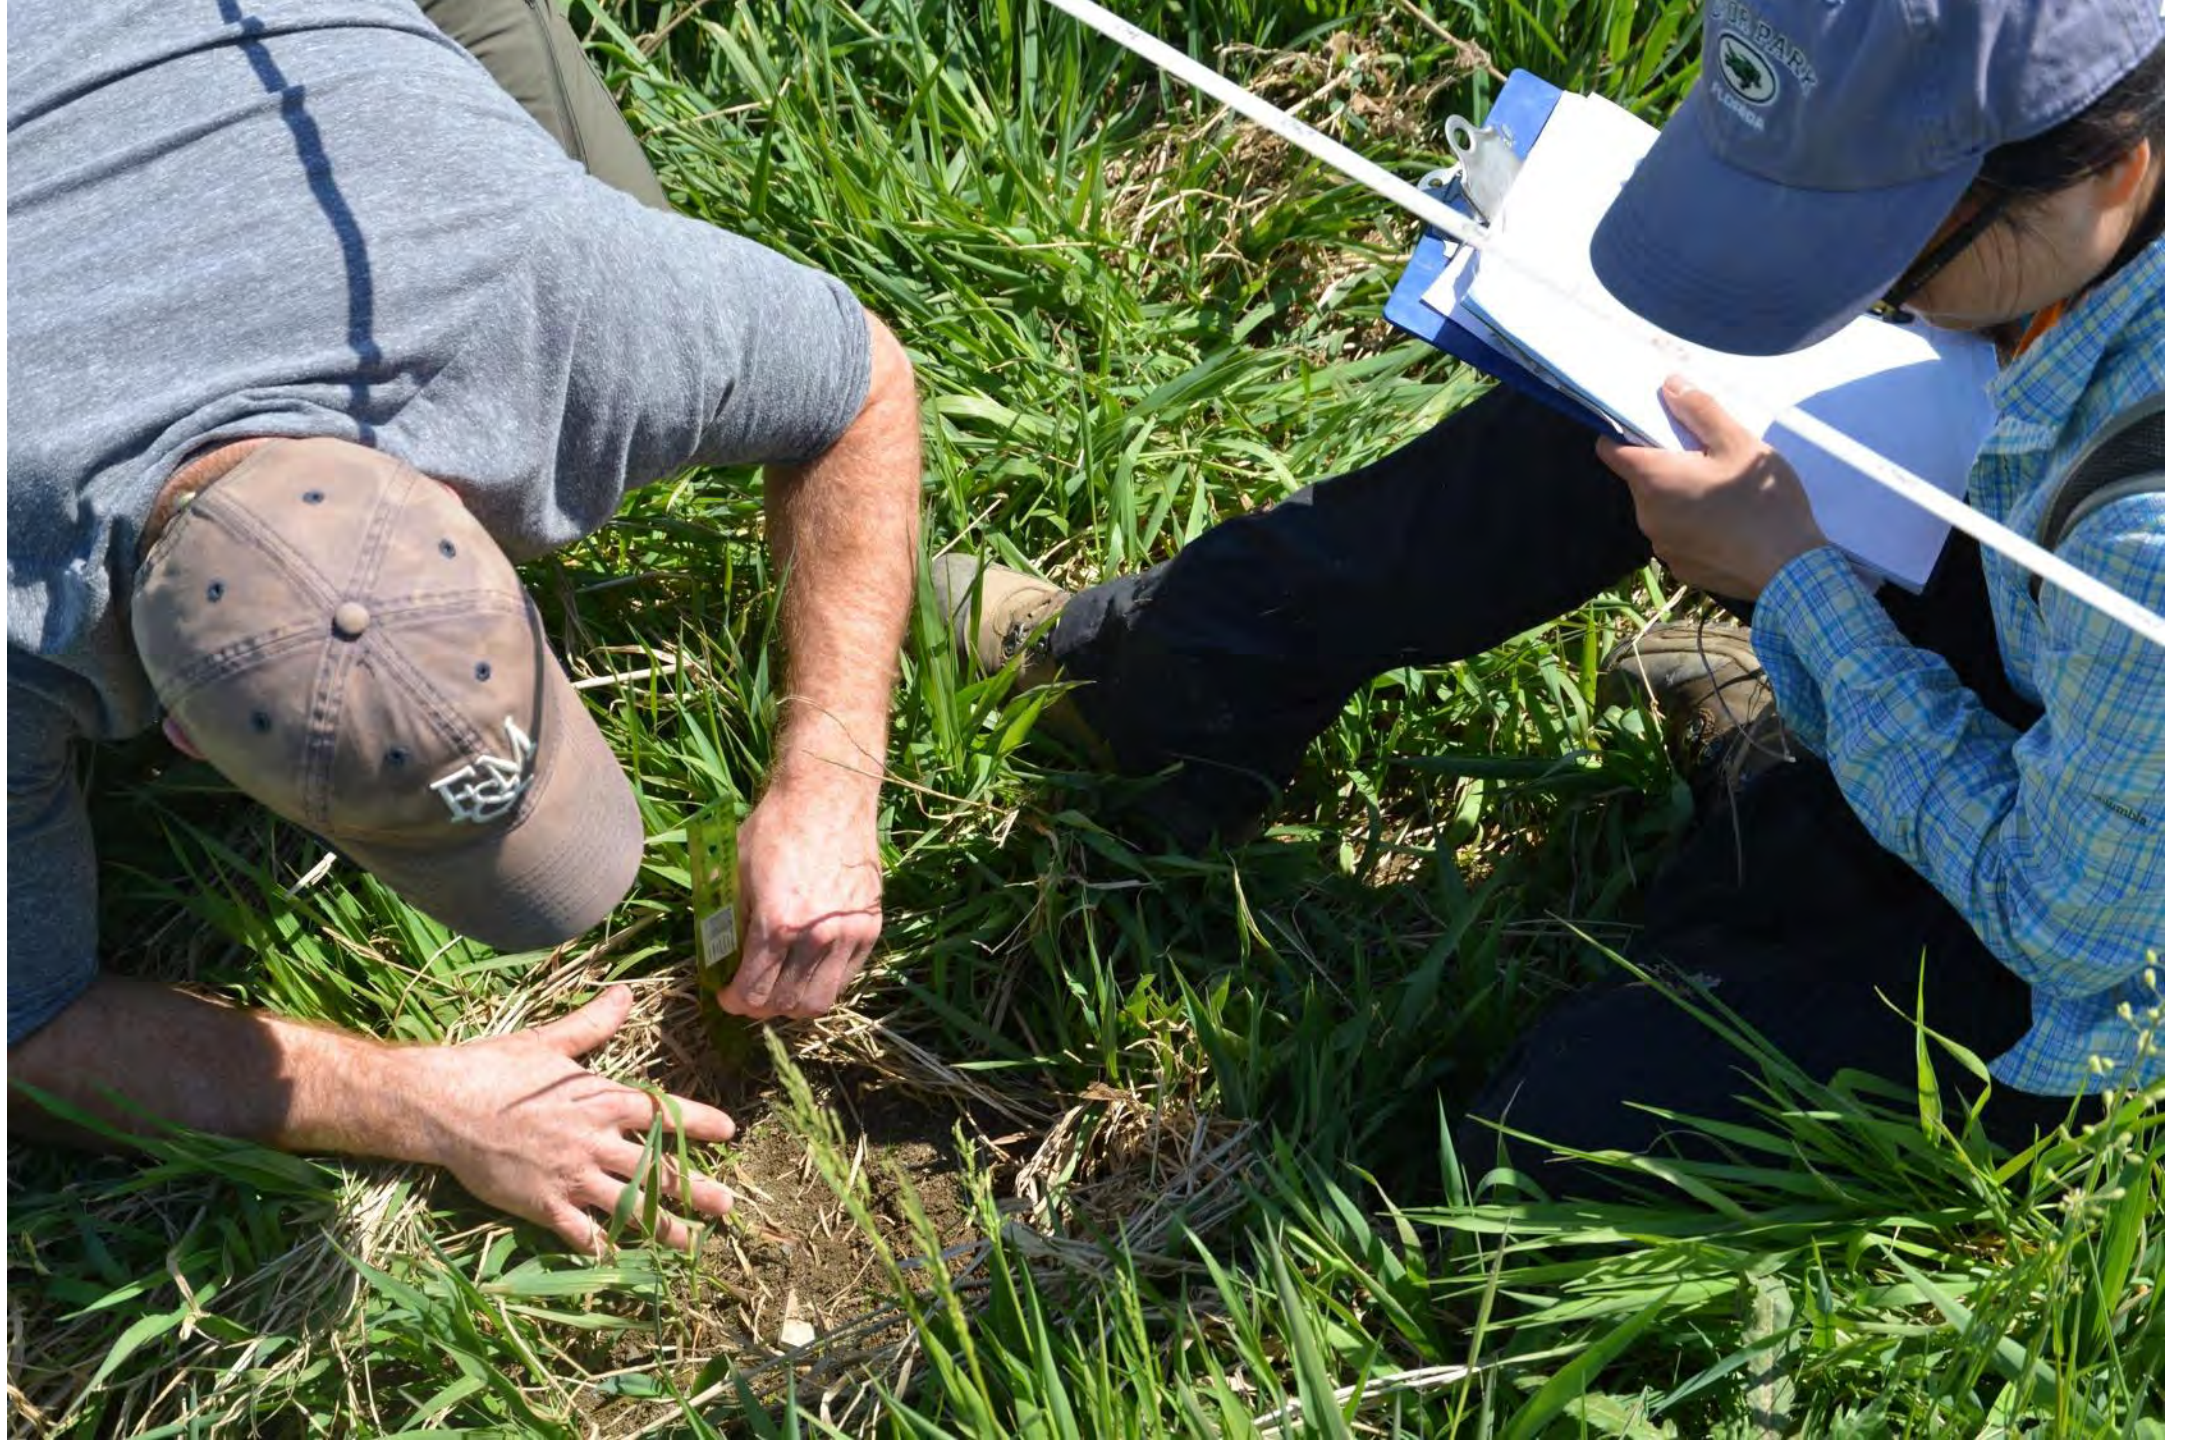
Post-Restoration Deposition (USGS Tile Pads)						
Cross section	Install date	Most recent measurement	Time between measurements, yrs	Distance from the to end, ft	Number of pads	Average deposition rate (weighted by distance), ft/yr	15.D. average deposition rate, ft/yr	Deposition rate from RTK-GPS surveys, ft/yr	
XS-3	1/24/13	4/24/16	3.25	138.8	8	0.02	0.005	0.09	
XS-4	1/24/13	4/24/16	3.25	134.8	9	0.04	0.008	0.06	
XS-5	1/24/13	6/12/17	4.38	238.7	18	0.01	0.015	0.09	
XS-14	12/12/12	6/6/17	4.48	82.5	10	0.02	0.001	0.01	
XS-6	12/12/12	6/12/17	4.5	142.7	8	0.08	0.023	0.08	
XS-8	12/12/12	6/6/17	4.48	187.3	10	0.02	0.003	0.08	
XS-10	12/12/12	4/20/16	3.36	205.3	14	0.04	0.006	0.02	
XS-11	12/12/12	4/20/16	3.36	61.7	7	0.03	0.006		
XS-12	12/12/12	4/20/16	3.36	121.6	15	0.03	0.003		
XS-13	12/12/12	5/8/14	1.4	126.5	11	0.02	0.003		
Average			3.58	143.99	11	0.03	0.01	0.06

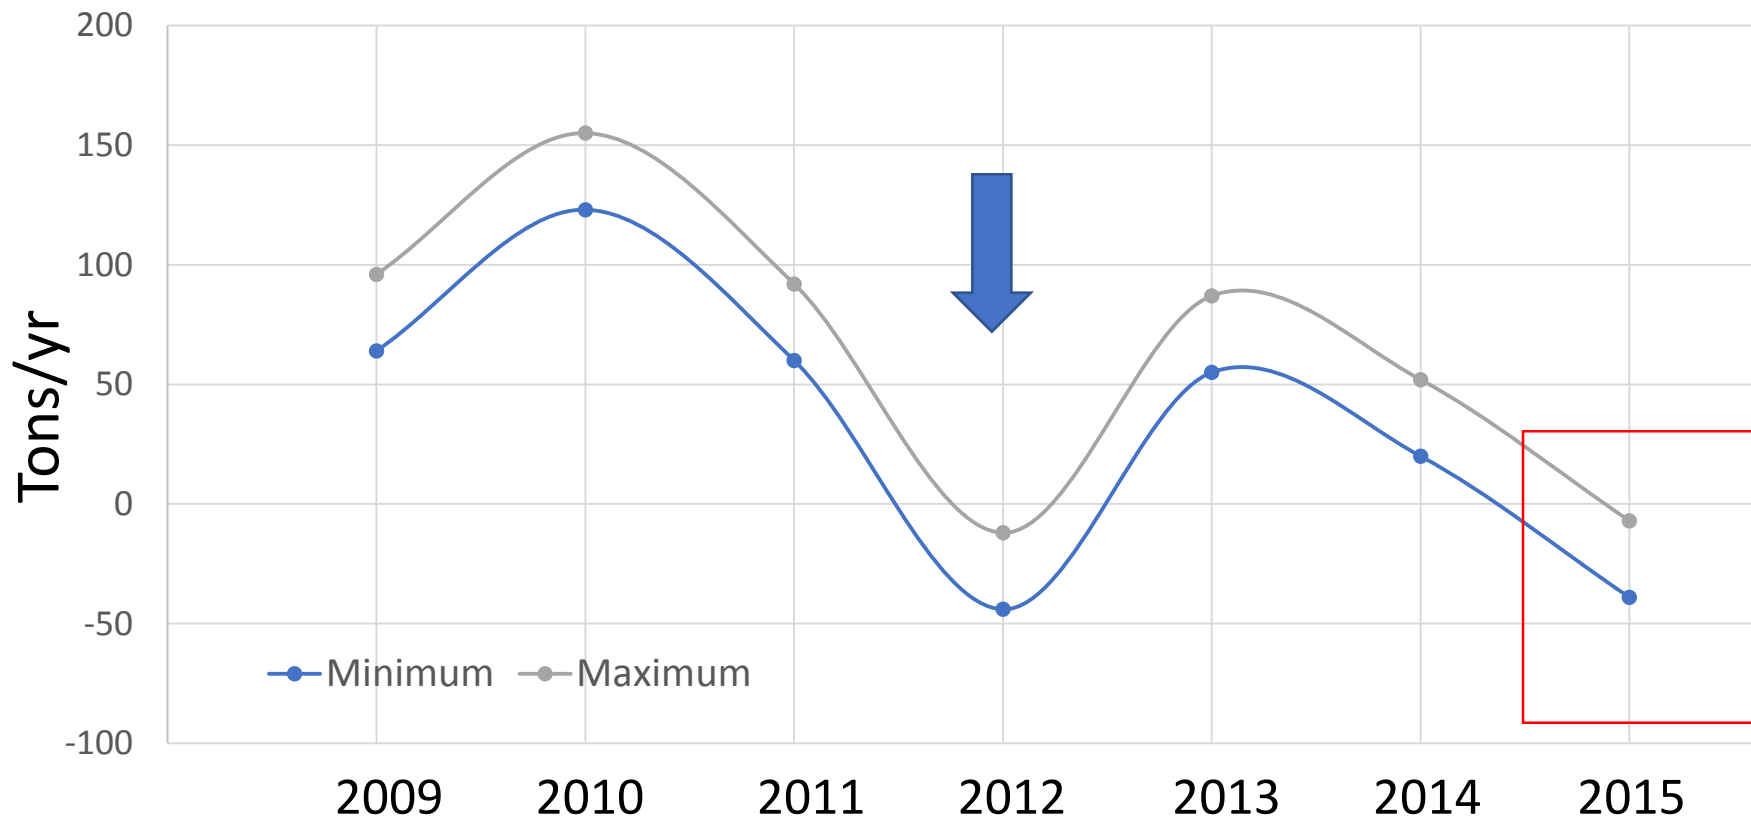
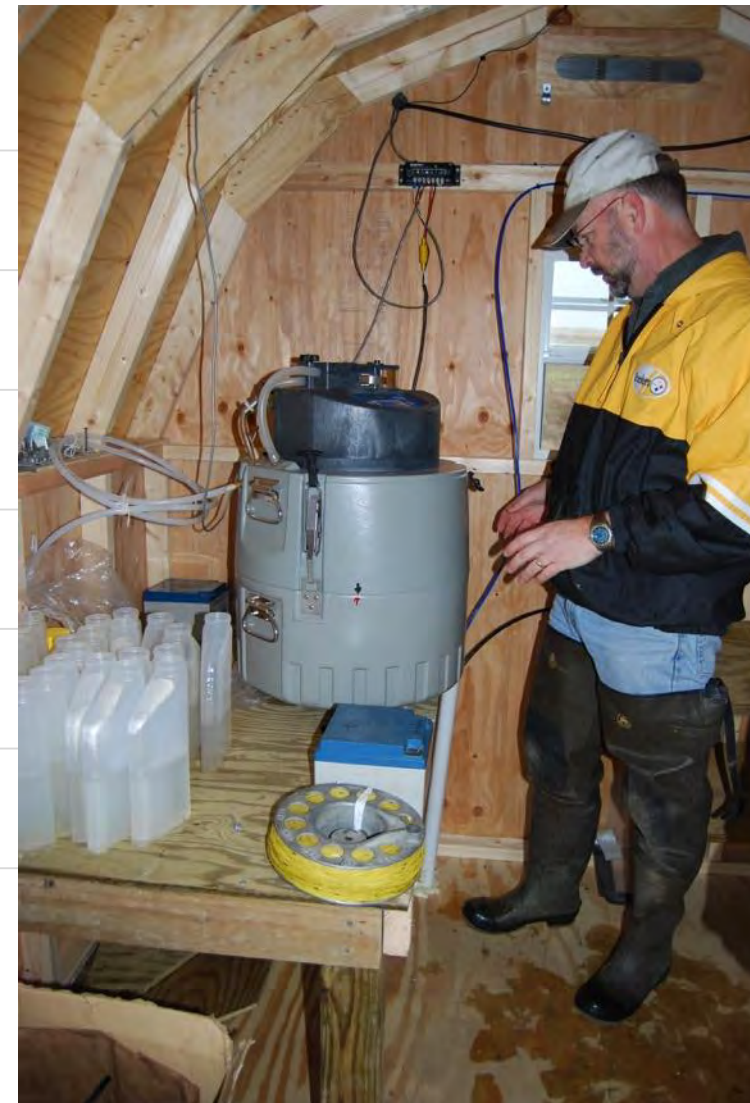
USGS Gage Data + lidar DEM Differencing:  
Sediment eroded from restoration reach

$$\Delta S = O - I_n$$

$$103 \text{ tons/yr} - ((62 \text{ tons/yr} + 16 \text{ tons/yr} + 25 \text{ tons/yr} + 15 \text{ tons/yr} + 23 \text{ tons/yr})) = \Delta S = 103 - 141 = -38 \text{ tons/yr (i.e., deposition)}$$

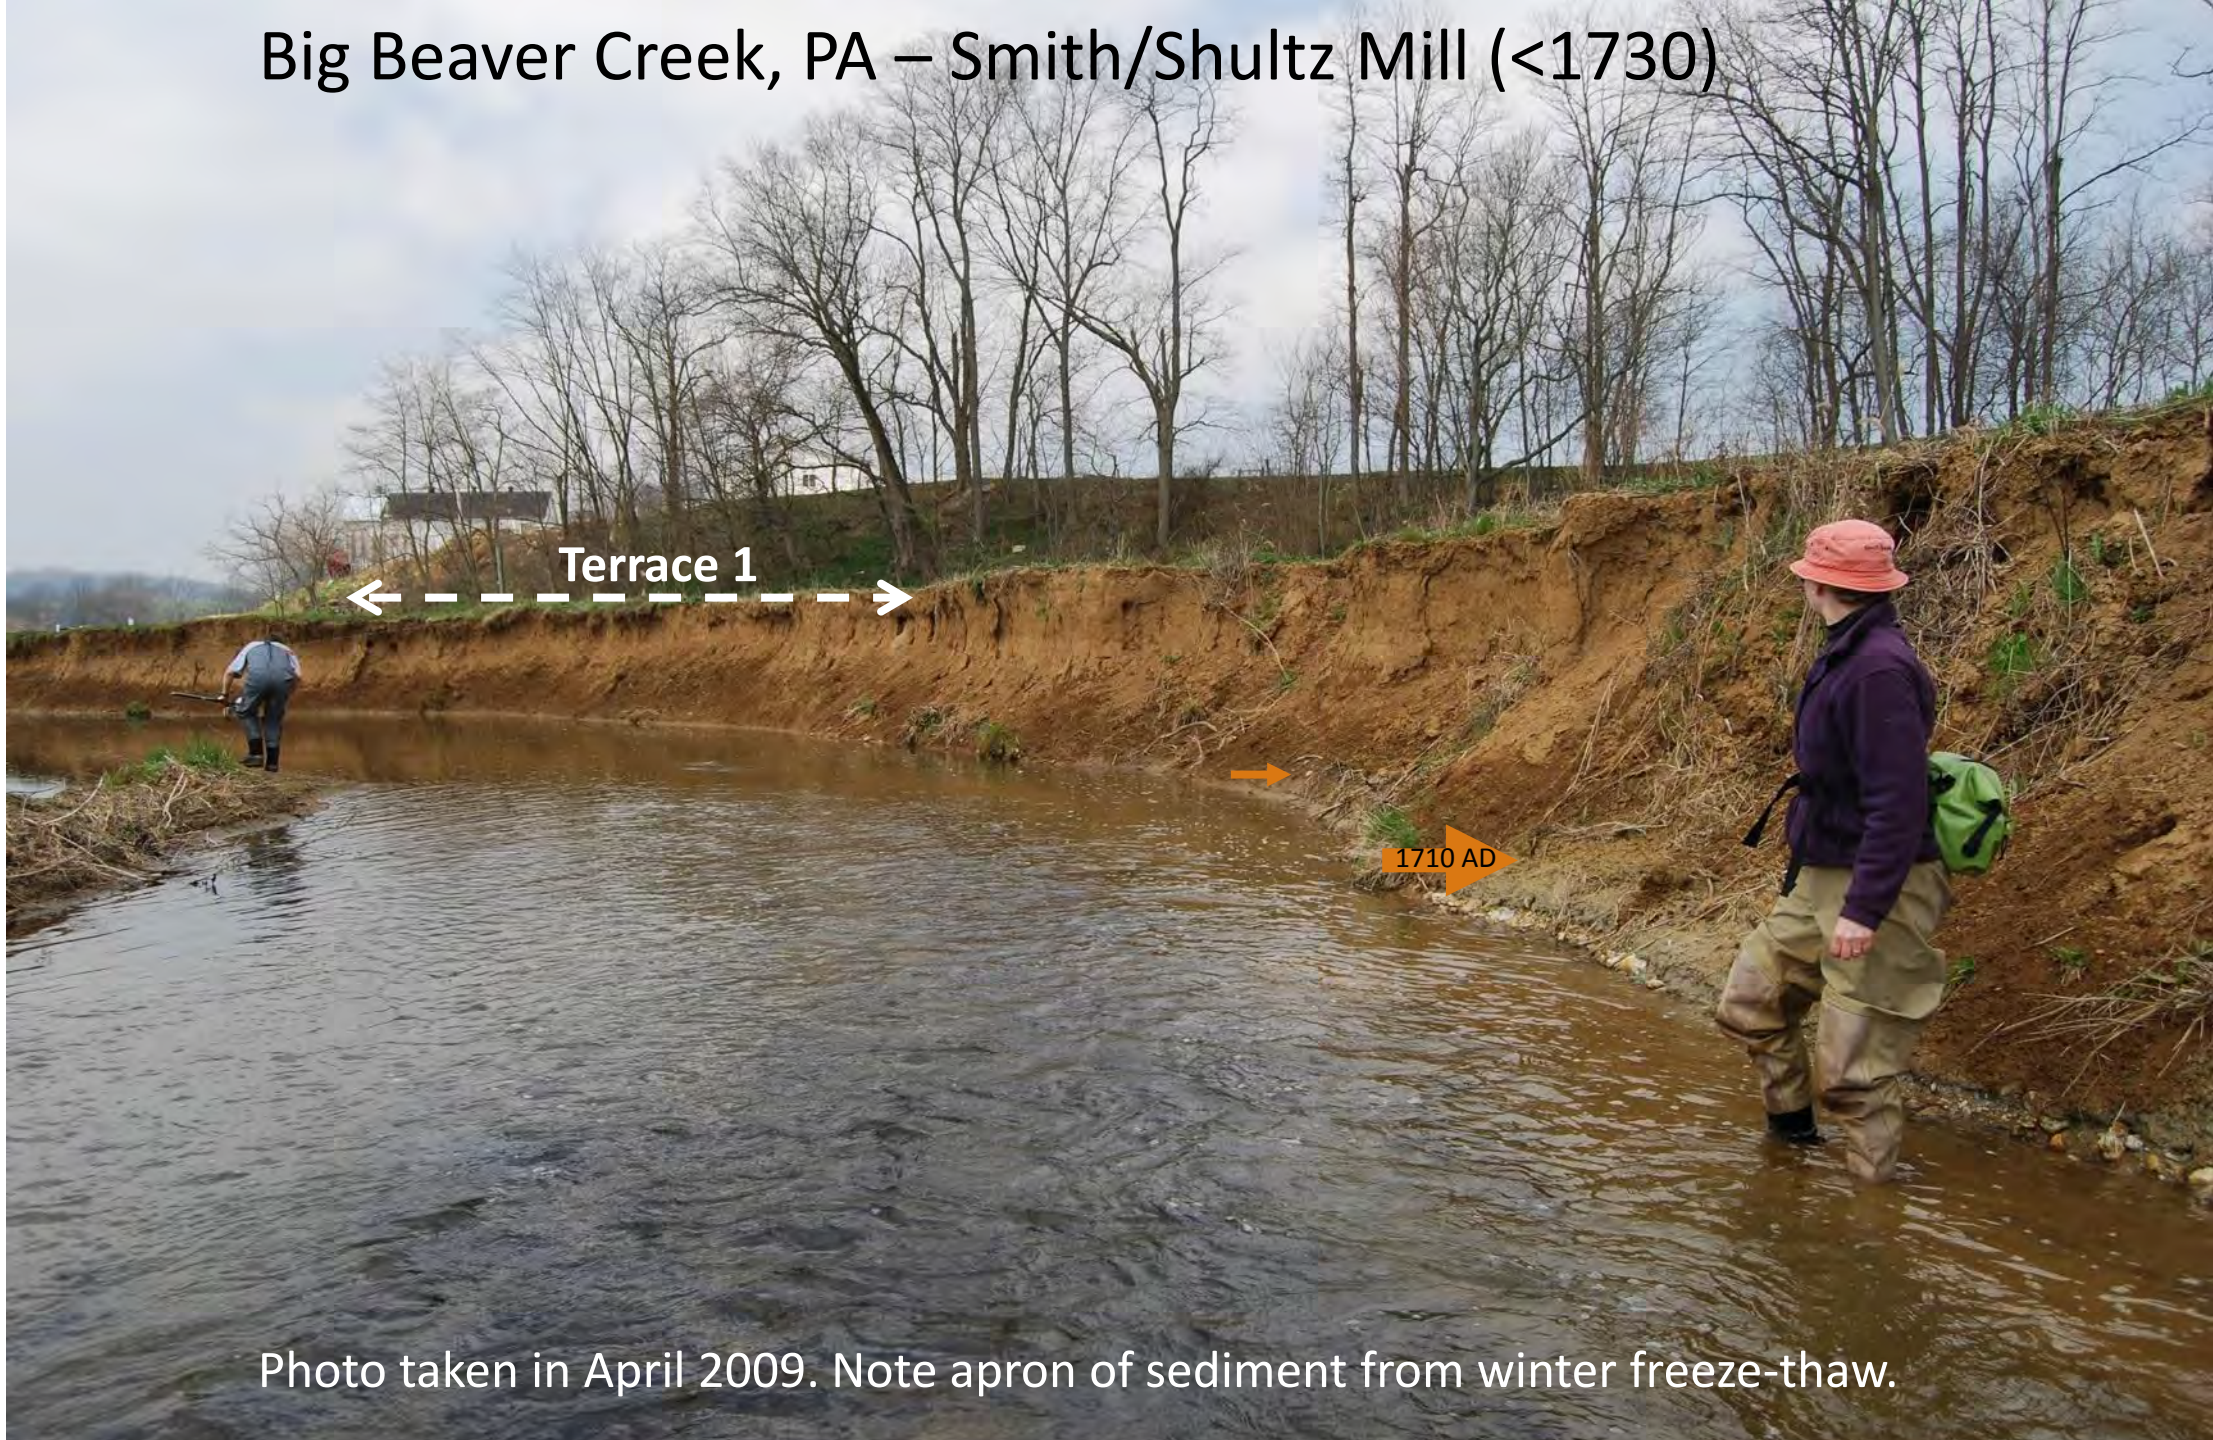
# Big Beaver Creek, PA – Smith/Shultz Mill (<1730)

Photo taken in April 2009. Note apron of sediment from winter freeze-thaw.
