Bloede Dam Removal

60% Design Report

JANUARY 2015

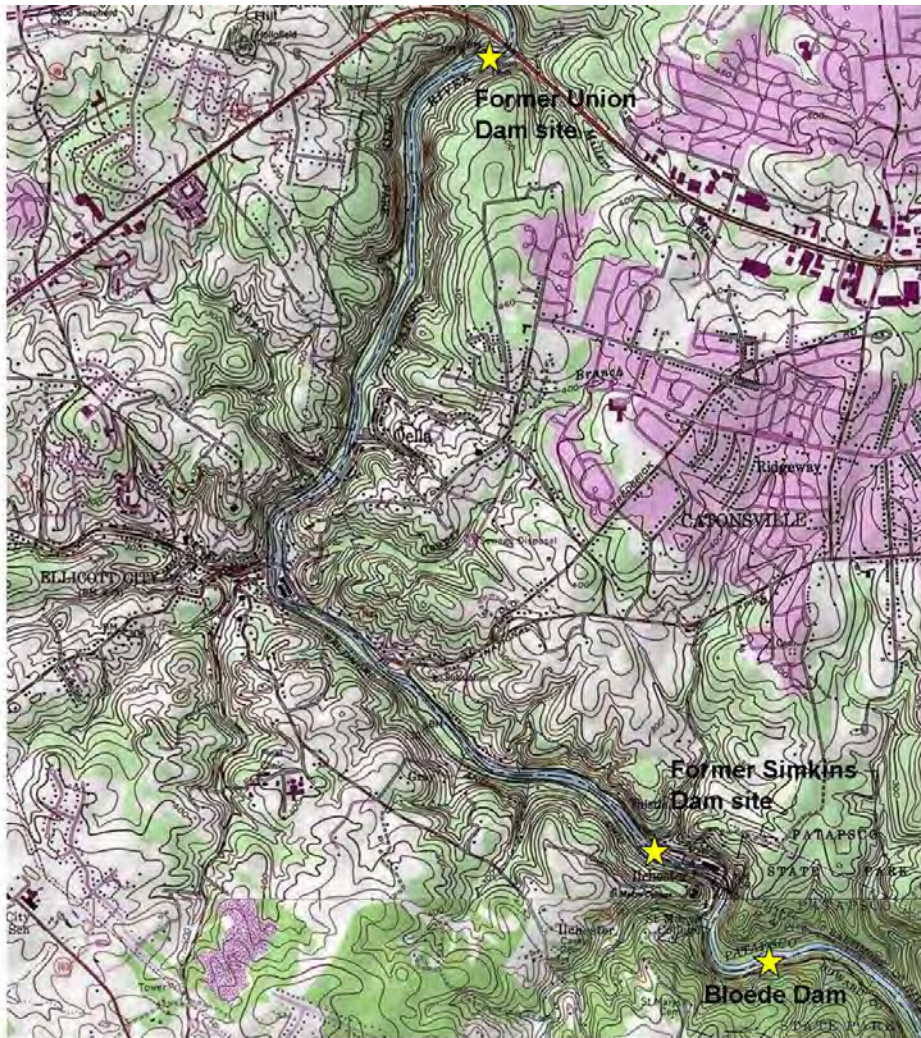
Figure 1- USGS Topographic map of the Patapsco River at Ellicott City, MD showing the location of the Simkins, Bloede and Union dams.

The Bloede Dam is located within the Patapsco Valley State Park approximately 11 miles upstream of Chesapeake Bay (Hanover Street) and 0.51 miles downstream of the Ilchester Road Bridge crossing the Patapsco River (Figure 1). American Rivers, on behalf of the Project Management team including the Maryland Department of Natural Resources and National Oceanic and Atmospheric Administration, contracted with Inter-Fluve to design the removal of Bloede Dam. This design report provides documentation of the 60% design submittal development.

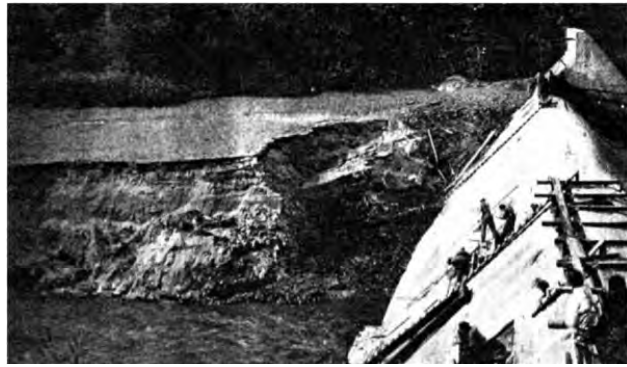
Figure 2- Dredging upstream of Bloede Dam (ca 1920)

The Bloede Dam is a hollow-core slab and buttress dam built in 1907 by the Ambursen Hydraulic Construction Company of Boston, Massachusetts. A buttress dam is a reinforced concrete structure characterized by an inclined flat slab upstream face supported by vertical buttresses. The spillway is 34-feet high and 160-feet long, with a 40-foot wide base and adjacent concrete abutments that span a total distance of 220 feet across the river valley. The turbines, which were once housed inside the dam, have been removed, and the current structure is filling with sand. The dam drains an area of approximately 304 square miles and impounds roughly ten acres. The original structure had three seven-foot diameter steel penstocks routing water to turbines, but only two were ever used. During 1912 and 1913, the intakes were replaced with gates operated from two motor houses on top of the spillway, and a sluice gate was added to one of the turbine bays. The design of the Bloede dam is unique, featuring water intakes below the crest that fed internal turbines. This design was also the reason for the dam's dysfunction, as large amounts of sediment deposited upstream of the dam and clogged the intake pipes. Dredging in the early 1920s temporarily restored power generation to the dam, but subsequent flooding brought more sediment. Hydropower generation was finally discontinued in March 1932 (Figure 2).

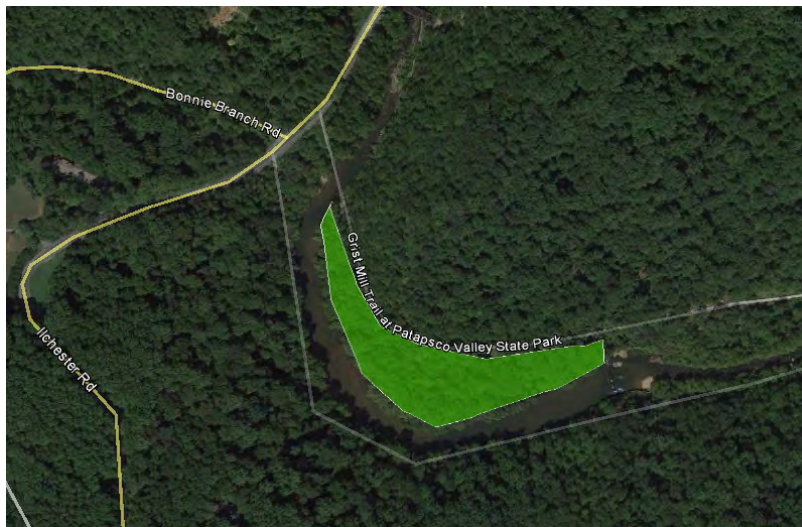
Figure 4 - Left Bank Impoundment Deposit Location

Impoundment sediment volume was estimated by combining sediment depth and character information provided in the subsurface investigations and borings described above. Several subsurface investigations were used to develop sediment volume estimates. The earliest of these was conducted by Associated Engineering Sciences, Inc., for the Dewatering of Bloede Dam report prepared in July 1987, which includes seven bores. Maryland Geological Survey performed subsurface investigations using vibrocoreing, ground penetrating radar and acoustic seismic equipment. MDGS vibrocores did not penetrate through the entire impounded sediment profile, but did provide grain size information at the bore locations. Three rounds of subsurface investigations were performed by Triad Engineering on September 6, 2012, December 11, 2012, and January 14, 2014 that included a total of 29 bores. Also, a floodplain geoprobe probing and coring operation was performed on July 24, 2013 and July 25, 2013. Data obtained from these efforts is summarized in *Bloede Dam Removal Draft Sediment Management Plan* (Inter-Fluve, 2013). The cores were used to estimate the extent, stratification, and character of sediment deposition within the channel and within the left (north) bank sediment deposit. The left bank deposit was determined to be a significant portion of the impoundment volume based on geotechnical investigation, which indicated the original main river channel is located there.

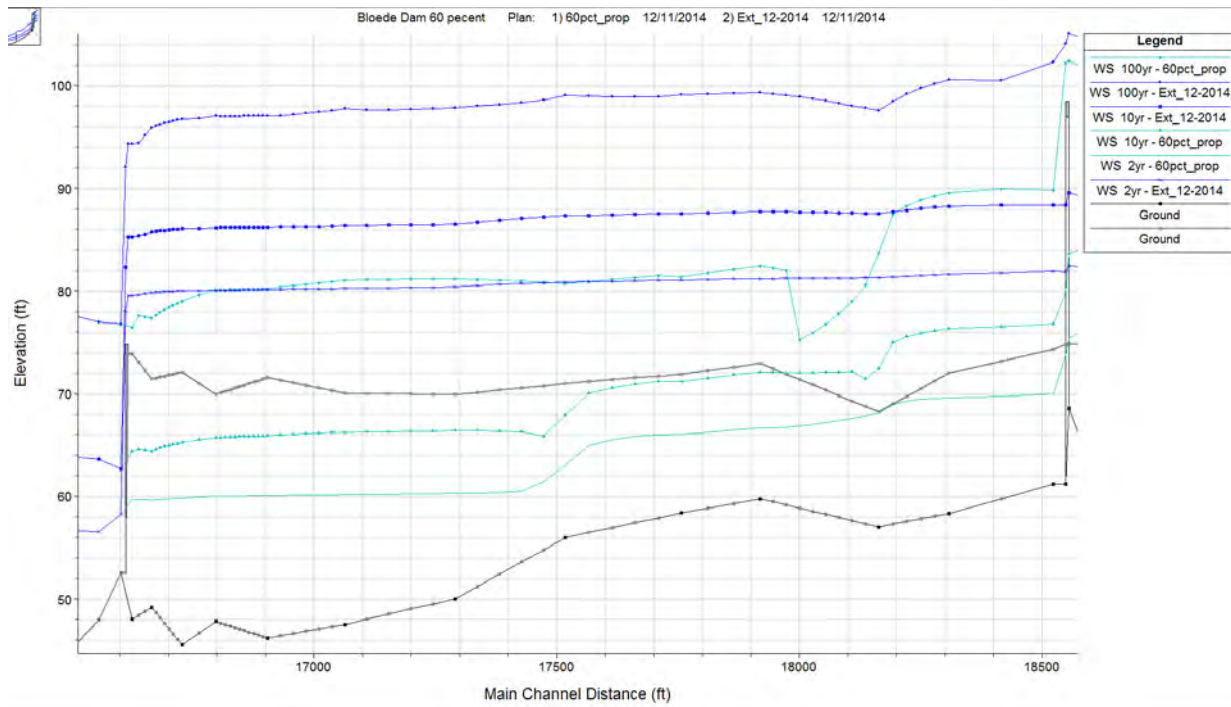
Figure 6 - Excerpt from HEC-RAS model output showing water surface elevations for existing (dark blue) and anticipated conditions (light blue) in the impoundment area.

Hydraulic model cross-section locations within the project reach are indicated by the existing and anticipated channel alignment stations shown on the design drawings. The channel thalweg is anticipated to shift to the north in the lower impoundment. Infrastructure locations can be determined relative to hydraulic model cross-section and their station on the design drawings. Roughness values for anticipated conditions were not changed from the existing values for the floodplain. However, roughness values were increased from 0.035 to 0.050 in channel based on an anticipated change from a sand bed channel to a large boulder bed channel, as shown in **Error! Reference source not found.** Hydraulic model output is provided for the anticipated and existing conditions in the project reach in the form of profile graphs, below. The profile graph in **Error! Reference source not found.** demonstrates the modeled water surface elevations along with channel bottom elevations under the existing conditions and anticipated conditions.

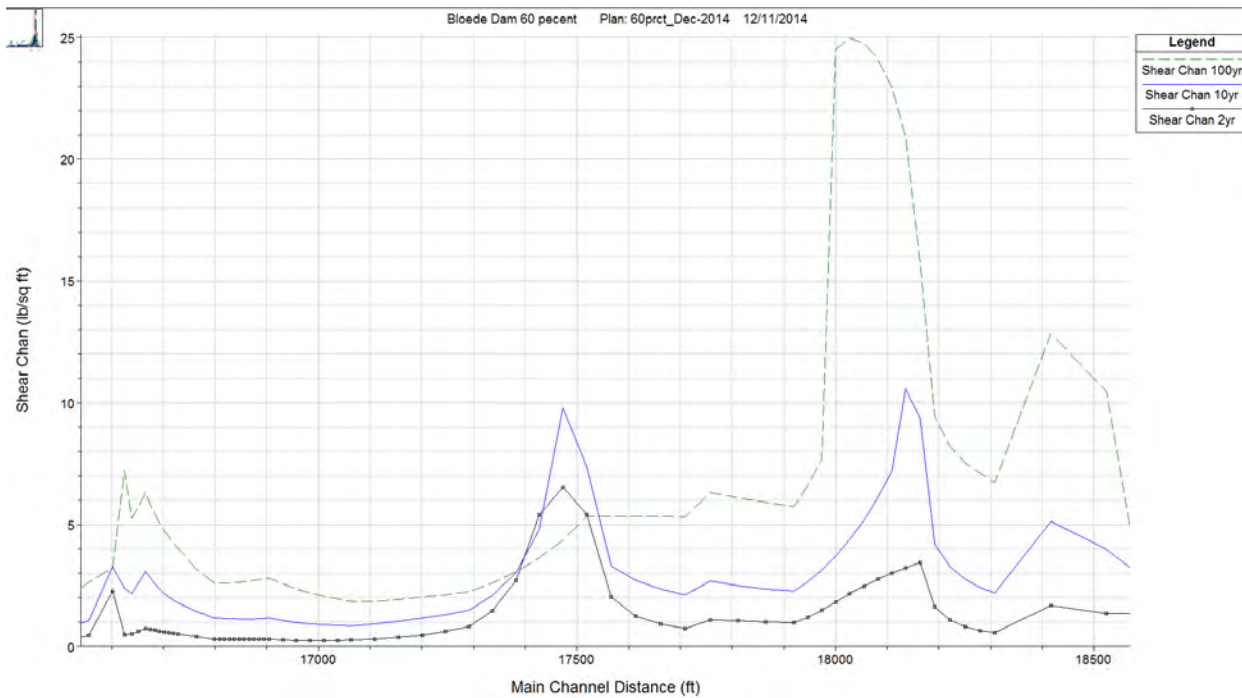
Figure 7 - Excerpt from HEC-RAS model output showing shear stress values (lb/ft²) associated with the 2-, 10-, and 100-yr recurrence flood for anticipated conditions.

The results from the HEC-RAS model indicate very high shear stresses at STA 180+00 where hydraulic jumps occur (See **Error! Reference source not found.** and **Error! Reference source not found.**). These are likely due to a valley wide flow constriction and downstream drop in channel elevation near STA 179+20. The proposed conditions model has been developed based on limited subsurface data; therefore, channel conditions following dam removal may vary. The channel exposed following dam removal and sediment evacuation should closely match the pre-dam channel. As such, if severely erosive conditions exist, the exhumed channel should have the erosional resistance to withstand severe hydraulics. The greater concern may be for fish passage, and an adaptive management approach may be necessary to assure fish passage.

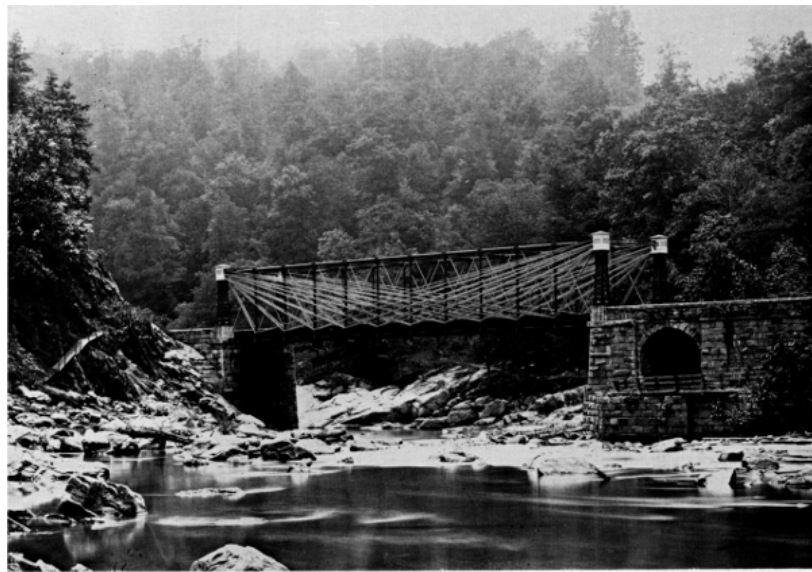
Figure 8 - Pre-dam photo of Railroad Bridge that has been converted to the Grist Mill Trail Cable Stay pedestrian bridge.

The upstream suspension bridge is termed the Cable Stay Bridge in engineering design plans. The Cable Stay Bridge abutments were built in the early to mid-1800s as part of the original railroad bed, and have withstood numerous large tropical storm events for over the last 150 years. It is assumed that removal actions at Bloede Dam will not affect Cable Stay Bridge abutment stability. Figure 8 shows that the bridge appears to be founded on bedrock.

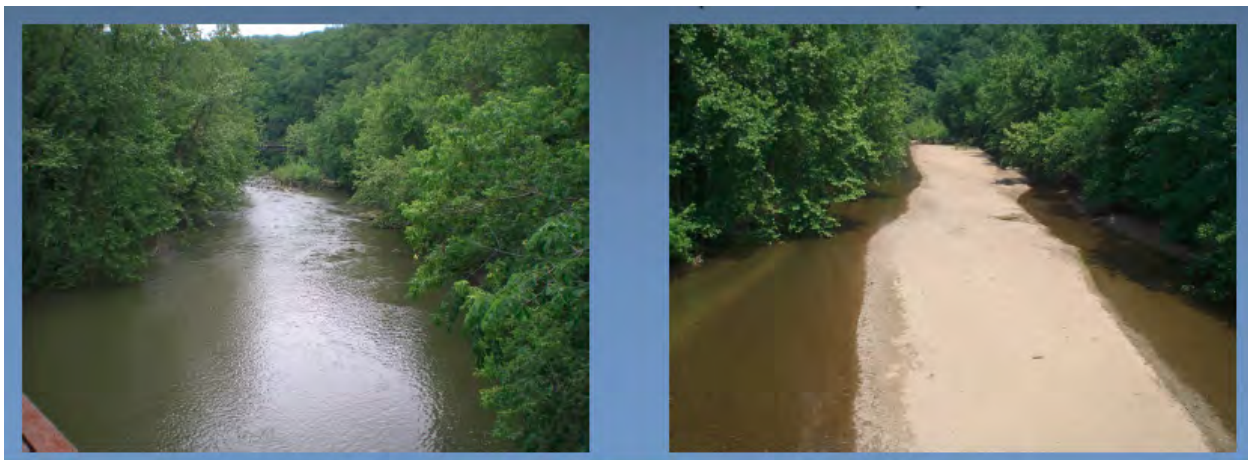
Figure 9- Proposed In-river Alignment (Pre- and Post-Simkins Dam Removal).

downstream of the CSX Railway Bridge on river right. The proposed upstream access is routed within the shallowest part of the Patapsco River to reduce impacts and crosses underneath the Grist Mill Trail pedestrian bridge. An alternative access alignment, closer to the Grist Mill Trail, has also been designed if required due to unforeseen issues at the primary access location. The primary access point is preferred since it reduces clearing of riparian forest cover.

Both temporary construction access alignments will require construction crossings of the existing 12-inch and 42-inch sanitary sewer, downstream of the pedestrian cable bridge. The sanitary sewers are both buried at the crossing locations. The contractor will be required to provide a plan for the crossing locations and a spill prevention and containment plan. The specifications will require that the contractor protect and monitor the sewer lines during construction.

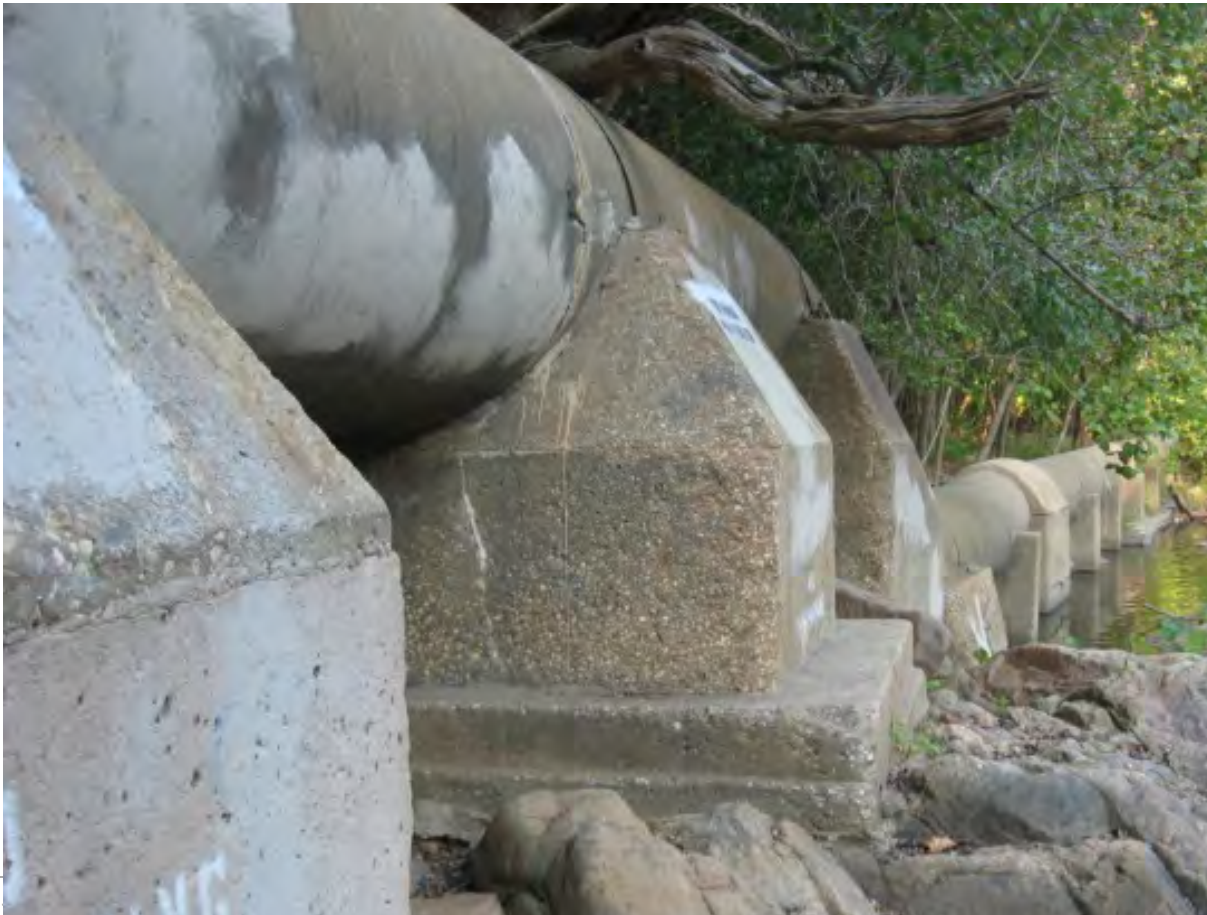
Figure 10- Existing 42-Inch Diameter Sewer.

A 42-inch diameter sewer main extends along the north side of the river channel and penetrates the

dam on the left side at the foundation contact. The pipe is exposed downstream of the dam and upstream of the impoundment, passing through the left abutment of the pedestrian bridge and into impounded sediments that will be mobilized following dam removal. Downstream of the dam, the pipe is supported by concrete piers mounted on bedrock outcrops at the toe of the left valley wall (Figure 10). Upstream of Bloede Dam, near the upper end of the impoundment, the interceptor is exposed along the left bank. The sanitary sewer pipe will be relocated from downstream of the existing pedestrian bridge to downstream of the Bloede Dam and moved within the Grist Mill Trail alignment (Figure 11).

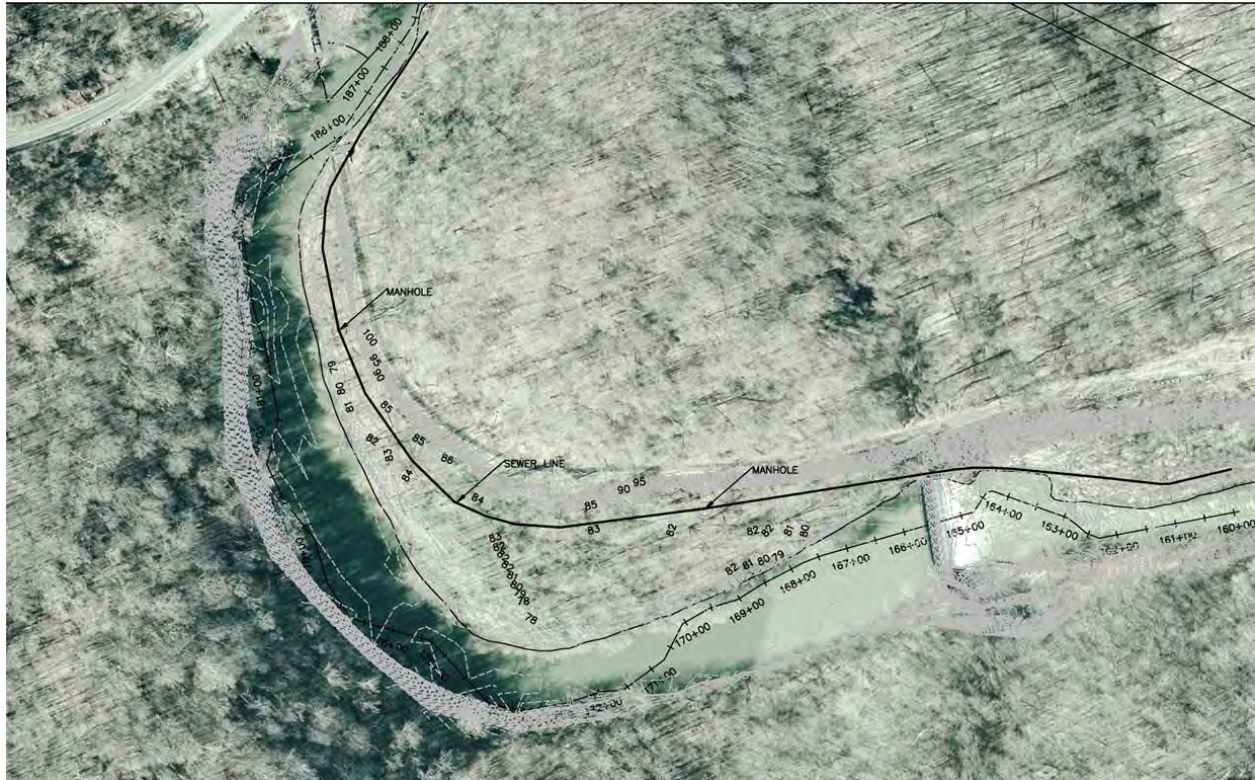
Figure 11- Grist Mill Trail alignment.

As discussed, this will require access to the left bank of the Patapsco River upstream of Bloede dam, and trees will be cleared between the Grist Mill Trail and the Patapsco River downstream of the existing pedestrian bridge and upstream of the dam. Trees will also need to be cleared downstream of the dam to facilitate the relocated sewer into the existing sewer. Construction of the pipe reroute will require temporary shutdown of the Grist Mill Trail for a period of up to twelve months. Long-term stability of the Grist Mill Trail and the associated proposed pipe alignment has been evaluated by geotechnical engineers as a part of the Final Design process. The geotechnical engineer (Triad Engineering) has determined that the slope conditions during construction are stable at the proposed 2:1 (H:V) slopes. For ultimate conditions, which are anticipated to include slopes as steep as 1.6:1, the slopes will require compaction in 4-foot lifts and a geotechnical engineer will be
