PPRP-169

## Coal Combustion By-Product Storage, Use, and Disposal Sites in Maryland

August 2019

**MARYLAND POWER PLANT  
RESEARCH PROGRAM**

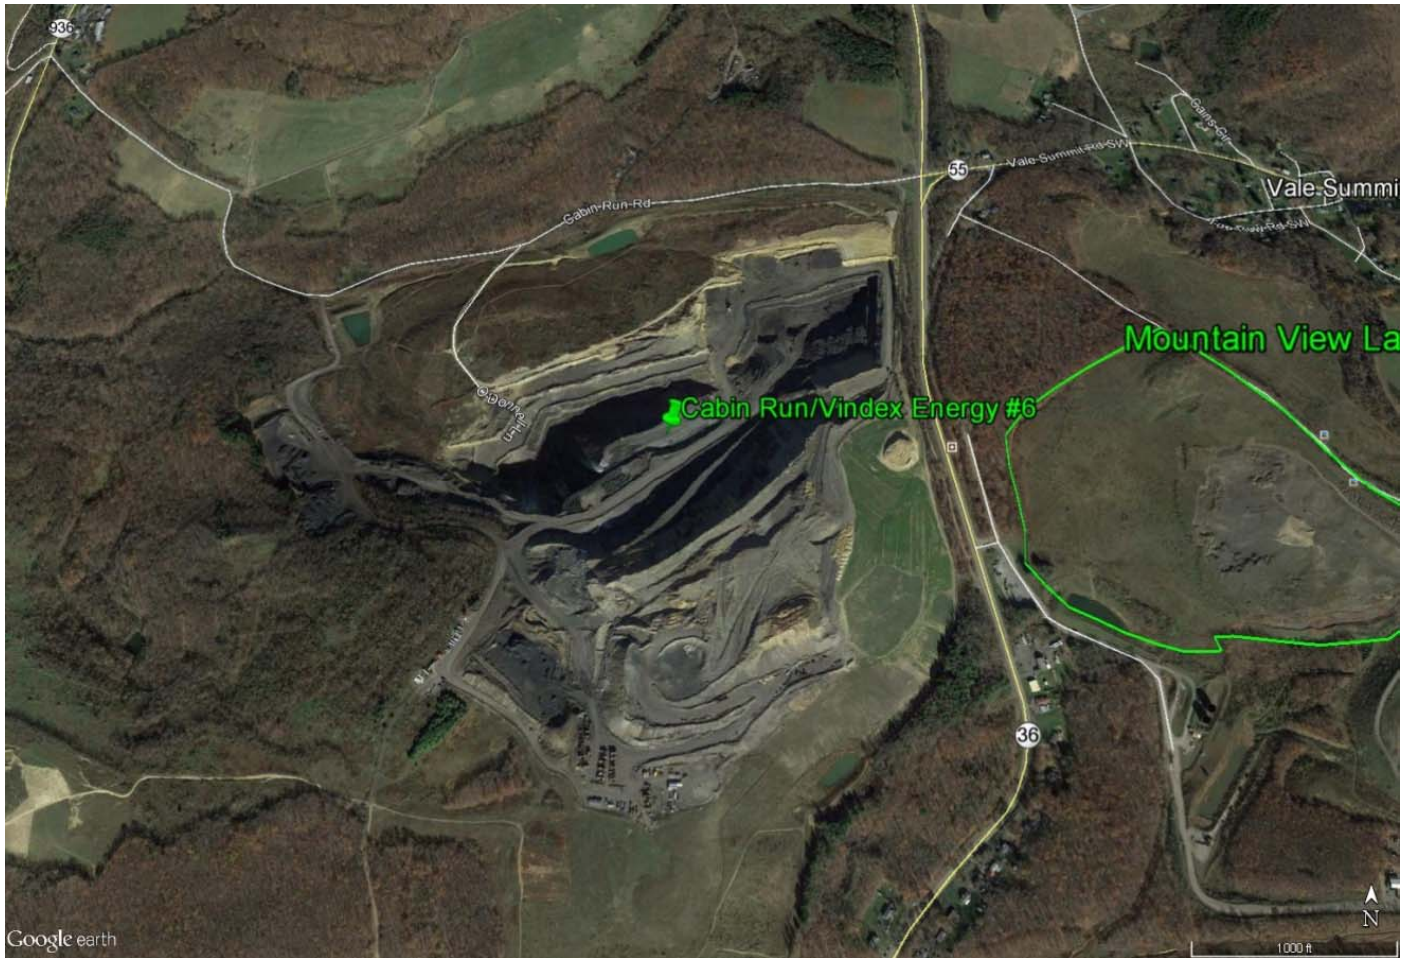
Site Name: Cabin Run/Vindex Energy #6

Recoverability: Not recoverable because Warrior Run CCBs were co-mingled with surface mine overburden in a manner that makes recovery of the CCBs impractical.

Notes: Location verified with MDE shapefile.

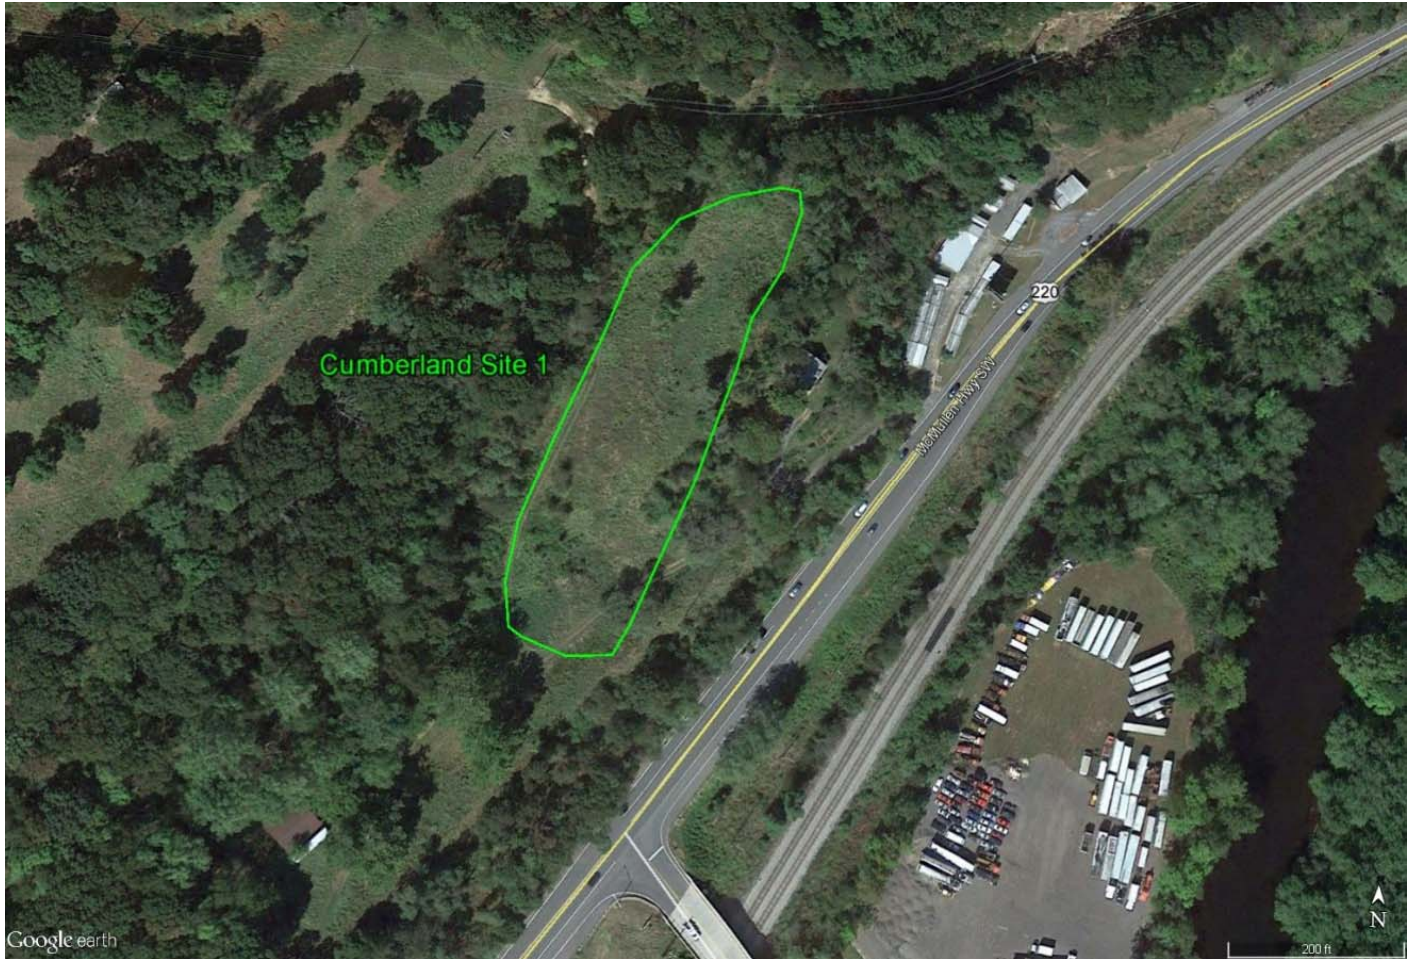
Site Name: Cumberland Site 1

Recoverability: Potentially recoverable because records indicate only CCBs and soil were placed at the site and site appears to be undeveloped.

Notes: Location is approximate. It appears that Log Trail Road may have been constructed over part of the fill site.

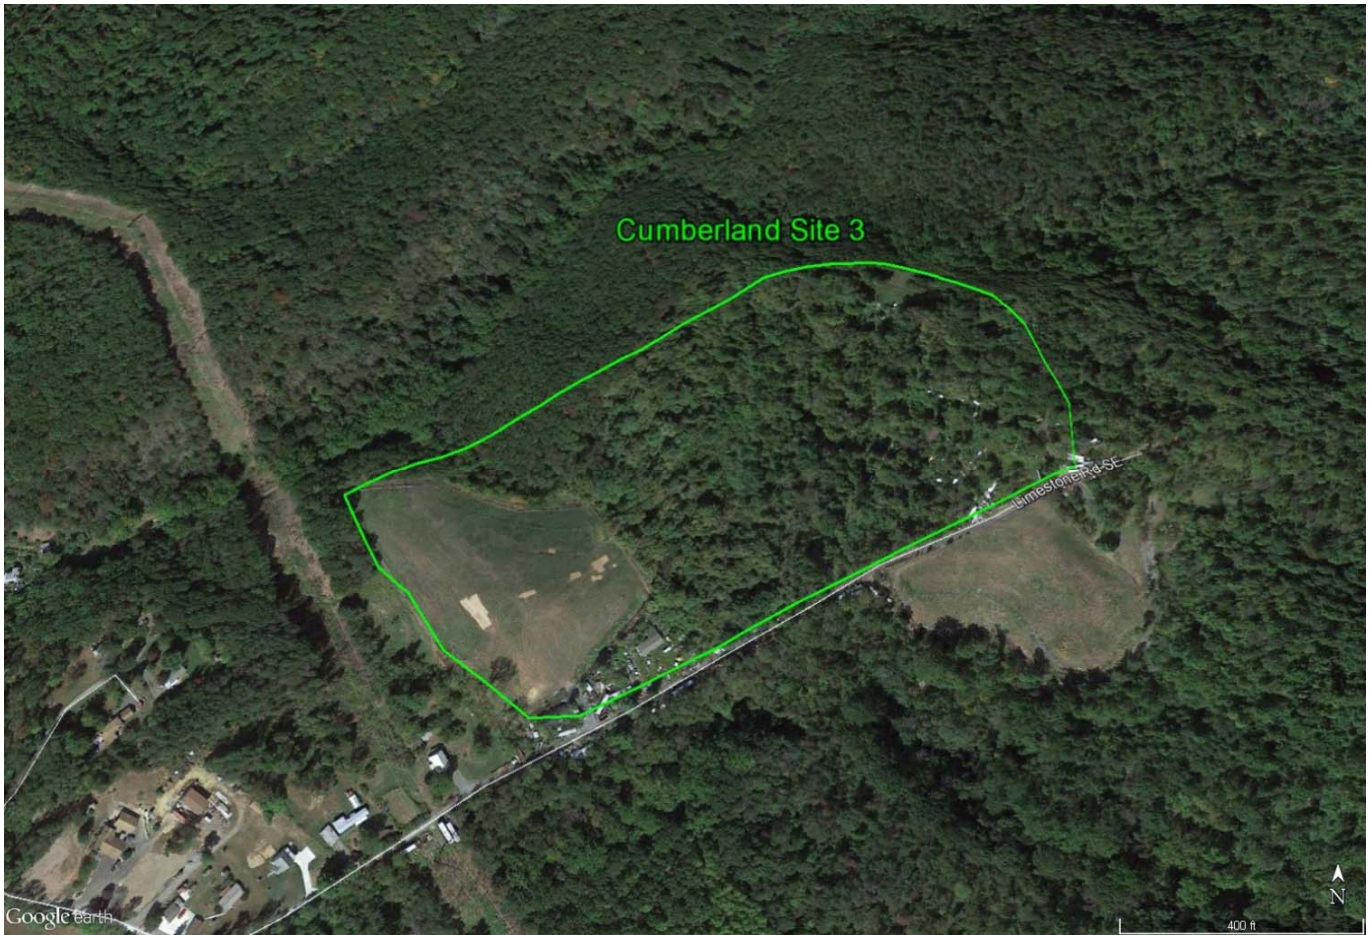
Site Name: Cumberland Site 3

Recoverability: Not recoverable because CCBs were placed along with other wastes.

Notes: Location is approximate.

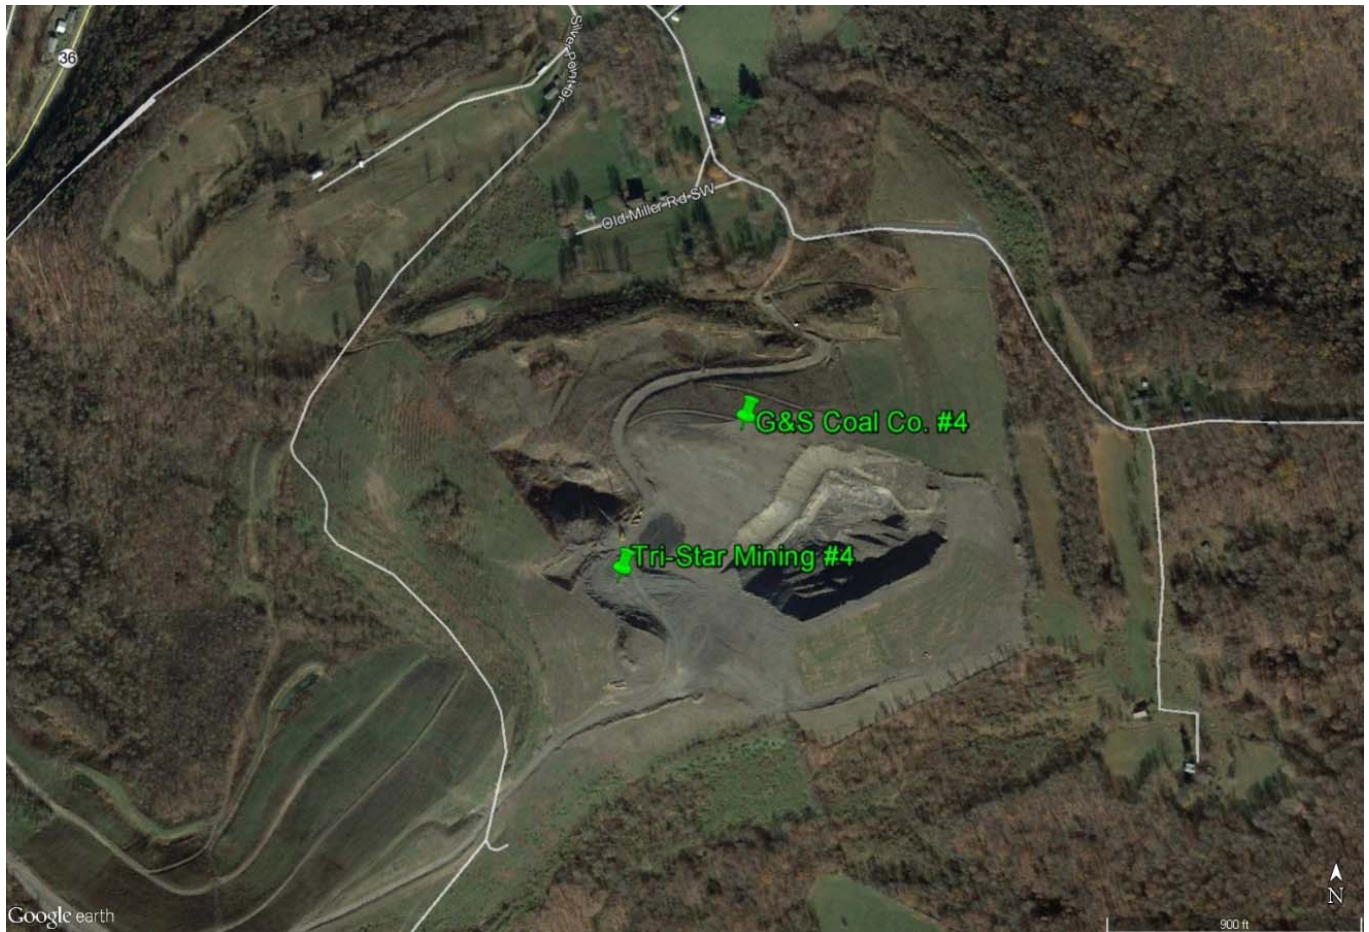
Site Name: G&S Coal Co. #4

Recoverability: Not recoverable because Warrior Run CCBs were co-mingled with surface mine overburden in a manner that makes recovery of the CCBs impractical.

Notes: Location verified with MDE shapefile.

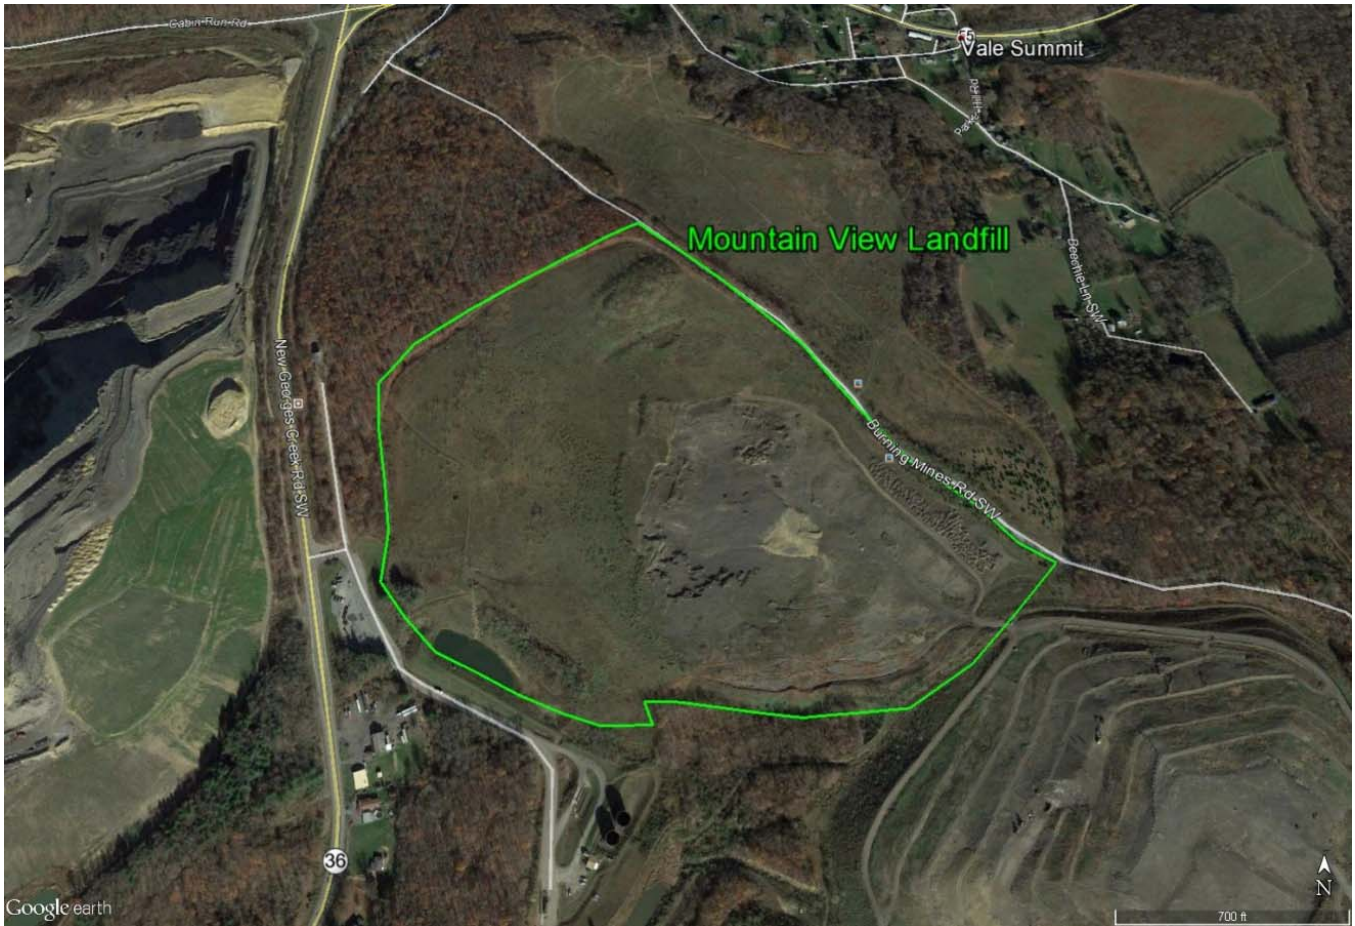
Site Name: Mountain View Landfill

Recoverability: Not recoverable because CCBs were placed along with other wastes.

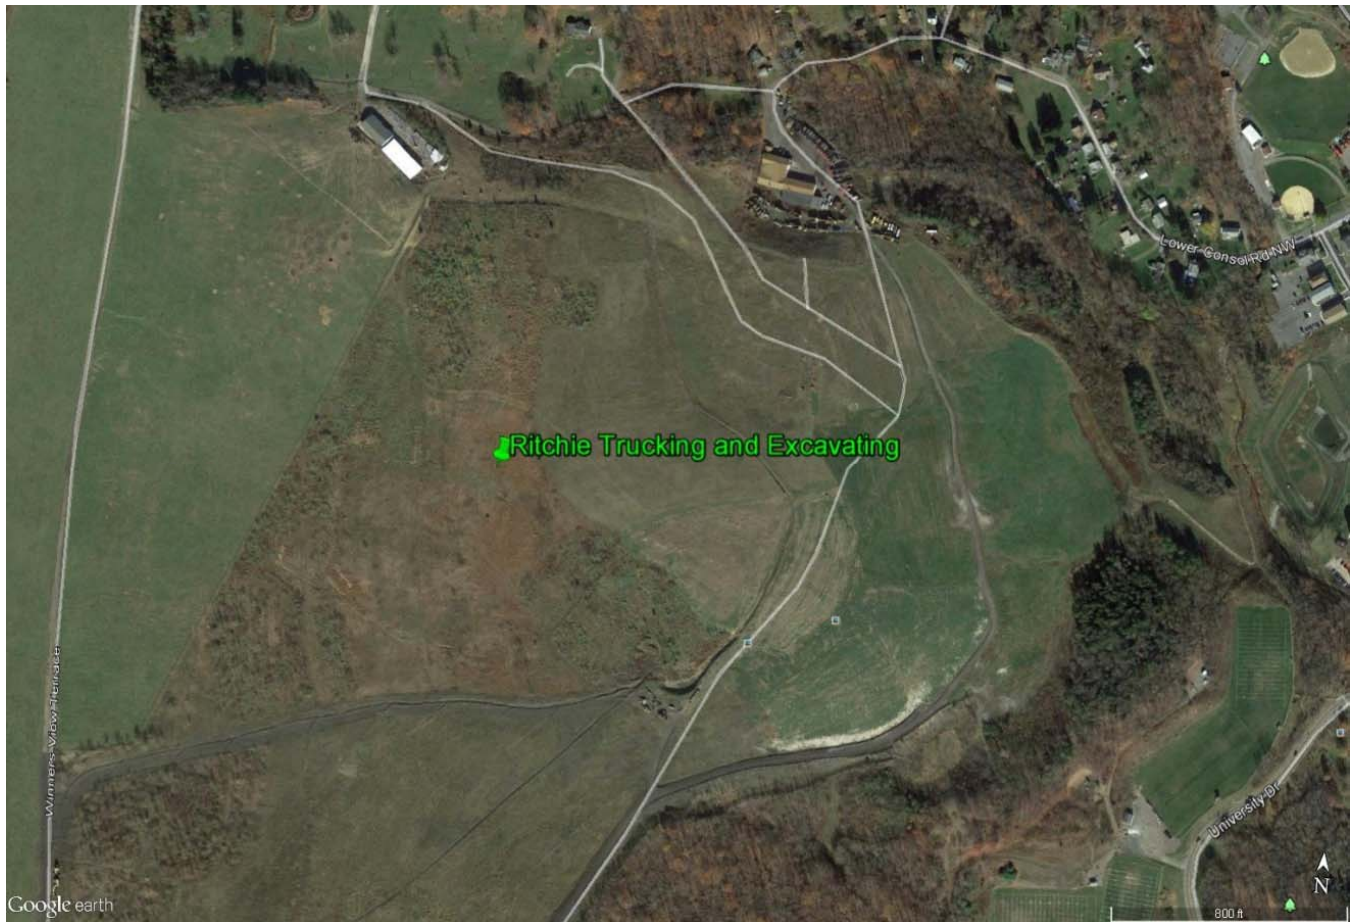
Site Name: Ritchie Trucking and Excavating

Recoverability: Not recoverable because Warrior Run CCBs were co-mingled with surface mine overburden in a manner that makes recovery of the CCBs impractical.

Notes: Location verified with MDE shapefile.

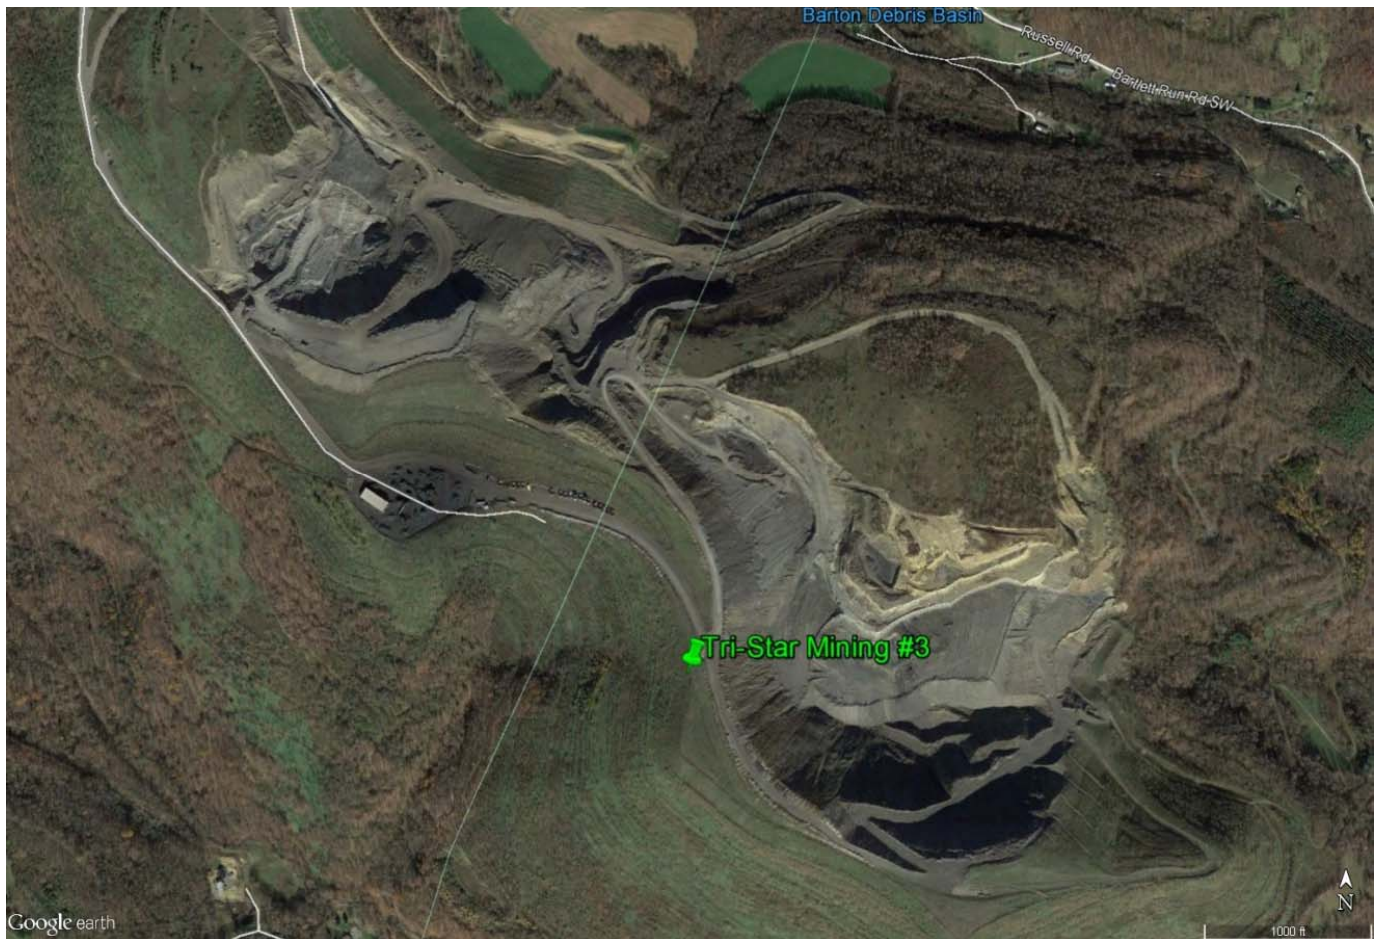
Site Name: Tri-Star Mining #3

Recoverability: Not recoverable because Warrior Run CCBs were co-mingled with surface mine overburden in a manner that makes recovery of the CCBs impractical.

Notes: Location verified with MDE shapefile.

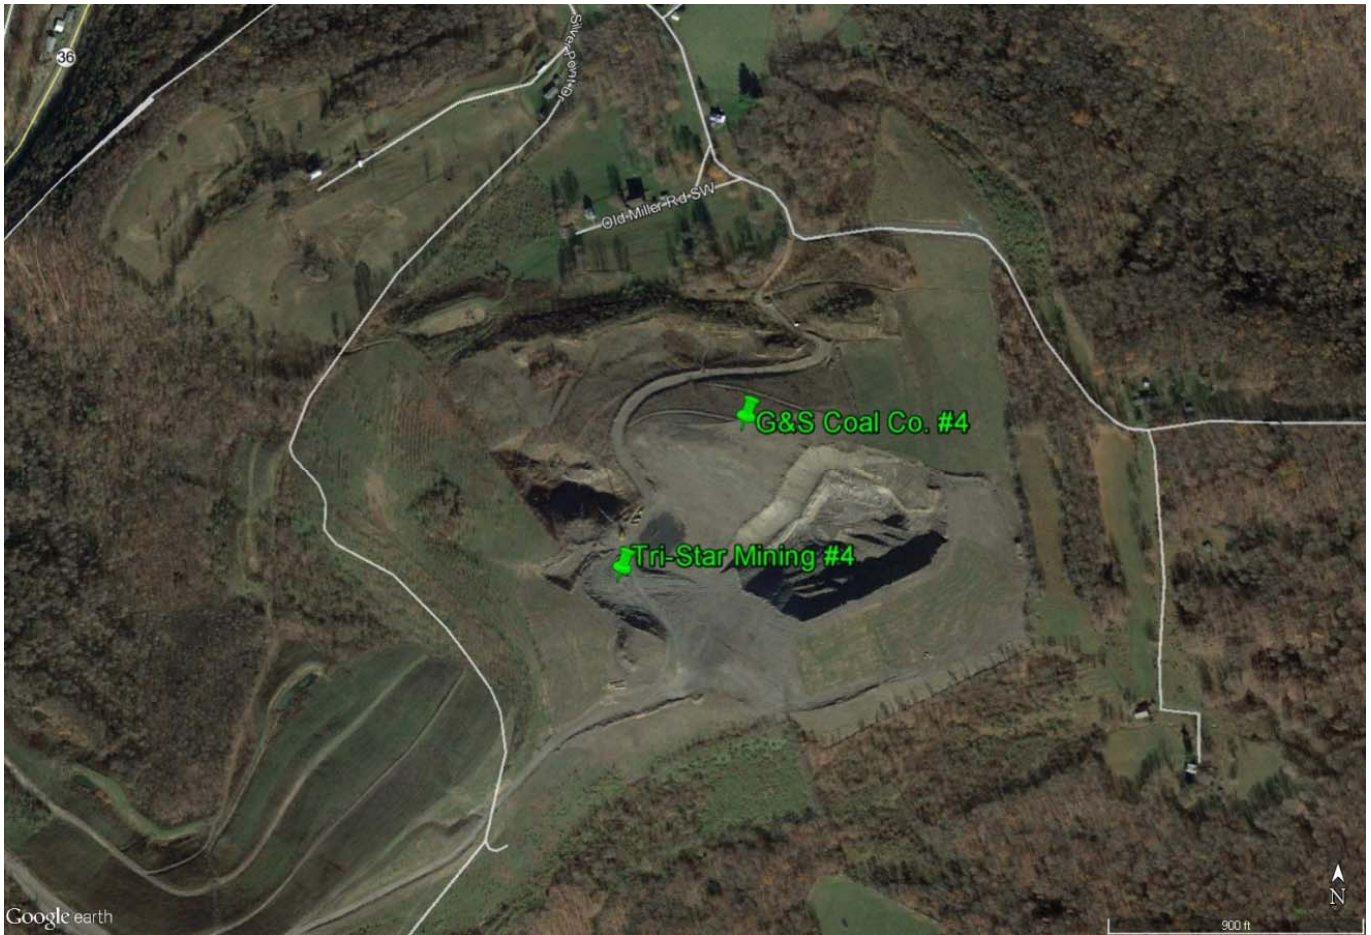
Site Name: Tri-Star Mining #4

Recoverability: Not recoverable because Warrior Run CCBs were co-mingled with surface mine overburden in a manner that makes recovery of the CCBs impractical.

Notes: Location verified with MDE shapefile.

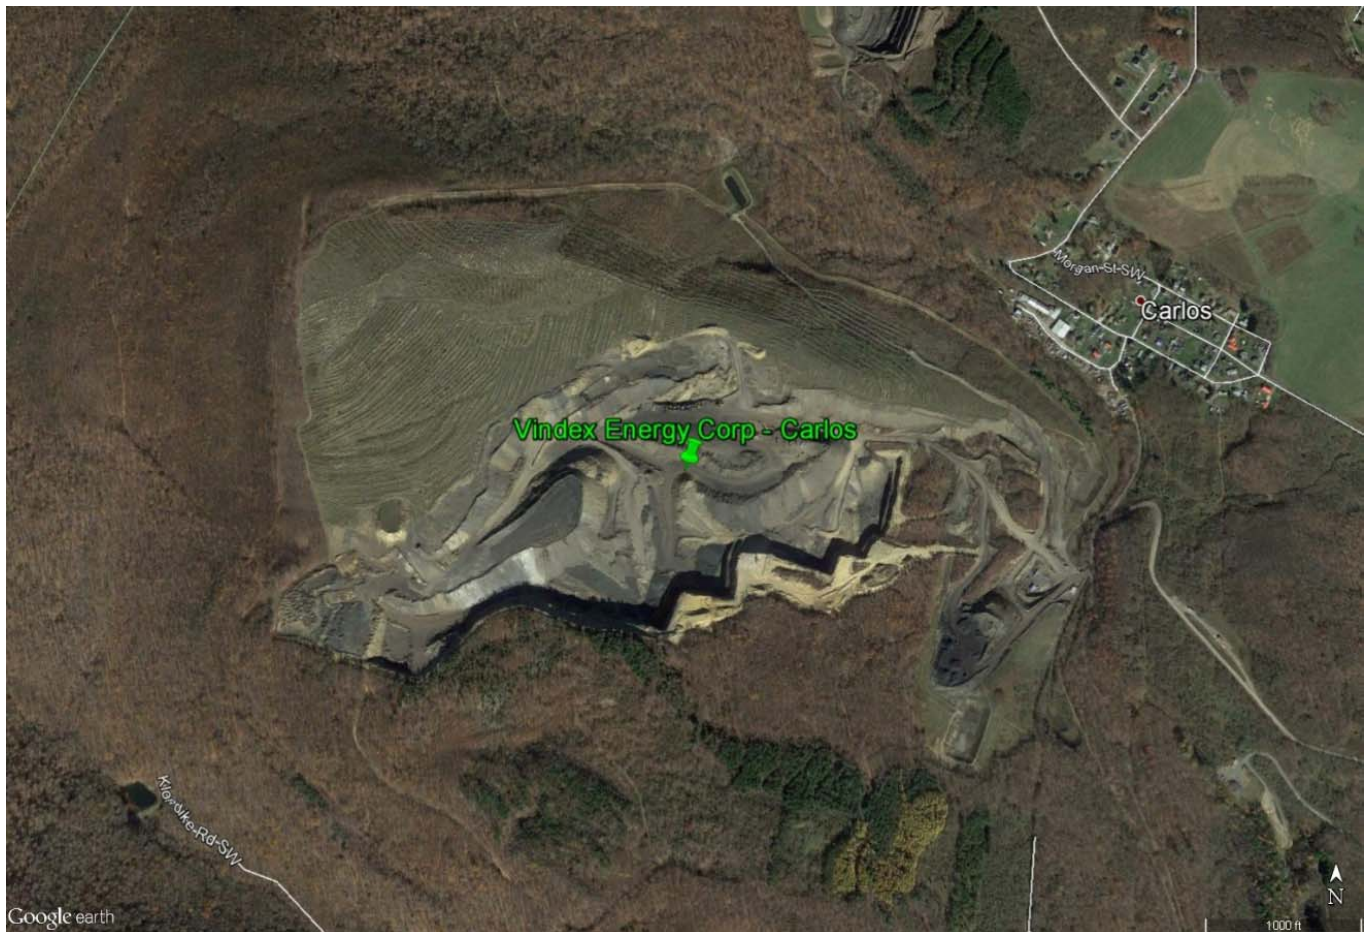
Site Name: Vindex Energy Corp - Carlos

Recoverability: Not recoverable because Warrior Run CCBs were co-mingled with surface mine overburden in a manner that makes recovery of the CCBs impractical.

Notes: Location verified with MDE shapefile.

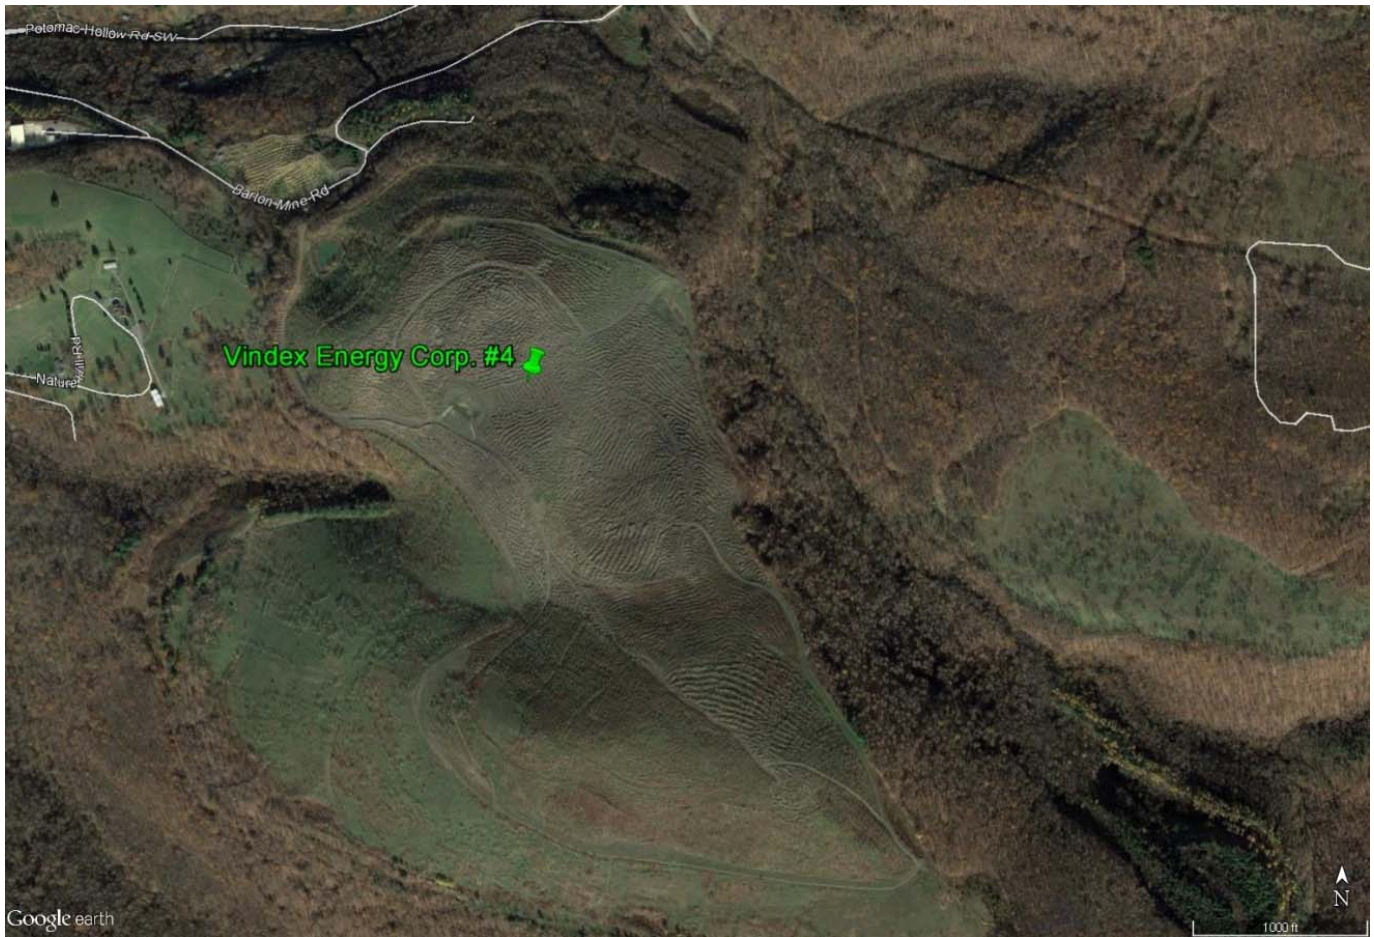
Site Name: Vindex Energy Corp. #4

Notes: Location verified with MDE shapefile.

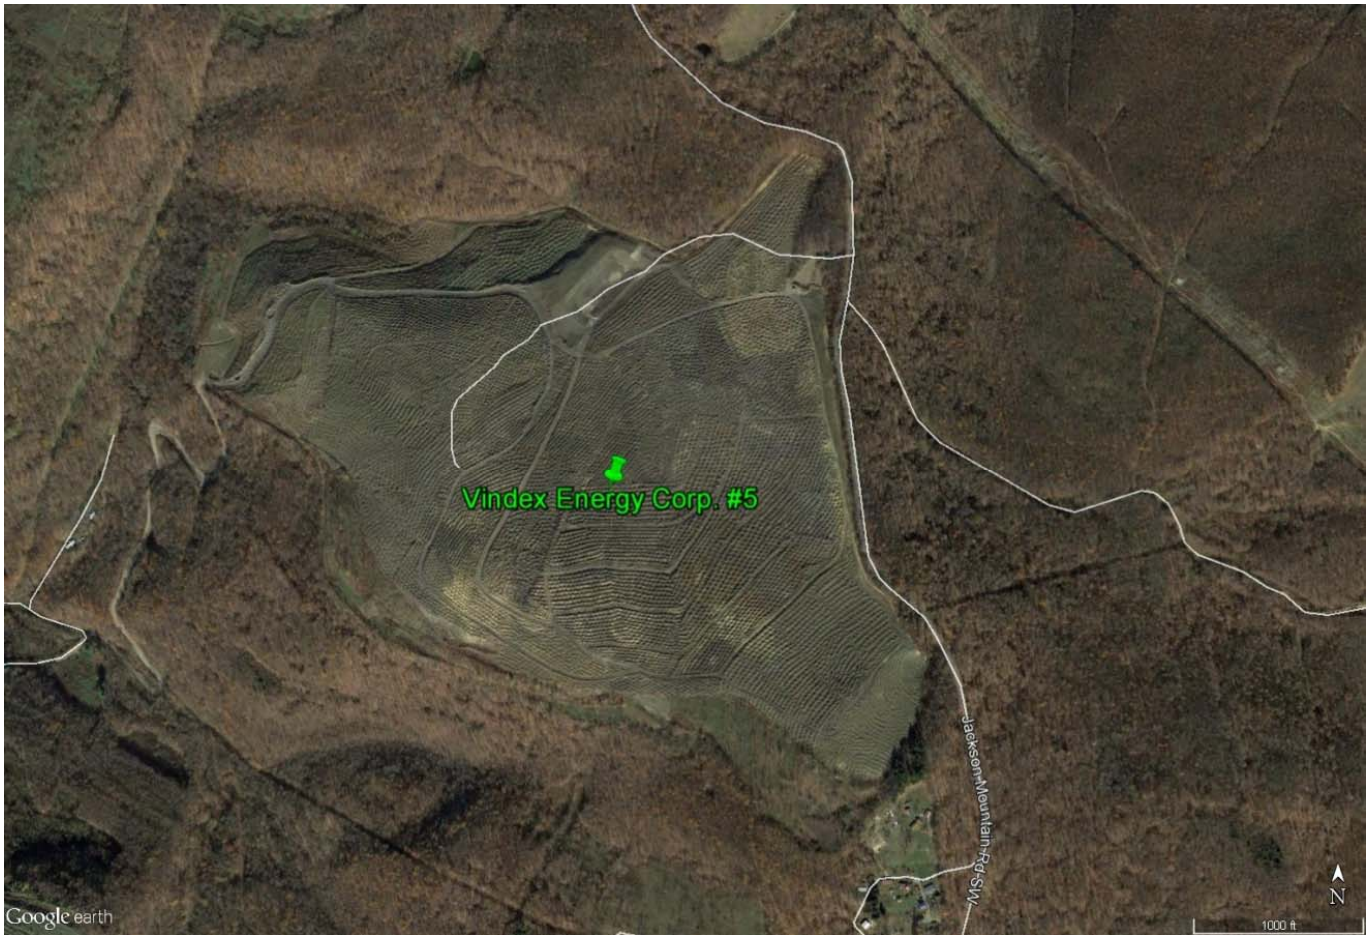
Site Name: Vindex Corp. #5

Recoverability: Not recoverable because Warrior Run CCBs were co-mingled with surface mine overburden in a manner that makes recovery of the CCBs impractical.

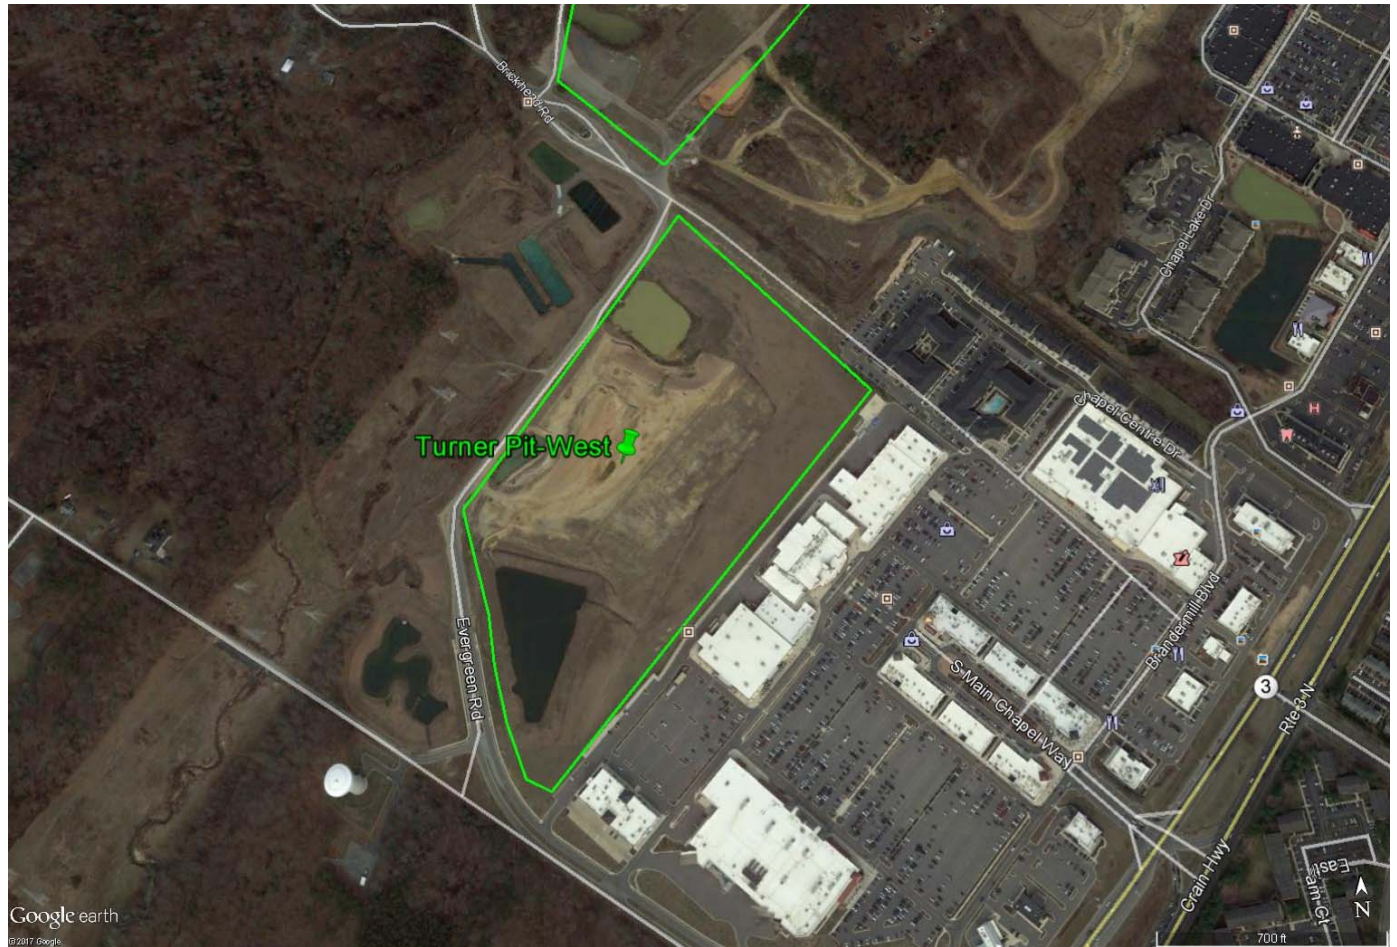
Site Name: Turner Pit (West)

Notes: The Turner Pit (West) is a small portion of the BBSS site. The majority of the Turner Pit has been capped and is covered by a shopping center and parking lots, but satellite imagery indicates that the western portion of the Turner Pit is not redeveloped or vegetated. Windshield Survey Performed 7/25/17: Site viewed from eastern boundary only (all other roads are private, owned by Reliable Construction). Triangular pond on southwestern part of site is still present. Earth moving activity observed on main part of site. Material appears to be mounded red-brown soil. No CCBs visible.

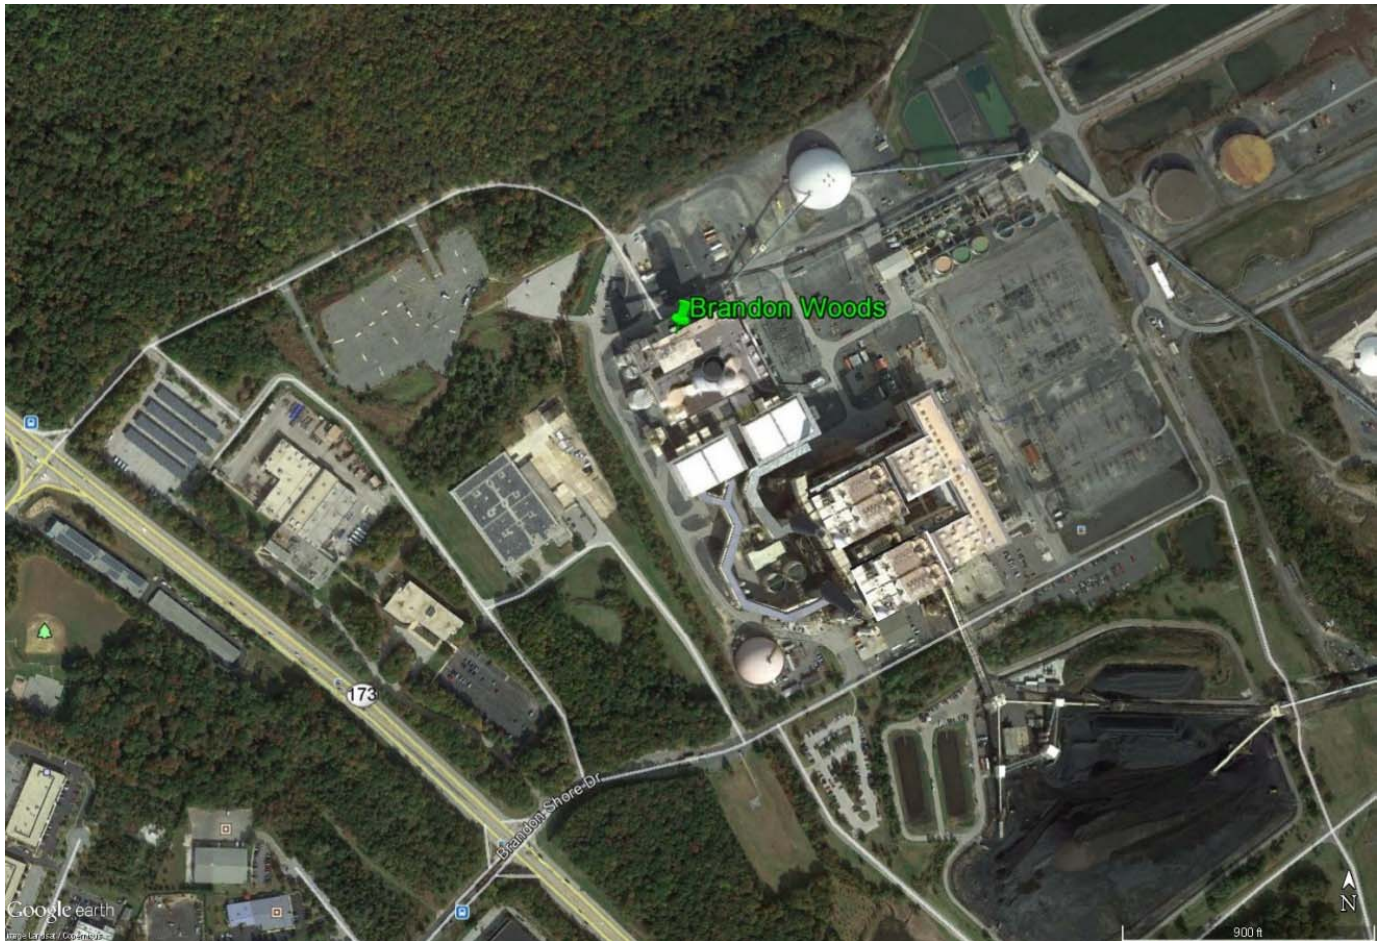
Site Name: Brandon Woods

Recoverability: Not recoverable because site is capped and redeveloped with buildings.

Notes: Since widening of Solley Rd. was done on the Brandon Woods side, a portion of the road may have been placed over CCBs.

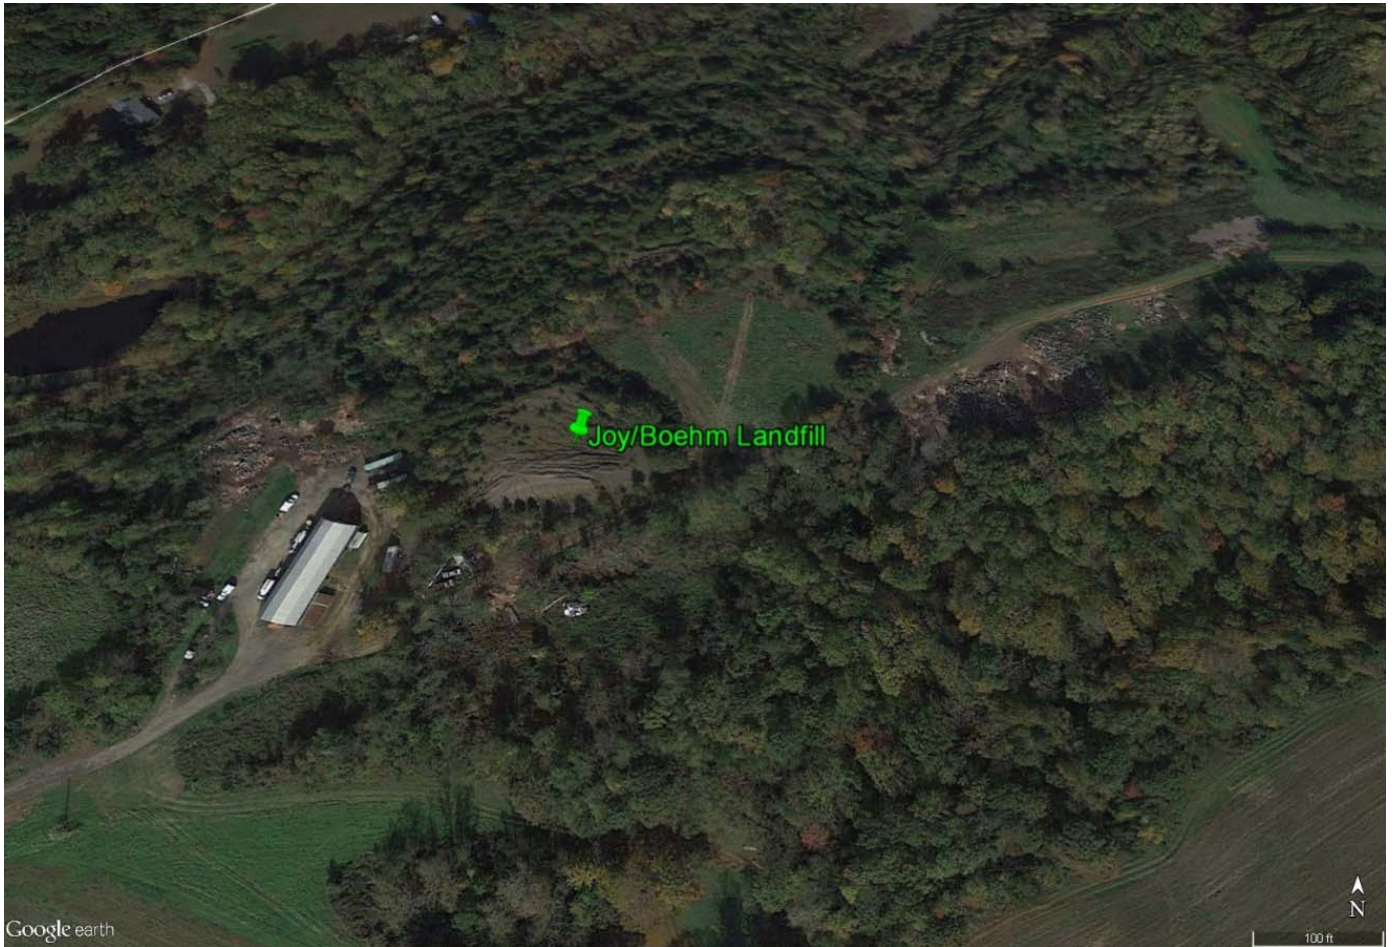
Site Name: Joy/Boehm Landfill State

Recoverability: Not recoverable because CCBS were disposed along with other waste materials.

Notes: Location is approximate based on address given in MDE, 2010.

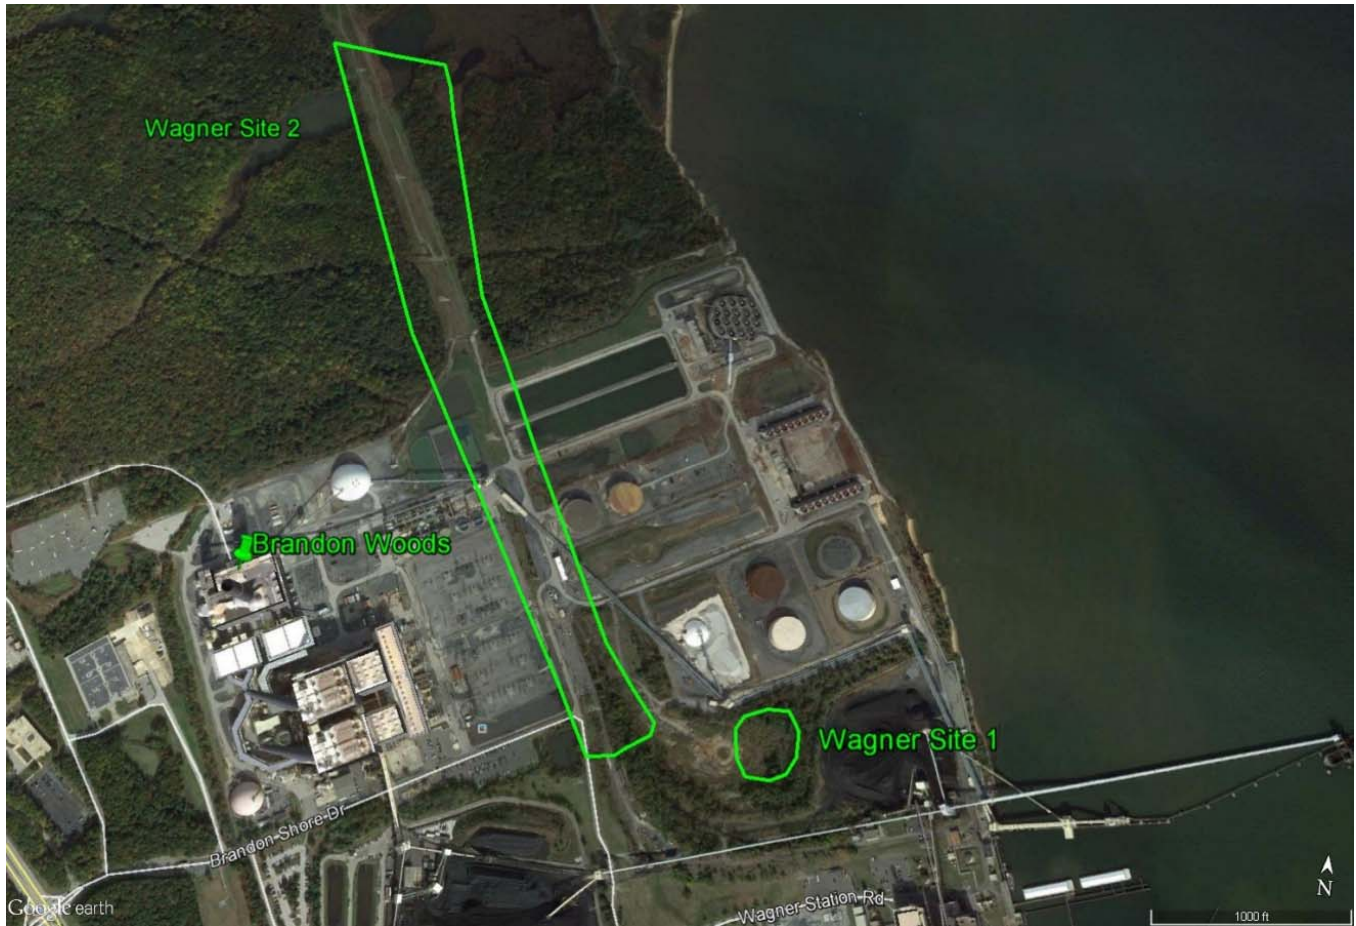
Site Name: Wagner Power Plant Site 1

Recoverability: Not recoverable because Hoyt, 2017 indicates no record of onsite CCB fill areas.

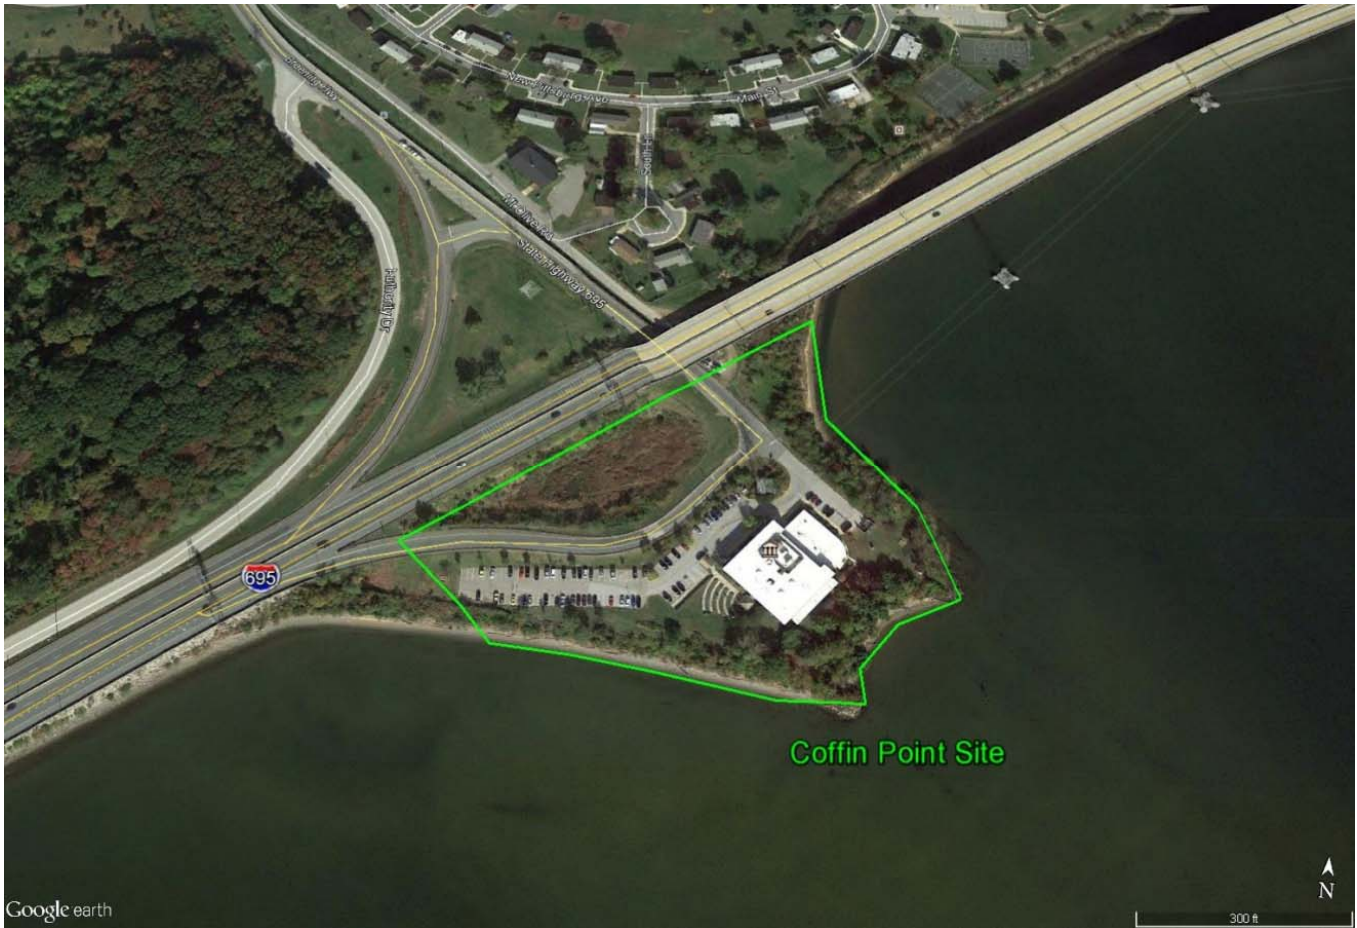
Site Name: Coffin Point Site

Recoverability: Not recoverable because site has been redeveloped with buildings.

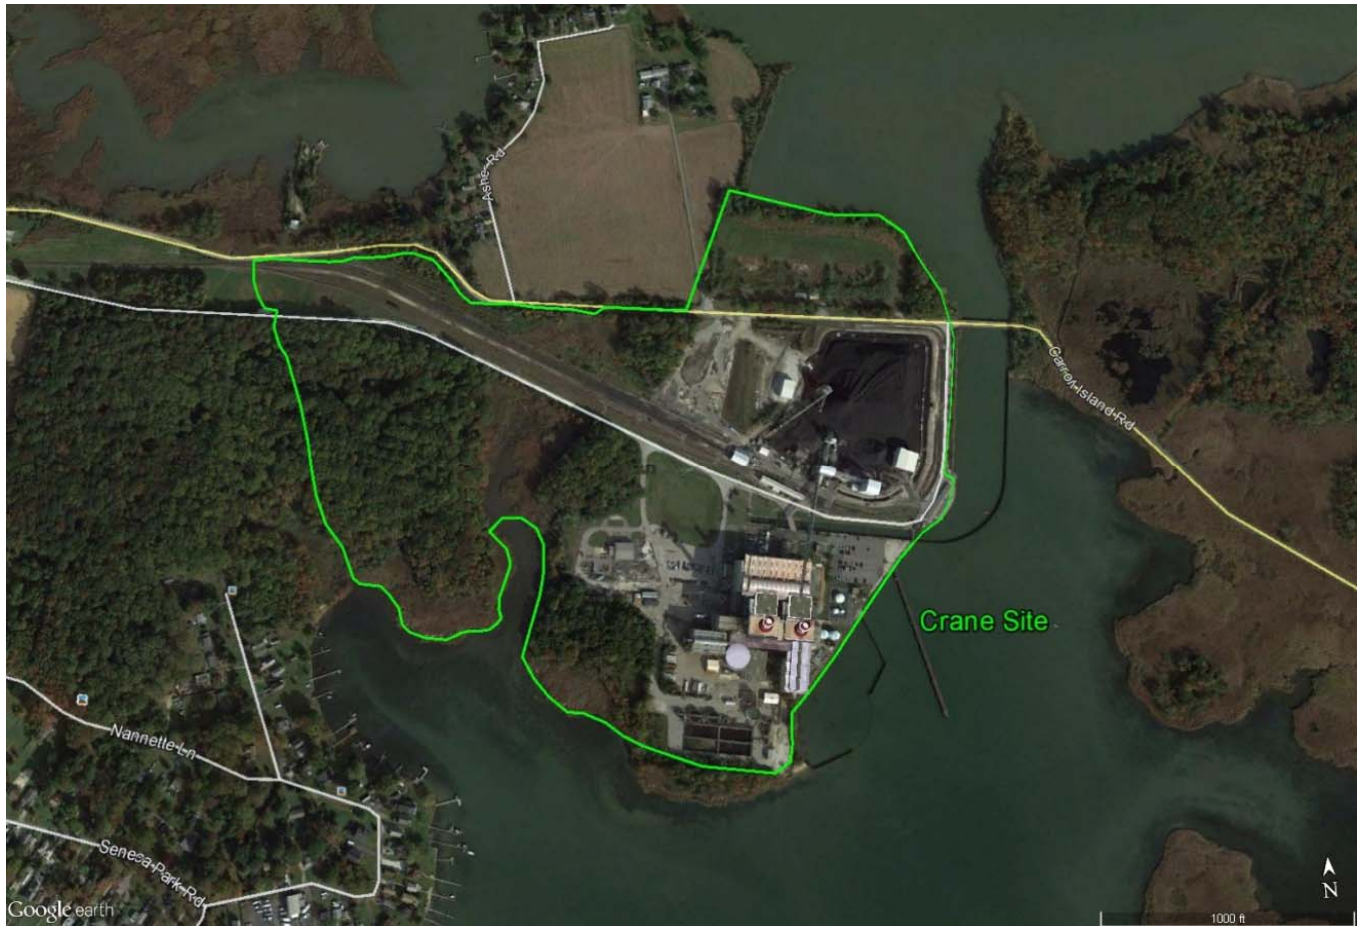
Site Name: Crane Power Plant Site

Recoverability: Not recoverable because Forbes, 2017 indicated no records of onsite CCB fill areas.
