PPRP-169

## Coal Combustion By-Product Storage, Use, and Disposal Sites in Maryland

August 2019

**MARYLAND POWER PLANT  
RESEARCH PROGRAM**

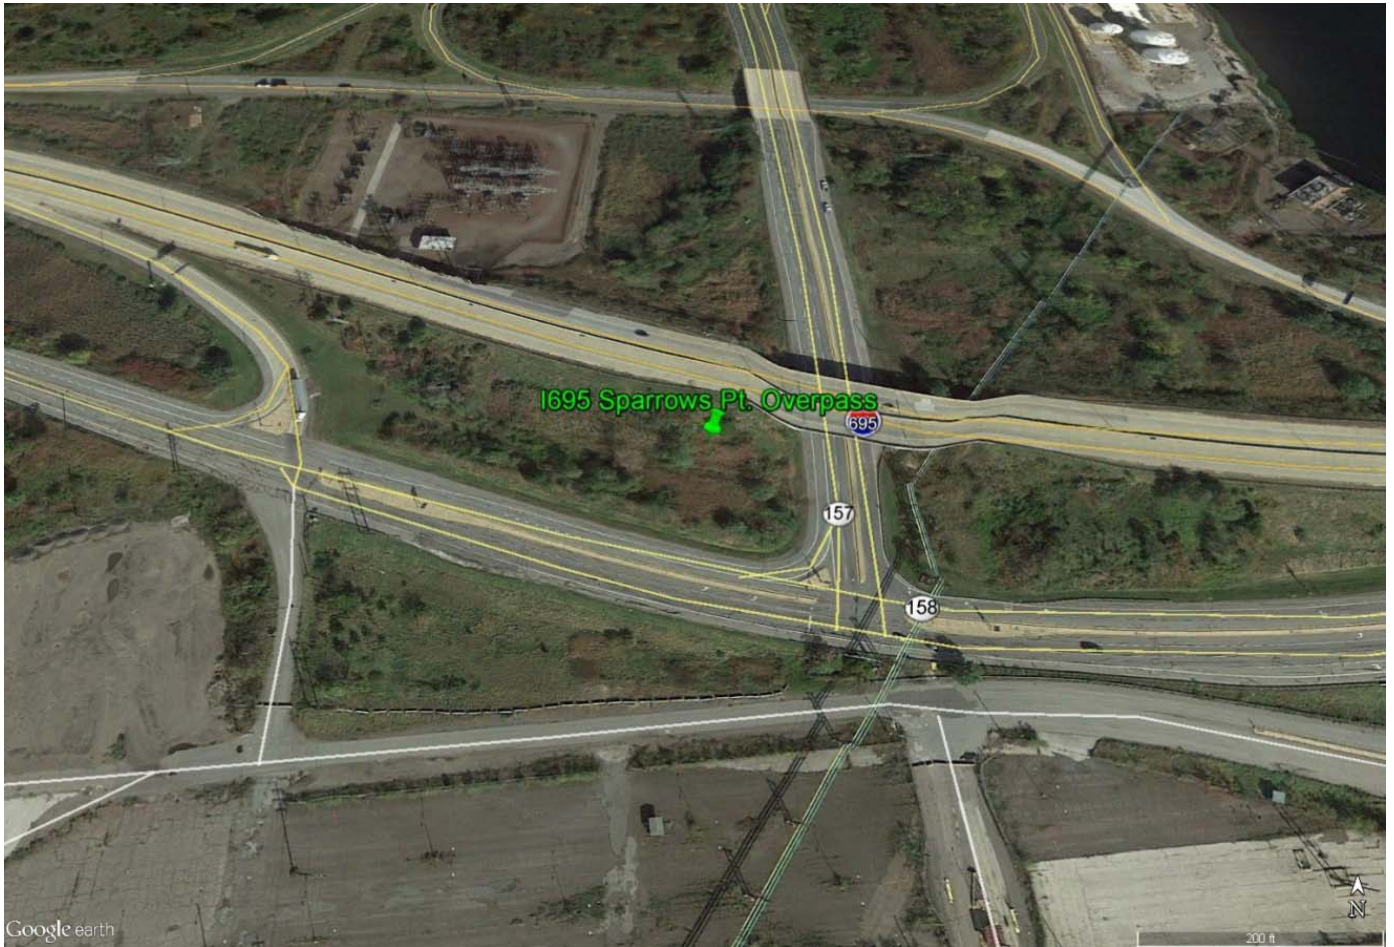
Site Name: I695 Sparrows Pt. Overpass

Recoverability: Not recoverable because fill areas are associated with public roads.

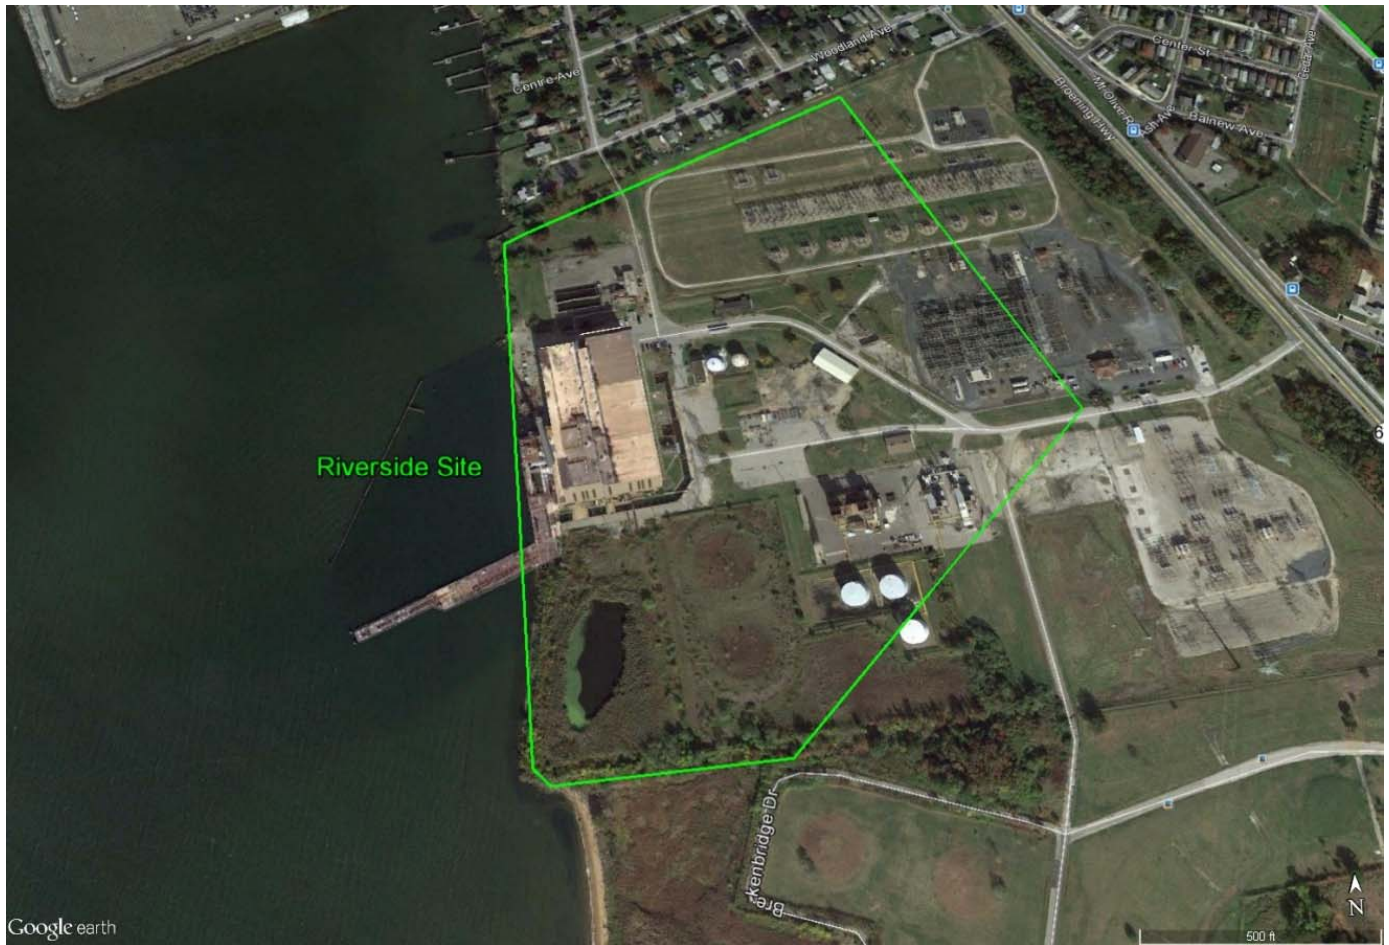
Site Name: Riverside Power Plant Site

Windshield Survey Performed on 7/25/17: Presence of buildings, above-ground storage tanks, and paved areas was confirmed. Southern portion of site was not easily visible. Trucks owned by BGE were noted at the site. Area where CCBs had been placed could not be discerned.

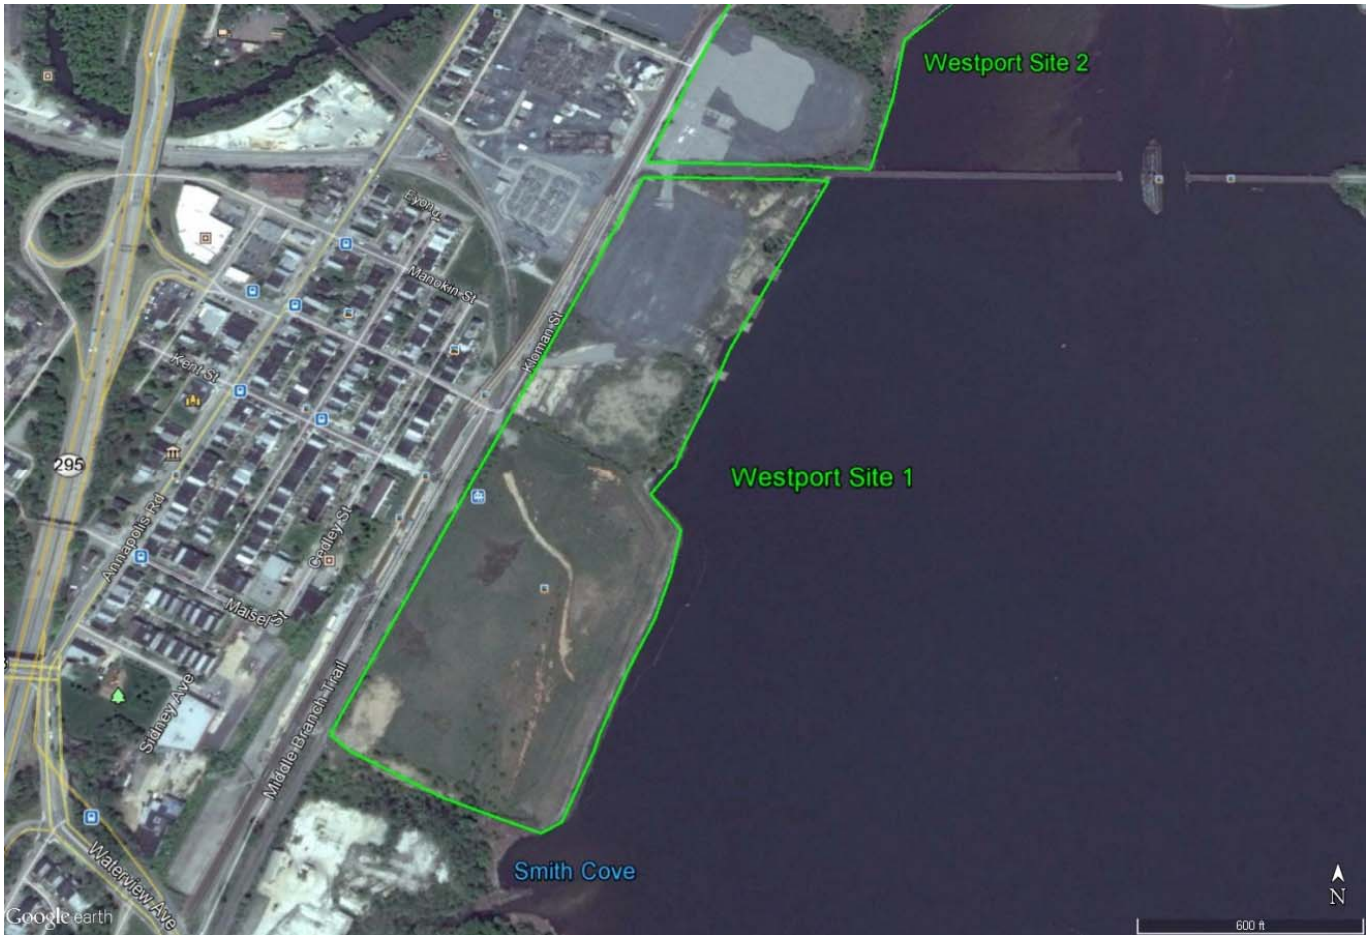
Site Name: Westport Power Plant Site 1

Notes: Windshield Survey Performed on 7/26/17. Site viewed from Kloman St., which runs along the western site boundary. Onsite observations combined with aerial imagery indicated that about 30% of the site is paved and an abandoned railroad spur is present. Remnants of a brick structure were observed, but no in-use buildings. Remainder of site is vegetated.

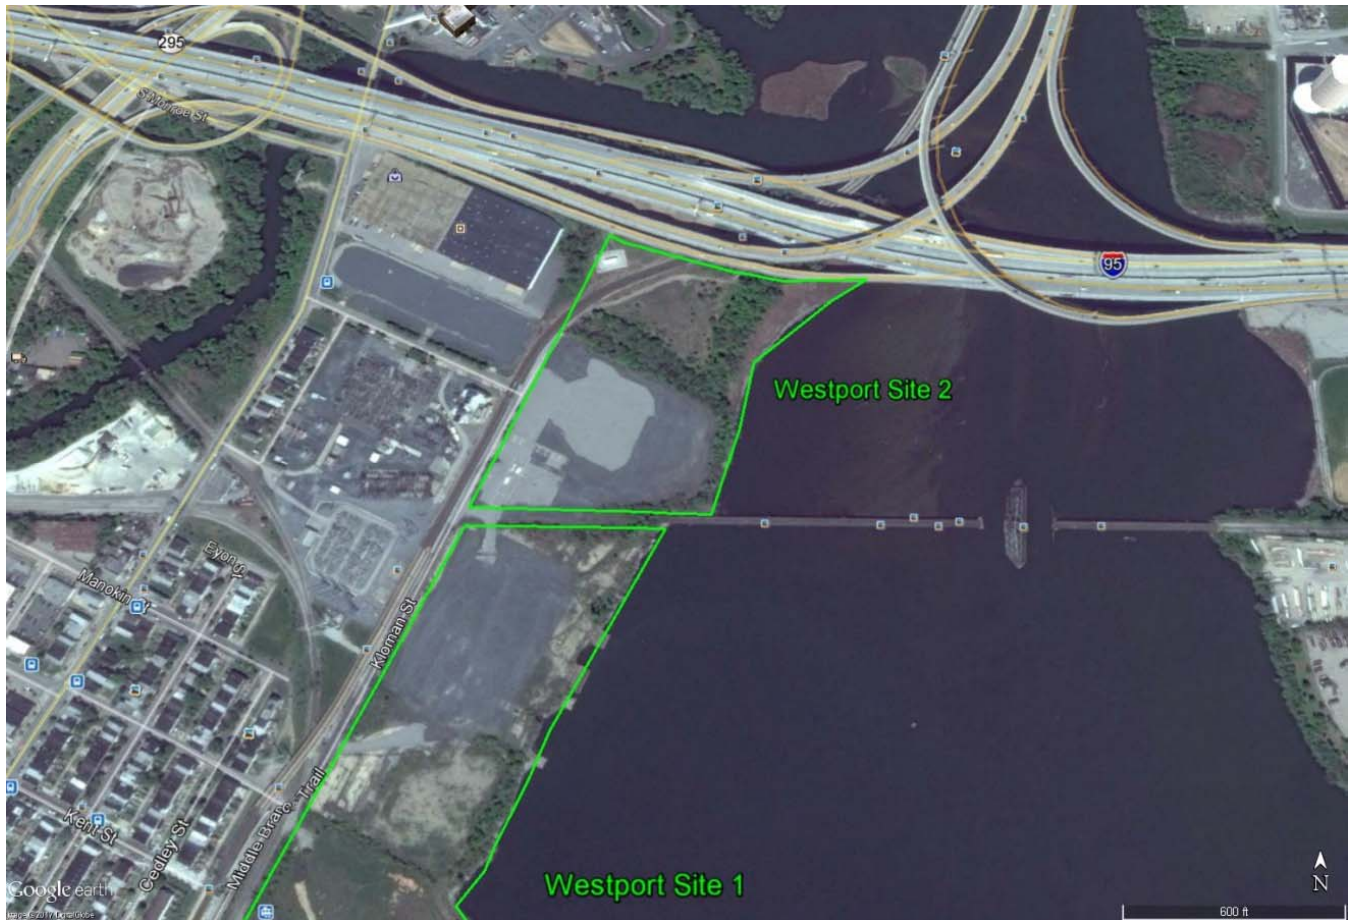
Site Name: Westport Power Plant Site 2

Notes: Windshield Survey Performed on 7/26/17. Site viewed from Kloman St., which runs along the western site boundary. Onsite observations combined with aerial imagery indicated that about 60% of the site is paved and a railroad spur crosses one corner of the site. No further development observed.

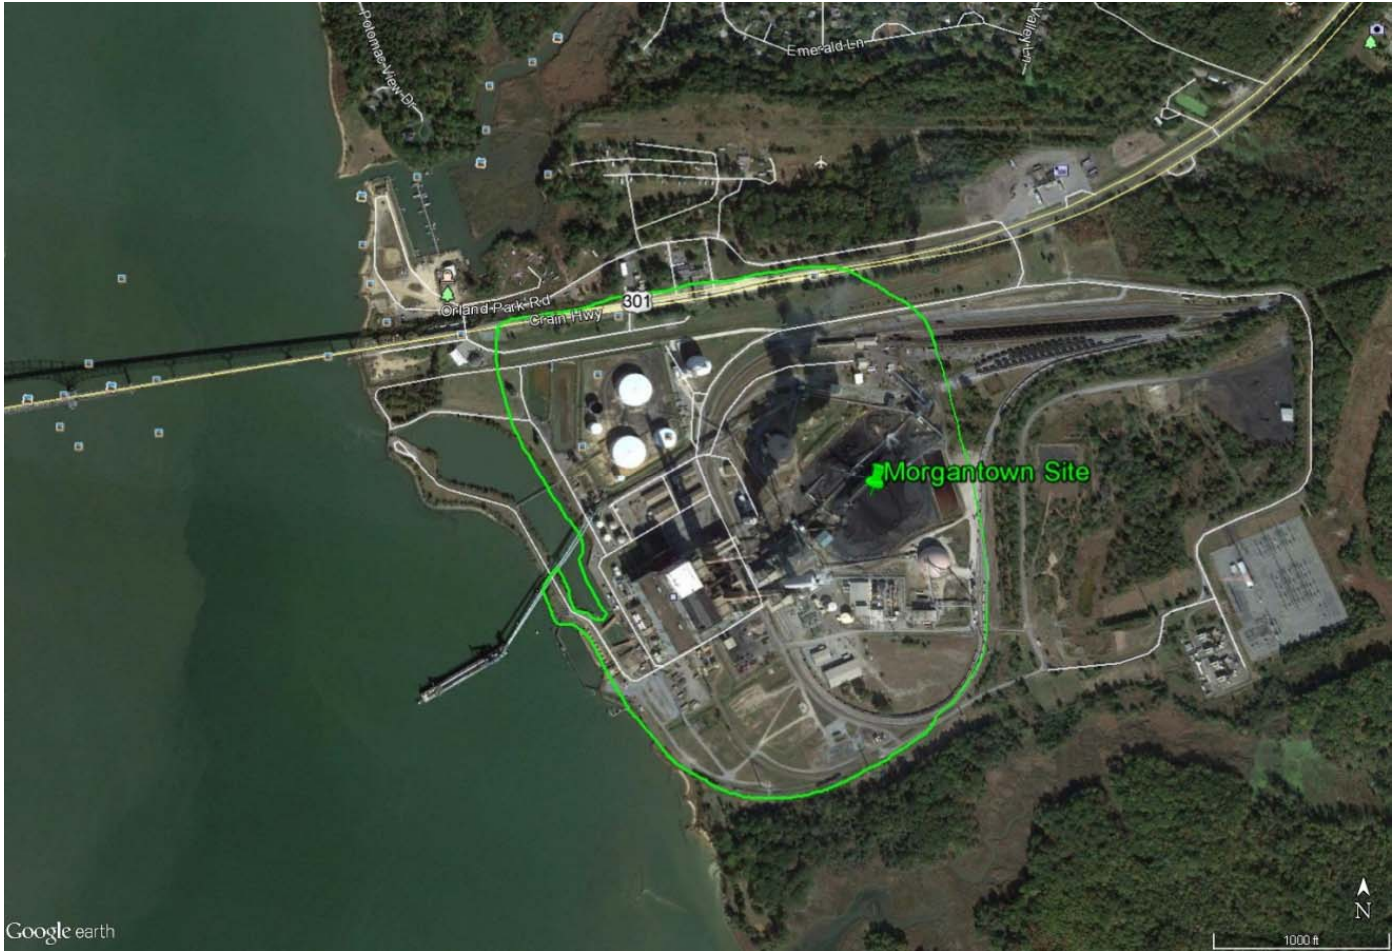
Site Name: Morgantown Power Plant Site

Recoverability: Not recoverable because site has been capped and redeveloped with buildings.

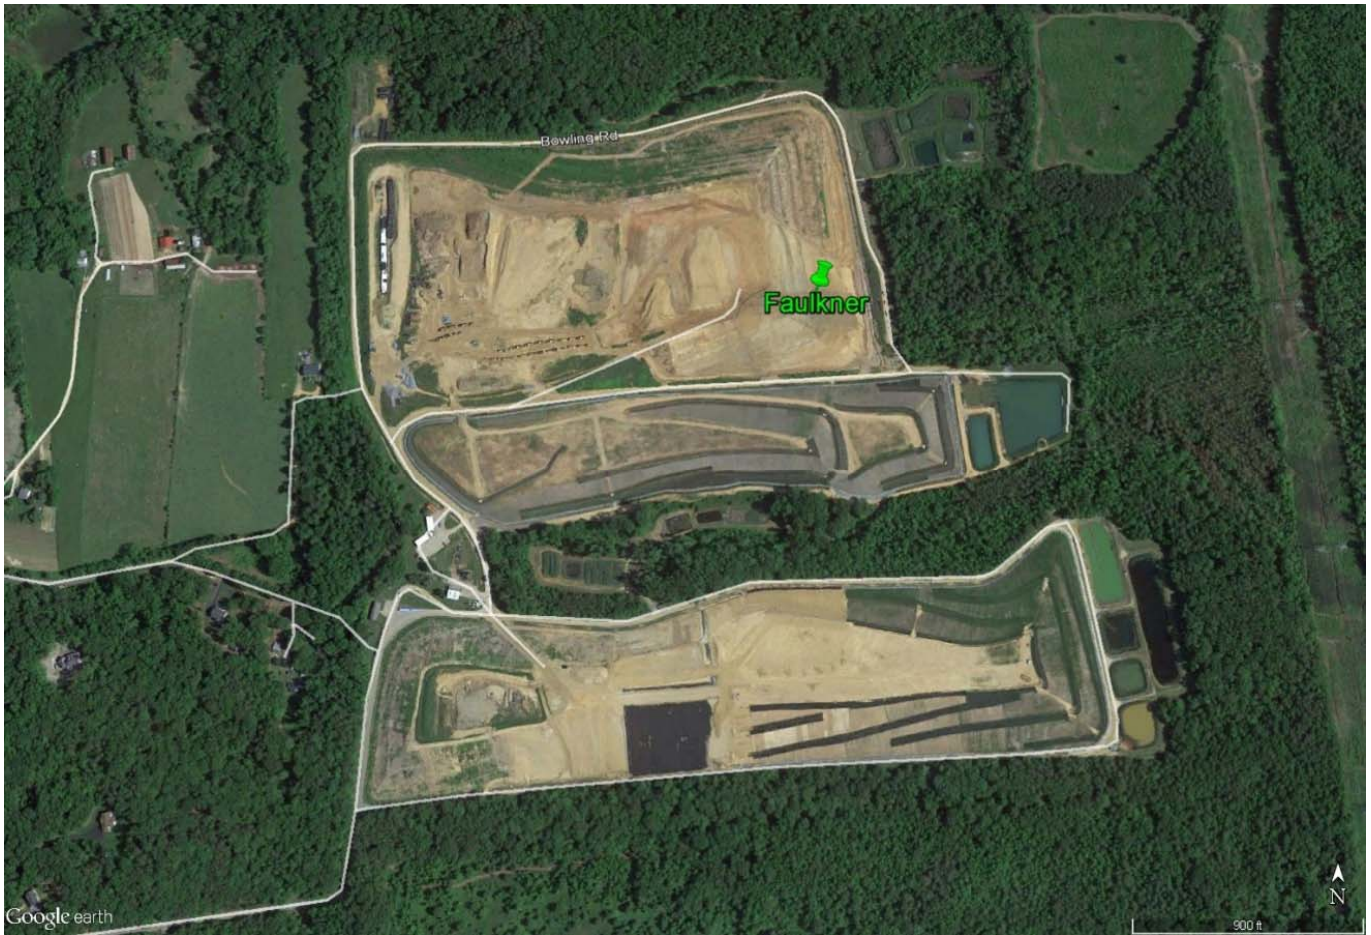
Site Name: Faulkner Fly Ash Storage Site

Notes: Inactive CCB storage site that received CCBs from Morgantown power plant from 1975 through at least 2010.

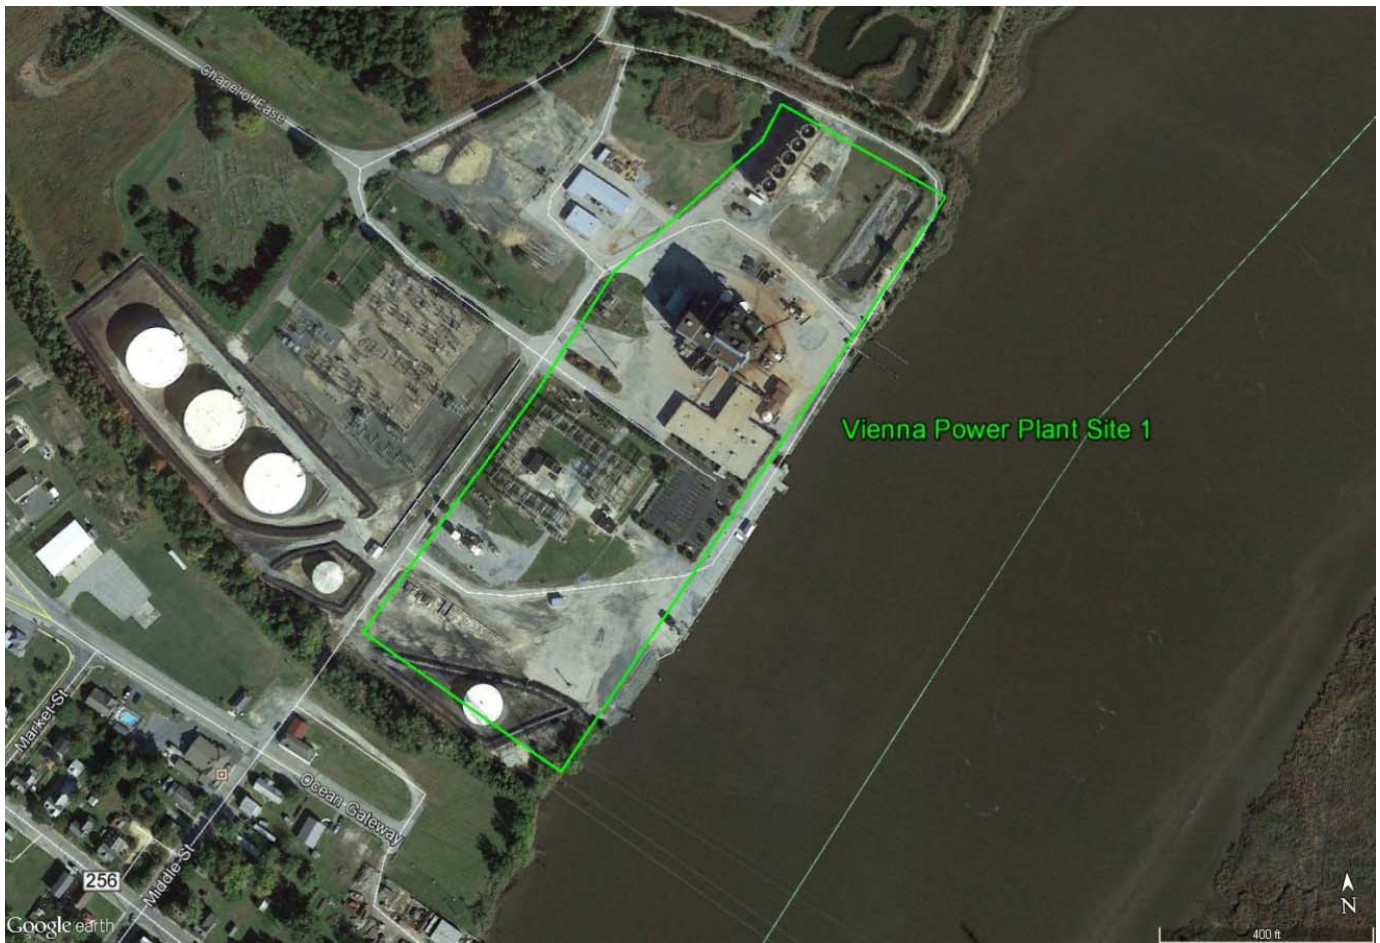
Site Name: Vienna Power Plant Site 1

Recoverability: Not recoverable because site has been capped and redeveloped with buildings.

Notes: PPSP, 1982a indicates that from 1950 to 1966, CCBs were sluiced to a settling basin onsite. Report is unclear on specific location of basin.

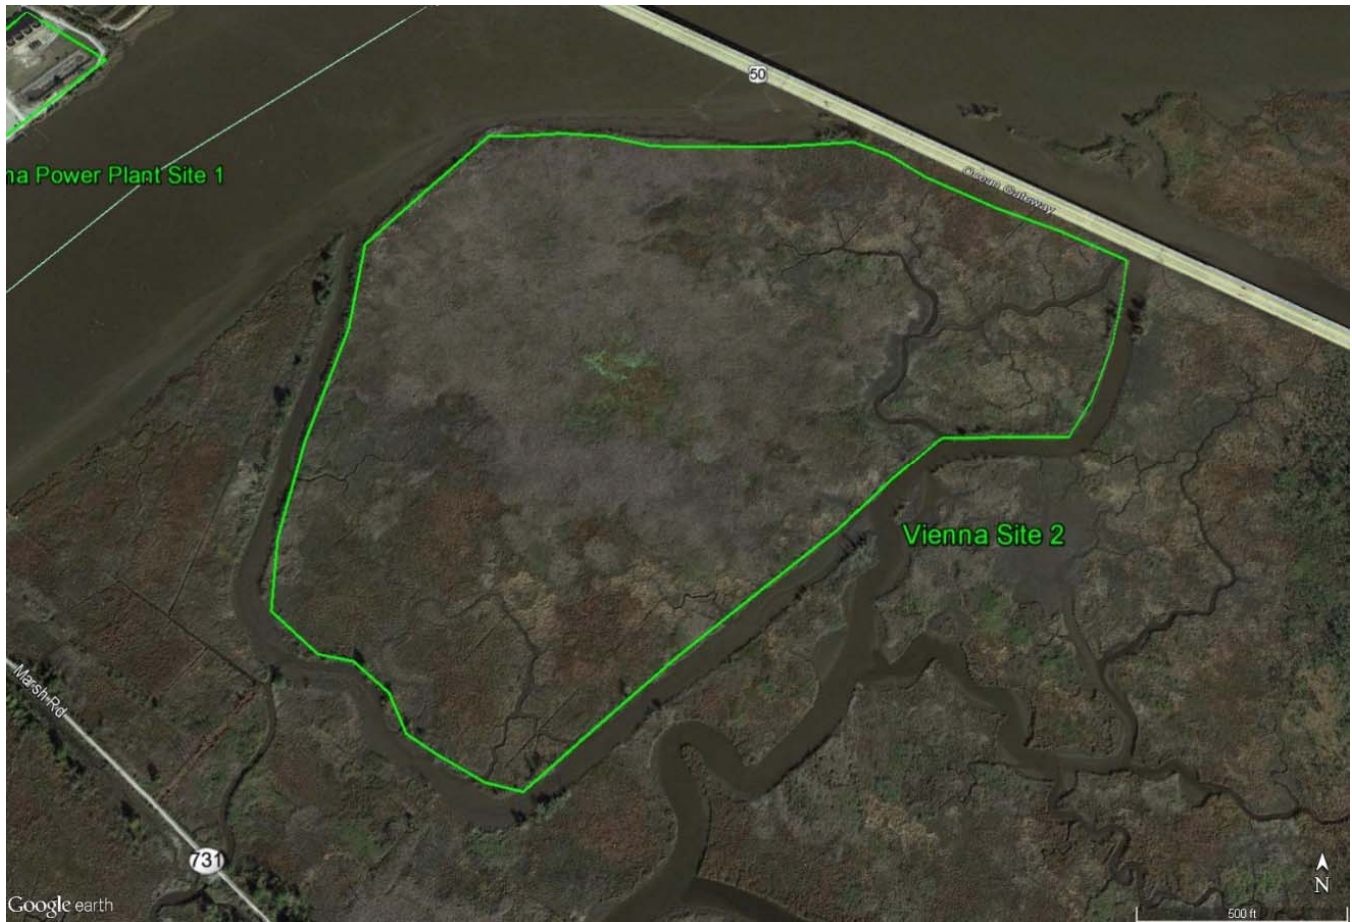
Site Name: Vienna Power Plant Site 2

Notes: Between 1966 and 1972, CCBs were sluiced from the Vienna power plant (located to the northwest on the opposite side of the Nanticoke River) to this area, which was surrounded by a dike. PPSP, 1982b indicates that several breaches of the dike occurred during the period when this placement area was active.

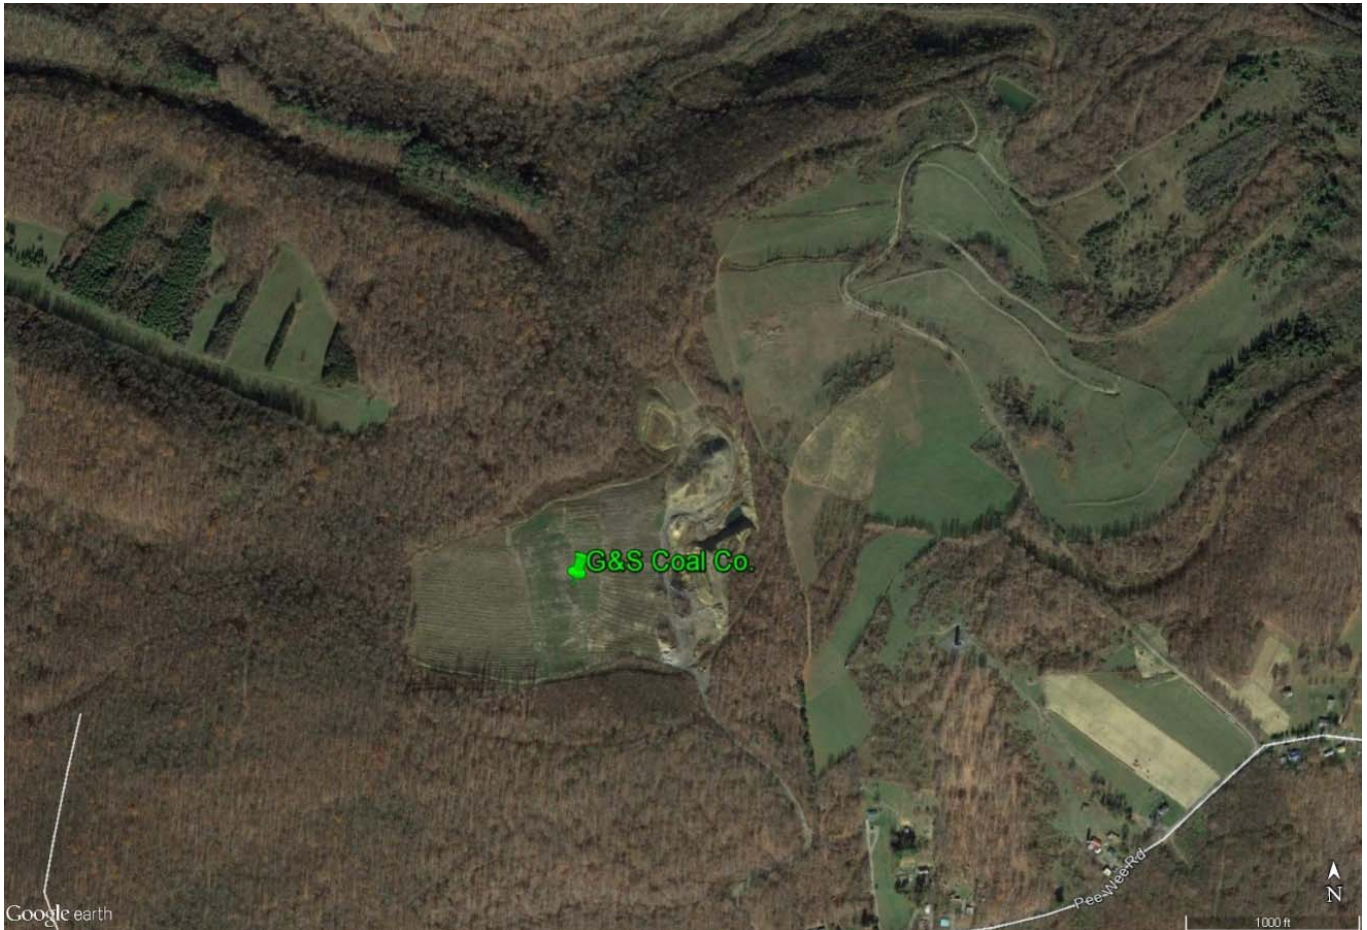
Site Name: G&S Coal Co.

Recoverability: Not recoverable because Warrior Run CCBs were co-mingled with surface mine overburden in a manner that makes recovery of the CCBs impractical.

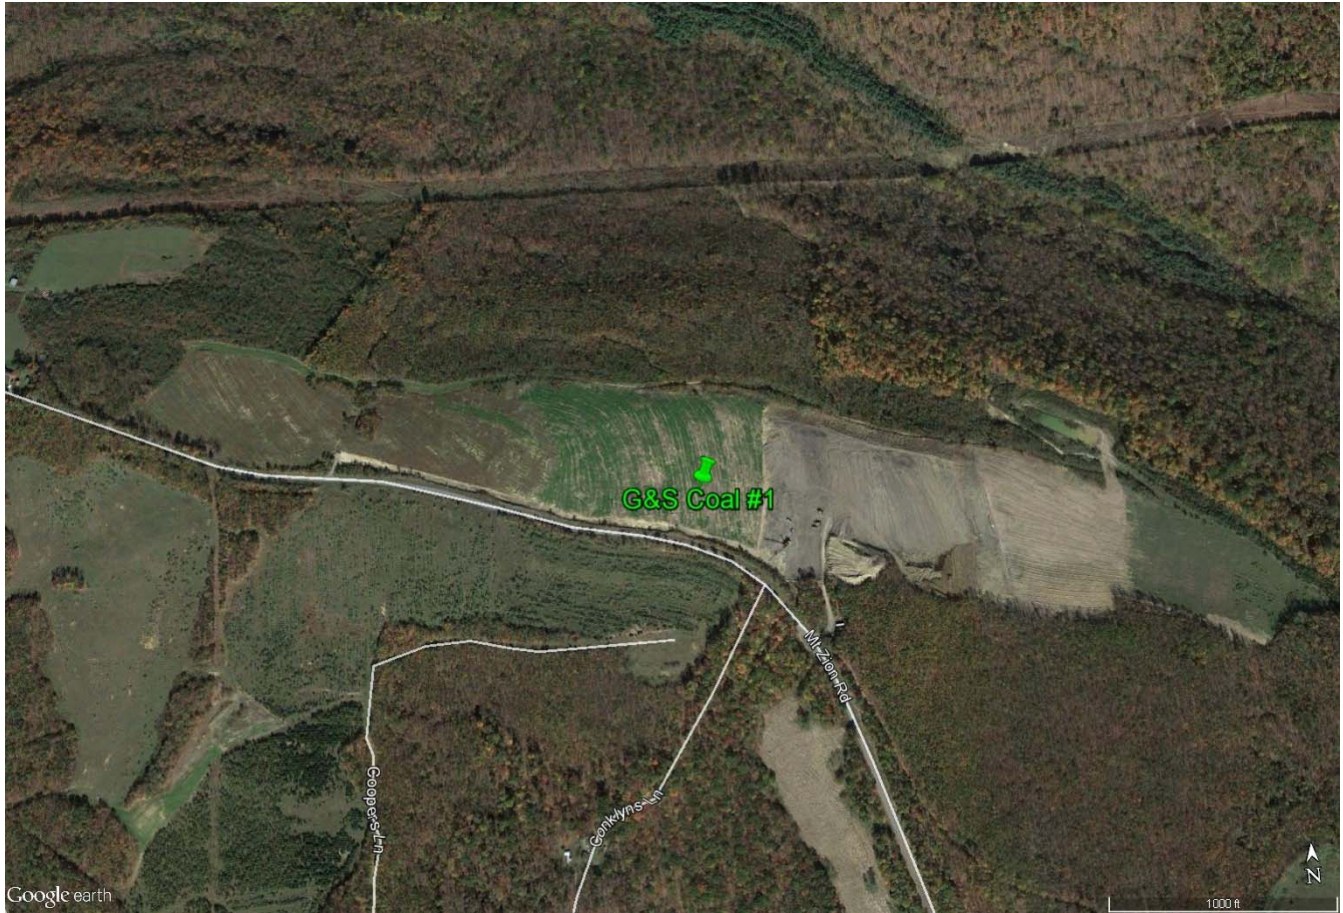
Site Name: G&S Coal Co. #1

Recoverability: Not recoverable because Warrior Run CCBs were co-mingled with surface mine overburden in a manner that makes recovery of the CCBs impractical.

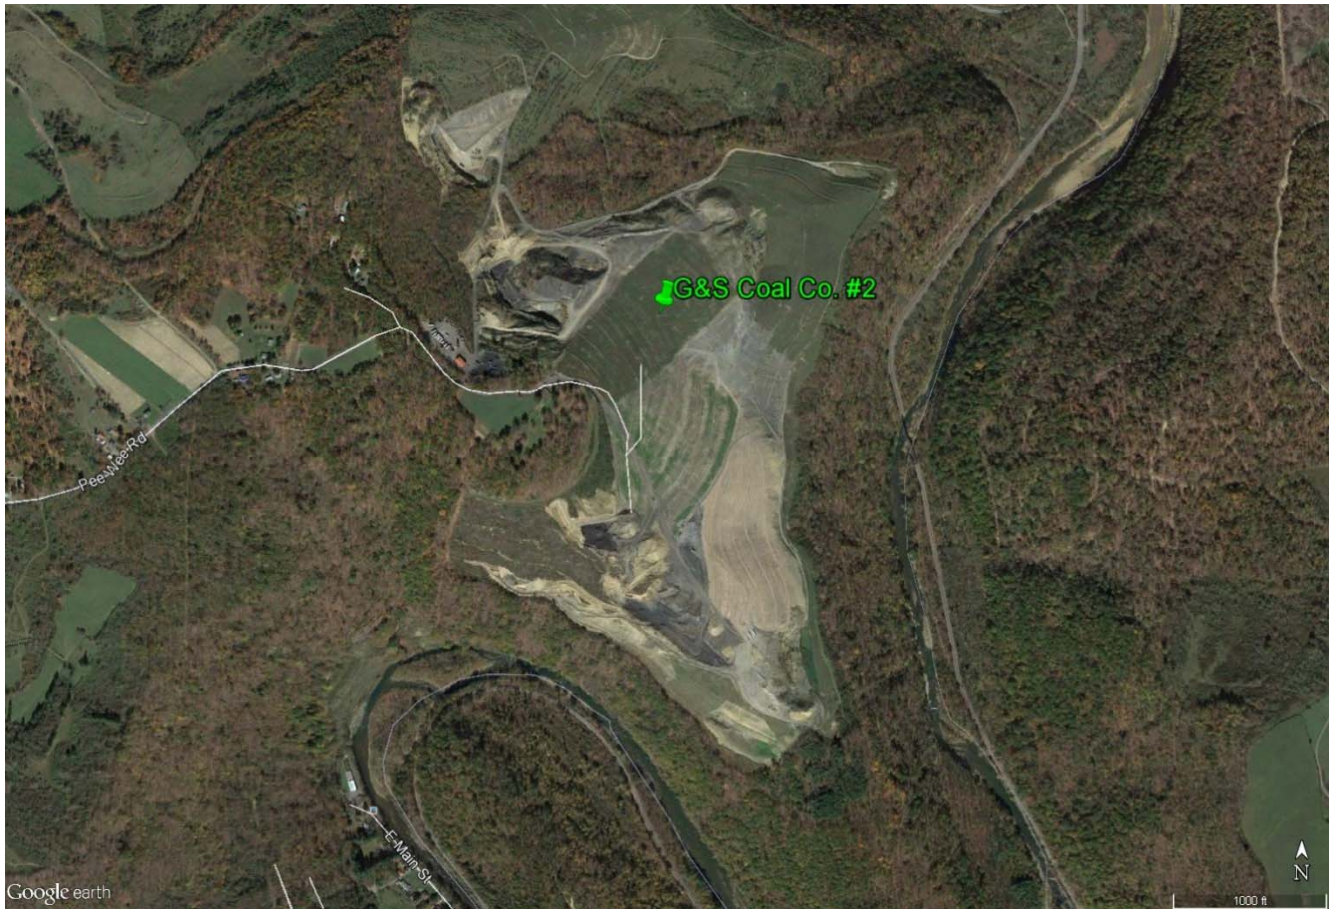
Site Name: G&S Coal Co. #2

Recoverability: Not recoverable because Warrior Run CCBs were co-mingled with surface mine overburden in a manner that makes recovery of the CCBs impractical.

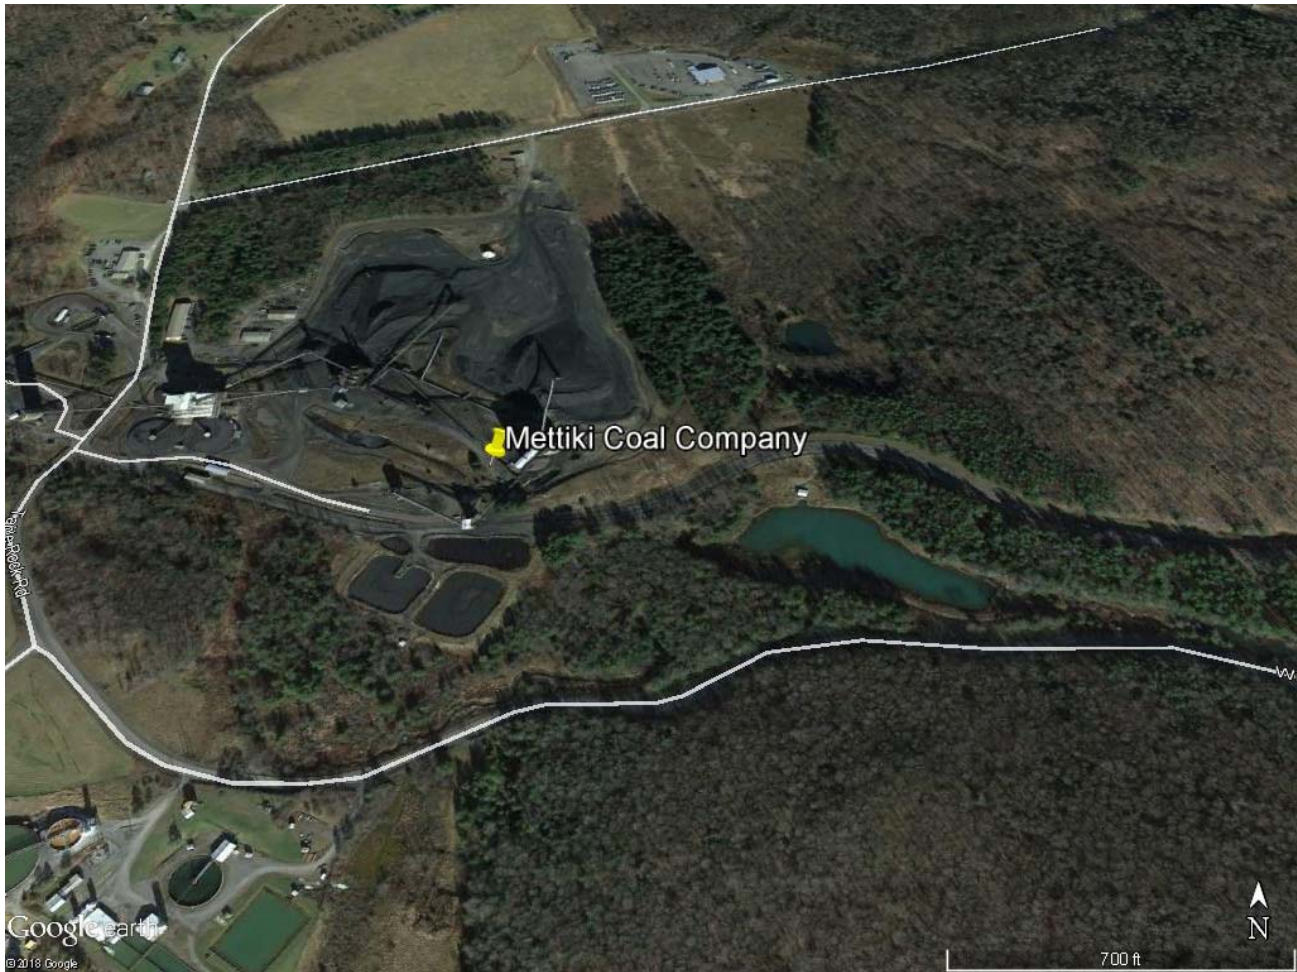
Site Name: Mettiki Coal Co. LLC

Recoverability: Not recoverable because CCBs placement at this site is a slurry of fly ash and FGD material.

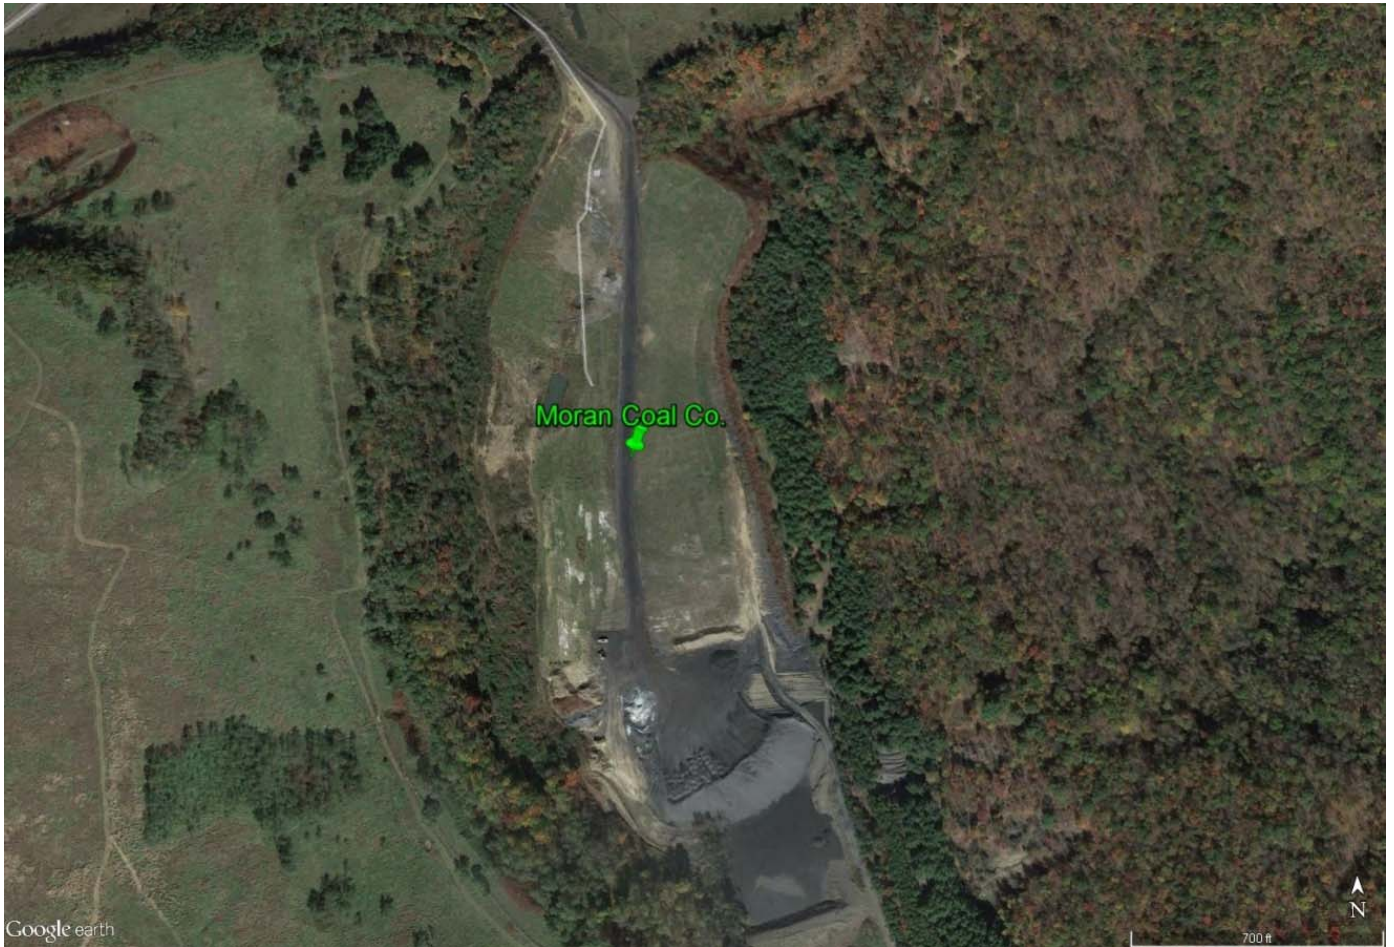
Site Name: Moran Coal Co.

Recoverability: Potentially recoverable because records indicate only CCBs (from the Verso power plant) were placed at the site and site is active.

Notes: Review of historic satellite photos indicates movement of active area gradually south and east. Portions may have been capped recently. Paul Petzrick indicated in a meeting on 7/21/17 that the material being placed at this site likely contains high unburned carbon levels (it is black in color) and would have to be tested to determine if it is appropriate for cement kiln feedstock.

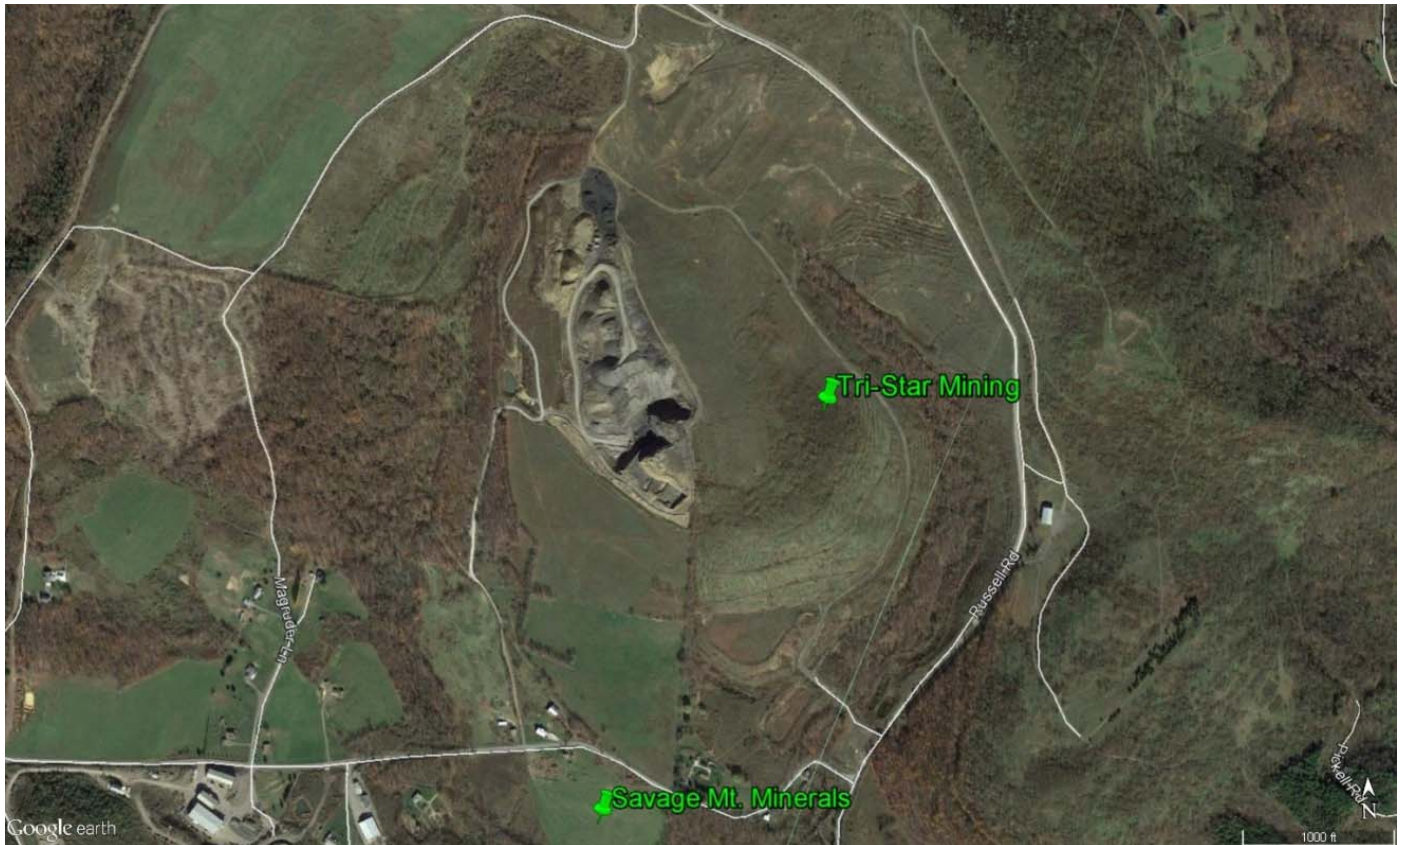
Site Name: Tri-Star Mining

Recoverability: Not recoverable because Warrior Run CCBs were co-mingled with surface mine overburden in a manner that makes recovery of the CCBs impractical.

Notes: Location verified with MDE shapefiles. This location appears to be where there was a highway collapse in 2007. Satellite imagery indicates there is still some activity adjacent to this site to the west (may be an adjacent mine permitted separately).

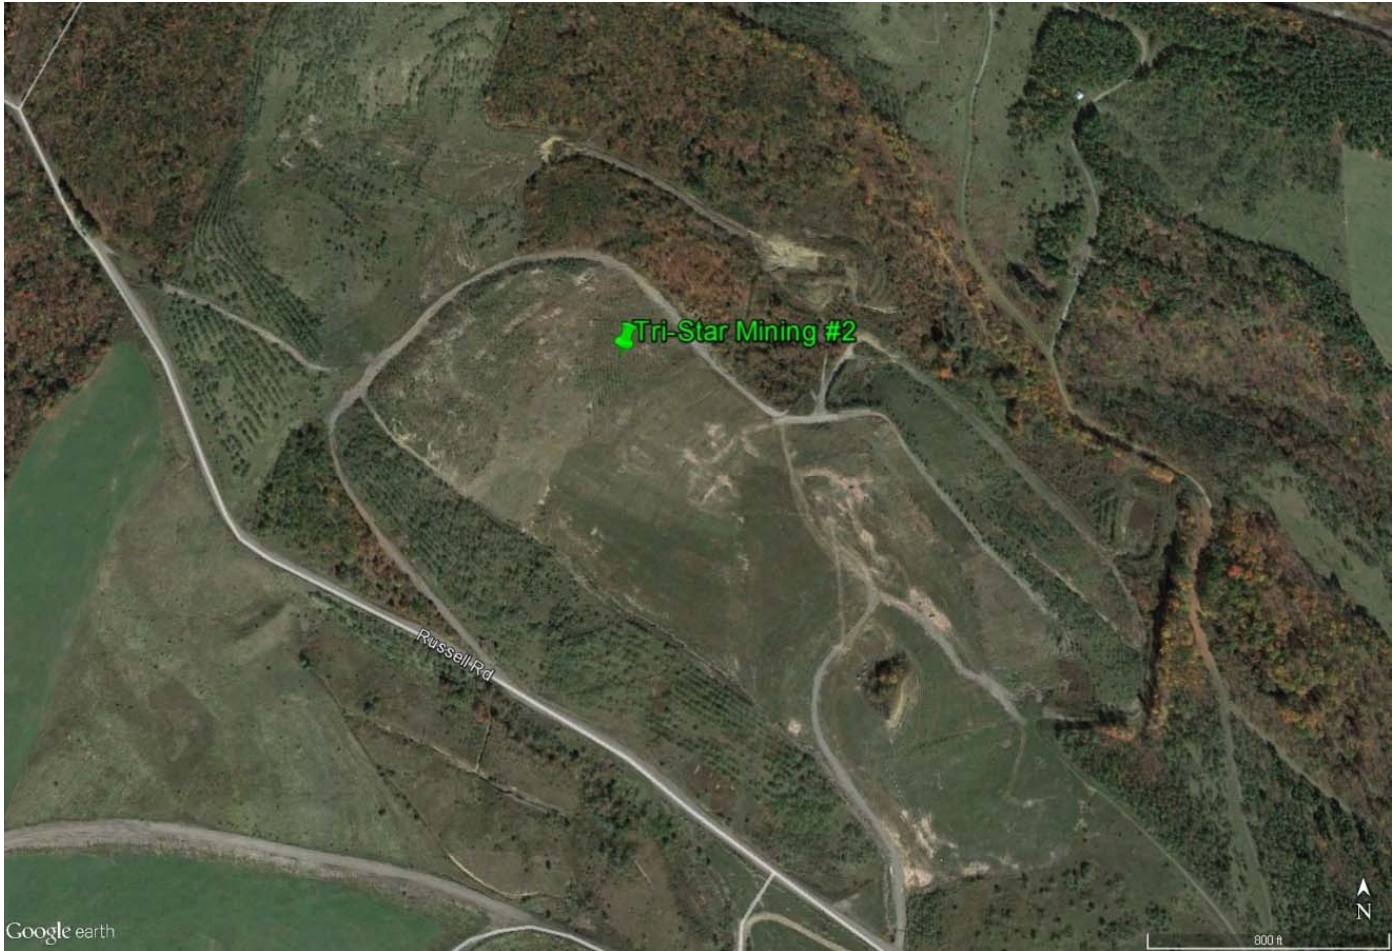
Site Name: Tri-Star Mining #2

Recoverability: Not recoverable because Warrior Run CCBs were co-mingled with surface mine overburden in a manner that makes recovery of the CCBs impractical.

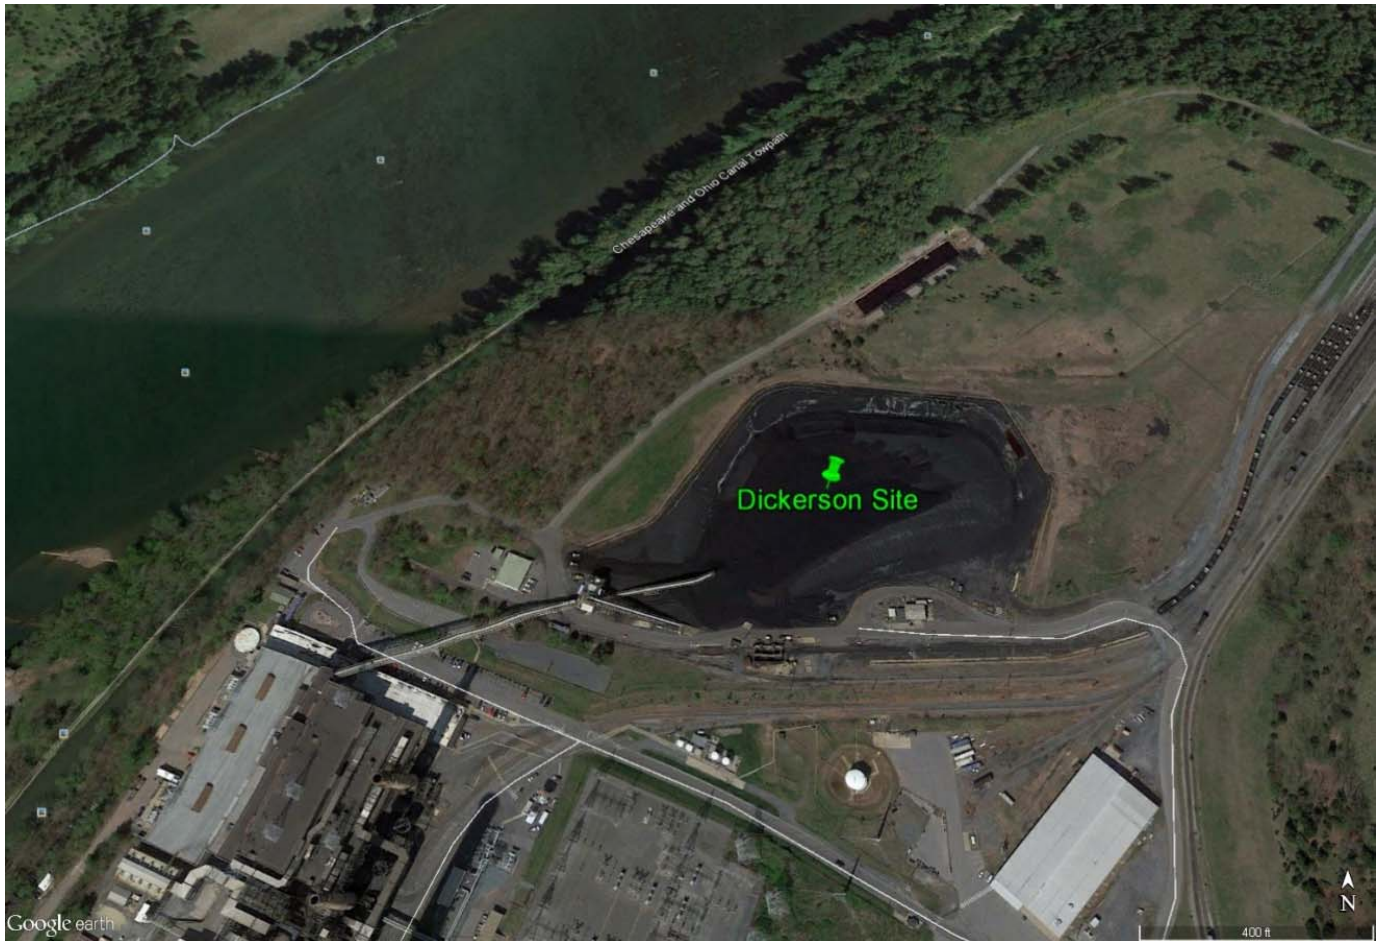
Site Name: Dickerson Power Plant Site

Recoverability: Not recoverable because Heimlicher, 2017 indicated no records of onsite CCB fill areas.

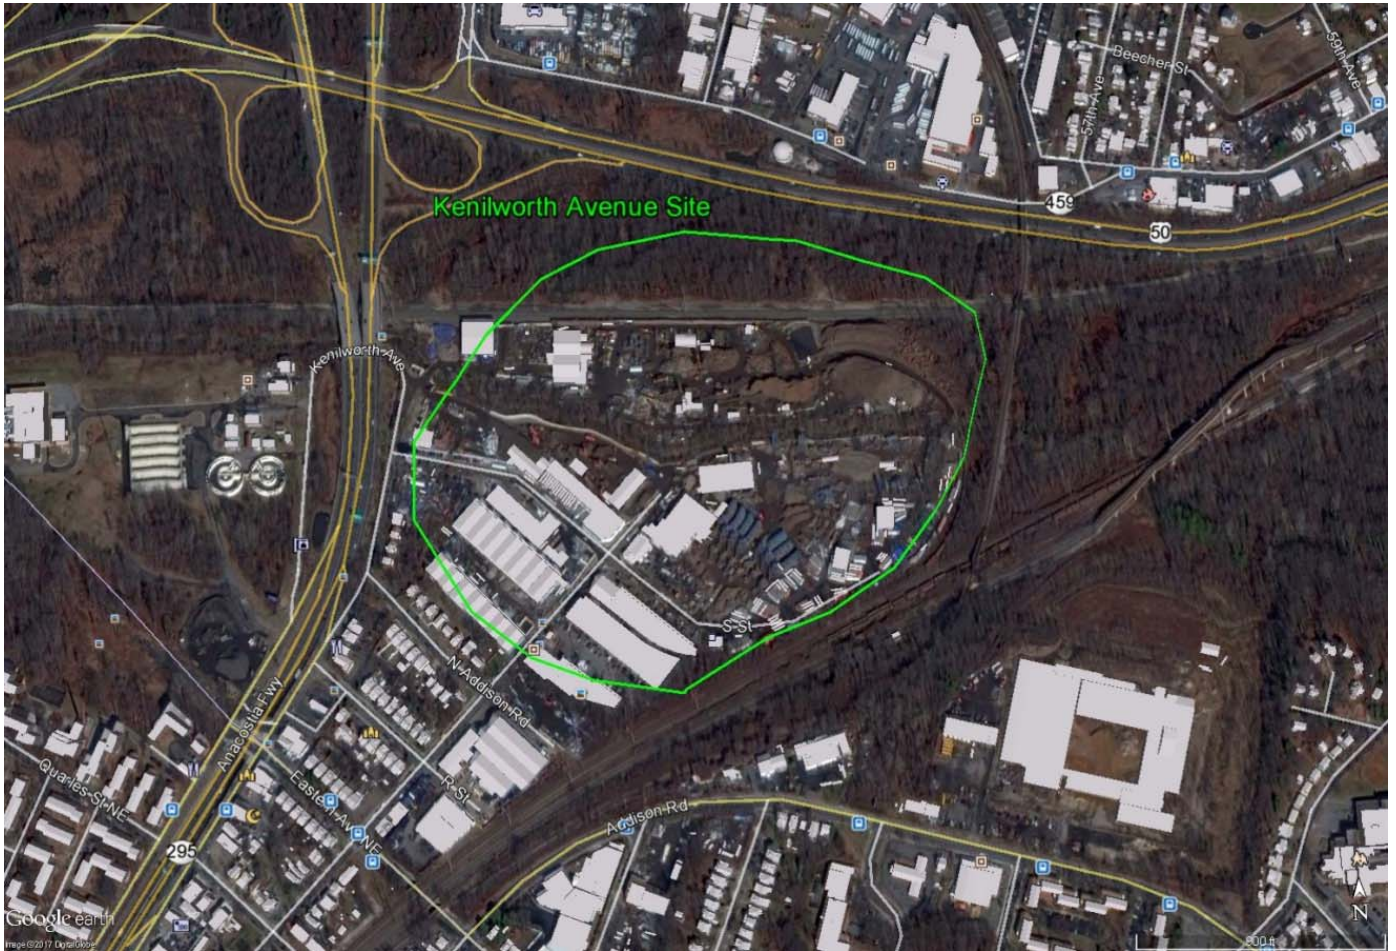
County: Prince George's

Recoverability: Not recoverable because CCBs were disposed along with other waste materials and majority of site is redeveloped with buildings and roads..
