PPRP-169

## Coal Combustion By-Product Storage, Use, and Disposal Sites in Maryland

August 2019

**MARYLAND POWER PLANT  
RESEARCH PROGRAM**

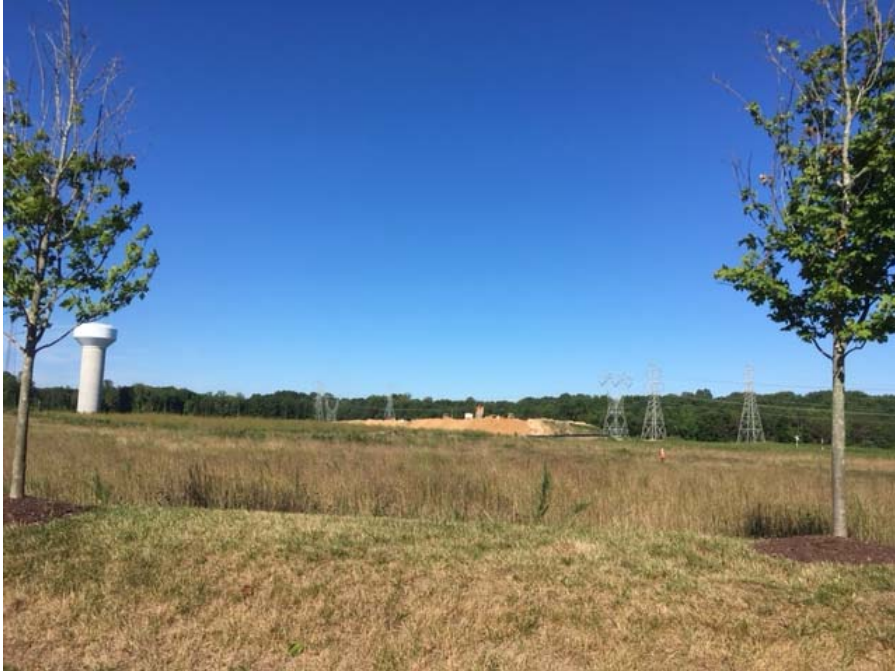
Photo 1: View of site looking southeast from Viewing Area 1 (parking lot of apartment complex).

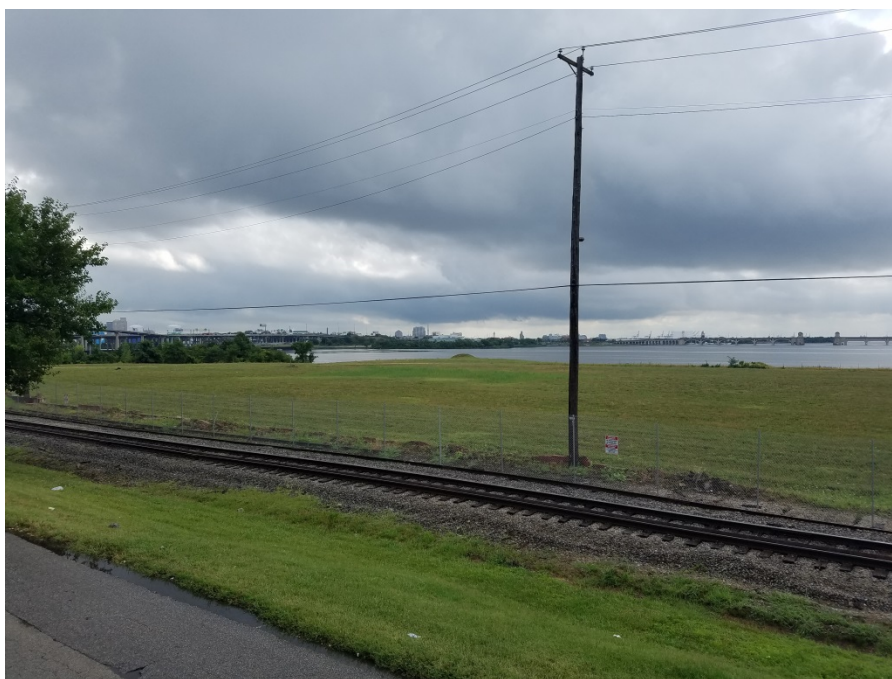
Photo 1: View of site looking northeast. Note small mound of material in center of image.

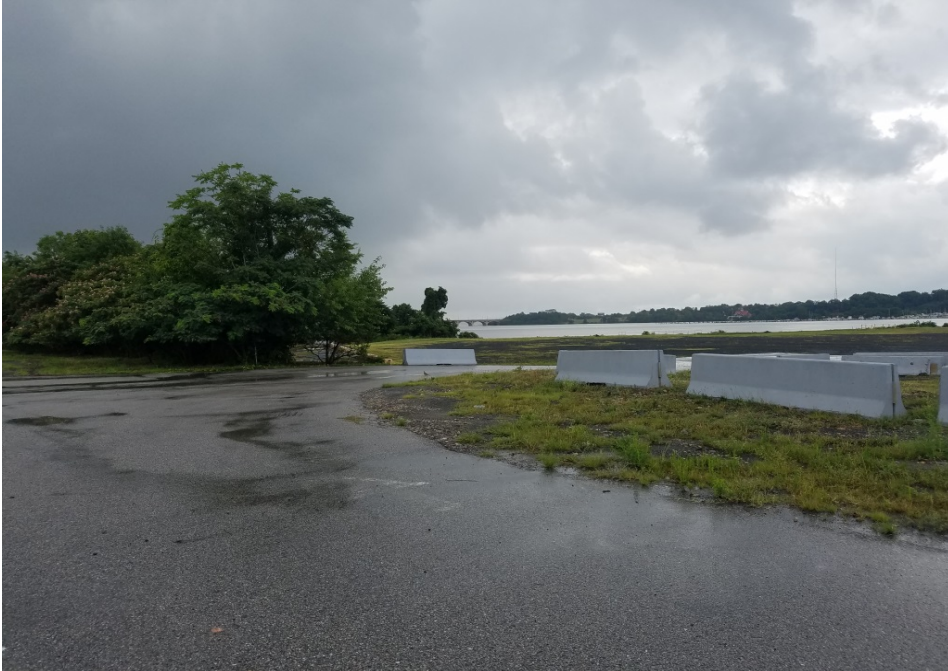
Photo 2: View of paved road and concrete jersey walls looking southeast.

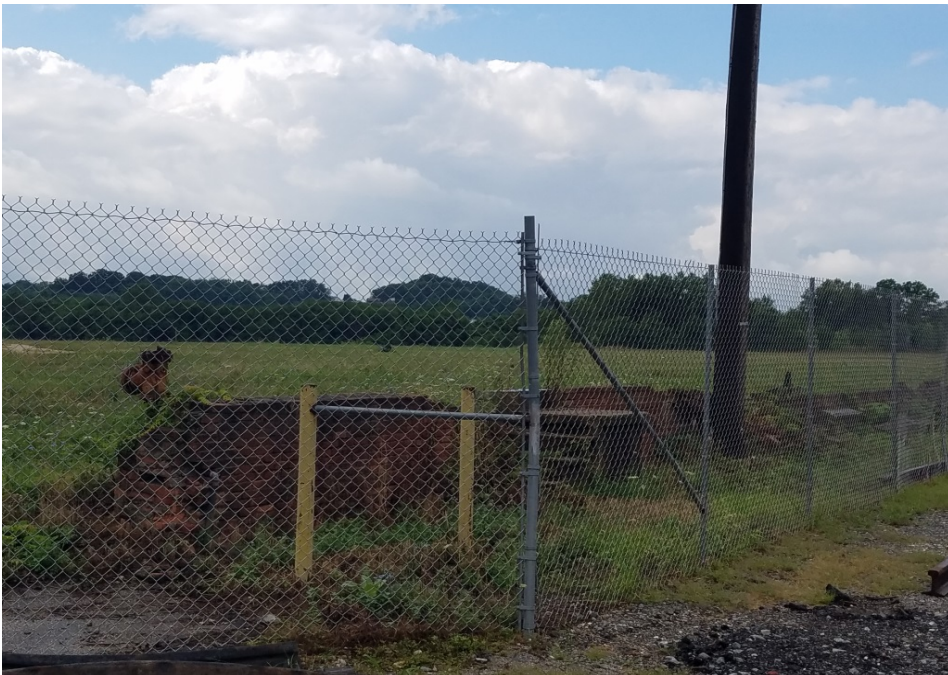
Photo 3: View of former brick structure looking southeast.

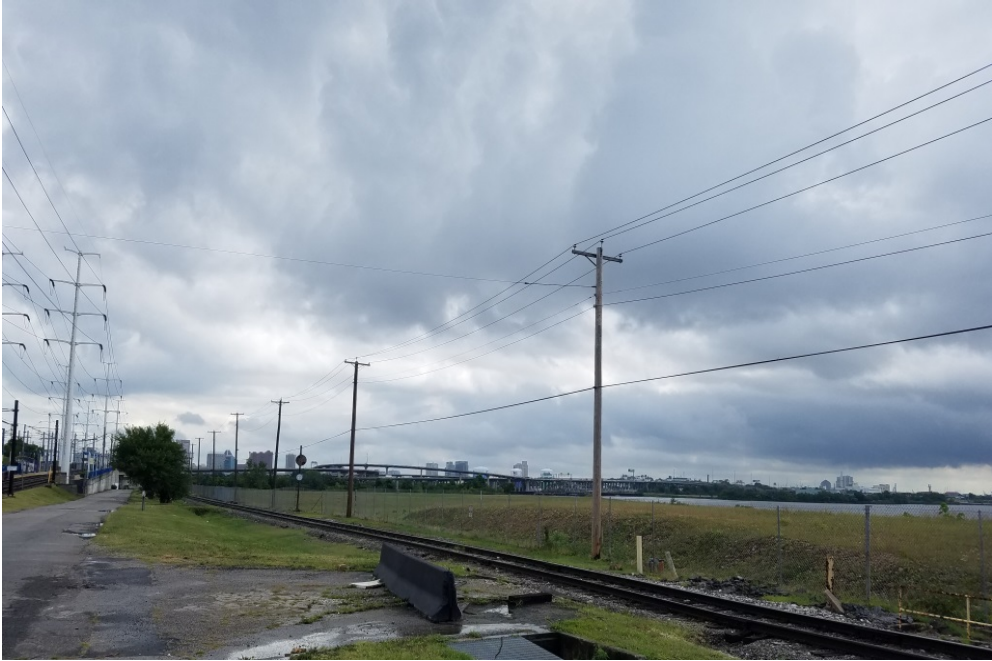
Photo 4: View of mounded material looking northeast.

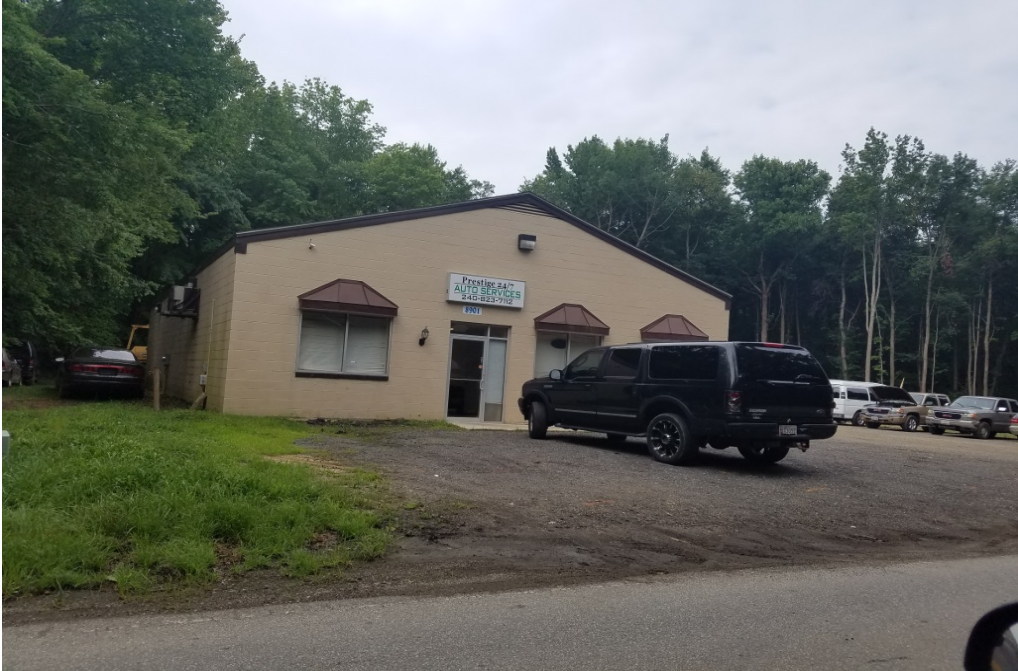
Photo 4: Prestige 24/7 Auto Services.

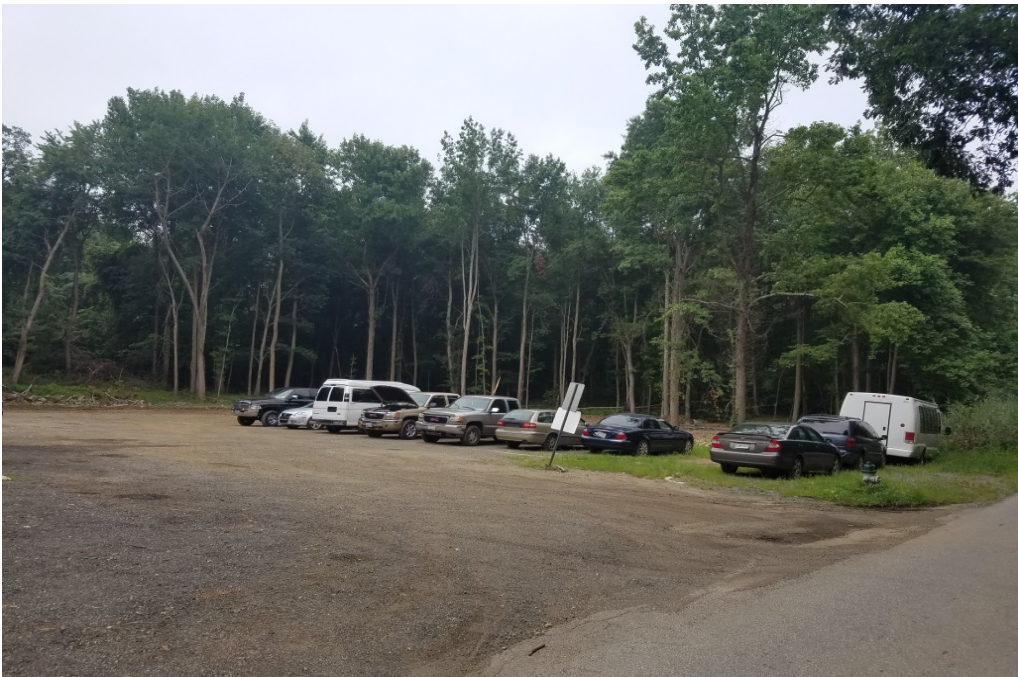
Photo 5: Prestige 24/7 parking lot and newly cleared area.
