## ANNEX 3 – Peristaltic Units

### Annex 3.1 - General Information

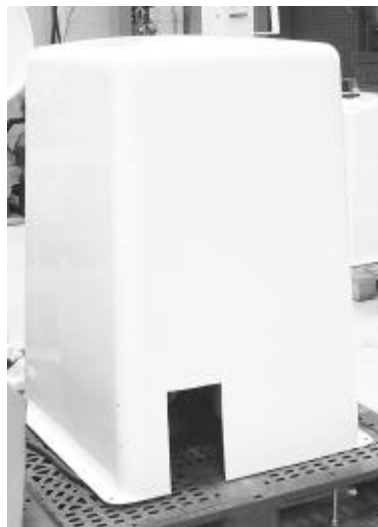
**External View of Enclosure**

The Edson International 286EP-40 Pump-Out unit operated for a total of 918.0 hours in the life-cycle testing set-up and suffered two failures during testing:

1. Tubular element failure – internal tube developed a leak;
2. Failure of the rubber coupling between the speed reducer and the peristaltic pump

<b>Repair Required</b>	<b>Run Time on Unit (hours)</b>	<b>Repair Parts Required</b>	<b>Cost of repair parts</b>	<b>Time required to receive parts (days)</b>	<b>Time required to make repair (hours)</b>	<b>Total Time Off-Line (days)</b>
Replace internal hose	579.4 <b>Note 1</b>	Internal hose	\$440.00	1	1	18 <b>Note 2</b>
Replace rubber coupling between speed-reducer and pump	918.0	Rubber coupling	\$48.00	<b>Note 3</b>	0.75	<b>Note 3</b>

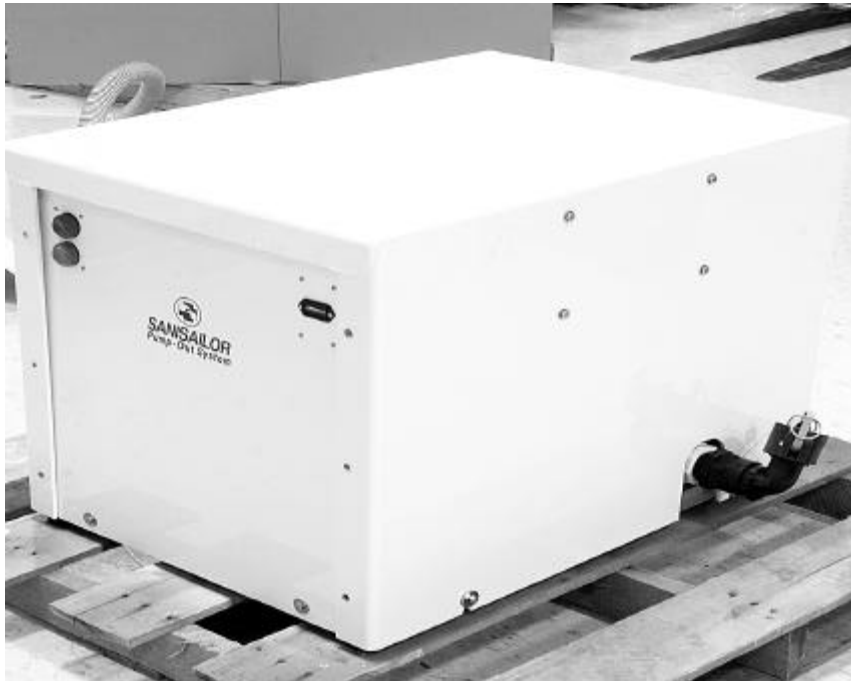
**External View**

The EMP Industries Sanisailor Sentinel – M300 Pump-Out unit operated for a total of 651.6 hours in the life-cycle testing set-up, and suffered two failures during testing (See *Summary of Repairs* below):

1. A failure of the time delay relay in the control circuit for the unit – This failure of the time delay relay also caused a failure of the following components: unit timer, secondary transformer, and relay contactor in the control circuit.
2. Tubular element failure – internal tube developed a leak

<b>Repair Required</b>	<b>Run Time on Unit (hours)</b>	<b>Repair Parts Required</b>	<b>Cost of repair parts</b>	<b>Time required to receive parts (days)</b>	<b>Time required to make repair (hours)</b>	<b>Total Time Off-Line (days)</b>
Time delay relay failed - causing failure of secondary components	108.1 <b>Note 1</b>	Time delay relay, transformer, timer, relay contactor	\$234.85	1	2 <b>Note 2</b>	85 <b>Note 3</b>
Replace internal tube	651.6 <b>Note 4</b>	Internal tube replacement kit	\$496.00	<b>Note 5</b>	2.0	<b>Note 5</b>

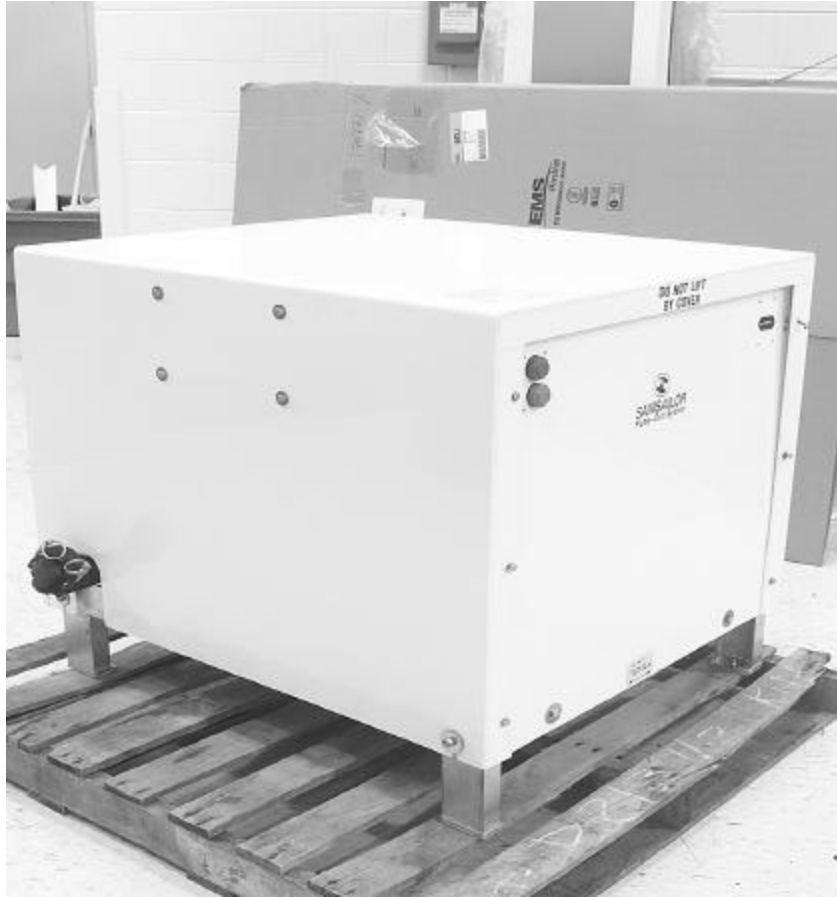
**External View**

The EMP Industries Sanisailor Sentinel – EV405 Pump-Out unit operated for a total of 706.9 hours in the life-cycle testing set-up and suffered one failure during testing. The discharge union on the pump developed a crack requiring that the union be replaced (See *Summary of Repairs* on page 58).
