Coastal Management for Traditional Villages

June
2011

COASTAL MANAGEMENT FOR TRADITIONAL VILLAGES: ROYAL OAK ASSESSMENT

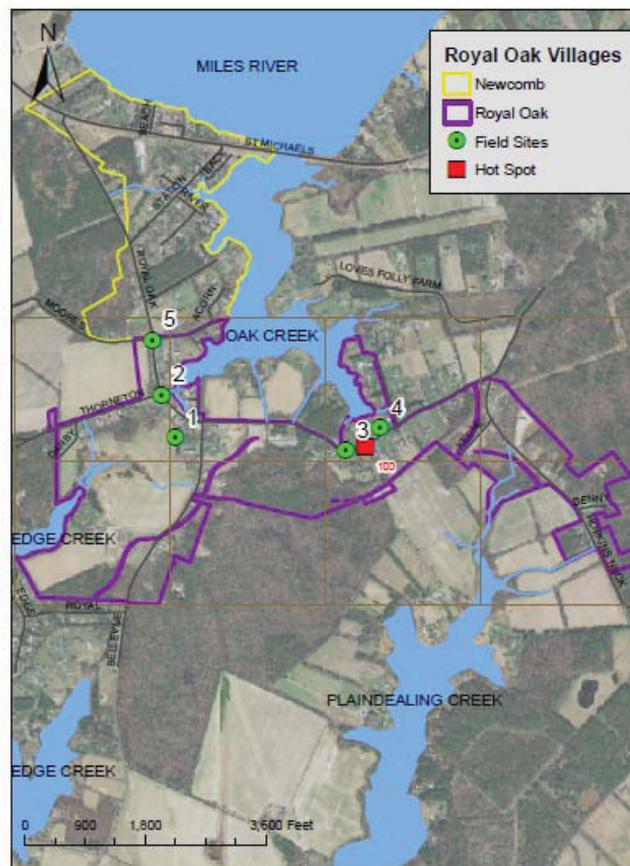
Figure 3. Field sites 1, 2, 3, 4, 5 and one Hot Spot (#100) are identified.

The field sites visited and one Hot Spot identified are indicated on the map in Figure 3. A detailed assessment for all sites is in the Village of Royal Oak Stormwater Retrofit Assessments section.

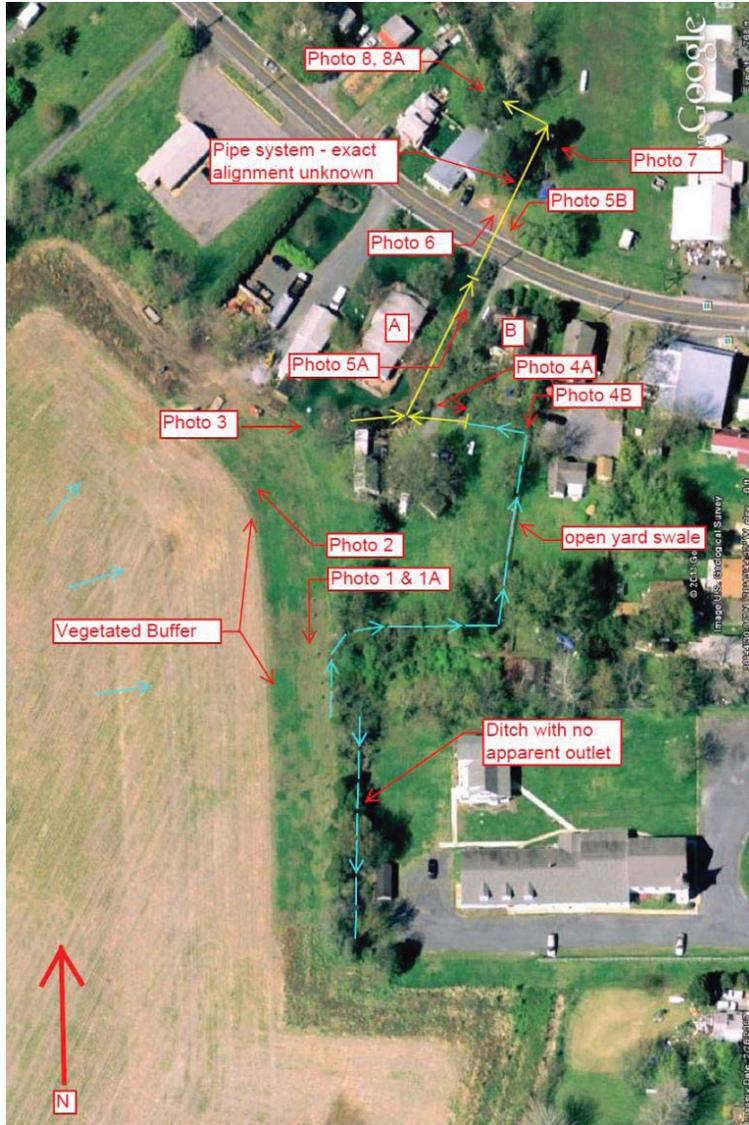
Figure 4. Site 1 picture index.

Site 1 is located approximately south of 25913 Royal Oak Road (38 ° 44' 30.47 N, 76° 10' 44.89 W). Site 1 has a combination of nuisance flooding issues and a potential water quality retrofit. Field photos are included in Table 2. This area represents a typical drainage situation that occurs when what appears to be a minor change in the watershed can have significant consequences. In this case, the farm field in the southwest quadrant of the Site 1 Picture Index in Figure 4 was previously managed through conventional tilling. Over the past 5 years (approximate), the farming practice transitioned to “no-till” and a vegetated buffer was added. According to Steve (last name unknown) (owner of Property A shown in the Picture Index in Figure 4) and Allan “Jay” Fox (owner of Property B shown in the Picture Index in Figure 4) whose residences front the south side of Royal Oak Road near 25913 Royal Oak Road, this has resulted in an increase in nuisance flooding during relatively large rainstorms.

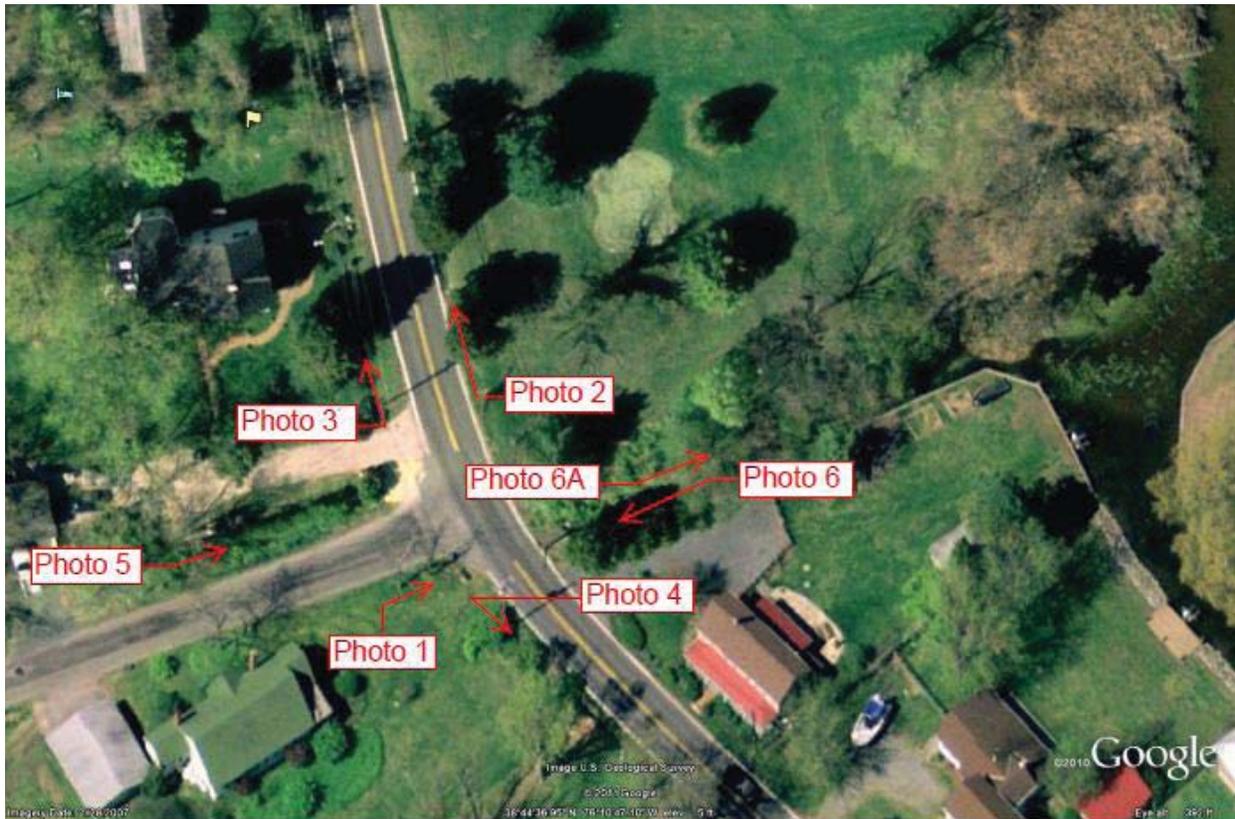
Figure 6. Site 2 picture index.

Site 2 consists of nuisance flooding at the intersection of Thorneton Road and Royal Oak Road (38 ° 44' 36.98" N, 76° 10' 47.73" W). The information from citizens indicates that the flooding occurs only during large or intense storm events. Field photos are included in Table 3 and Figure 6 gives the picture index.

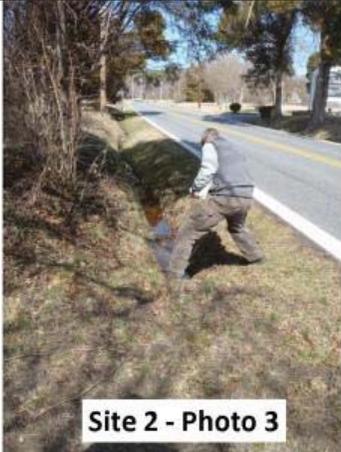
<p>Site 2 - Photo 3</p>

Photos 2, 3, 4 and 5 show inlet pipes that connect to a large grate inlet (Photo 1), however, since only 3 incoming pipes were observed, there is likely an alternate alignment. Also, along the alignment of the pipe depicted in Photo 3 is a connection of another 15 inch diameter pipe and since no junction box is evident, it is assumed that this is a field connection. A more thorough investigation of these systems is required in order to evaluate if there is any drainage system upgrade or reconstruction required. It should also be noted that the entrance of the 18 inch CMP pipe on Thorneton Road is crushed (Photo 5).

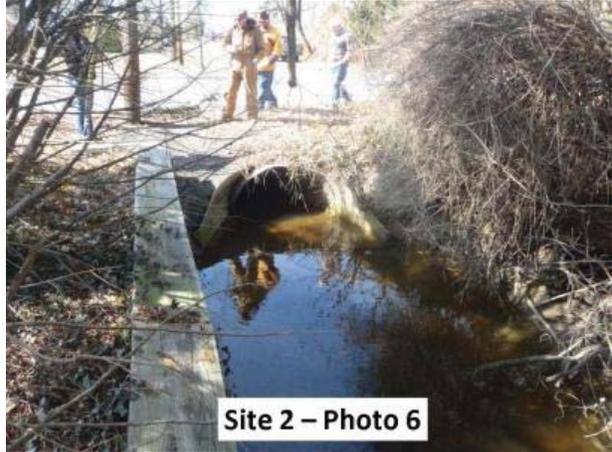
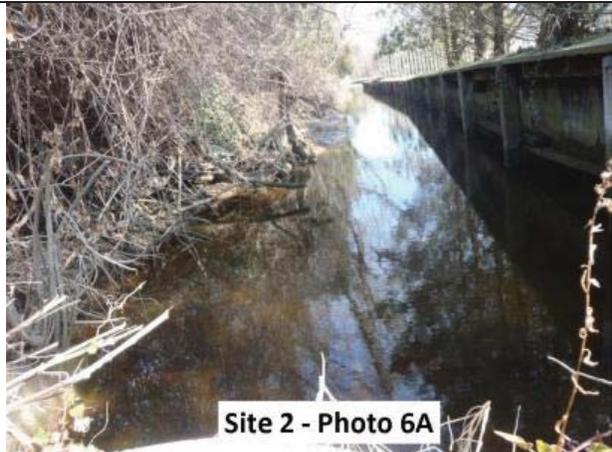
The drainage system serving the intersection is anchored by a large culvert that crosses under Royal Oak Road and discharges directly into a long channel (Photo 6 and 6A) that connects to the adjacent upper finger of Oak Creek as the drainage the outfall from Site 1. A series of inlets serving Royal Oak and Thorneton Road connect at some point and discharge to the single outlet.

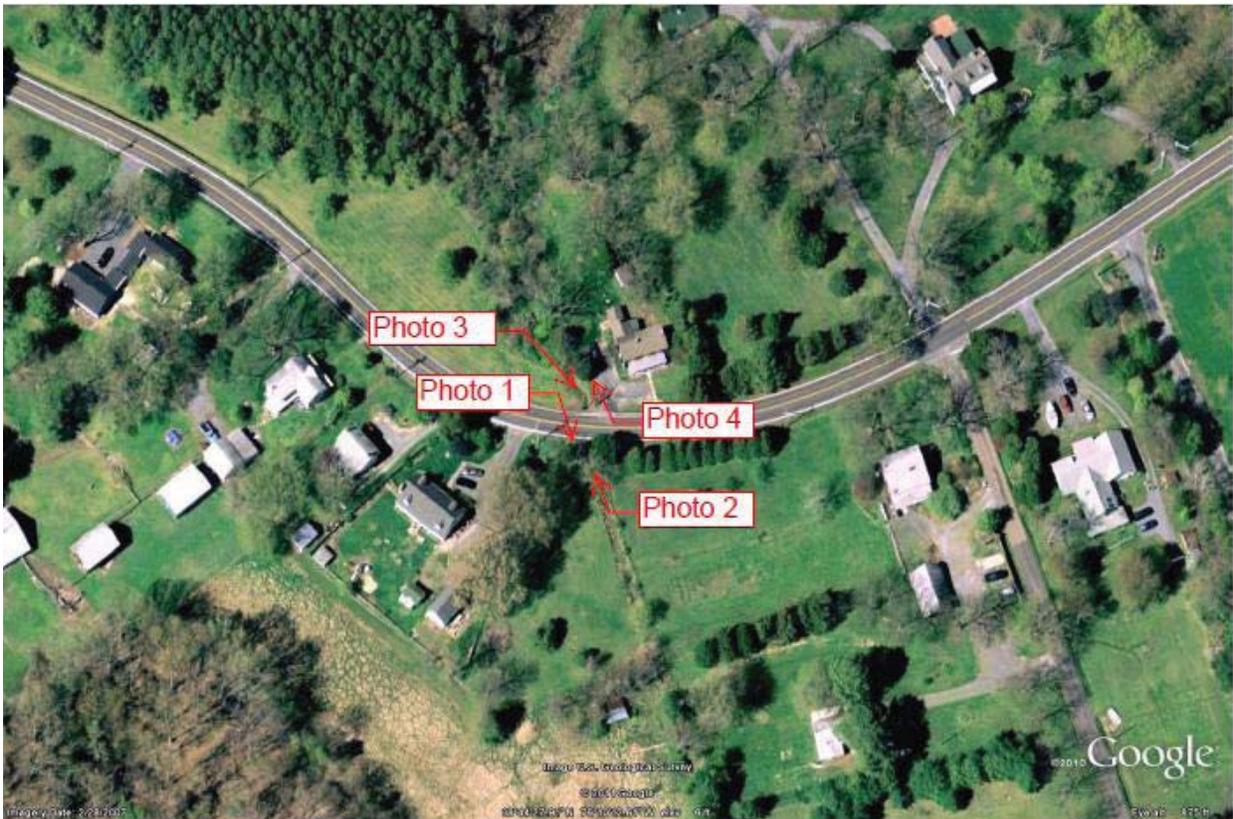
Figure 7. Site 3 picture index.

Site 3 represents a typical roadway cross-culvert condition where the flow velocity during storm events serves to keep the culvert clear of sediment. This site is located to the west of the Schoolhouse Lane and Royal Oak Road intersection on Royal Oak (38 ° 44' 28.28" N, 76° 10' 12.85" W). However, the condition of the downstream channel shows the beginning signs of scour where the channel makes a slight bend within a confined section adjacent to the road. The citizen interest in this as a retrofit project was due to the potential for continuing erosion under current conditions, as well as possible accelerated erosion into the future (in conjunction with a currently proposed development in the upper reaches of this sub-watershed). Resident(s) report losing a tree and potential to loose land due to increased erosion. Field photos are included in Table 4 and Figure 7 gives the picture index.

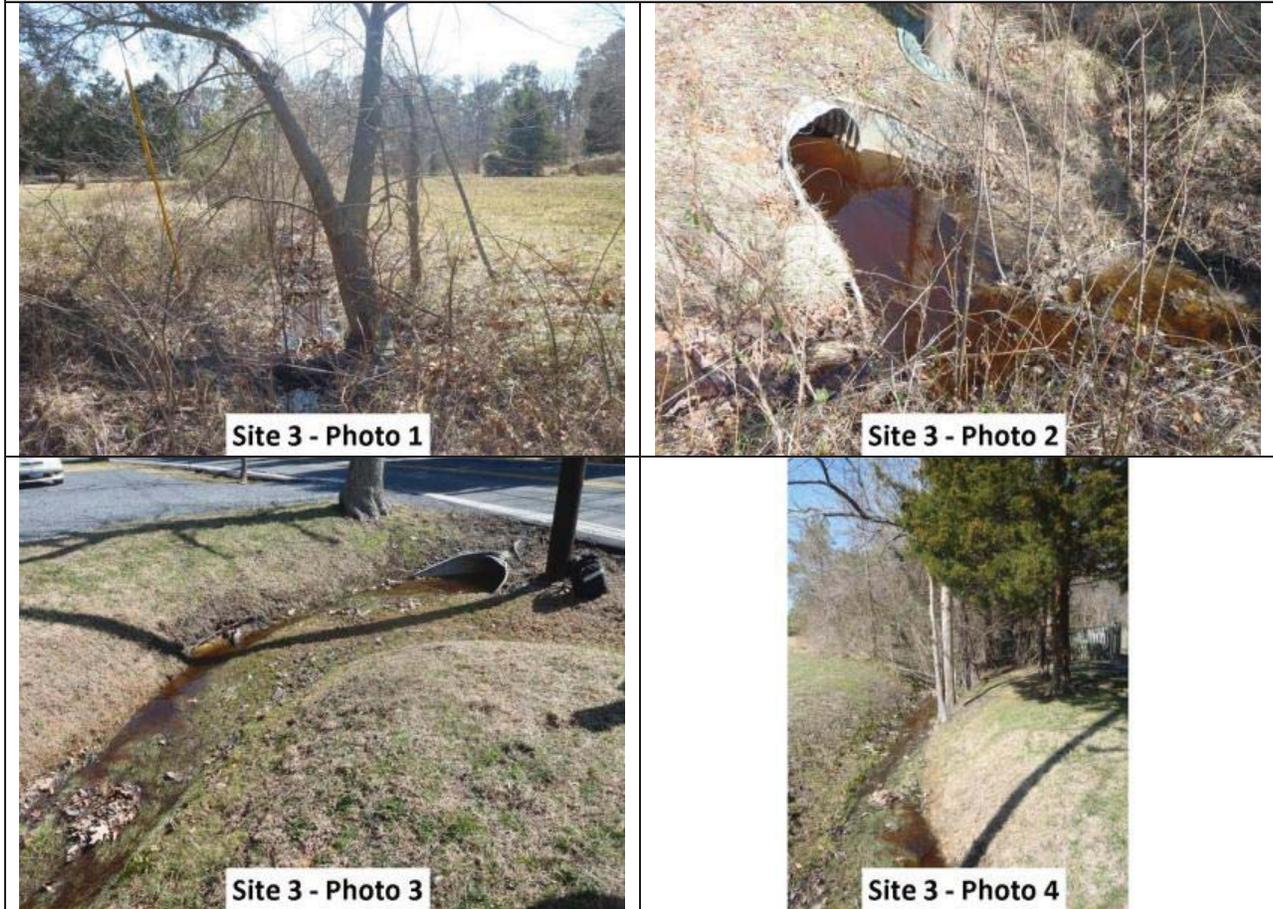
Table 4. Site 3 field photos.

The upper portion of the contributing drainage shed to the cross culvert consists of forested wetlands. Closer to the road, the area is clear with a small the drainage consisting of a small shallow channel with thick vegetation (Photo 1). The area where the flow enters the roadway culvert is well maintained (clear of woody vegetation) and the culvert itself is in good condition (Photo 2).

The roadway culvert includes a field connection. The driveway on the east side of the culvert outlet (Photo 3) has a small culvert that connects directly into the roadway culvert approximately three feet upstream of the outlet. This driveway culvert connects one of the four roadside ditches that connect to this channel – two on the upstream side and two on the downstream side. The reports of periodic flooding over the roadway may be the result of the hydraulics caused by the field connection as well as the hydraulics of the contributing ditches; although the issue of potential channel erosion below the culvert (Photo 3 & 4) is more of a concern than flooding.

There are no obvious retrofit opportunities or fixes to this system of ditches and the cross culvert. The ongoing management practice of maintaining this area as a close-cropped lawn is contributing to the erosion. The area of channel now currently experiencing erosion may benefit from minor stabilization with biodegradable matting and vegetation. The plantings appropriate for this area should be relatively strong rooted ground cover rather than a bushy or thick shrub that would restrict the flow in the channel.

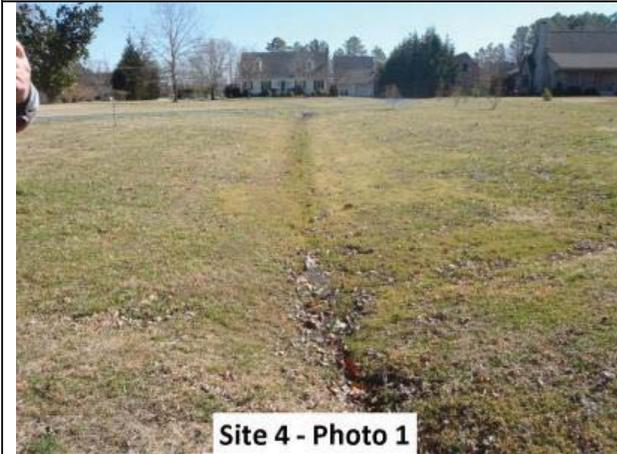
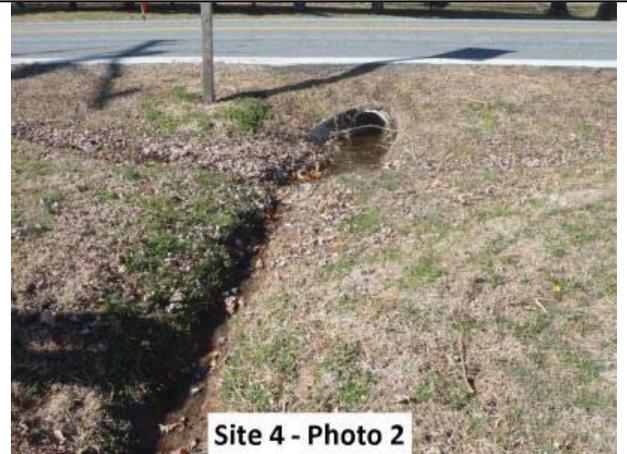
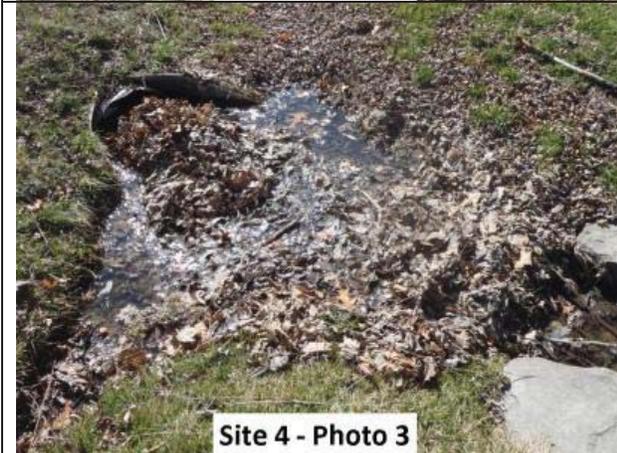
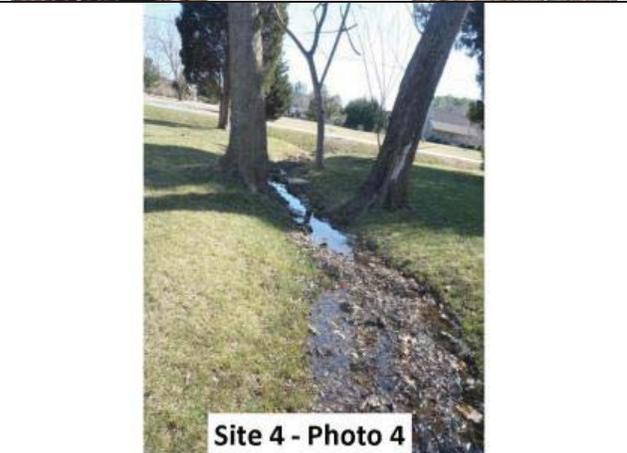
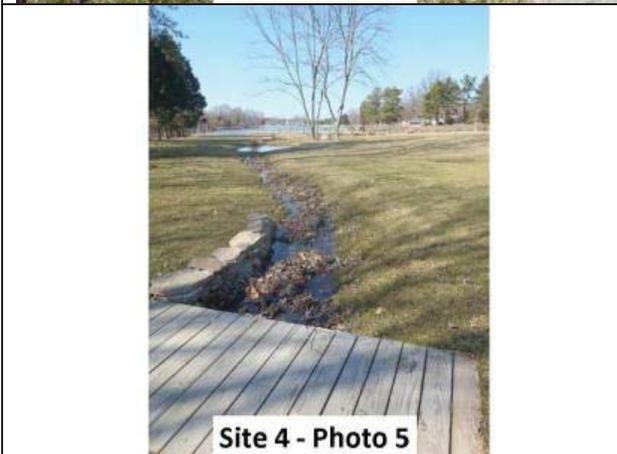
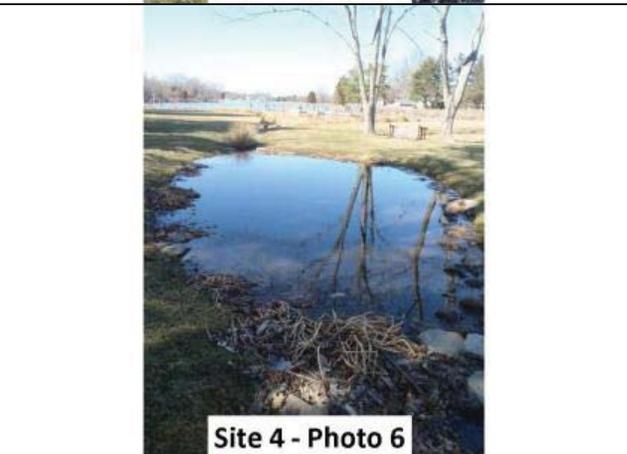
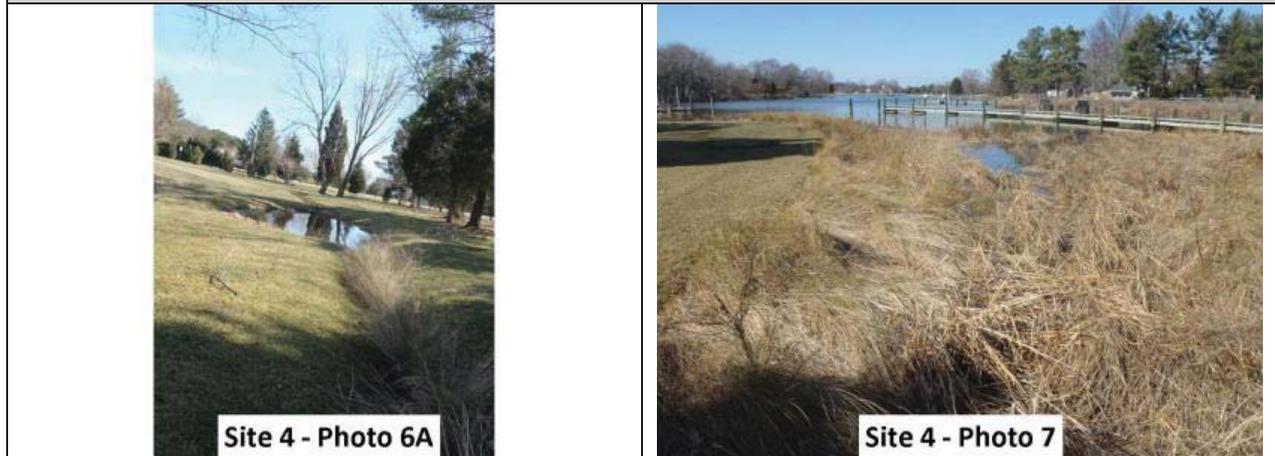
Table 5. Site 4 field photos.

The upper drainage area to the roadway cross-culvert consists of managed lawn. A broad flat swale gradually becomes more defined as it approaches the culvert (Photo 1 & 2). Typical for roadway culverts in the area, there is very little headwater depth available for the roadway cross-culvert to carry large storm flows. Therefore, the water is likely to back up during large storms and overtop the road. Also, this could occur in smaller storms (e.g., < 1 inch rainfall) if the culvert becomes clogged with leaves or debris (Photo 3).

This drainage channel has been incorporated into the private property landscaping (Photo 4), including a decorative bridge (Photo 5) and a landscape pond (Photo 6 & 6A). The landscape pond has a thick layer of organic material (leaves and bud shatter) on the pond bottom. The channel continues until below the landscape pond and then discharges to the upper finger of Oak Creek (Photo 7).

The upper portion of the channel (upgrade) – south of Royal Oak Road (Photo 1), could be retrofit with a shallow bioretention area to help reduce nutrient loads associated with managed turf in the upper drainage area, thereby improving the aesthetic conditions of the existing landscape pond. The proposed shallow bioretention area could consist of a heavy planting of herbaceous, local vegetation and include a six inch ponding area with a permeable berm. The permeable berm is proposed in lieu of an underdrain since there is no option to “daylight” an underdrain due to the flat grades.

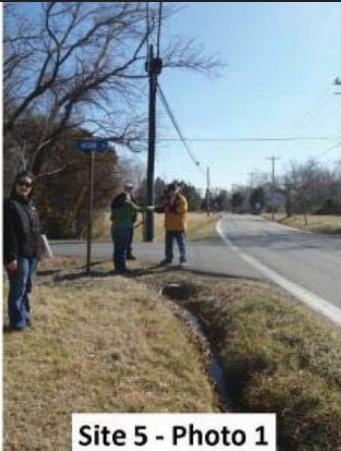
<p>Site 5 - Photo 1</p>

The grade along Royal Oak Road is extremely flat, such that it is very difficult to determine the direction of the flow without a very accurate level. The drainage ditches at the site were all holding water. The roadside ditches appeared to contain sediment and/or organic material.

There is no retrofit recommendation for this site. However, if flooding is a major concern and/or observed often at the site, delineating the drainage area is recommended and should be based on survey data. Roadside ditches should then be assessed to determine if they are functioning as designed. The survey data can help guide improvements if it is determined that the ditches are inadequate for the road conditions.

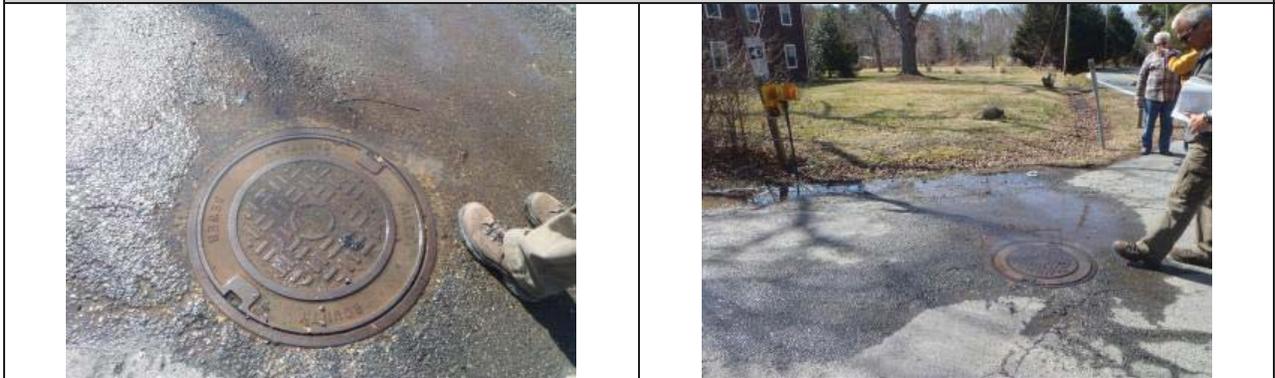
Table 7. Hot Spot investigation field photos.

A manhole that covers the pump station overflow was found in the field. This Hot Spot (Site Number 100) was located on the corner of Schoolhouse Lane and Royal Oak Road (38° 44' 28.23" N, 76° 10' 9.09" W). The site is indicated in Figure 3 with a red box. The overflow was documented (Table 7) and phoned into Talbot County Planning and Zoning Division. The City of Saint Michael's waste water treatment staff investigated this within hours of the original identification. Groundwater infiltrates the well, rises, and comes out of the manhole. It was tested that afternoon and contained no evidence of sewage contamination. This site often overflows according to the Royal Oak residents.

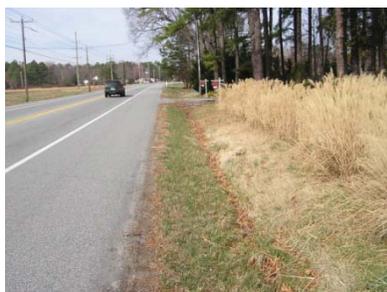
*Photo 27
(St. Michaels Road)*

The roadside drainage ditches are typically usually 1-2' deep, and in the case of the ditch system along Royal Oak Road, the ditch was a minimum of 2.5' up to 3.5'. Ditch bottom widths range from 6-12". The Royal Oak Road ditch system is located immediately off the driving lane. Some evidence of pavement failure is evident along the ditch system. Ditches near or under trees are filled with leaves and other debris. River and Woodside Roads have shallow parabolic grass swales that are approximately 6" deep. The drainage system along the St. Michaels Road (Rt. 33) is located off the road's shoulder on each side and tends to have milder side slopes, roughly 4:1 or less, as is typical with most State roads. All drainage ditch systems discharge into the Miles River or Oak Creek without any stormwater management devices in place.

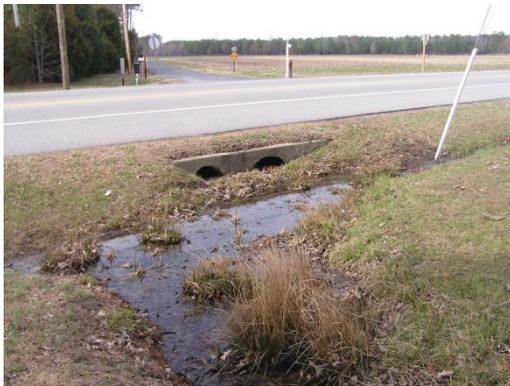
Photo 38

Miles-1 is a 660' long, tree-lined trapezoidal-ditch that flows northeast from St. Michaels Road towards the Miles River (Photos P39 – P41). Twin culverts crossing St. Michaels Road, in which are 50% clogged, pass the runoff from the south (Photo P38). The ditch transforms into a wide floodplain channel before discharging into the river (Photos P42 – P44). The floodplain is a tidal area. The ditch is approximately 2' deep and appears stable. However, as evidenced from a fallen tree that was identified along the ditch, it appears the ditch cannot handle the volume of water from large storm events.

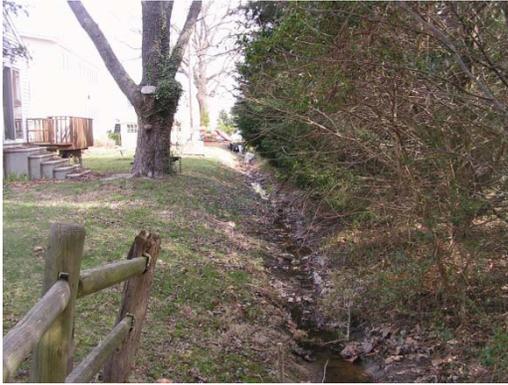
Photo 23

MILES 3 is a 750' long, narrow and shallow trapezoidal ditch that bisects residential properties near Beach Road. Standing water was noticed at the upstream end of the ditch where it crosses Rt. 33 (P021 - P023). A residential house was being constructed at the time of the investigation. The house is within 6' of the ditch. Several roof drains discharge into the ditch. The ditch flows into a culvert and then through the bulkhead into the river (P024 - P026). There were some signs of scouring on the side slopes of the ditch. The outfall pipe and bulkhead are in disrepair.

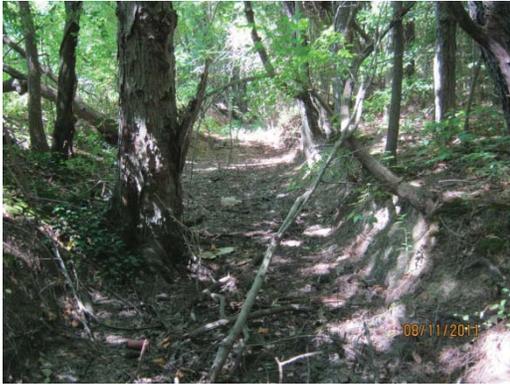
Photo 136

OAK 4 is a 1,180' long drainage channel that begins at Royal Oak Road and continues to Station Road. As listed in Table 1, OAK 4 is the focal drainage point of approximately 102 acres. A cross culvert discharges runoff into the channel from the western side of Royal Oak Road. The channel begins in a wooded area (P135 - P138) and then continues into an open space (P097 - P098). After the open space, the channel turns sharply northeast and then east towards Station Road. After crossing Station Road in a 30" CMP culvert, it discharges into a large tidal channel off of Oak Creek. The channel has consistent cross section for its entire length between Royal Oak and Station Roads, including a 5' bottom width, 3-4' deep, and 1:1 side slopes. Some trees and limbs have fallen into the channel. After Station Road, the channel passes the historic cemetery and two private sheds that are constructed right upon the banks of the channel (P081 - P089).

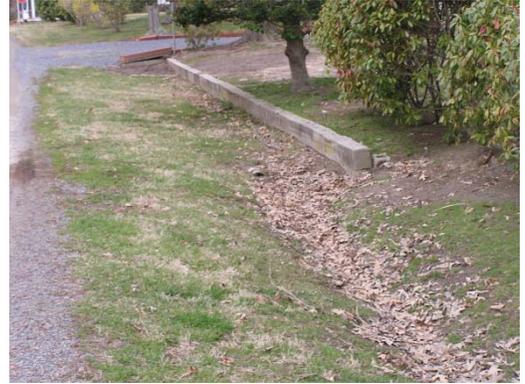
Photo 104

OAK 5 is an outfall culvert that receives runoff from River Road. Two culvert pipes and a roadside swale drain towards the outfall culvert. Although the downstream of the pipe was identified, the upstream side was not visible (P103 - P104). The outfall pipe discharges through a deteriorated timber bulkhead (P105) where significant washout is evident (Photo 105A). In observing the elevations of the pipe's downstream invert compared to the estimated upstream invert, it appears the pipe has a negative slope. Outfall pipe and bulkhead are in disrepair.

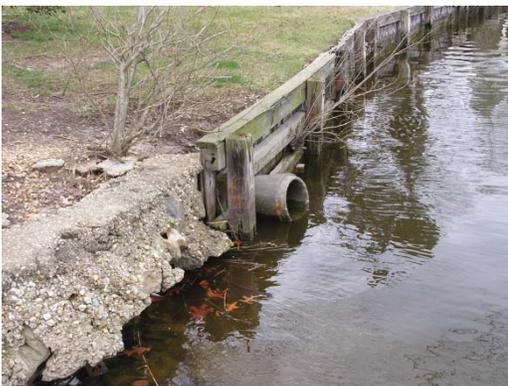
Photo 103

<p>Photos: W63 – W67</p> <p>Remarks: Aged bulkhead in need of replacement. Openings between timber sheeting boards evident. At time of investigation, water was draining from hole in bulkhead (shown in picture). Pipe visible in hole (Photo 67). OAK 5 daylight through bulkhead. Area behind OAK 5 is washed out (Photo 103 & 105A).</p>					
9	265'	Natural - Vegetation	Moderately Unstable

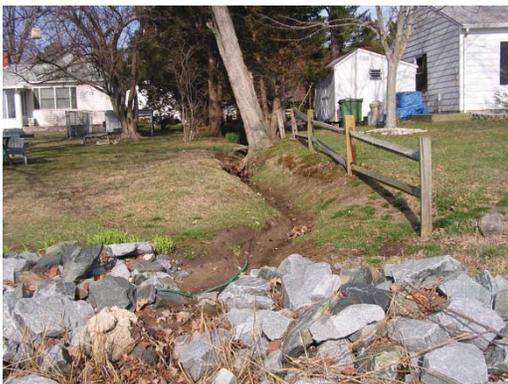
Photo W10

Oak-9 is a naturally created v-ditch along a property line due to erosion (PW10 - PW13).

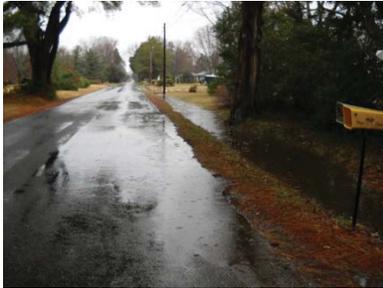
Station Road, Facing Northeast

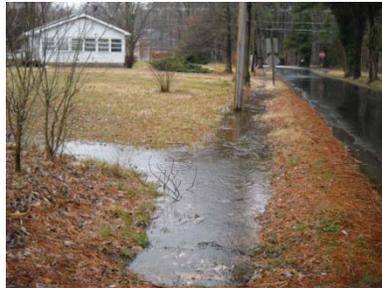
Station Road, Facing Southwest

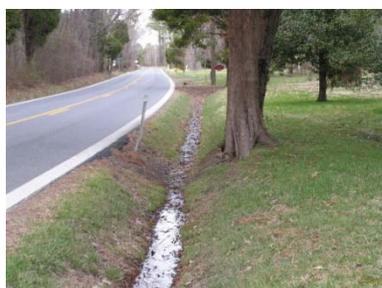
*Photo 119 - Royal Oak Road, Northwest
(Note Blocked Culvert Downstream)*

Many residents also stated that the County should regularly maintain the roadside ditches removing leaves and sediments. As previously mentioned, most of the driveway culverts are clogged up to 75%. The residents state if the culverts were clear, the drainage system within Newcomb would probably work sufficiently.

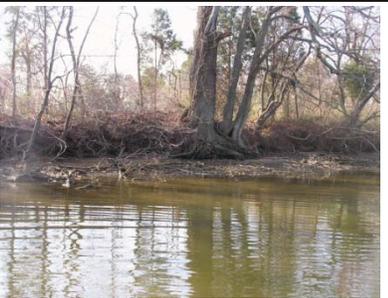
3	315'	Natural - Wooded	Unstable

<p>Photos: W31 – W34</p> <p>Remarks: Natural shoreline is mud flat beach with sparse trees and heavy vegetation. Some scouring and tree roots apparent. Area is secluded thus it is anticipated that erosion is caused by either rainfall or refracted waves from adjacent bulkhead.</p>				
4	170'	Bulkhead / Stone Revetment	Stable

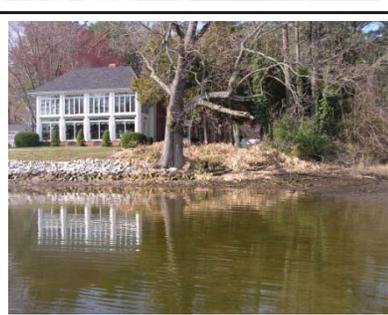
<p>Photos: W35, W38</p> <p>Remarks: Combination of timber bulkhead and stone revetment protecting single property.</p>				
5	200'	Natural - Floodplain	Stable

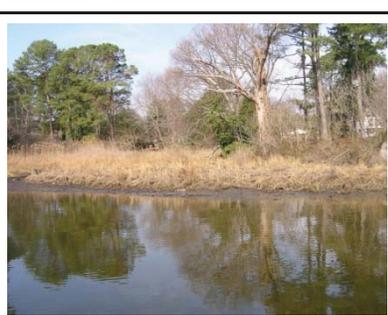
<p>Photos: W36 – W37, W39 – W45</p> <p>Remarks: Natural floodplain area (OAK 7).</p>				
6	685'	Stone Revetment	Stable

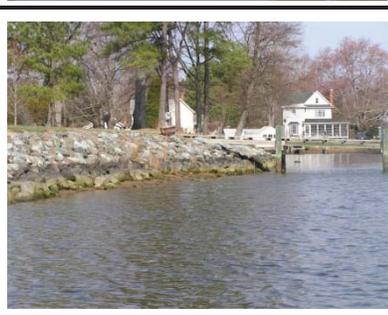
<p>Photos: W46 – W54</p> <p>Remarks: Stone revetment for protecting two properties. Storm drain pipe daylights through revetment (Photo W48). Upstream end of pipe unknown. No erosion evident. Apparent fill outboard of revetment for approximately 125' (Photo W49).</p>

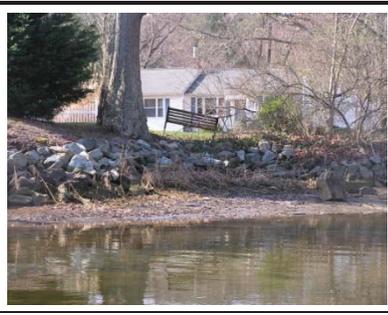
Photo 62

7	315'	Minor Stone Revetment	Mostly Stable

<p>Photos: W55 – W62</p> <p>Remarks: Minor stone revetment that is non-linear and non-uniform in height and width. Revetment area mostly stable. Last 30' of revetment is concrete rubble in disrepair (Photo 62). Undercutting of rubble revetment is evident. Rubble revetment located adjacent to OAK 5.</p>

Section 7 has approximately 30' of a concrete rubble revetment (Photo 62) that should be removed (see Table 11). Instead of replacing the revetment, a living shoreline is proposed. This could be tied into the OAK 5 project. The outfall pipe would discharge into a stone plunge pool to dissipate the velocity. Tidal wetlands would be planted behind coir fiber logs. The logs would provide protection from any minor wave activity that enters the cove. A plan view of the living shoreline is shown on **Exhibit 7**.

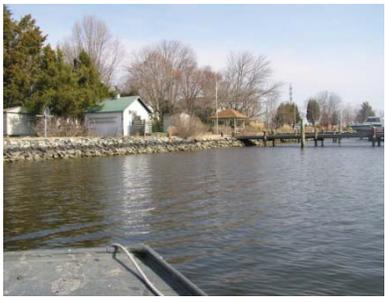
12	640'	Bulkhead / Stone Revetment	Stable

<p>Photos: W78 – W85</p> <p>Remarks: Mostly stone revetment shorelines with small section of timber bulkhead. With the exception of one area at the before timber bulkhead begins (Photo 81), all structural shoreline appears stable.</p>				
13	400'	Steel / Timber Bulkhead	Stable

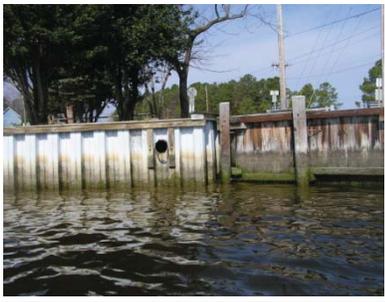
<p>Photos: W86 – W91</p> <p>Remarks: Steel then timber bulkhead on County property. Timber bulkhead continues along Rt. 33 bridge.</p>				
14	330'	Natural – Beach / Armor stone	Stable

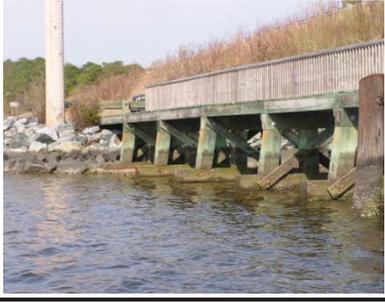
<p>Photos: W92 – W95</p> <p>Remarks: Beach located on south side of bridge. Armor stone protects bridge abutment abutment.</p>				
15	1,250'	Stone Revetment	Stable

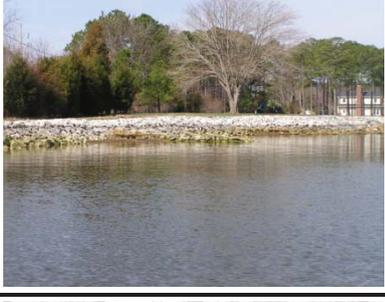
<p>Photos: W92 – W95</p> <p>Remarks: Stone revetment with high elevation (~ +6.0').</p>				
16	1,665'	Timber Bulkhead	Mostly Stable
