# BRETON BAY STREAM CORRIDOR ASSESSMENT SURVEY

Robin Pellicano and  
Kenneth T. Yetman

WATERSHED RESTORATION DIVISION  
CHESAPEAKE AND COASTAL WATERSHED SERVICES  
MARYLAND DEPARTMENT OF NATURAL RESOURCES  
ANNAPOLIS, MARYLAND

January 2003

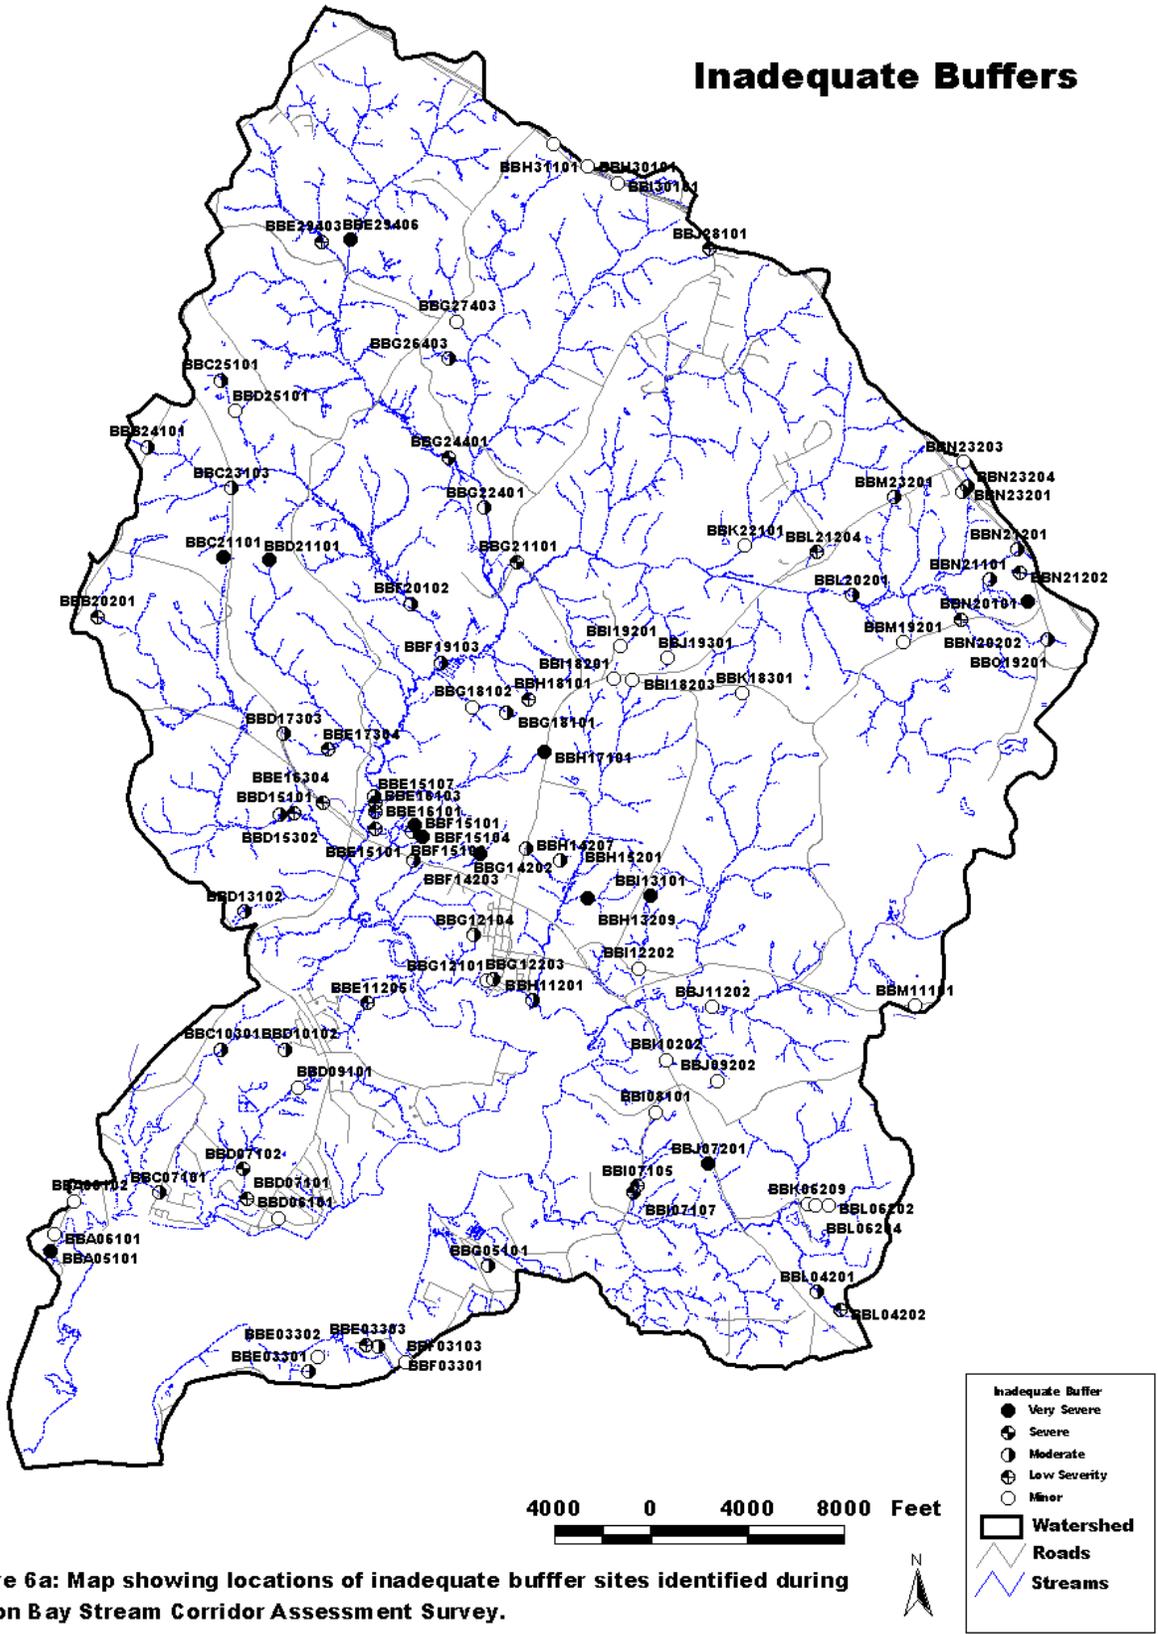
# Inadequate Buffers

While there is no single minimum standard for how wide a stream buffer should be in Maryland, for the purposes of this study a buffer is generally considered inadequate if it is less than 50 feet wide, measured from the edge of the stream. Inadequate buffers were reported at 97 sites during the survey and their locations are shown in Figure 6a. The field crew provided a rough estimate of the length of the inadequate stream buffer at all sites (Appendix B). Based on the data that was collected, there are approximately 59,635 feet (11.3 miles) of inadequate buffer in the Breton Bay watershed. Field teams found inadequate buffers ranging in distance from 30 feet to 2,600 feet. This survey was done in a mostly rural area, with crop fields and pasture reported as the dominant adjacent land use at inadequate buffer sites, accompanied by a moderate amount of lawn. Most sites received a moderate to minor severity rating (Figure 6b). This would indicate that most of the stream reaches with inadequate buffers were not very long or some trees were already present at many of the sites.
