Georges Creek Stream Corridor Assessment Survey

Watershed Restoration Division
Chesapeake & Coastal Watershed Services
Maryland Department of Natural Resources
December, 2002

GEORGES CREEK

STREAM CORRIDOR ASSESSMENT SURVEY

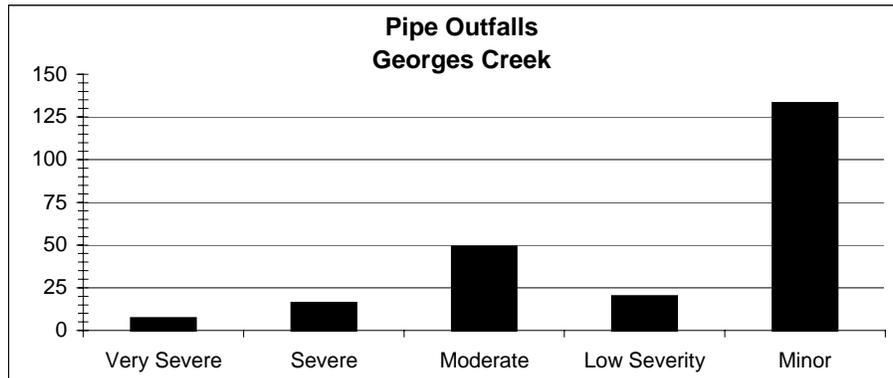
Severity ratings for pipe outfalls were given based on discharge, type of discharge, and location in the watershed of the outfall. In the Georges Creek SCA Survey, 7 pipe outfalls were given very severe ratings, along with 16 severe, 49 moderate, 20 low severity, and 133 minor sites. This can be seen in Fig 4a.

Figure 4a: Histogram showing the frequency of severity ratings given to Pipe outfall sites during the Georges Creek SCA survey.

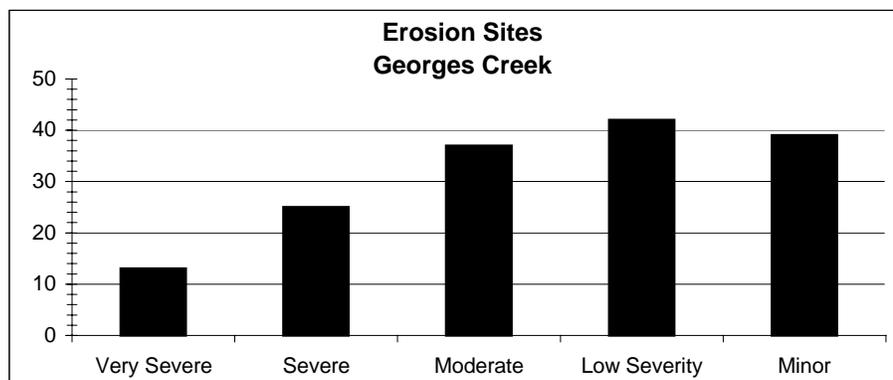
Figure 5a: Histogram showing the frequency of severity ratings given to stream bank erosion sites during the Georges Creek SCA Survey.

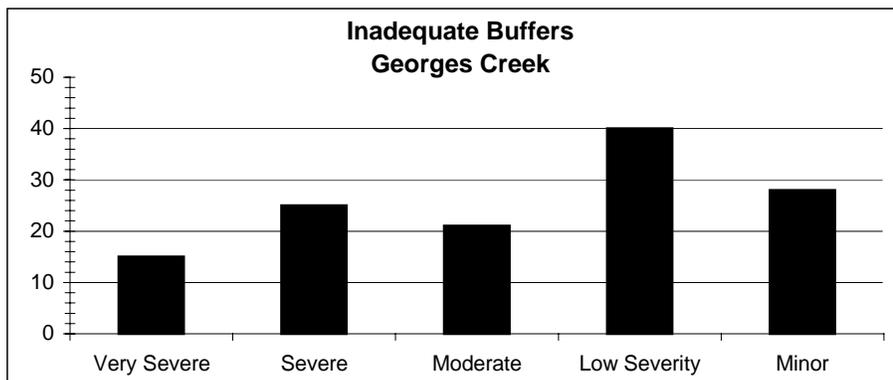
Figure 6a: Histogram showing the frequency of severity ratings given to inadequate buffers during the Georges Creek SCA Survey.

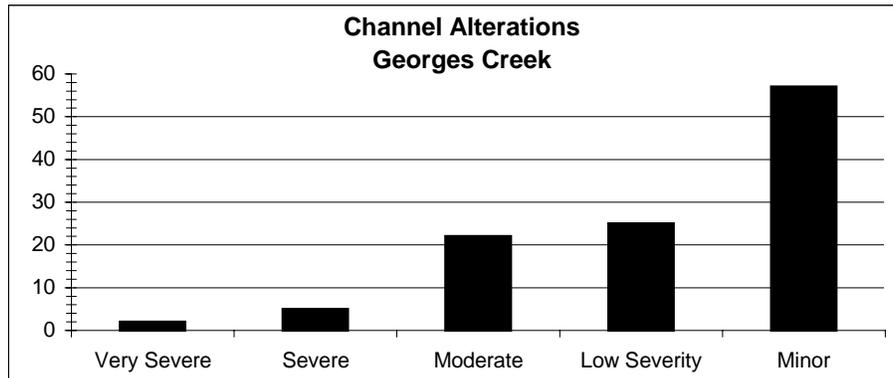
Figure 7a: Histogram showing the frequency of severity ratings given to channel alteration sites during the Georges Creek SCA survey.

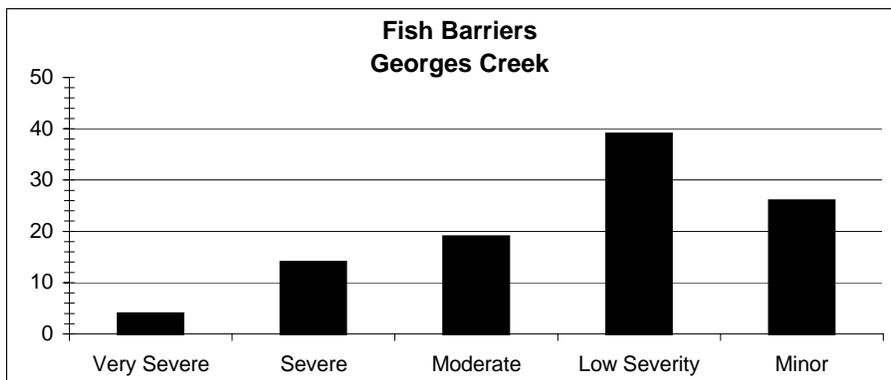
Survey crews identified 102 fish migration barriers during the survey. The locations of fish migration blockages are shown in Figure 8b, 8c, and 8d. At 95 sites the survey crews reported a water drop that was too high for some fish to move upstream, while at an additional 10 sites they reported that the water was too shallow for fish migration. Natural falls were cited as the main type of fish barrier and were reported at 46 sites. Fish migration barriers at road crossings were found at 29 sites. Other causes of fish barriers in the watershed were dams (12), in-stream debris (9), pipe crossings (3), channelized sections of stream (2), in-stream ponds (2), log weirs (2), and railroad crossings. The majority (60 of 102 sites) of the fish migration blockages were characterized as being total fish migration barriers, blocking the whole width of the stream with a permanent structure. Temporary structures blocking full movement of fish were cited at 39 sites. Partial barriers allowing some flow through unimpeded were found in 3 cases. Most of the fish migration blockages also were given low severity or minor ratings (Figure 8a).

Figure 7a: Histogram showing the frequency of severity ratings given to fish migration blockages seen during Georges Creek SCA survey.

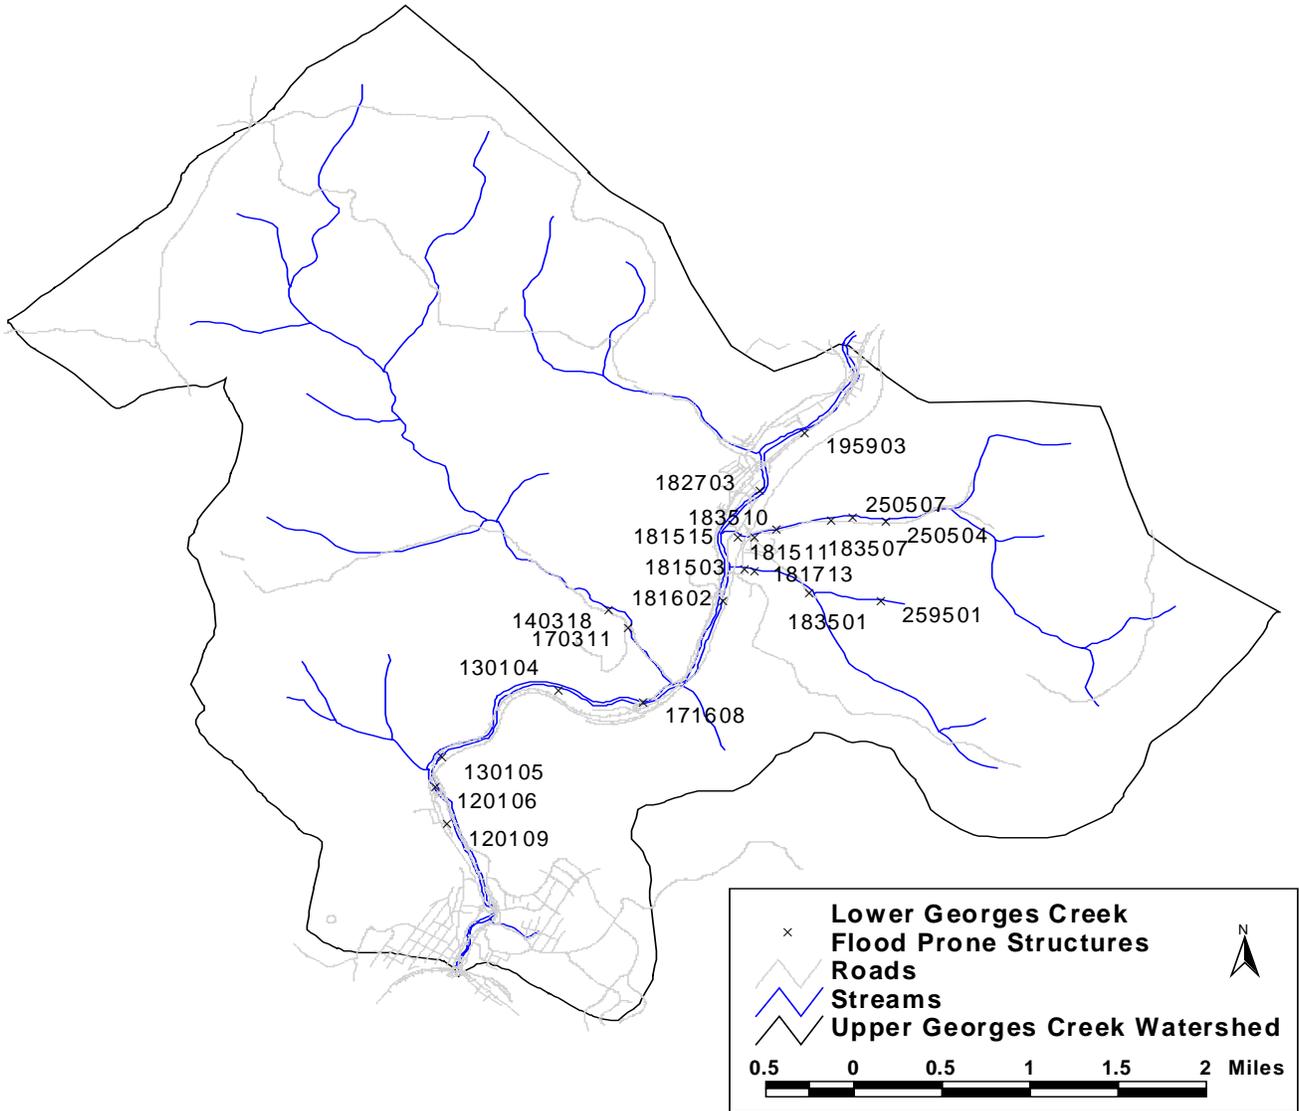
Figure 9c: Lower Georges Creek Flood Prone Structures.

Ninety-one flood prone structure sites were cited during the Georges Creek Survey. Multiple structures were recorded at each site. Type of structure, location, distance from the top of the bank, and the existence of flood proofing and floodwalls were all recorded at these sites, as well as the number of structures. These sites were not given severity rankings. In total, 261 structures (183 houses, 61 sheds, 15 businesses, 1 pool, and 1 school) were recorded during this survey. Six sites involving 34 houses, 3 sheds, and several garages were found to have had a floodwall. Three sites with 4 houses were found to have had flood proofing, including 1 concrete wall, 1 stone wall, and 1 failing gabion basket. The majority of structures (126 or 48.28%) were recorded on the mainstem and Jackson Run. The mainstem contains 61 houses, 15 sheds, 7 businesses, and 1 school. Jackson Run contains thirty-two houses, 5 sheds, and 6 businesses.

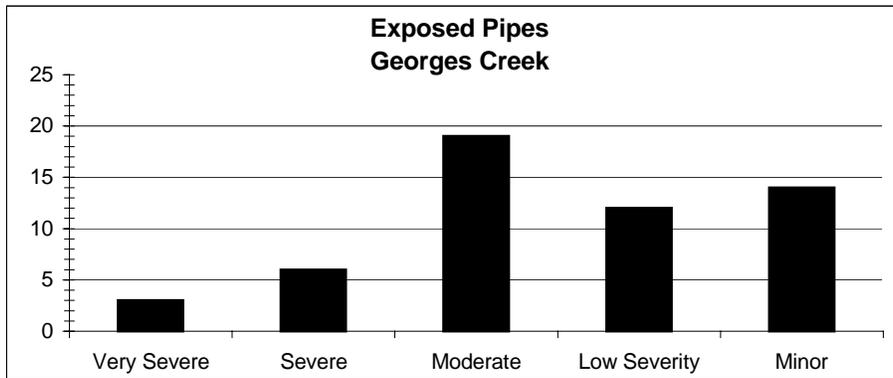
Figure 10a: Histogram showing the frequency of severity ratings given to Exposed pipes seen during Georges Creek SCA survey.

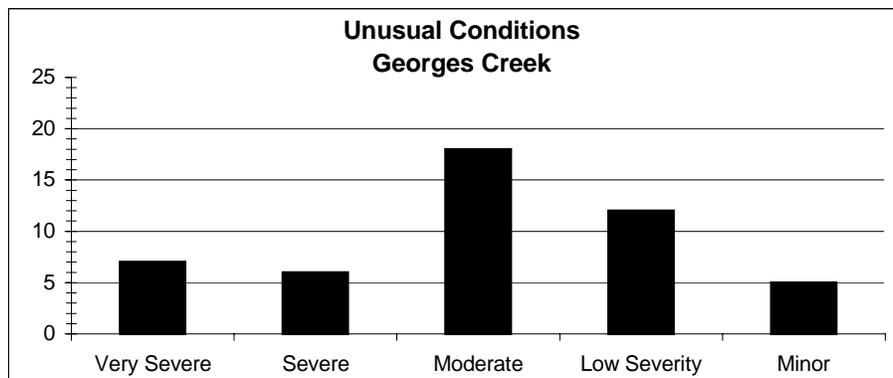
Twenty unusual conditions and 14 comments were recorded in the upper portion of the watershed. Of these, 1 was ranked very severe and five severe (Figure 11a). Site 536601 is a very large lake not on the map and was given a very severe rating. The stream channel is dry and the mainstem of Georges Creek is several feet above the water surface of the lake. For severe sites please refer to appendix B.

Figure 11a: Histogram showing the frequency of severity ratings given to unusual conditions seen during Georges Creek SCA survey.

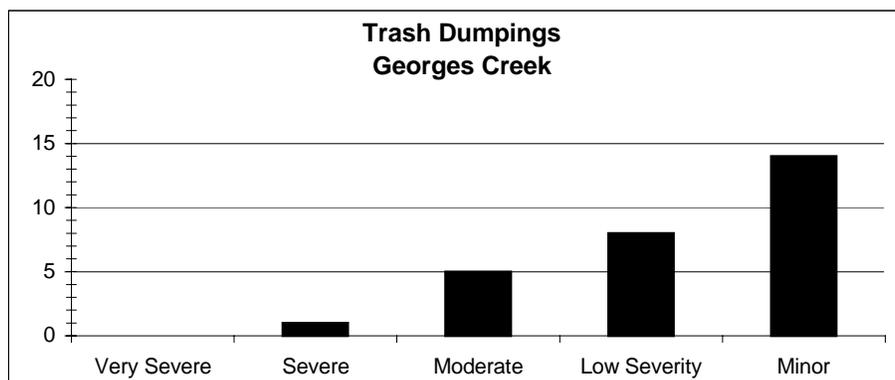
Trash dumping sites in the Georges Creek watershed range in size from 1 to 40 truckloads, to 1 acre. Single site trash dumping sites were recorded 21 times, while large area dumping sites were recorded 7 times. Types of trash found include: residential (18 times), industrial (6 times), tires (4 times), and yard waste (3 times). Fifteen trash dumping sites were found on private land, and 5 were found on public land. Eight sites could not be identified as private or public. Two trash sites were found in Savage State Forest, two off county roads, and one by the Gilmore reservoir. Site 381303 was the only site given a severe rating. Here, an estimated 40 truckloads of clay pigeons were found on Jackson Run.

Figure 14a: Histogram showing the frequency of severity ratings given to trash dumping sites seen during Georges Creek SCA survey.

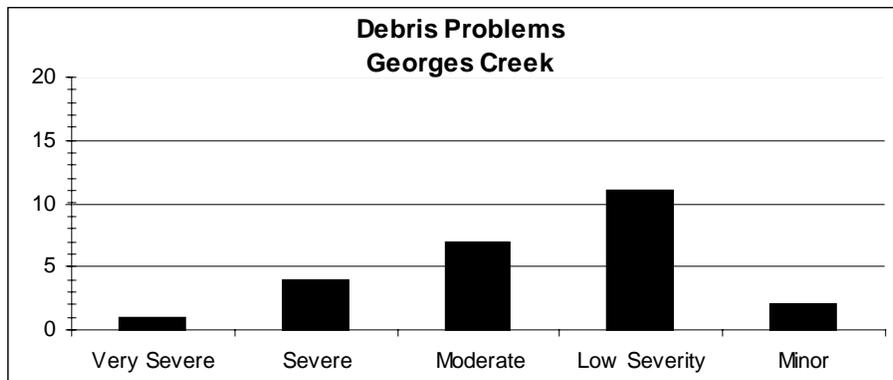
Figure 15a: Histogram showing the frequency of severity ratings given to Debris problem sites seen during Georges Creek SCA survey.

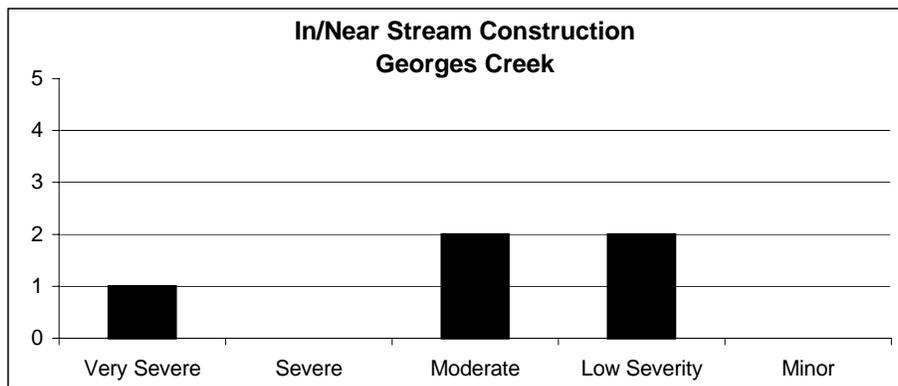
Most sites were given a moderate to low severity rating (Figure 16a). One site (182703) was given a very severe rating. At Site 182703 survey crews reported that the Carl Belt Co. was constructing a wall in the lower Georges Creek mainstem. Field crews indicated that they did not believe the construction site had adequate sediment control and reported excess sediment washing into Georges Creek.

Figure 16a: Histogram showing the frequency of severity ratings given to in/near stream construction seen during Georges Creek SCA survey.
