# Lower Linganore Creek Stream Corridor Assessment Survey

Watershed Assessment and Targeting Division  
Watershed Services  
Maryland Department of Natural Resources  
June 2005

# LOWER LINGANORE CREEK STREAM CORRIDOR ASSESMENT SURVEY

Frederick County, Maryland

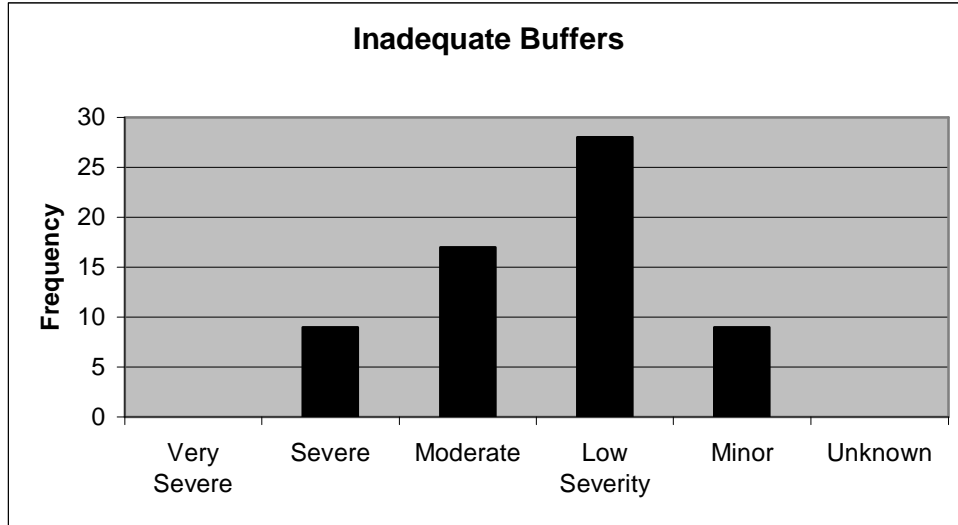
Figure 4a: Histogram showing the frequency of severity ratings given to inadequate buffer sites during the Lower Linganore Creek SCA survey

The survey crew identified 63 inadequate buffers sites (Figures 4b-4e) and provided an estimate of the length of the inadequate stream buffer at all sites (Appendix B). Based on the collected data, there are approximately 161,635 feet (30.61 miles) of inadequate buffers on the left bank and 170,258 feet (32.25 miles) on the right bank of the streams (Table 2). Field teams found inadequate buffers ranging in length from 383 feet to 14,415 feet (2.73 miles). Severity ratings varied from severe to minor with the greatest number of sites given a low severity rating (Figure 4a). Inadequate buffer sites are distributed throughout the watershed, with approximately 32.35 percent of the left bank and 34.09 percent of the right bank inadequately buffered.

Wetlands and livestock access are two important areas to consider for restoration as they both greatly affect the amount of nutrients reaching the stream. Wetlands help to slow the flow of water and act as a sponge, absorbing excess nutrients from the water, while livestock access can have negative effects on the stream. Cattle and horses can cause additional erosion by compromising the stability of the banks at crossing points and thus increasing sediment levels. Nutrient and bacteria levels can also rise due to the increased possibility of animal feces entering the water. It is recommended that sites that could benefit from livestock fencing and sites that may be suitable to restore wetlands be further investigated.

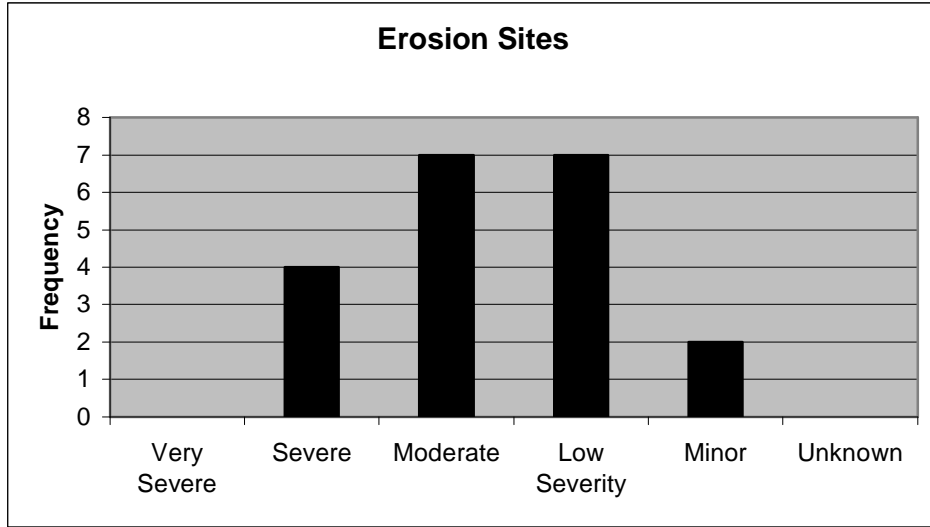
Figure 5a: Histogram showing the frequency of severity ratings given to erosion sites during the Lower Linganore Creek SCA survey.

The SCA survey found 20 eroding stream banks with a total length of 67,316 feet (12.75 miles). Erosion sites noted by the survey crews are congregated primarily in the eastern part of the Lower Linganore Creek watershed. Based on the land use, soil type and gradient within the watershed, levels of erosion vary. According to the Frederick County Annual Report, the Lower Linganore Creek watershed has a total urban impervious area equaling 1,174 acres (7.2% of the watershed). Though it is likely that these impervious surfaces are contributing to erosion levels, the contribution is probably small. Figure 3 shows that the much of the watershed is agricultural in land use. These areas tend to have minimal forest buffering; an increase in forest buffers could help reduce the rate at which water runoff enters the stream channel.

The severity and location of erosion sites in the Lower Linganore Creek watershed are shown in Figure 5b. Severity ratings ranged from minor to severe. The frequency of the severity ratings is shown in Figure 5a.

In addition, survey crews are asked to evaluate whether there is a threat to infrastructure due to the erosion. Crews cited only one instance where this was the case, and the threatened infrastructure is listed as a baseball diamond.

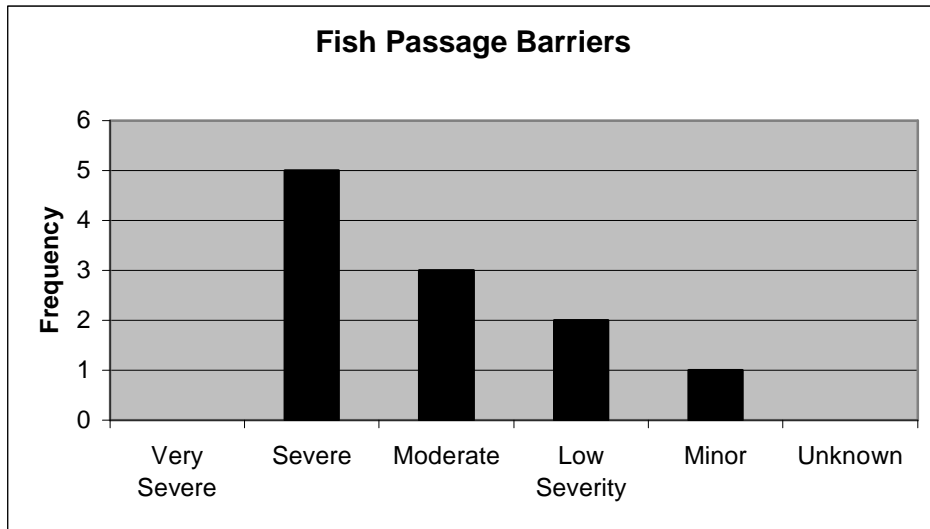
Figure 6a: Histogram showing the frequency of severity ratings given to fish passage barrier sites during the Lower Linganore Creek SCA survey

The Lower Linganore Creek SCA survey found 11 fish passage barriers. The locations of fish blockages are shown in Figure 6b. The fish barriers found in the Lower Linganore Creek watershed are due to road crossings (5), channelized stream beds (2), a debris dam (1), a dam (1), an exposed pipe (1), and a dam/channelized stream bed (1). Figure 6a shows that severity ratings varied from severe to minor with 5 sites listed as severe. These sites were 0719103, 1011101, 1016203, 1310403, and 1410402. Four of the eleven sites were observed to be too shallow with the remainder of the sites marked as too high. Total structures blocking full movement of fish were observed at seven sites while partial barriers allowing some flow were found in three cases. One site was noted as being a temporary barrier.

In all cases, areas should be assessed for viable fish habitat before restoration work begins, giving preference to sites with the most potential habitat area created.

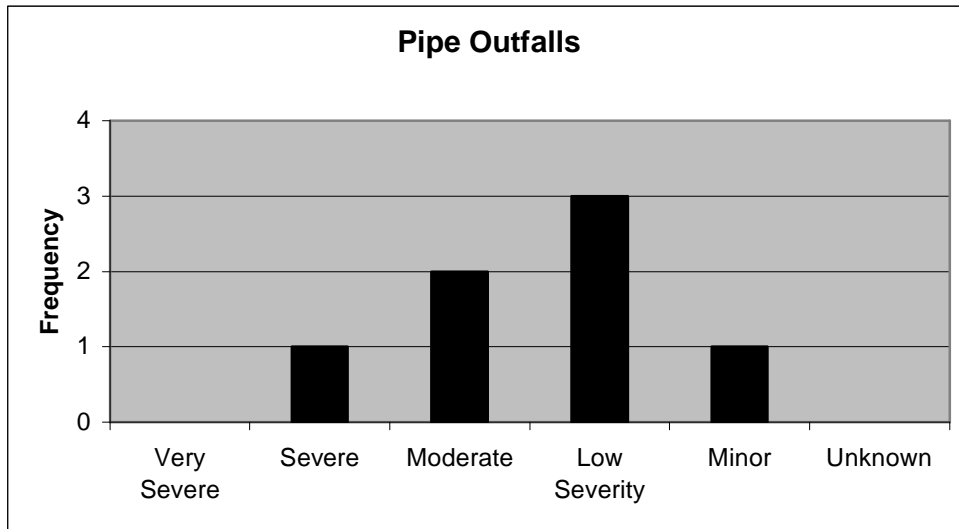
Figure 7a: Histogram showing the frequency of severity ratings given to pipe outfall sites during the Lower Linganore Creek SCA survey

Pipe outfalls include any pipes or small, constructed channels that discharge into the stream through the stream corridor. Pipe outfalls are considered a potential environmental problem in the survey because they can carry uncontrolled runoff and pollutants such as oil, heavy metals and nutrients to a stream system. The survey crew identified a total of 7 pipe outfalls (Figure 7a). The locations of pipe outfalls are shown in Figure 7b.

Five of the seven pipe outfalls observed during the survey were recorded as having a discharge. Of these, three had a clear discharge and no odor associated with it at the time of the survey (Appendix B). Site 0521201 was recorded as having a green discharge and no odor, and site 0703201 was recorded as having an oily medium brown discharge. Five of the pipe outfalls were recorded as being stormwater pipes. Those that were not marked as stormwater were either for an unknown use (1107301) or agricultural use (0521201). In these cases, it is recommended that further investigation be performed to determine the type of outfall. It is also recommended that the pipes with a colored discharge be reported to the Environmental Compliance Section for further investigation of the source of discharge.

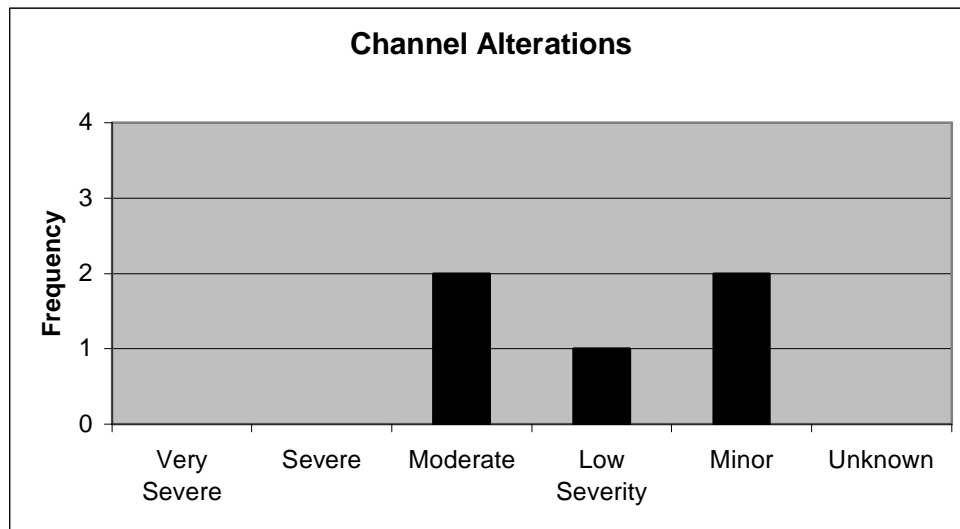
Figure 8a: Histogram showing the frequency of severity ratings given to channel alteration sites during the Lower Linganore Creek SCA survey

In the Lower Linganore Creek watershed, survey crews found 5 areas where the stream channel had been recognizably altered. Locations of channel alteration sites are shown in Figure 8b. Channel alterations were clustered primarily in the southwestern portion of the watershed. The channel alterations were approximately 181 feet in total length. Three sites were made of rip rap, 1 concrete, 1 a railroad crossing, and 1 an earth channel. Severity ratings varied from minor to moderate (Figure 8a).

The severity of channel alterations is based on both the channel type and the length of the site. The presence of hardened stream banks using concrete or rock for a total length of over a thousand feet increases the severity of a site. This is due to the greater habitat potential of earth channels, which can easily develop and support vegetation, stream sinuosity, and refuge areas for wildlife within the channel bed than areas with a hardened stream channel.

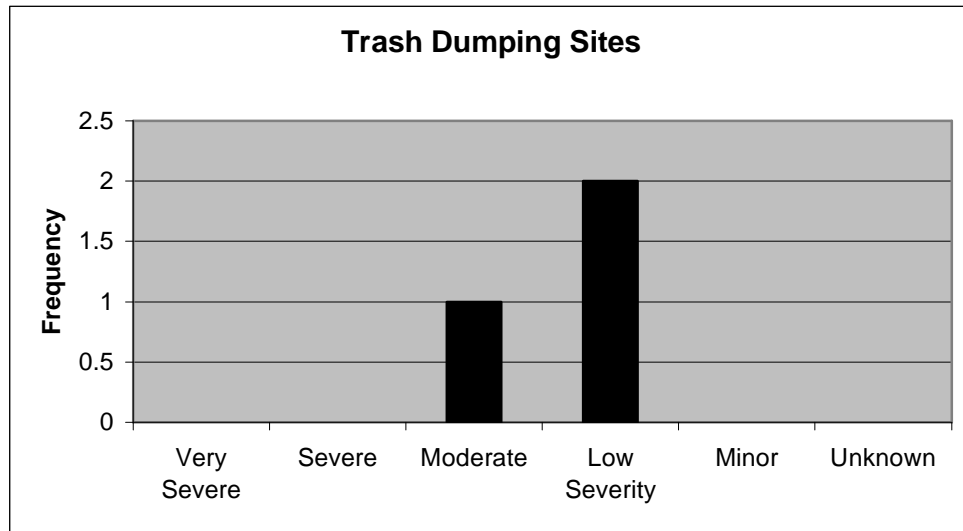
Figure 9a: Histogram showing frequency of severity ratings given to trash dumping sites in the Lower Linganore Creek SCA survey.

Survey crews found a total of 3 trash dumping sites dispersed throughout the Lower Linganore Creek watershed (Figure 9b). This is a low number of sites compared to other watersheds previously surveyed throughout Maryland. In terms of severity, the six sites are ranked as moderate (1) and low severity (2), as shown in Figure 9a. The sites contained residential waste (1), agricultural (1), and industrial waste (1). All sites were found on private land and only one was considered suitable for a volunteer clean up project.

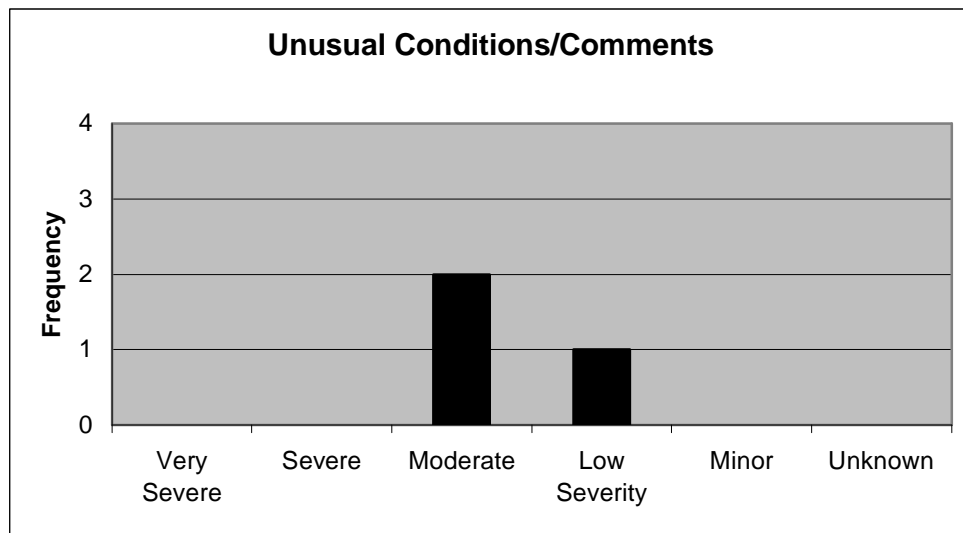
Figure 10a: Histogram of the frequency of severity ratings given to unusual condition sites in the Lower Linganore Creek SCA survey.

Survey teams record unusual conditions or comments to note the location of anything out of the ordinary observed during the survey or to provide additional written comments on a specific problem site. The survey crews identified 3 unusual conditions and 1 comment site throughout the Lower Linganore Creek watershed. The conditions and comments noted vary from red flock to excessive algae to pipe outfalls along a golf course. It is recommended that unusual conditions be further investigated to determine cause and potential correctability (Figure 10b).

Only sites marked as unusual conditions are given a severity rating. The frequency and ratings of these can be seen in Figure 10a.

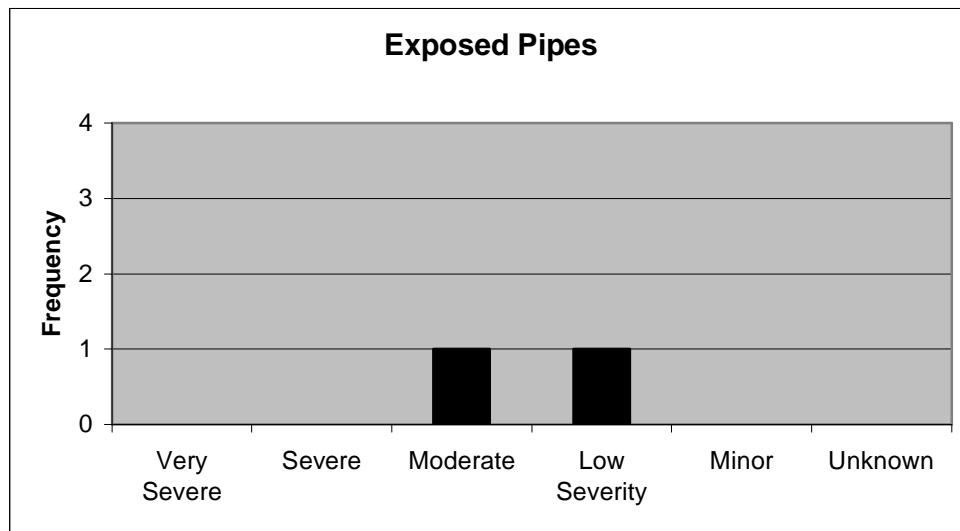
Figure 11a: Histogram showing the severity rating given to exposed pipe sites during the Lower Linganore Creek SCA survey.

Field crews observed two exposed pipes during the survey with a moderate or low severity rating (Figure 11a). Figure 11b shows the locations of the exposed pipes cited within the Lower Linganore Creek watershed. One of the pipes was exposed above the stream and the second pipe was exposed within the stream. Site 0719101 was recorded as having a clear odorless discharge at the time of the survey. Its diameter was estimated to be four inches, while the other pipe had a diameter of 14 inches. One of the pipes was made of corrugated metal and the other pipe was made of plastic. In one case, survey crews were unable to determine the purpose of the pipe (Appendix B).
