Anacostia River Stream Corridor Survey

Maryland Department of Natural Resources
Watershed Services
June 2005

ANACOSTIA RIVER STREAM CORRIDOR ASSESSMENT

Robin Pellicano & Ken Yetman
Watershed Assessment and Targeting Division
Watershed Services Unit
Maryland Department of Natural Resources

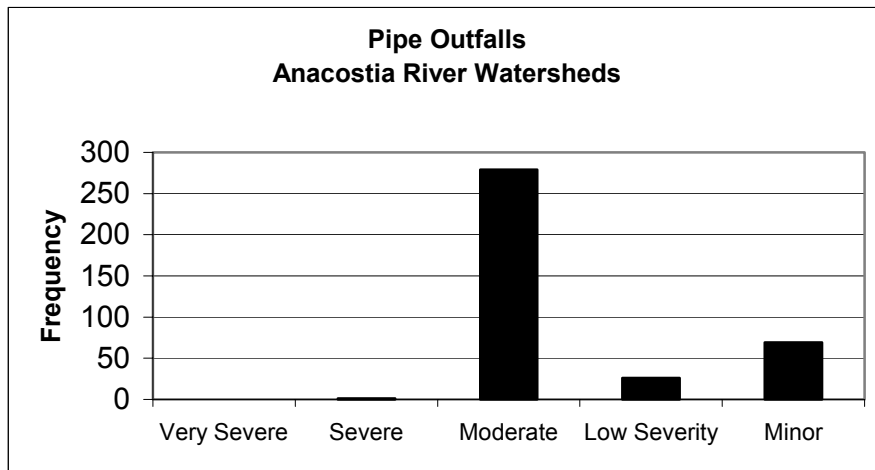
Only one pipe outfall was rated as severe. At site 345402, the pipe was discharging a clear fluid that smelled of sewage. Most of the outfalls carried stormwater, or discharged from a small pond or reservoir. Of the outfalls observed, 98 were dry when surveyed and 293 had a clear discharge with no associated odor

Figure 5a. Histogram showing the frequency of severity ratings given to pipe outfall sites during the Anacostia River SCA survey.

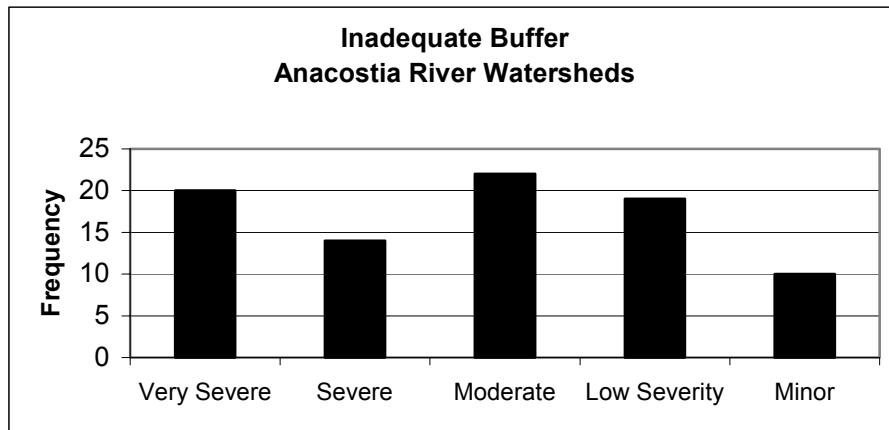
Survey crews identified 85 inadequate buffer sites with a total length of 112,100 feet (21.2 miles), or approximately 28 percent of streams surveyed. The severity and location of inadequate buffer sites is shown in Figure 6b, and 6c. Thirty-four of these sites are ranked as very severe or severe, while the other sites are moderate, of low severity, or minor (Figure 6a). Crews reported that livestock were present at one site, 157101.

Figure 6a. Histogram showing the frequency of severity ratings given to inadequate buffer sites during the Anacostia River SCA survey.

Almost any inadequate buffer site would benefit from the restoration of trees and shrubs along both stream banks. Unfortunately many of the sites in the Anacostia River are along paved areas, sometimes on both sides. This would prevent any tree planting. Some sites are located in the gaps of green infrastructure. Green infrastructure are areas where there are natural lands. There are hubs, which is an area of unfragmented natural landscape. Corridors are areas that allow movement from one hub to another. Sites 129201, 174102, 174103, 190201, 510202 are located in those gaps. Planting these areas could help provide better movement between hub areas.

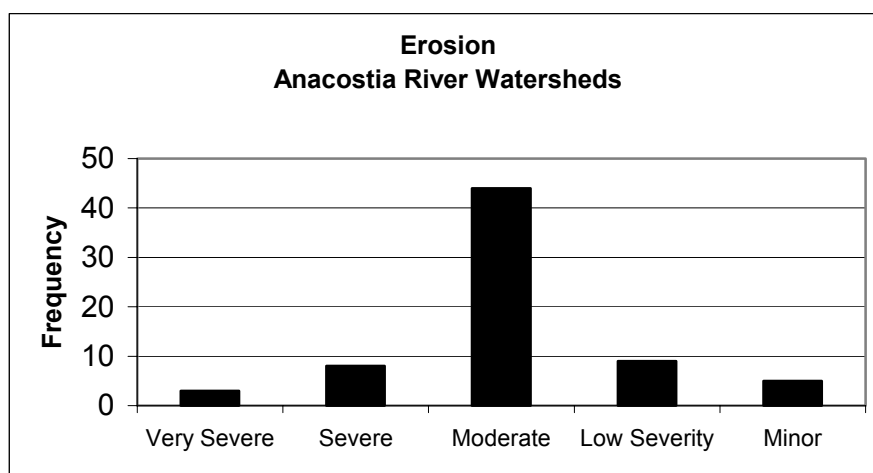
The SCA survey found 69 eroding stream banks over the length of 61,525 feet (11.65 miles) of stream, or about 15 percent of streams surveyed. The severity and location of erosion sites is shown in Figure 7b, and 7c. Three sites are ranked as very severe, 349312, 354110, and 373104.

Figure 7a. Histogram showing the frequency of severity ratings given to erosion sites during the Anacostia River' SCA survey.

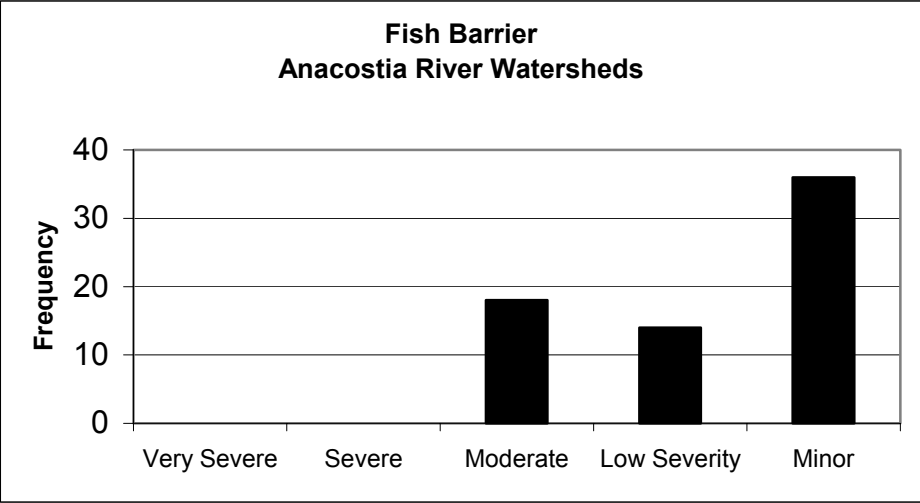
The Anacostia River SCA survey found 68 fish migration barriers. The locations of fish blockages are shown in Figure 8b and 8c. Fish barriers in these watershed are due to road crossings (18), natural falls (14), debris (9), a pipe crossing (7), beaver dam (3), railroad crossing (2), instream pond (1) and where the stream goes underground (1). The majority of fish migration barriers (50 out of 68) are low to minor in severity (Figure 8a). Eighteen barriers received moderate severity rankings because they isolate a significant length of the tributary upstream from the barrier. Five fish barrier sites in the watershed, which have a moderate rating, are in channelized areas.

Figure 8a. Histogram showing the frequency of severity ratings given to fish barrier sites during the Anacostia River SCA survey.

In all cases, areas should be assessed for viable fish habitat before restoration work begins, giving preference to sites with the most potential habitat area created.

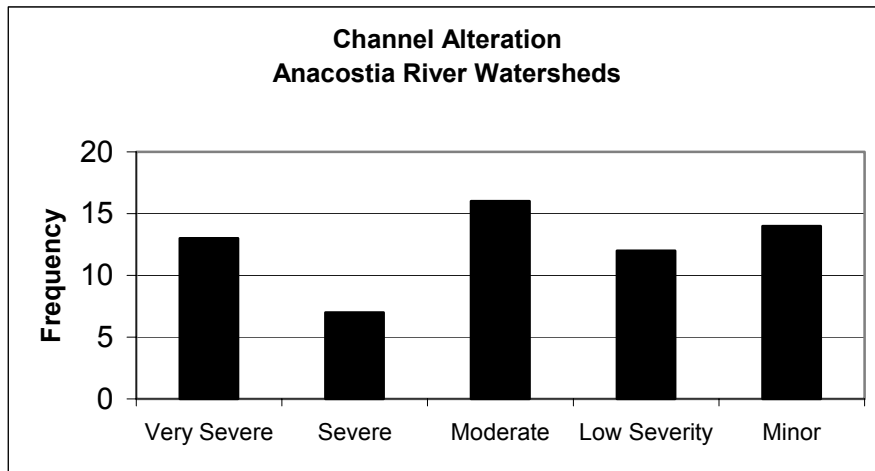
Severity rankings for the sites range from minor to very severe and are fairly evenly distributed over these four rankings (Figure 9a). The severity of channel alterations is based on both the channel type and the length of the site. The presence of hardened stream banks using concrete or rock for a total length of over a thousand feet increases the severity of a site. Thirteen sites received a very severe rating. All of these sites were concrete channels, which total 24,650 feet, nearly half of the total channel alteration length. Seven sites are ranked as severe. All of these sites are also concrete. Table 3 presents a summary of the lengths of channel alteration sites according to alteration type.

Figure 9a. Histogram showing the frequency of severity ratings given to channel alteration sites during the Anacostia River SCA survey.

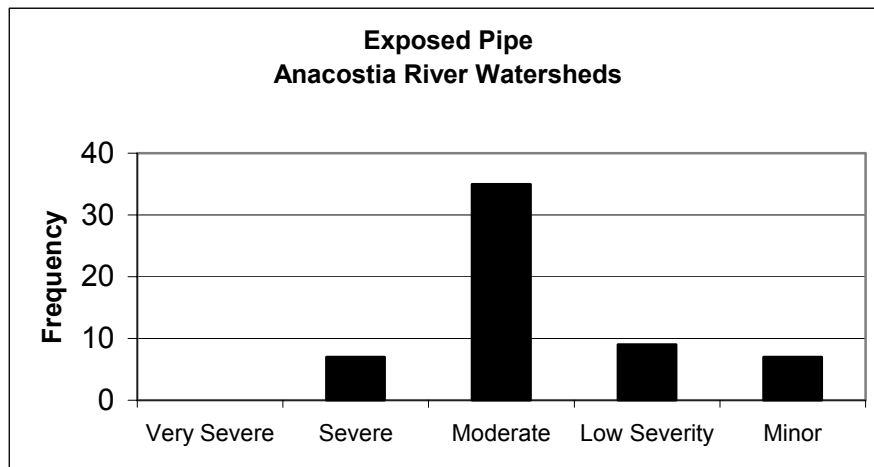
Field crews observed 58 exposed pipes during the survey. Seven were rated as severe, the rest were rated moderate to minor in severity (Figure 10a). The pipes were rated as severe because most of the pipes are being undermined by erosion and may collapse. One of the severe sites, 346304, is a manhole stack that is damaged and open to the elements. Locations of these sites are shown in Figures 10b and 10 c. The lengths observed ranged from half a foot to 250 feet. The majority (34) of the 58 exposed pipes are manhole stacks located in or along the stream channel. Follow-up visits should be made to evaluate its severity and a means for repairing or replacing the pipes.

Figure 10a. Histogram showing the severity rating given to exposed pipe site during the Anacostia River SCA survey.

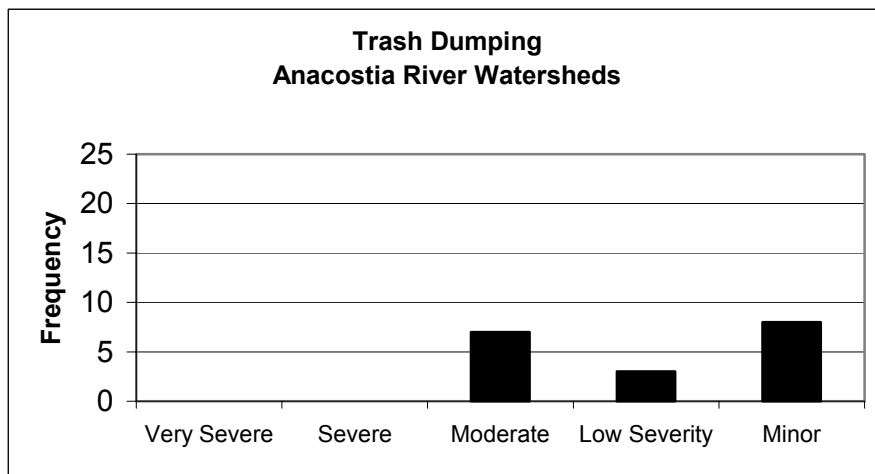
Survey crews found eighteen trash dumping sites (Figure 11b and 11c). In terms of severity, the eighteen sites are ranked as moderate (7), low severity (3), and minor (8), as shown in Figure 11a. The sites contained residential waste (5), mixed types (4), yard waste (1), construction (1), floatables (2), industrial (2), tires with floatables (1), cars (1) and casket liners (1).

Figure 11a. Histogram showing the frequency of severity ratings given to trash dumping sites during the Anacostia River SCA survey.

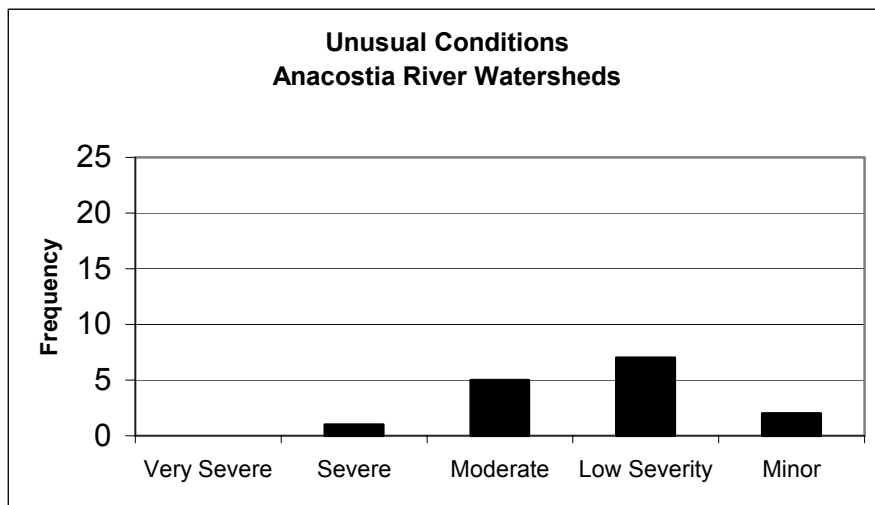
The fifteen unusual conditions included sites with red flock (2), sediment accumulation (1), excessive algae (3), a culvert with debris (1), possible sewage discharge (1), piped streams (5), and a damaged manhole. Site 345403 is a possible sewage discharge. This site was given a severe rating.

Figure 12a. Histogram showing the frequency of severity ratings given to unusual condition sites during the Anacostia River SCA survey.

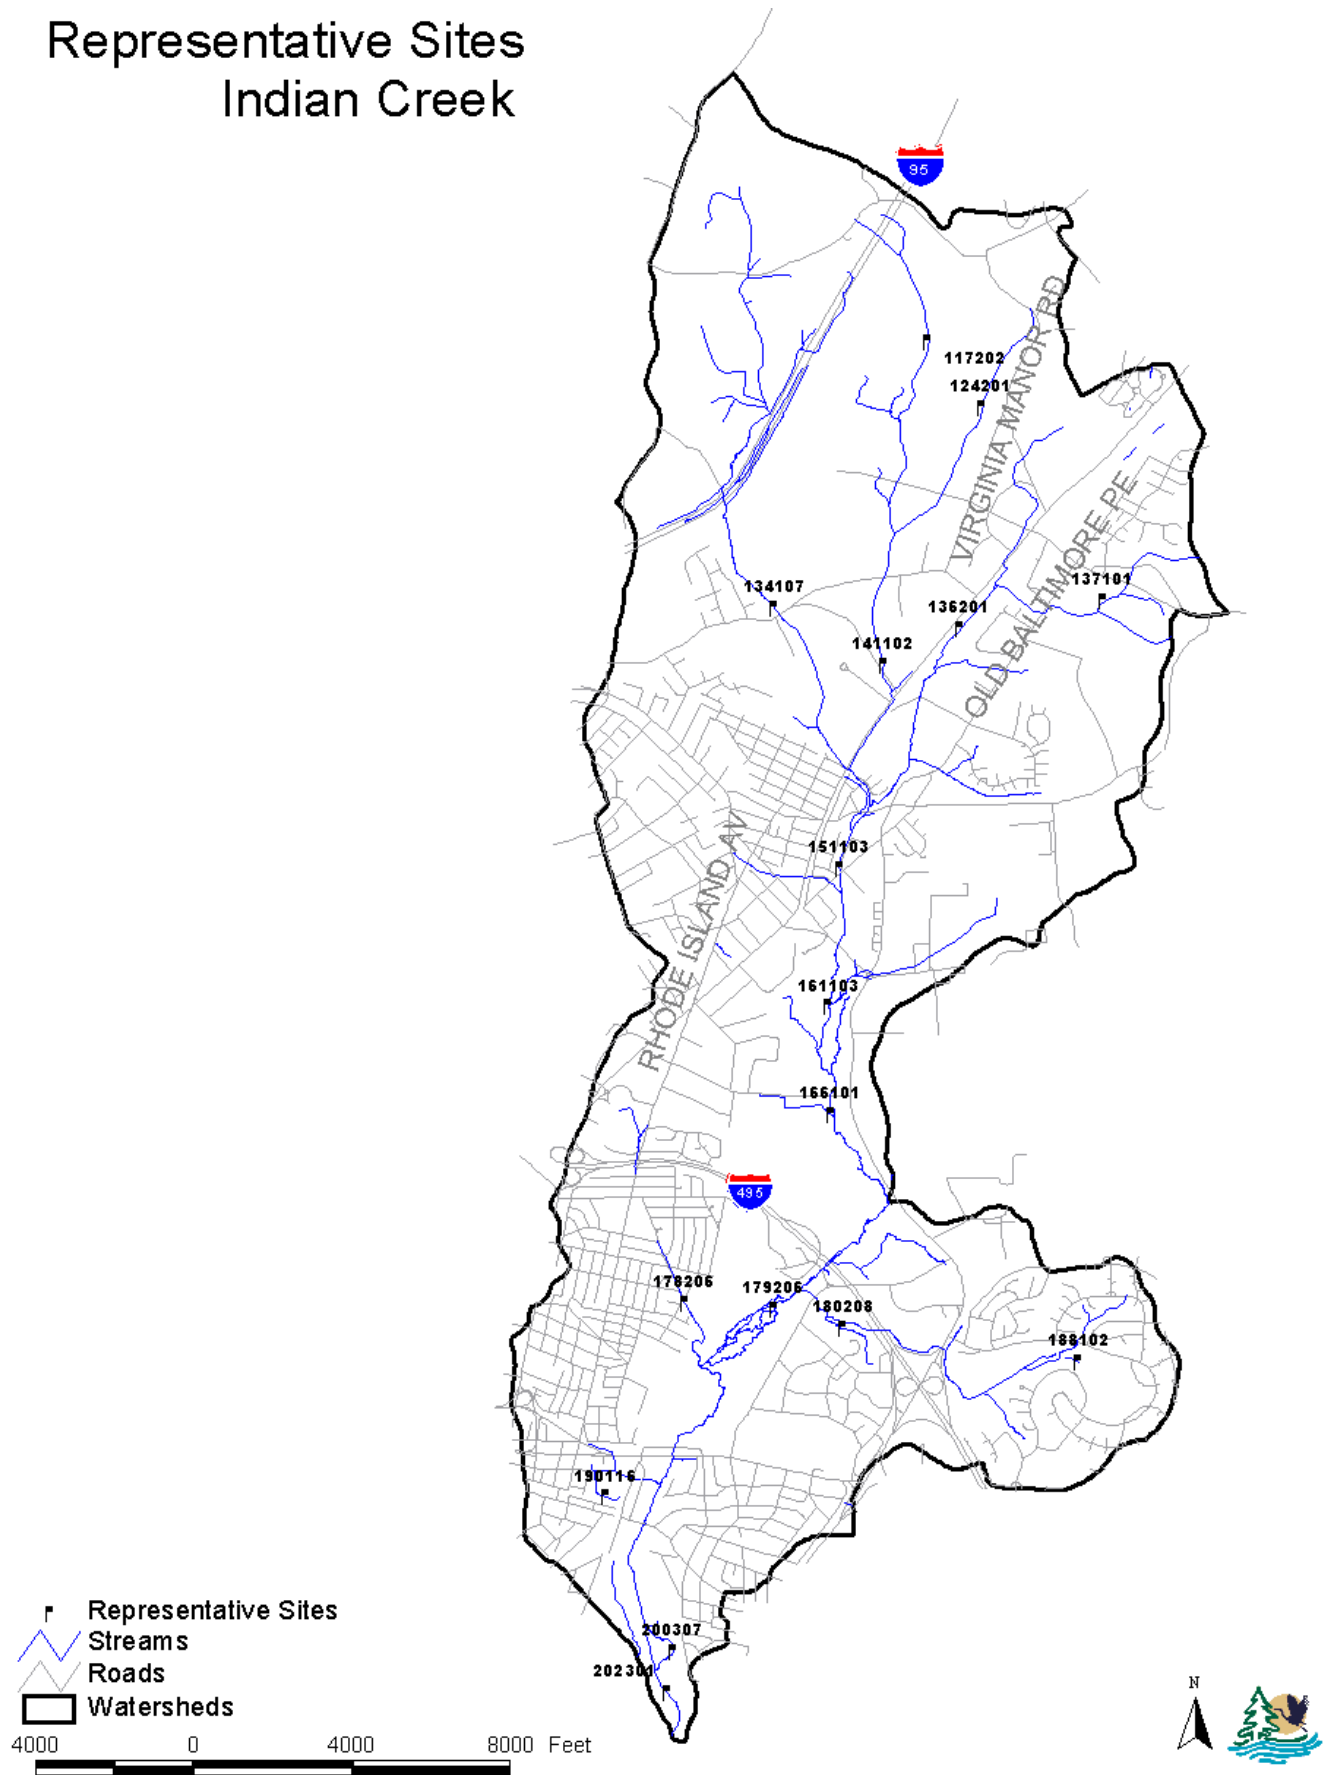
Figure 14a: Map showing the representative sites in Indian Creek sub-watershed of the Anacostia River

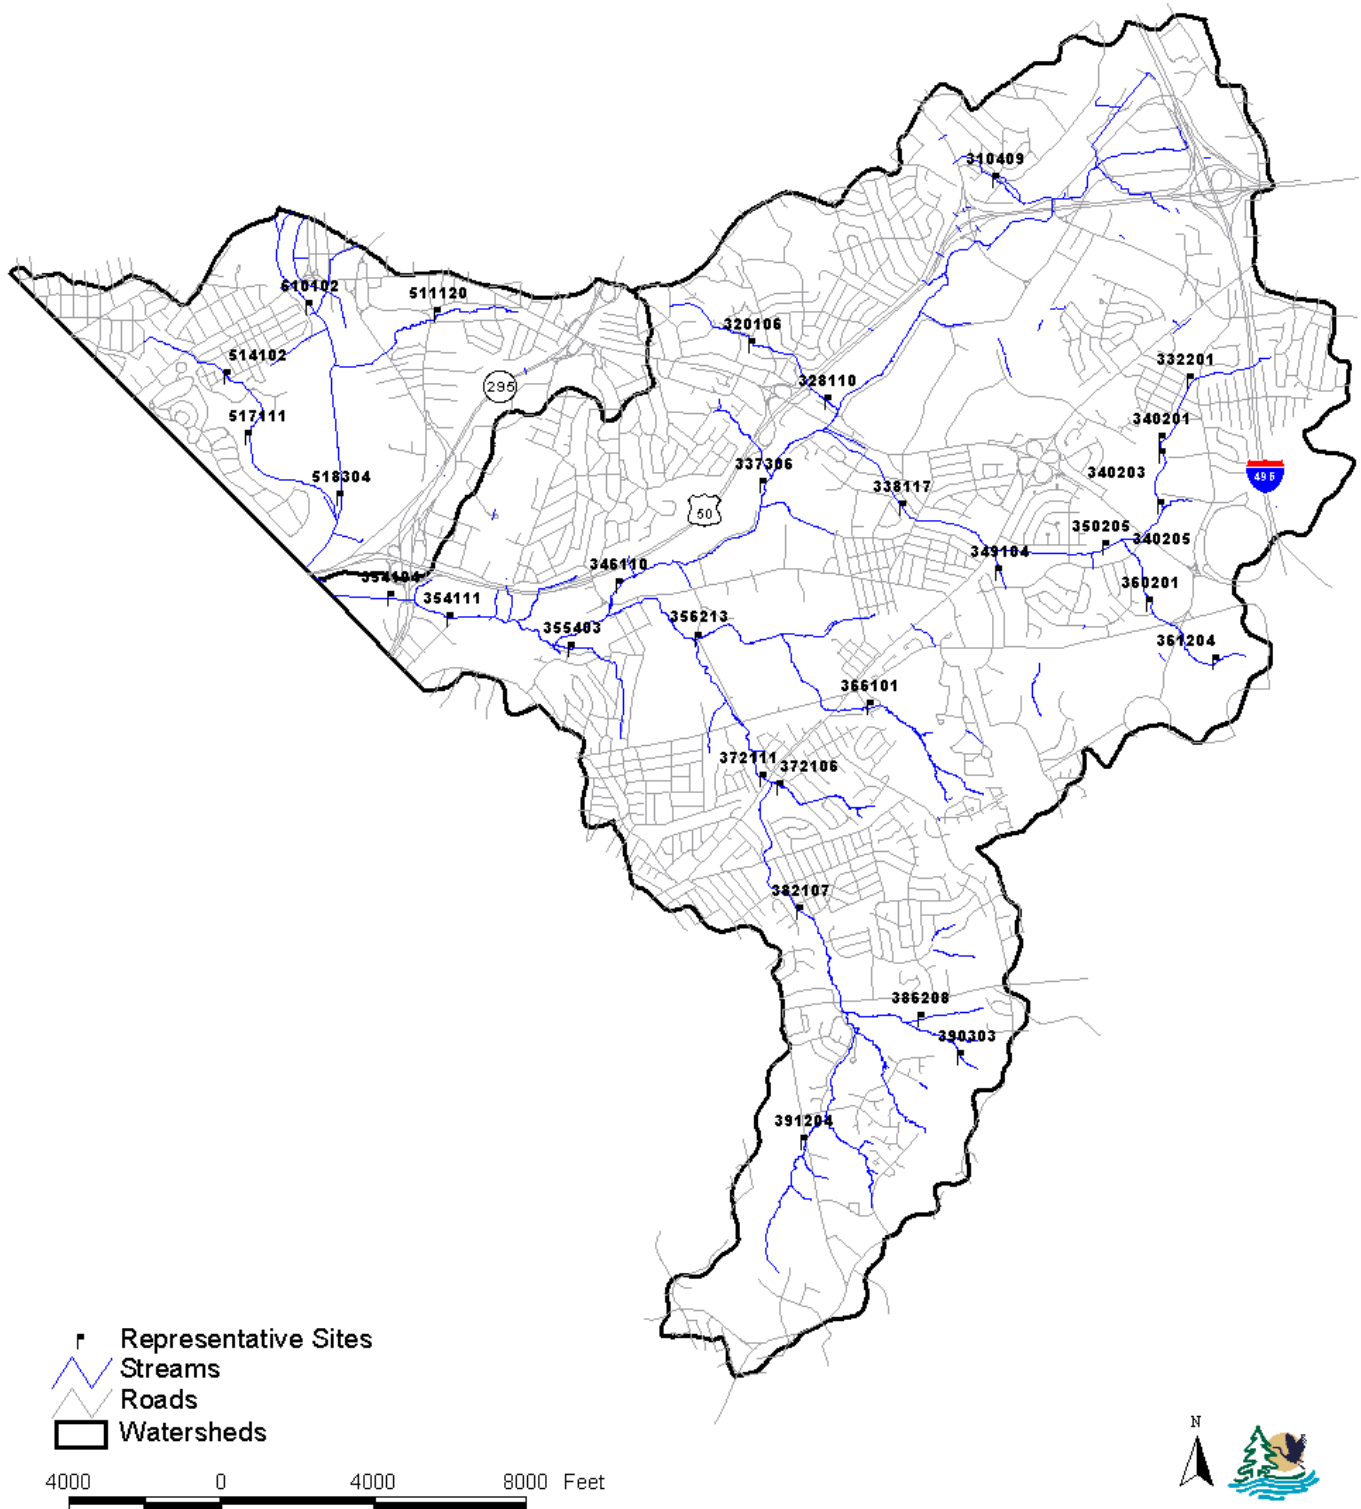
Figure 14b: Map showing the representative sites in Upper Anacostia and Lower Beaver Dam sub-watersheds of the Anacostia River
