**Stream Corridor Assessment Survey for the Assawoman Bay Watershed,  
Worcester County, Maryland**

**April 2006**

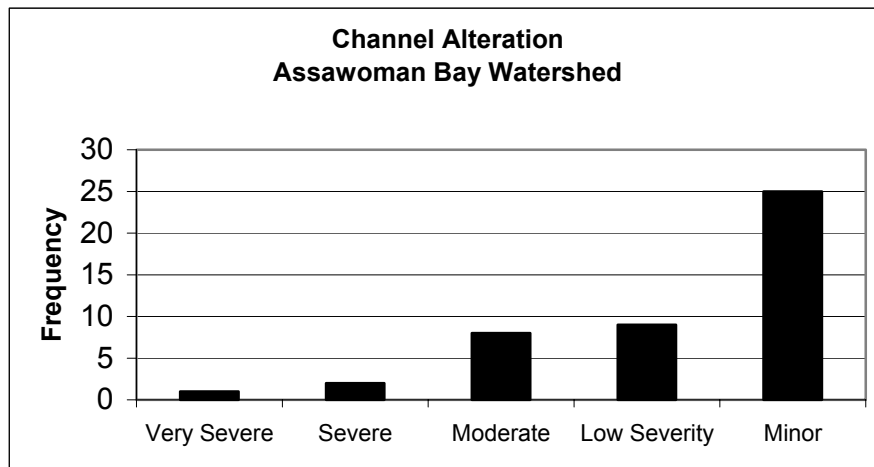
**Figure 5a. Histogram showing the frequency of severity ratings given to channel alteration sites during the Assawoman Bay SCA survey.**

Results of this survey show recognizably altered stream channels at 45 sites. The severity and location of channel alteration sites is shown in Figure 5b. The total length of stream affected by channelization is estimated to be 216,950 feet (41 miles). Severity rankings for the sites are shown in Figure 5a.

Restoring channel alteration sites can increase fish and wildlife habitat and may allow for more time for nutrient uptake in the waterway. In its simplest form, restoration for earth channels would include allowing vegetation and/or tree roots to stabilize the sediment along the channel, causing sinuosity to re-form naturally. This sinuosity may reform within the bed of the channelization or along its banks, depending on the site and the depth of the channel alteration.

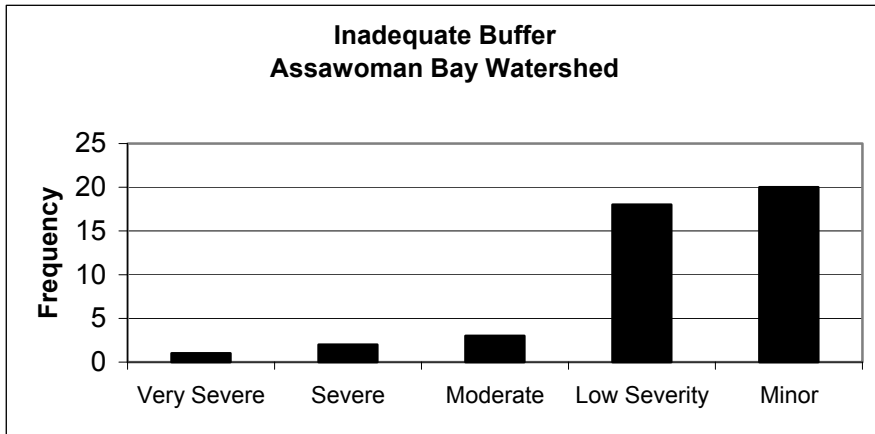
**Figure 6a. Histogram showing the frequency of severity ratings given to inadequate buffer sites during the Assawoman Bay SCA survey.**

Survey crews identified 44 inadequate buffer sites with a total length of 202,780 feet (38.4 miles). The severity and location of inadequate buffer sites is shown in Figure 6b. Three of these sites are ranked as very severe or severe, while the other sites are moderate, of low severity, or minor (Figure 6a). Land use along the stream at inadequate buffer sites, were reported as mostly crop fields.

Any inadequate buffer site would benefit from the restoration of trees along both stream banks. For sites on agricultural land, farmers also may qualify for federal and state government financial incentives for allowing 50-foot forest buffers to grow on their farmland. Those sites that may have particular natural resource value are headwater streams, or those that form gaps in existing forested buffer areas.

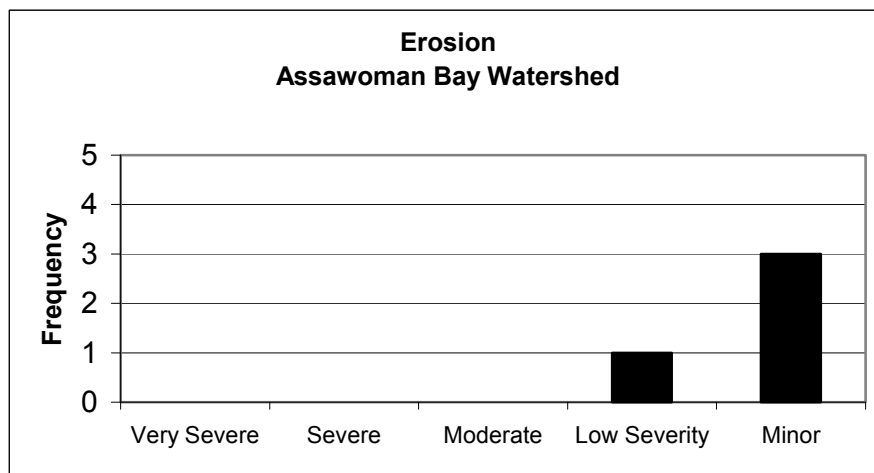
**Figure 7a. Histogram showing the frequency of severity ratings given to erosion sites during the Assawoman Bay SCA survey.**

The SCA survey found 4 eroding stream banks over the length of 140 feet (0.027 miles) of stream. The severity and location of erosion sites is shown in Figure 7b. The severity ratings are shown in Figure 7a.

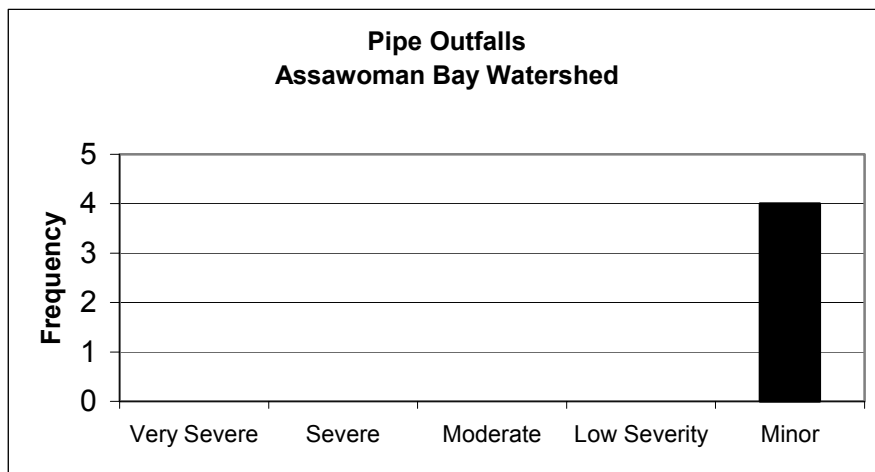
**Figure 8a. Histogram showing the frequency of severity ratings given to pipe outfalls sites during the Assawoman Bay SCA survey.**

The survey crew identified a total of 4 pipe outfalls. The severity and location of pipe outfall sites is shown in Figure 8b. None of the pipes had a discharge. All of the pipes were rated as minor (Figure 8a). All the pipes appear to be for stormwater discharges.

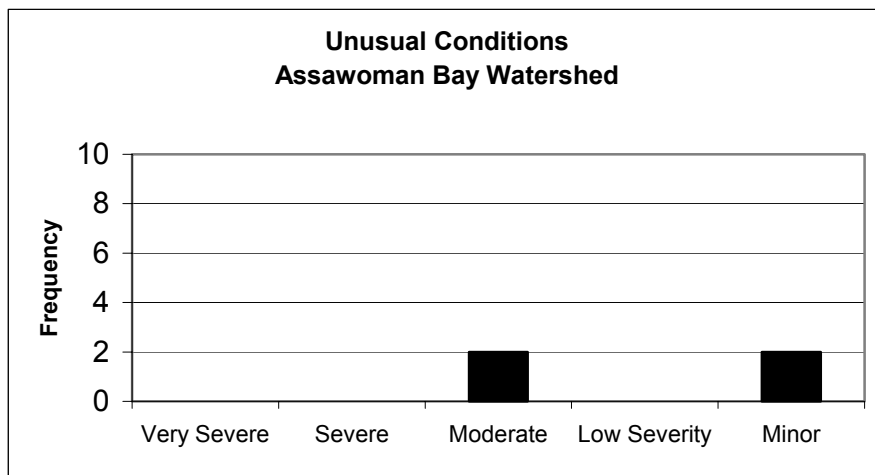
**Figure 9a. Histogram showing the frequency of severity ratings given to unusual condition sites during the Assawoman Bay SCA survey.**

The survey crew identified 4 unusual conditions and 4 comments throughout the Assawoman Bay watershed. The severity and location of unusual condition sites is shown in Figure 9b. The four unusual conditions sites were where there was excessive algae.
