LOWER MONOCACY RIVER STREAM CORRIDOR ASSESSMENT

Stephen Czwartacki & Ken Yetman
Watershed Assessment and Targeting Division
Watershed Services Unit
Maryland Department of Natural Resources

November 2004

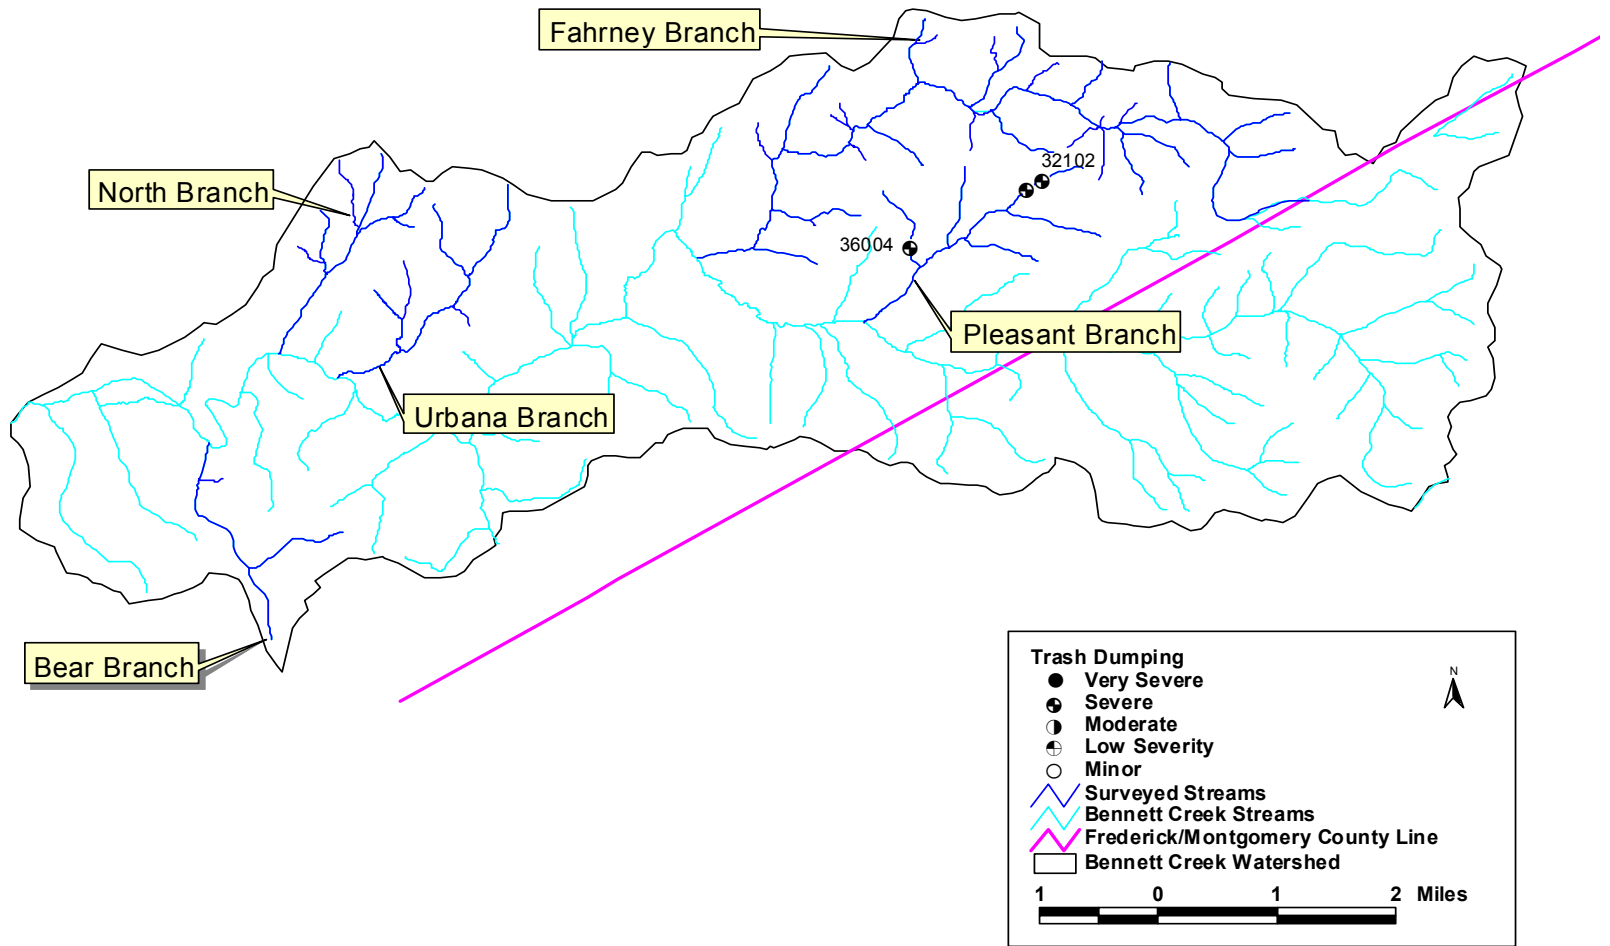
Figure 9b: Bennett Creek Trash Dumping Locations.

Three sites were given severe ratings. These sites were all found in the Bennett Creek sub-watershed of Pleasant Branch. Site 032102 is a 25 pick-up truckload residential and yard waste site. Site 032106 is a 10 pick-up truckload yard waste site. Site 036004 is estimated to have 2 dump truck loads of cars. Sites 032102 and 032106 were recorded as possible opportunities for volunteers.
