Newport and Sinepuxent Bays Stream Corridor Assessment Survey

Watershed Assessment and Targeting Division
Watershed Services Unit
Maryland Department of Natural Resources
2004

NEWPORT AND SINEPUXENT BAYS STREAM CORRIDOR ASSESSMENT

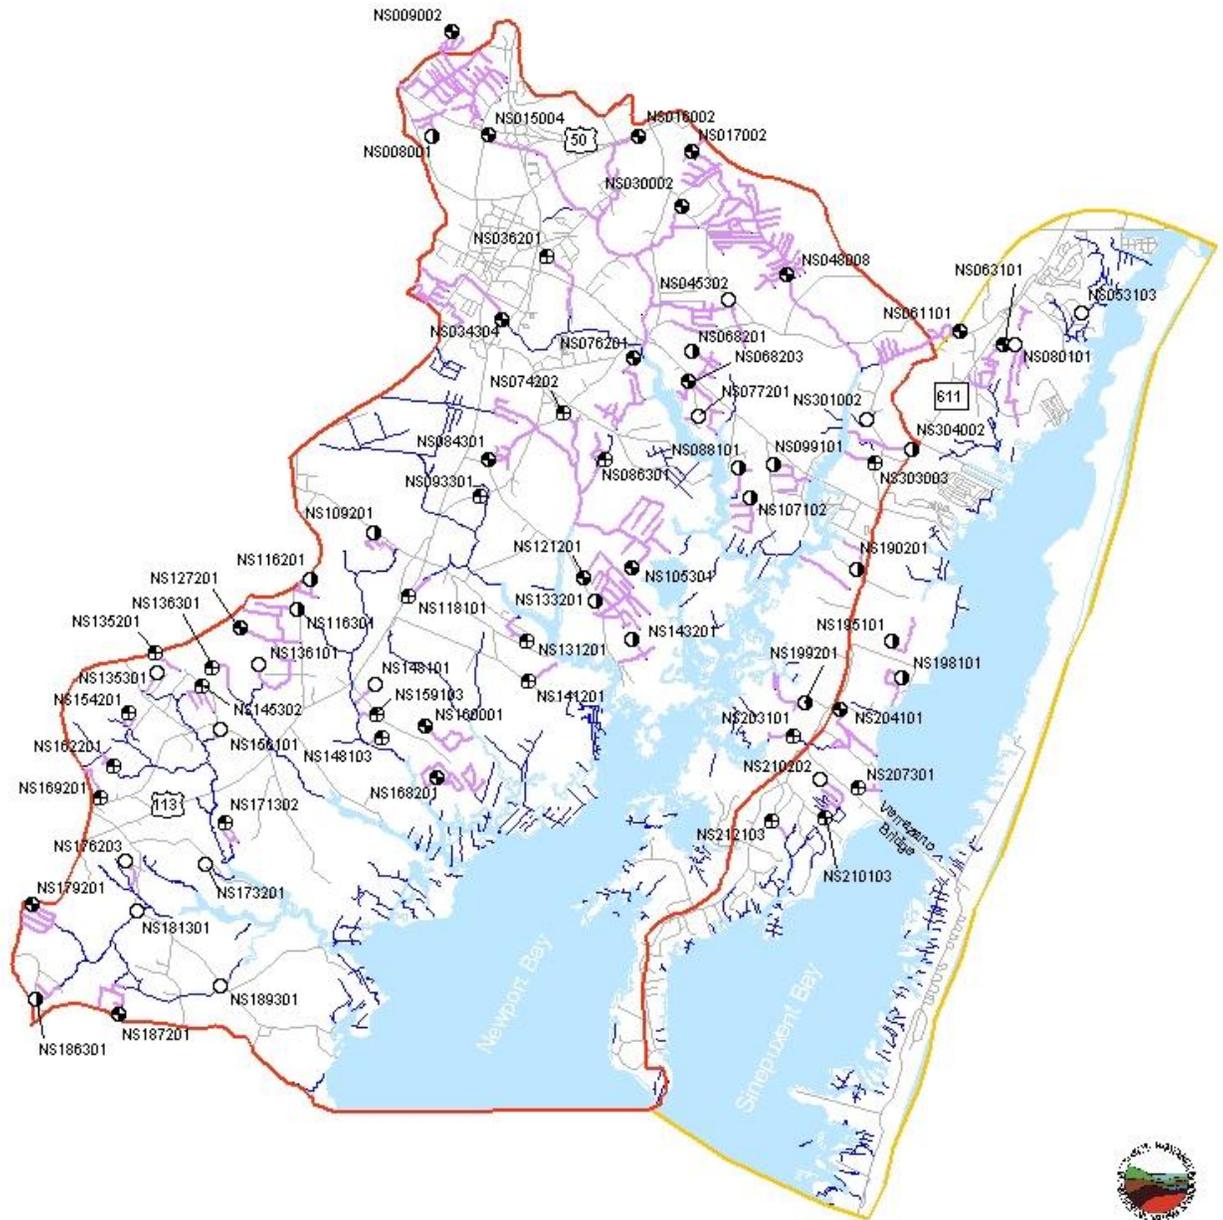
Channel Alteration Sites

Figure 4a. Map showing the location of channel alteration sites in the Newport and Sinepuxent Bay Watersheds

Results of this survey show recognizably altered stream channels at 72 sites. The severity and location of channel alteration sites is shown in Figure 4a. The total length of stream affected by channelization is estimated to be 355,122 feet (67.26 miles), or 58.32 percent of streams surveyed. Channel alteration sites occur with inadequate forest buffer sites at 65 sites, or for 90 percent of the channelized stream length (Table 3). Nine of the 20 tributaries in these two watersheds have channel alterations for greater than 10,000 feet of their length. The majority of sites, 71 out of 72, are earth channels, areas where the stream is straightened and/or deepened to increase both surface drainage and water passage. At the remaining site, NS181301, the stream was hardened using rip-rap for about 40 feet below a road crossing.
