Upper Patuxent in Prince George's Co. Stream Corridor Assessment Survey

Watershed Restoration Division
Chesapeake & Coastal Watershed Services
Maryland Department of Natural Resources
February 2003

UPPER PATUXENT IN PRINCE GEORGES CO. STREAM CORRIDOR ASSESSMENT SURVEY

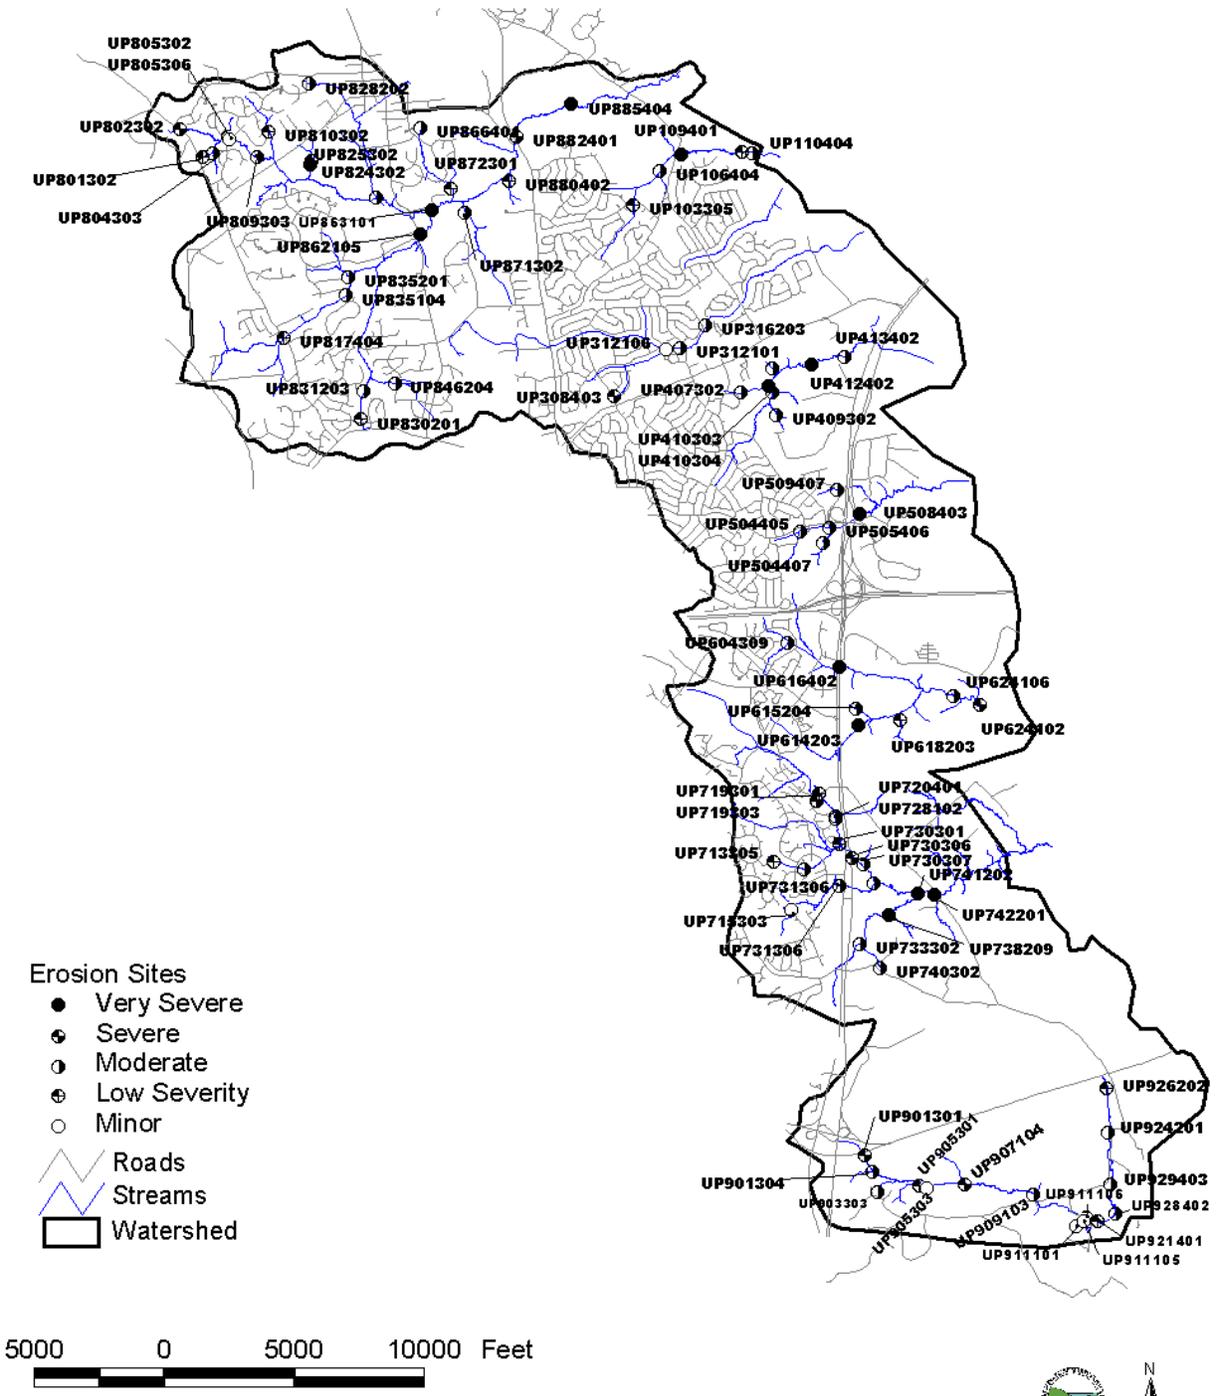
Figure 7: Map showing the Erosion locations in the Prince George's Upper Patuxent Watershed

Unstable eroding streams are areas where the stream banks are almost vertical and the roots from the vegetation along the stream's banks are unable to hold the soil on the banks. Unstable eroding stream banks were reported at 85 sites during the survey (Figure 7). The majority of the erosion sites showed moderate to minor erosion that extended over long distances. The lengths of stream segments that were recorded as having unstable banks varied from 10 feet in some areas, to other areas where up to 6,200 feet of stream was found to have an erosion problem (Appendix B). Overall, results indicate approximately 19.3 miles of unstable eroding banks in the Upper Patuxent watershed. Figure 7b shows the frequency of the severity rating given to erosion sites. Thirteen sites received a very severe rating. These sites had high banks over long distances.
