Lower Patuxent Stream Corridor Assessment Survey

Watershed Assessment and Targeting Division
Watershed Services Unit
Maryland Department of Natural Resources
April 2004

LOWER PATUXENT STREAM CORRIDOR ASSESSMENT SURVEY

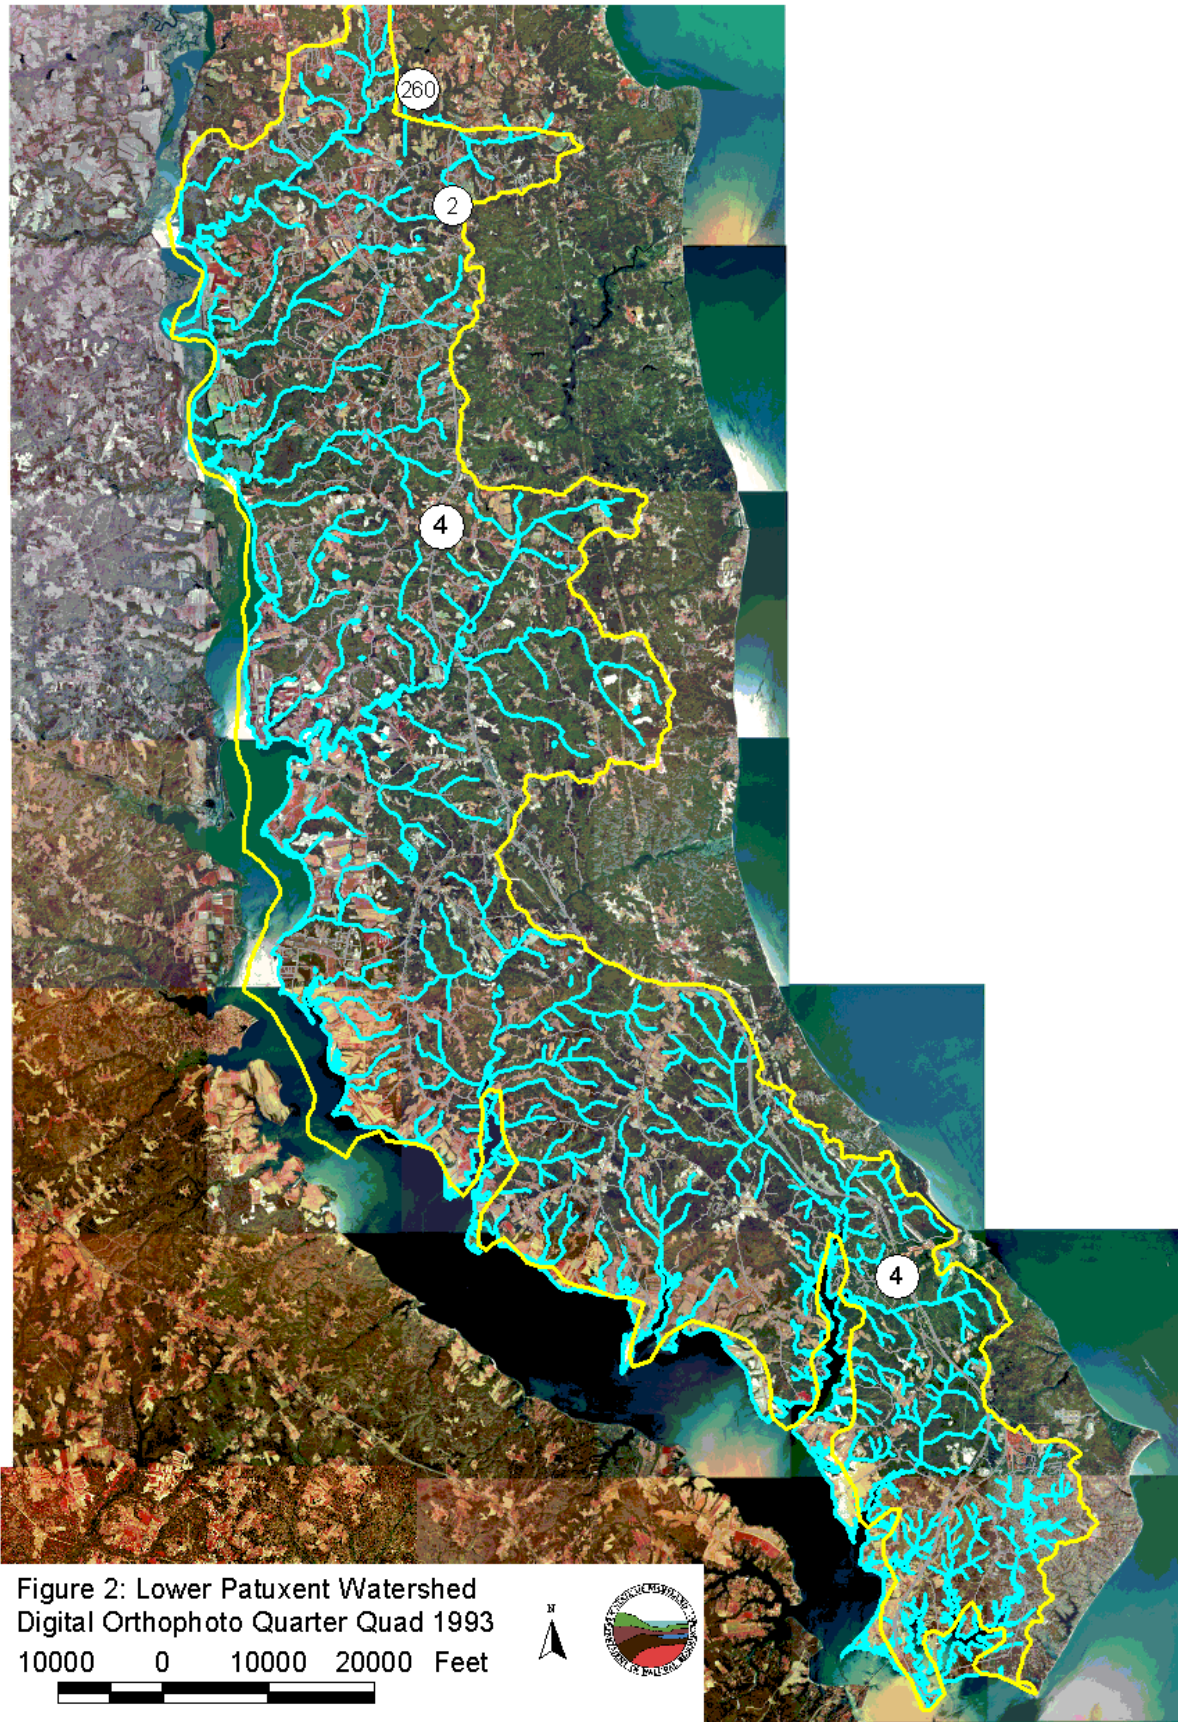
Figure 2: Lower Patuxent Watershed
Digital Orthophoto Quarter Quad 1993

7-month period from March to October 2003. A digital orthophoto map of Lower Patuxent watershed is shown in Figure 2. Figure 3 shows the same watershed boundary superimposed on a seven and ½ minute USGS topographic quadrangle maps. Figure 4 shows the survey's sub-watershed boundaries.

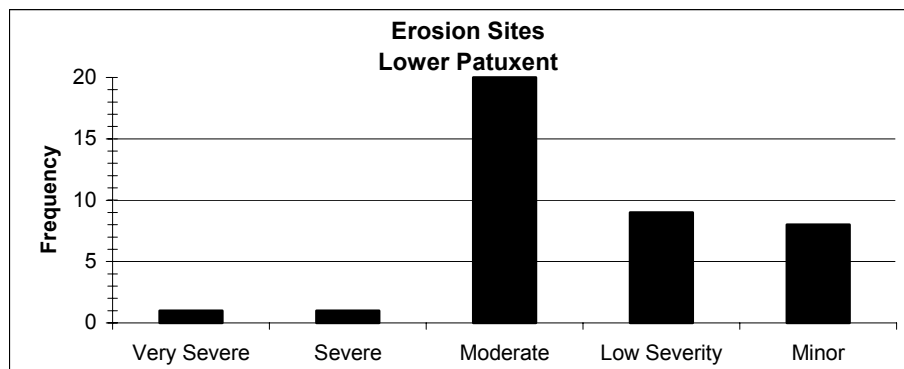
Figure 5a: Histogram showing the frequency of severity ratings given to stream bank erosion sites during the Lower Patuxent SCA Survey.

Erosion sites were spread throughout the sub-watersheds that were surveyed with 20 reported erosion sites in Hall Creek, 14 being reported in Island Creek, and 5 in Back and Mill Creeks. The lengths of the erosion sites reported ranged from 20 ft to 13,000 ft with heights ranging from 1ft to 15 ft. The most frequently reported causes for erosion were: land use changes upstream (3), bend at steep slope (12), road crossing (3), channel alteration upstream (4), pipe outfalls (2), and causes unknown (14).
