MANOKIN RIVER STREAM CORRIDOR ASSESSMENT SURVEY

Stephen Czwartacki & Ken Yetman
Watershed Restoration Division
Coastal and Chesapeake Watershed Services
Maryland Department of Natural Resources

April 11, 2002

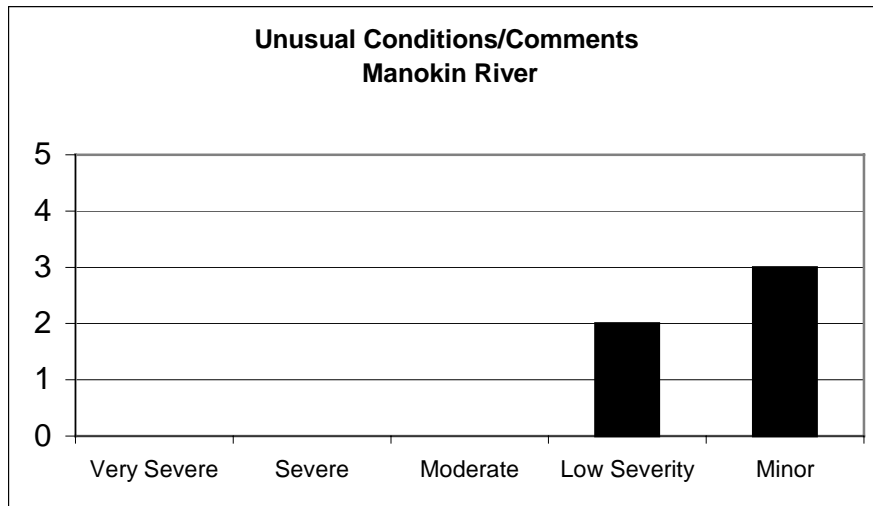
Figure 9a. Histogram showing the frequency of severity ratings given to unusual condition sites during the Manokin SCA survey.

The unusual condition/comment data sheets are used by field teams to record the location of anything out of the ordinary, or to provide some additional written comments on a specific problem. Five unusual condition sites were identified during the Manokin River survey and their locations are shown in Figure 9b. In addition, 15 comment data sheets were filled out. All unusual condition sites were given low to minor severity ratings (Figure 9a).

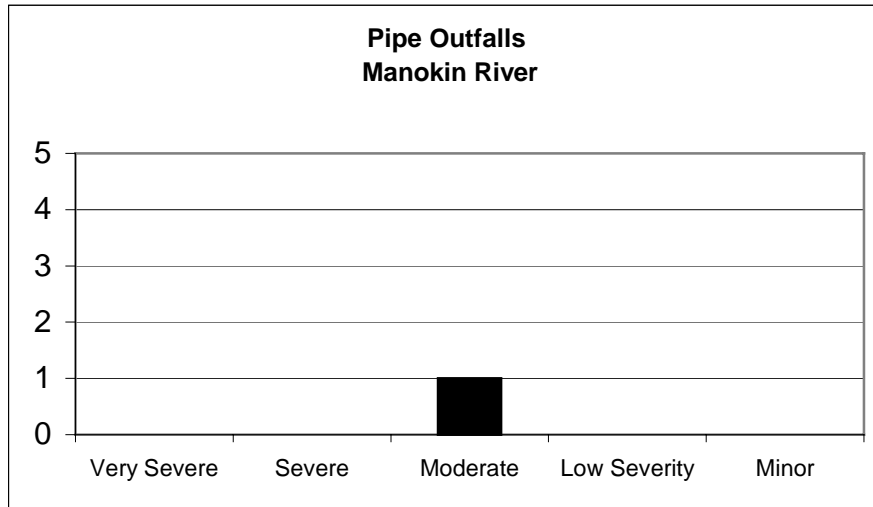
Figure 11a: Histogram showing the frequency of severity ratings given to pipe outfall sites during the Manokin SCA survey.

Pipe outfalls include any pipes or small man made channels that discharge into the stream through the stream corridor. Pipe outfalls are considered potential environmental problems in the survey because they can carry uncontrolled runoff and pollutants such as oil, heavy metals and nutrients to a stream system. Only one pipe outfall was identified during the Manokin River survey. The pipe outfall was from the Princess Anne Wastewater Treatment Plant and discharged into the tidal portion of the Manokin River (Figure 11b). The discharge from the pipe was clear and there was no odor. The pipe outfall was given a moderate severity rating.
