UPPER PATUXENT RIVER WATERSHED RESTORATION ACTION STRATEGY (WRAS) FORM 1 -- Catchment Information

UPPER PATUXENT RIVER WATERSHED RESTORATION ACTION STRATEGY (WRAS) FORM 2 -- Site Information

Site Name: Richardson Building	Address: 2127 Espey Court
Site Owner: King Commercial Properties 301-345-630	0
State Plane Coordinates of Site Centroid: X	: <u>1398104</u> Y: <u>481686</u> Date: <u>5/27/03</u>
Personnel: PM	Weather: <u>cloudy, rain 65F deg</u>
Area (ac): 2	Impervious Area (ac): <u>1.2</u>
Percent Impervious: <u>62%</u>	Soil Recharge Factor (S): 0.38
WQ _v (required): 0.1	Re _v (required): 0.04
Property Area (ac): 2	Property Area Included in Site: 100%
Amount of Catchment Occupied by Site: 100%	_
Storm Drainage System Within Site Piped: <u>100%</u> Open Channels: <u>09</u>	Area Drained by System: <u>100%</u>
Open Channel Lining - Vegetation:0% Riprap	.: <u>0%</u> Concrete: <u>0%</u> Other: <u>0%</u>
	on: Excellent Good Average Fair Poor on: Excellent Good Average Fair Poor
Site Information	
Type of Pavement: Image: Bituminous Concrete Image: Concret Image: Concrete Image: Concret	Gravel Grid Pavers Other

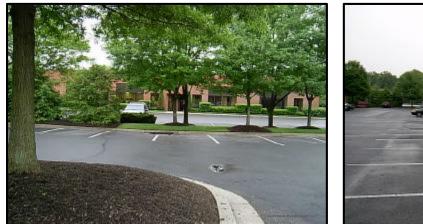
IMP / BMP SUMMARY			
WQ _v (provided):	0.010	Re _v (provided):	0.010
Area Treated (ac):	0.16	Impervious Area Treated (ac):	0.13
Photographs			
No. <u>12</u>	Description:	looking west	
No. <u>13</u>	Description:	looking south	
No.	Description:		
No	Description:		
Comments			
IMP size = 909 sq ft
