Watershed Assessment and Targeting Division
 Watershed Services Unit
 Maryland Department of Natural Resources
 November 2003

WESTERN BRANCH STREAM CORRIDOR ASSESSMENT

Robin Pellicano & Ken Yetman
Watershed Assessment and Targeting Division
Watershed Services Unit
Maryland Department of Natural Resources

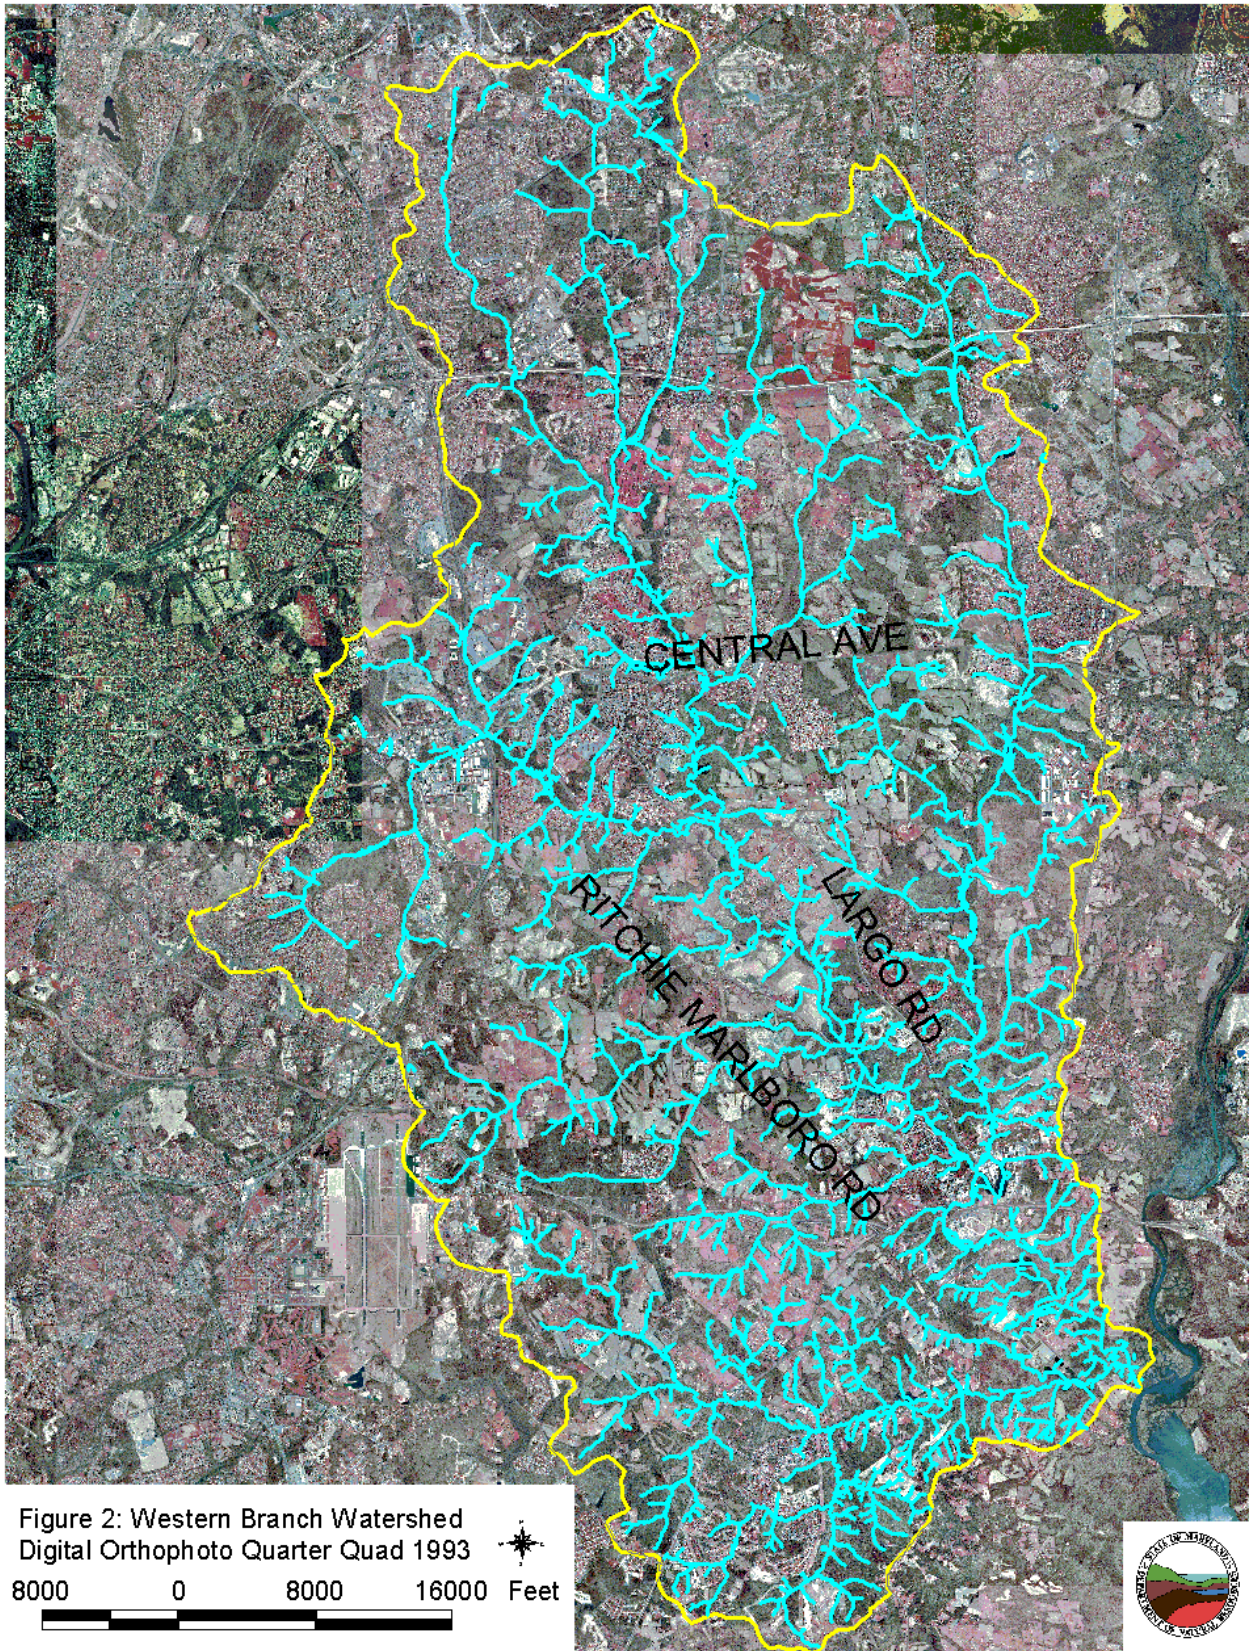
Figure 2: Western Branch Watershed
Digital Orthophoto Quarter Quad 1993

The Western Branch watershed in Prince George's County contains 71,114 acres (111 mi²) of land. Approximately 15% (10,731 acres) of the land in the watershed is categorized as agricultural land, 39% (28,071 acres) of land is forested and 43.8% (31,341 acres) is designated as urban (Shanks, 2003). Due to funding and time limitations, the SCA survey was done in three sub-watersheds. The sub-watersheds were chosen by the WRAS committee and included Collington Branch, Lottsford Branch, and Northeast Branch in Prince George's County Maryland. The targeted area encompasses 22,581 acres (39 mi²) of land. Collington Branch contains 14,851 acres, Northeast Branch contains 5,549 acres, and the Lottsford Branch contains 2,181 acres. There are approximately 113 miles of stream within the three sub-watersheds. Survey teams walked all 113 miles from April 2003 to June 2003. A digital orthophoto map of watershed is shown in Figure 2. Figure 3 shows the same watershed boundary superimposed on

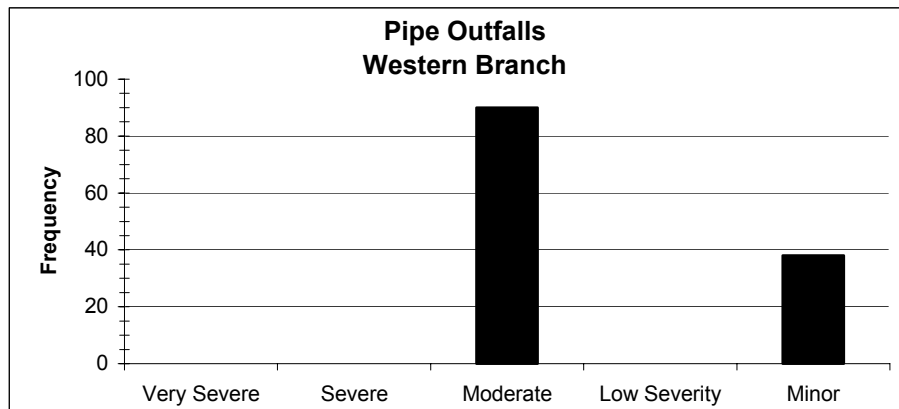
Figure 5a: Histogram showing the frequency of severity ratings given to pipe outfall sites during the Western Branch SCA survey.

Severity ratings for pipe outfalls were given based on outfall type, discharge, and type of discharge. In the Western Branch SCA Survey there were 90 moderate and 38 minor sites (Figure 5a). The severity rating of moderate is for pipes with a discharge and the discharge is clear with no odor or if the discharge has a color and/or odor, the amount of discharge is very small compared to the stream's base flow and any impact appears to be minor and localized. (Yetman, 2001)

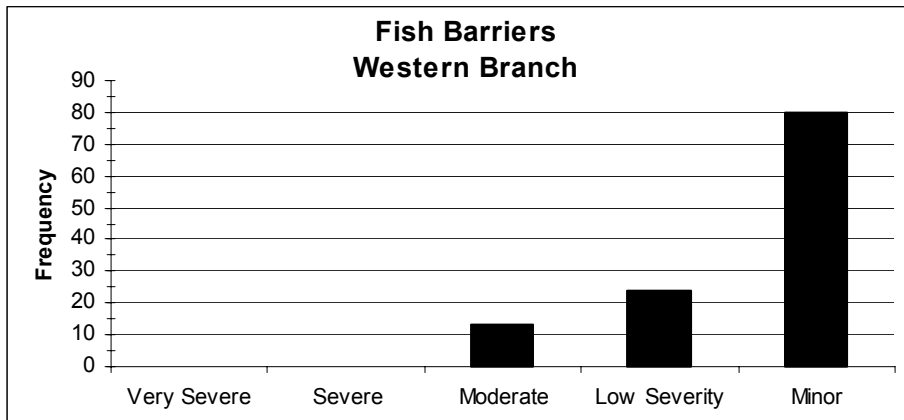
Figure 6a: Histogram showing the frequency of severity ratings given to fish barriers seen during the Western Branch SCA Survey.

All of the fish migration barriers were given moderate to minor ratings (Figure 6a). Severity ratings were based on position in the watershed, as well as the type and height/depth of the barrier. The main stems of the three sub-watersheds are relatively barrier free except for a few minor sites. Migratory fish such as white perch and herring have been found to spawn in some areas of the Western Branch. White perch in particular was found in Collington Branch. (Mower J. and M. McGinty. 2002)

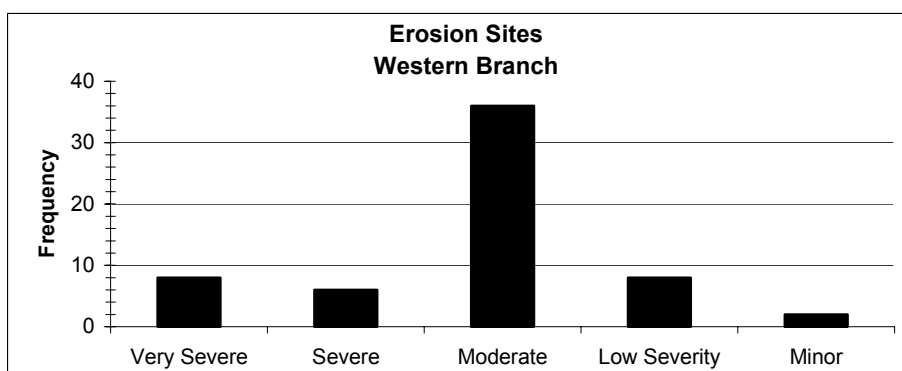
Figure 7a: Histogram showing the frequency of severity ratings given to stream bank erosion sites during the Western Branch SCA Survey.

Erosion sites were mainly in Collington Branch with a few in Lottsford and Northeast Branch. There were 52 reported erosion sites in Collington Branch, 4 being reported in Lottsford Branch, and 4 in Northeast Branch. The lengths of the erosion sites reported ranged from 30 feet to 9,000 feet with heights ranging from 4 feet to 8 feet. The most frequently reported causes for erosion were: land use changes upstream (7), road crossing (14), crop field runoff (1), and unknown (31).

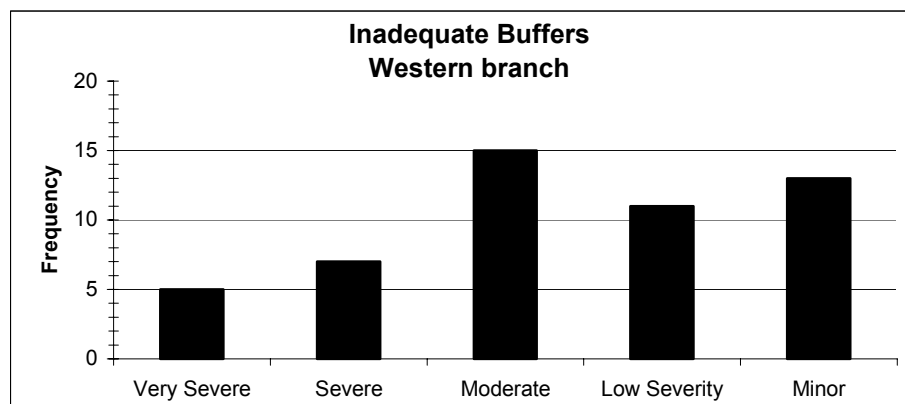
Figure 8a: Histogram showing the frequency of severity ratings given to inadequate buffers during the Western Branch SCA Survey.

As part of the data collected by the field crews, a rough estimate of the length of the inadequate stream buffer at each site was made. Based on this data, there is an estimated 52,000 feet (9.85 miles) of inadequately buffered stream banks in the Collington Branch, Lottsford Branch, and Northeast Branch sub-watersheds. This accounts for 8.7% of the total stream miles that were surveyed by the field crews. The length of inadequate buffers ranged from 100 feet to 5,000 feet. At 30 sites, the field crew reported that there were no trees on both sides of the stream, while at an additional 21 sites trees were present on only one side of the stream. The most commonly reported land use along these inadequately buffered banks was lawn at 19 sites. Four sites were reported to have livestock present. The very severe sites involve areas where the inadequately buffered area totaled over 1000 feet of stream with no buffer on either stream bank. The severe sites were sites in which there were no buffer on either side for 500 feet – 1000 feet long, or sites where there was a buffer on one side and inadequate buffer on the other for over 1000 feet.

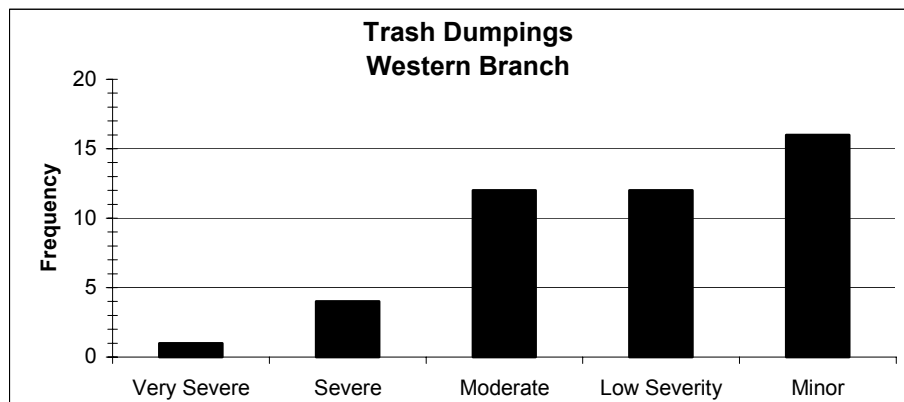
Figure 9a: Histogram showing the frequency of severity ratings given to trash dumping sites seen during the Western Branch SCA survey

Trash dumping sites in the Collington Branch, Lottsford Branch, and Northeast Branch sub-watersheds range in size from 1 to 14 pickup truckloads and for sites with other measures, 3 to 12 dump truck loads. Single site trash dumping sites were recorded at 25 sites, while large area dumping sites were recorded at 20 locations. Types of trash sites found include: residential (23), tires (3), yard waste (5), floatables (3), construction materials (3), and mixed (7). Site 409102 was the only site to be given a very severe rating. An estimated 8 dump truck loads of mixed types of trash. This included appliances, tires, and auto parts.

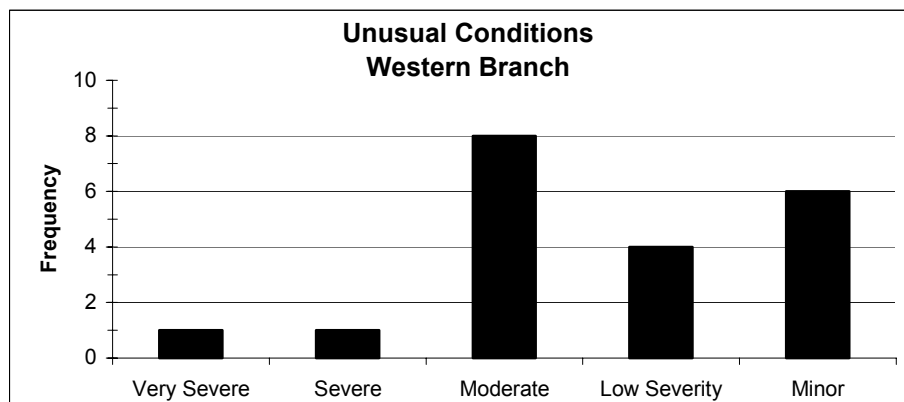
Figure 10a: Histogram showing the frequency of severity ratings given to unusual conditions seen during the Western Branch SCA survey.

The unusual condition/comment data sheets are used to record the location of anything out of the ordinary seen during the survey or to provide some additional written comments on a specific problem. Twenty unusual conditions were reported during the Western Branch survey, and six additional comments were recorded. The locations of the unusual conditions and comments can be found in Figures 10b, 10c, and 10c. Severities of the unusual conditions found during the Western Branch survey can be seen in Figure 10a.

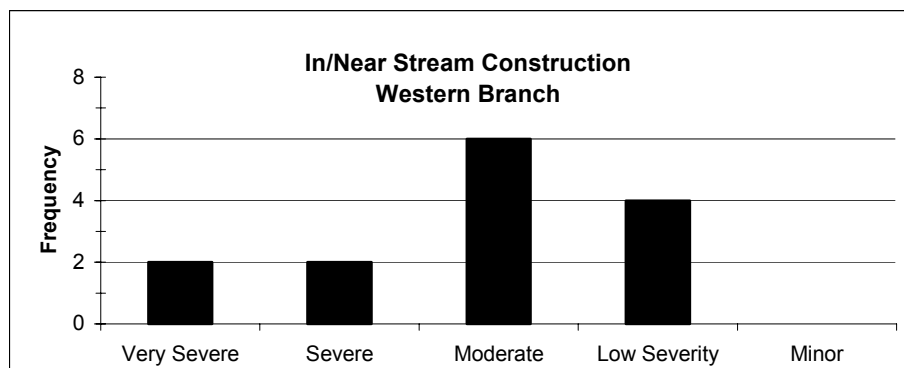
Figure 11a: Histogram showing the frequency of severity ratings of In/Near Stream Construction sites seen during the Western Branch SCA survey.

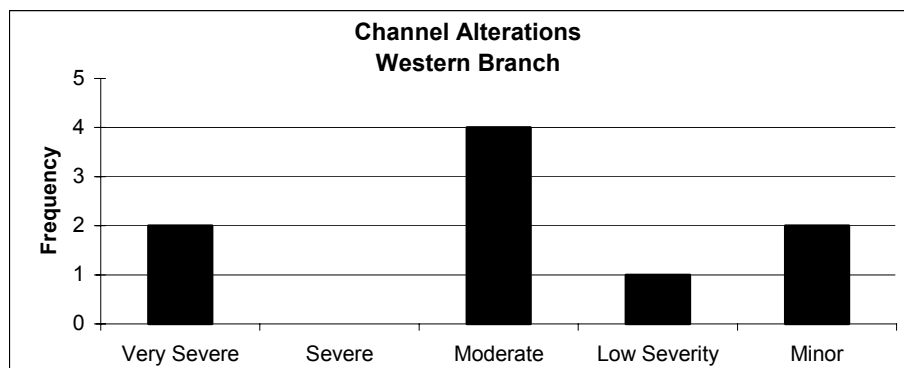
Figure 12a: Histogram showing the frequency of severity ratings given to channel alteration sites during the Western Branch SCA Survey.

In the three surveyed sub-watersheds of the Western Branch watershed, survey crews found 9 areas where the stream channel had been recognizably altered. Locations of channel alteration sites are shown in Figure 12b, and 12c. The total length of stream affected by channelization was estimated to be 5,845 feet, or about 1.1 miles. The majority of the sites were rip-rap channels (4), and earth channels (3). Other sites were found to be a concrete channel (1) and a vinyl plastic sheet (1). Perennial flow was reported at all 9 sites, and sediment deposition was reported at 4 sites. Vegetation was found in the channel at 3 sites. Most of the sites in the Western Branch watershed were given low severity ratings (Figure 12a). There were only two sites that received very severe ratings. Site WB243103 is a concrete channel that is 1,800 feet long. At site WB401401 the stream has been placed in a channel lined with black plastic sheeting. Both if these channels are open to the sunlight. Such channels are prone to thermal heating, which contributes to a decline in in-stream aquatic populations.
