## M; 23-88 George L. Stabler Smokehouse/Dairy.

Measured and Drawn by Peter Morrill. September, 2021

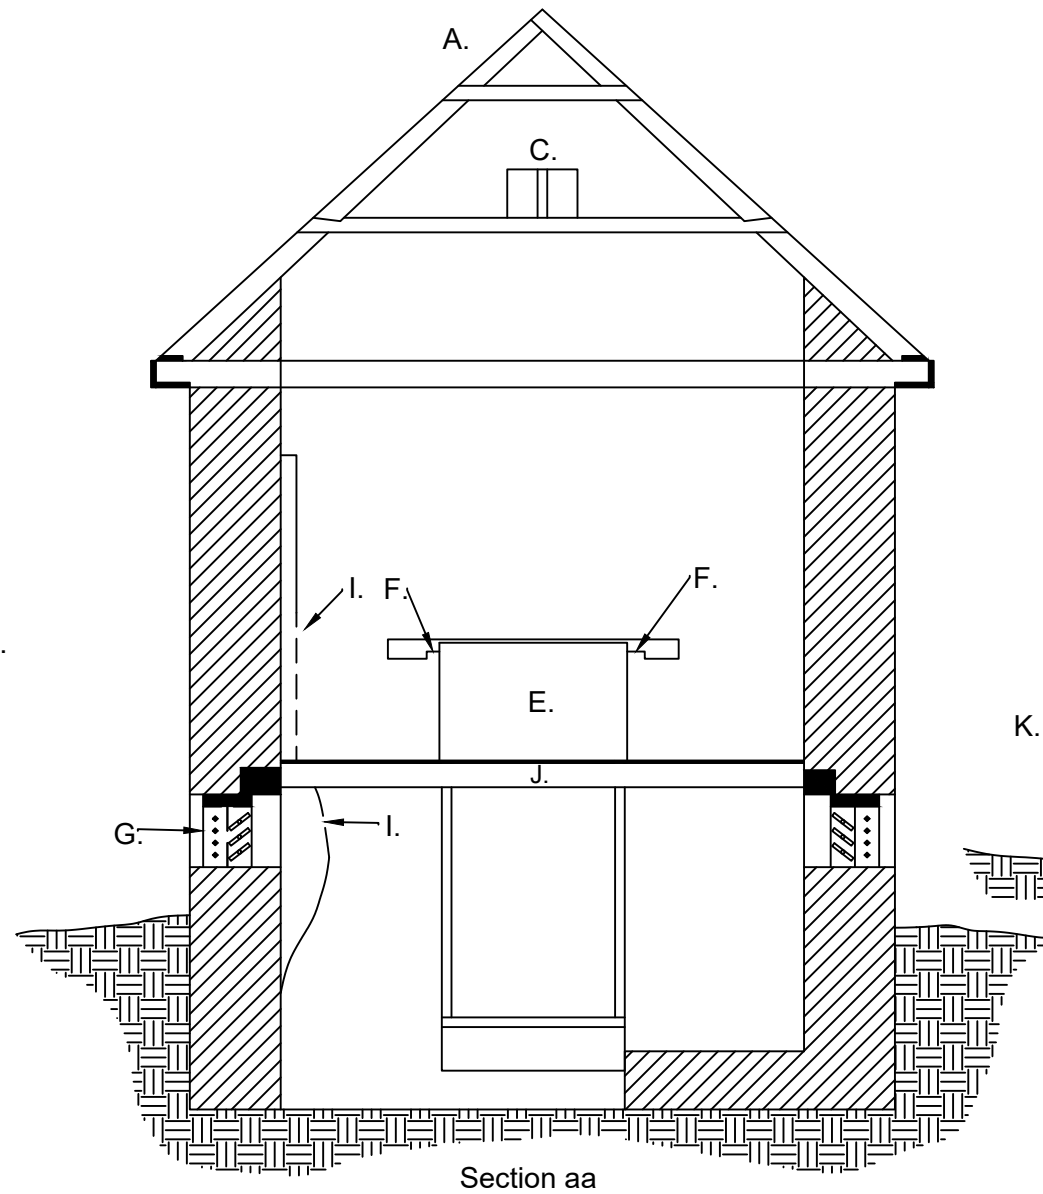
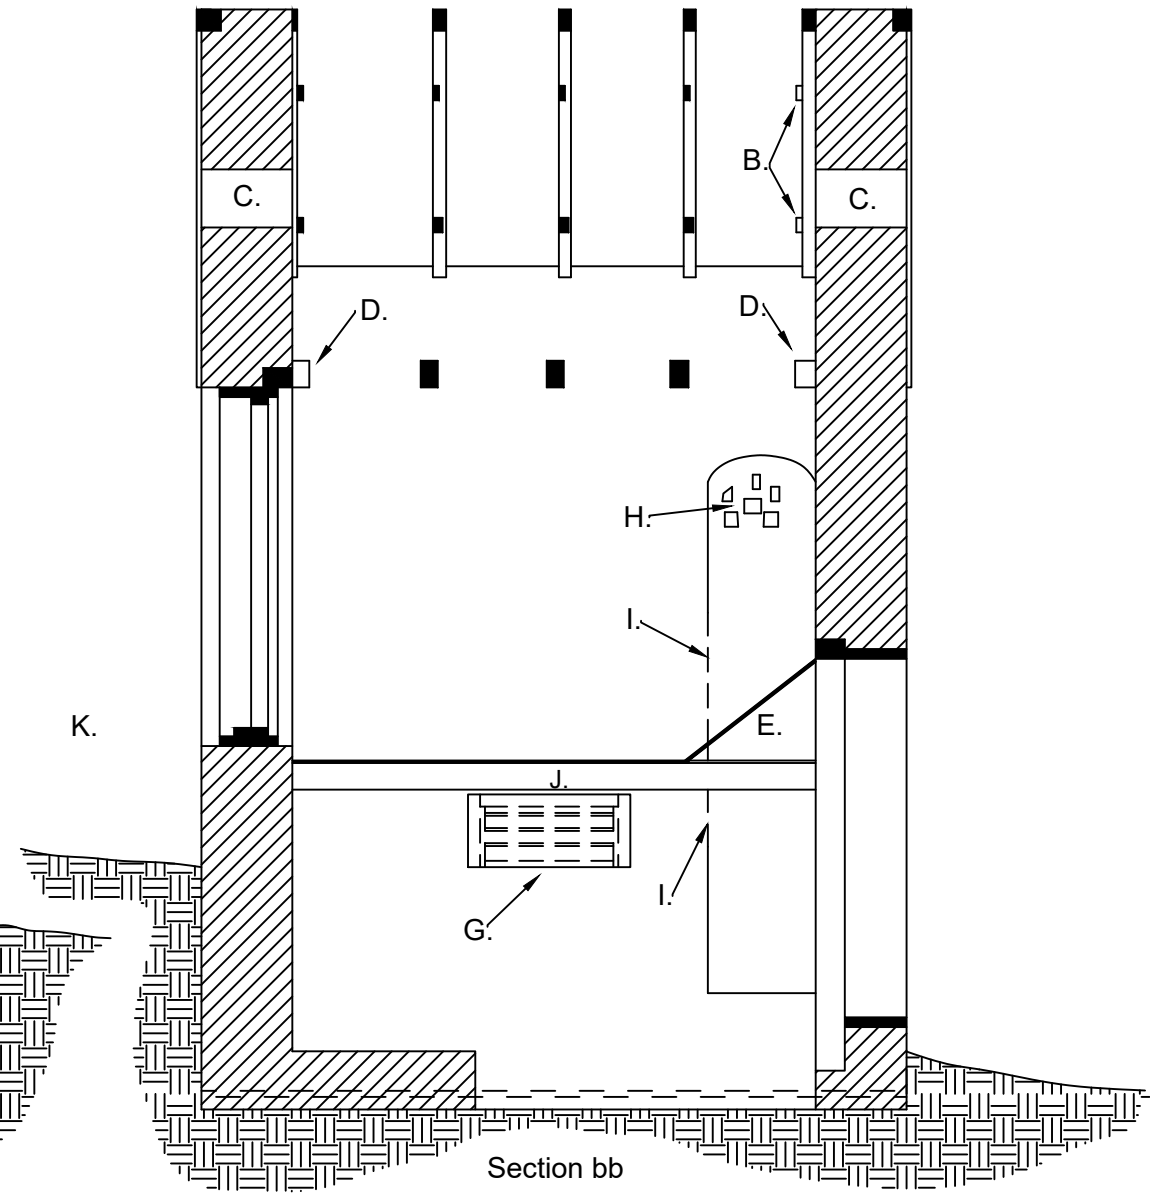
- A. Roof sheathing and shingles not shown.
- B. Collar missing.
- C. Vent.
- D. Beam cut off near wall.
- E. Modern door bulkhead.
- F. Location of original bulkhead framing.
- G. Original window frame, louvers, and bars missing.
- H. Smoker vents.
- I. Smoker chimney partially missing.
- J. Modern floor structure.
- K. Modern deck/stairs not shown.
