Monitoring Results: Stream Restoration in the Red Hill Branch Watershed

HOWARD COUNTY, MARYLAND

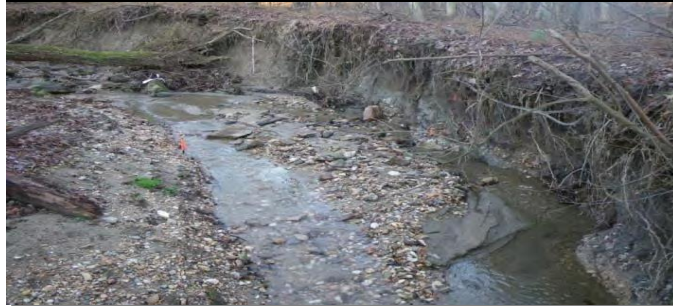
BEFORE RESTORATION IN 2011

Eroding stream banks in an urban area were allowing excess nutrients and sediment to reach the Chesapeake Bay.

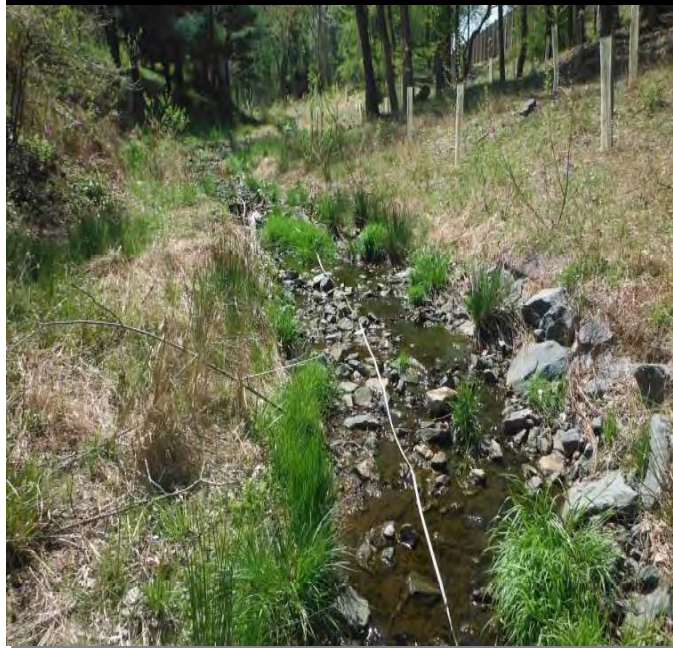
AFTER RESTORATION

The stream was restored in 2011 by stabilizing and re-vegetating 3,165 linear feet of stream banks for \$1,048,000 thereby reducing excess nutrients and sediment. Added benefits included improved stream habitat, protected property and infrastructure.

Stabilized stream banks are reducing excess nutrients and sediment reaching the Chesapeake Bay.
